Camp Lutherlyn Passive Treatment System
SRI O&M TAG Project #1 Request #2
OSM PTS ID: PA-100

Requesting Organization: Camp Lutherlyn
 Receiving Stream: Semiconon Run
 Watershed: Connoquenessing Creek
 Municipality/County: Connoquenessing Township, Butler County
 Latitude/Longitude: 40°52'23.9988"N / 80°01'15.9996"W

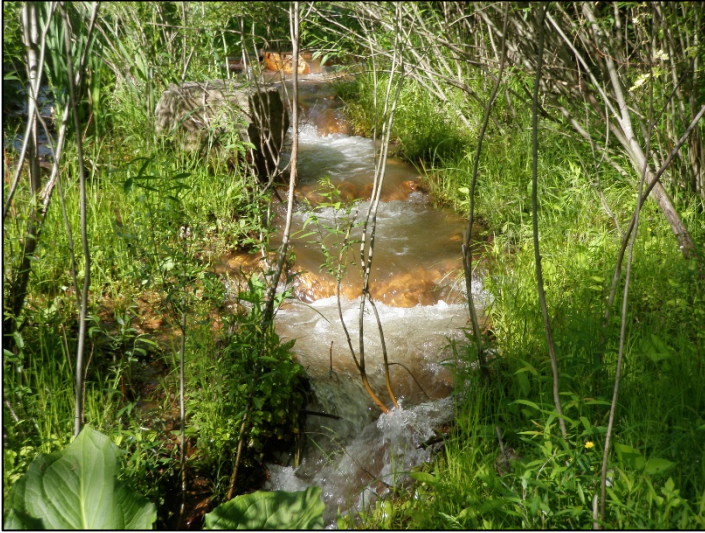
Top Left: A mine pool blowout significantly increased flow and iron concentrations to the Lutherlyn passive system.

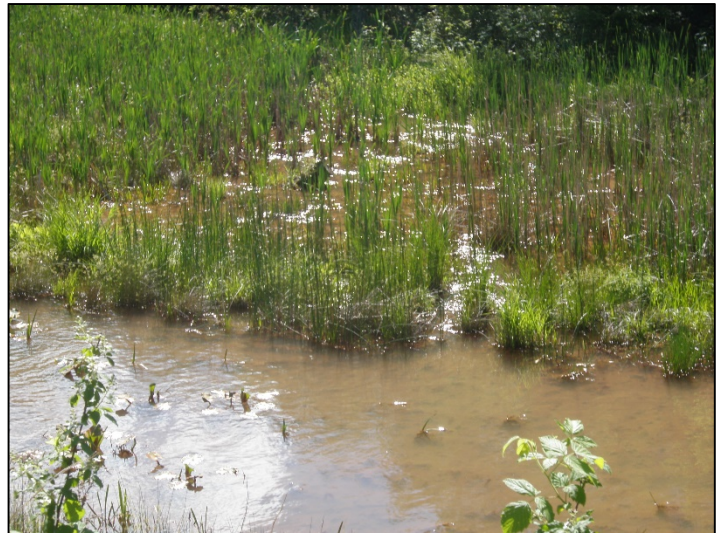
Top Right: The blowout caused or at least enhanced breaches in the berm separating the inlet pool from the wetland as well as channelization in the treatment wetland, resulting in short-circuiting and therefore decreased treatment efficiency.

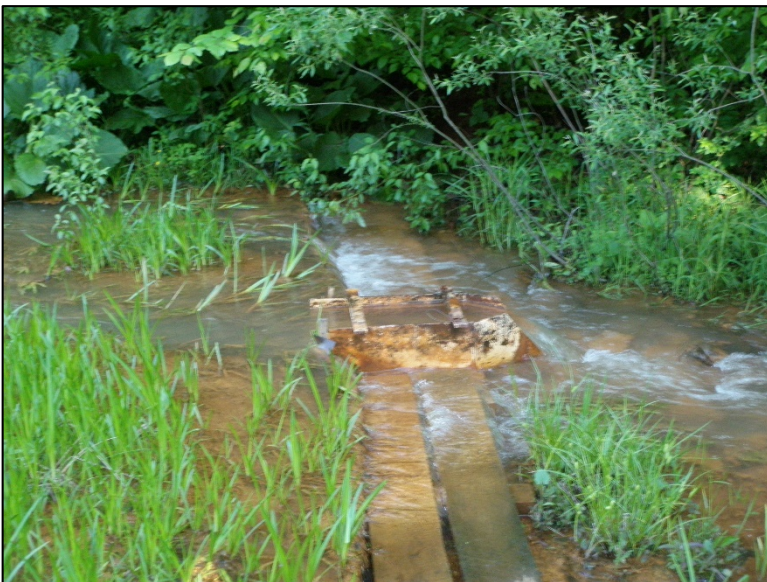
Bottom Left: In addition, during the blowout, increased flow overwhelmed the system and drastically reduced treatment performance, allowing a large iron load to enter the stream.

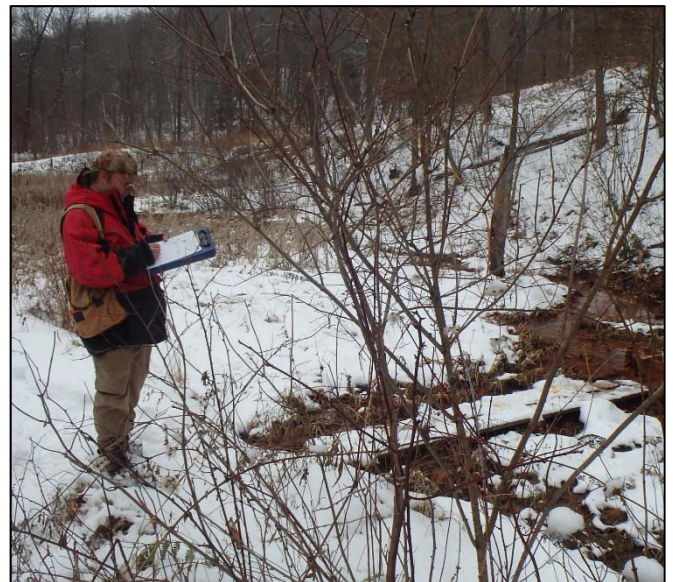
Bottom Right: Several site investigations and meetings were conducted as part of this project to evaluate and discuss the maintenance and repairs needed.
