**Aylesworth Creek Acid Mine Drainage Project**  
**SRI O&M TAG Project #4 Request #1**  
**OSM PTS ID: PA-130**

Requesting Organization: Lackawanna County Conservation District  
Receiving Stream: Aylesworth Creek  
Watershed: Lackawanna River  
Municipality/County: Archbald Borough, Lackawanna County  
Latitude/ Longitude: 41°31'12"N / 75°31'28"W

This report is an update to and should replace the report completed in June 2015 under O&M TAG 1.

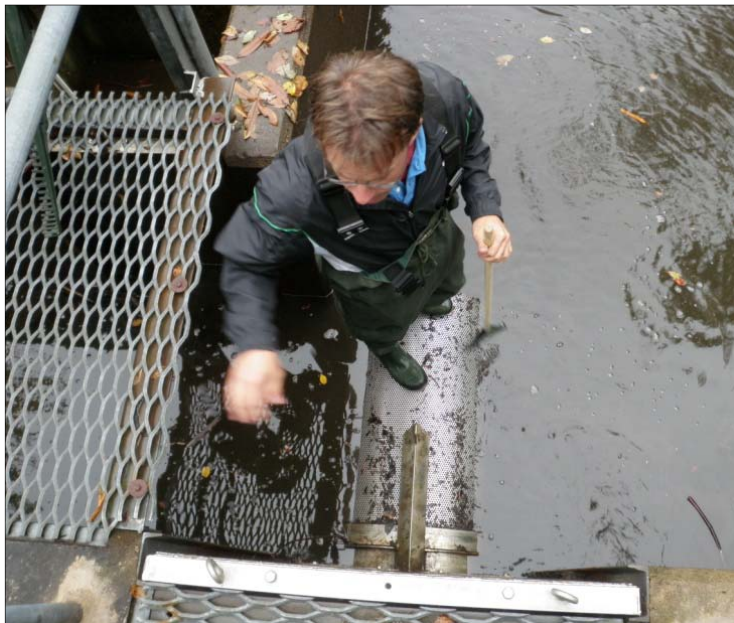
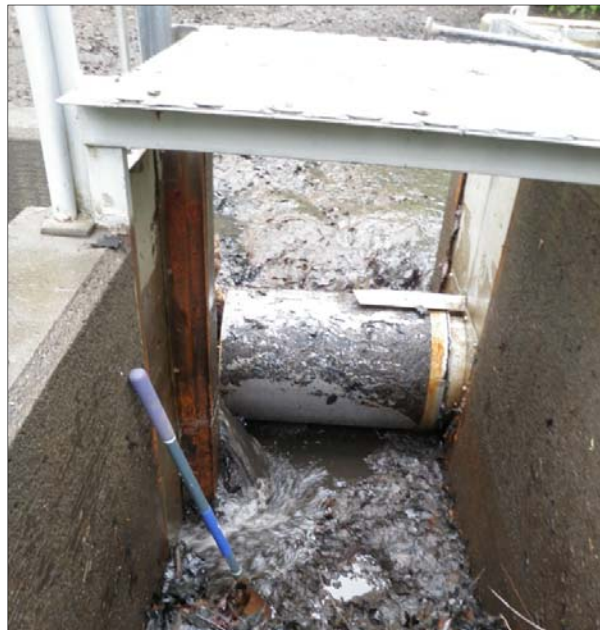
Another issue identified as a potential problem was the excess amount of leaves and other organic material which had accumulated in the forebay. The organic material not only reduces the capacity of the forebay, but also reduces the ability of the cyclone screen to spin. This issue could be remediated by removing material currently in the forebay, as well as developing a plan for future scheduled removal. One option would be to flush the organics downstream using the emergency spillway that discharges to a lower settling pond, from which the organic matter could easily be removed by excavation or other means. Another alternative would be to pump the organic material to an existing settling pond above the treatment system, or dredge the material.

**Top Left & Right:** The cyclone screen being cleaned to allow flow to the Oxid Limestone Drain.  
**Bottom Left:** The siphons which may be disabled as needed to allow the cyclone to function properly.  
**Bottom Right:** The bearings for the cyclone screen were replaced.

- As the cyclone screen will continue to clog with organic material, removal of leaf litter within the forebay should be considered as a regular maintenance item. If possible, the Lackawanna County Parks maintenance staff should flush the forebay each fall.

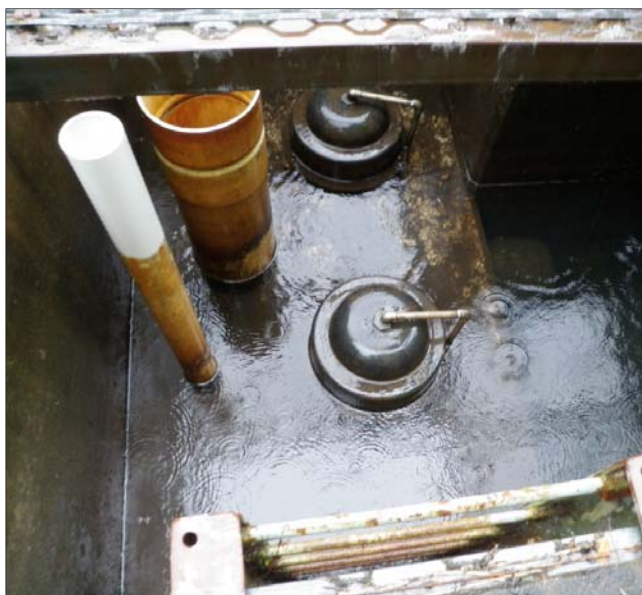
After additional research and communications with the manufacturer, there was the realization that at least part of the problem with the screen was caused by the siphon system. The screen required a certain flow rate as well as head difference (water level) for the screen to turn. With the siphon

engaged, the water level within the box would be too high for the screen to rotate causing the screen to plug with debris. This problem could potentially be amended by increasing the flow rate of the siphons, restricting flow to the cyclone, removing the siphons, or disengaging the siphons and utilizing the much larger drain pipes within the siphon box. The last option was considered the easiest approach as the siphon system was no longer needed due to the previous installation of the Oxidizing Limestone Drain. Another option considered placing the cyclone screen at a higher elevation and raising the water level in the forebay; however, further evaluation of this option is necessary.

- At this time, the siphons are not a necessary component for the OLD passive system to function correctly. While the siphons have been disengaged, they should be left in place and should not be removed unless absolutely necessary as they may be utilized in future retrofitting of the system.

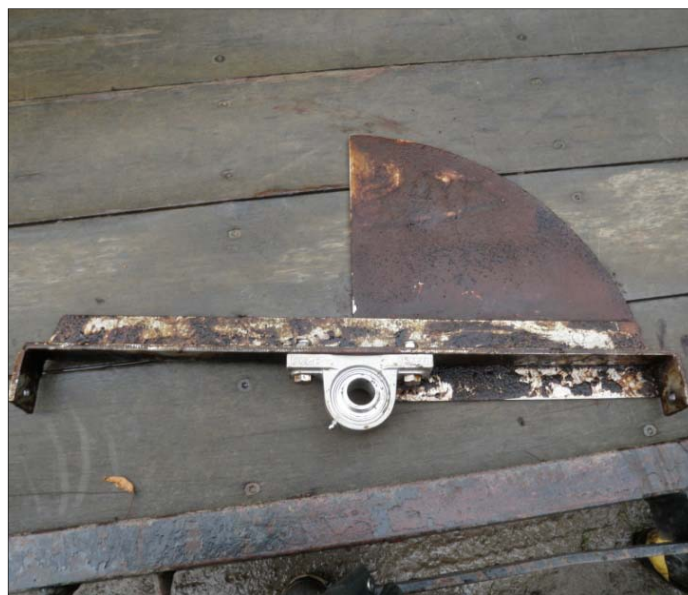
On 6/10/13, Bryan Page and Ryan Mahony of BMI inspected the Aylesworth treatment system and conducted an initial field investigation to identify possible issues restricting rotation of the cyclone screen. An imbalance in the fan structure was observed, which caused the stationary support beam to interfere with the rotation of the fan blades. This issue could have been the result of weight or pressure being placed on the cyclone screen after installation. To correct the problem, adjustments were made to the support beam. New bearings were also lubricated and installed to eliminate another possible source of cyclone rotation issues. While this action helped to improve the functionality of the screen, the problem was not completely resolved as the screen was still not spinning freely.

- Ideally, the leaf litter currently in the forebay could be removed using an excavator or similar piece of equipment.
- Do not stand on the screen as it may damage the fan structure, bearings, etc., that could prevent the screen from rotating.

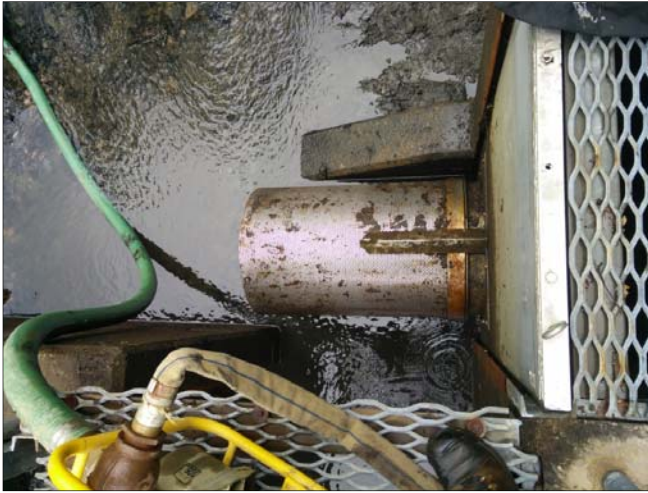
**Top Left:** Flushing the forebay using a pump to direct organic matter to the flush pipe.  
**Top Right:** Removing organic matter by hand.  
**Bottom Left:** The siphon vault was washed.  
**Bottom Right:** The siphons were disabled by removing a plug to allow the cyclone to function properly.

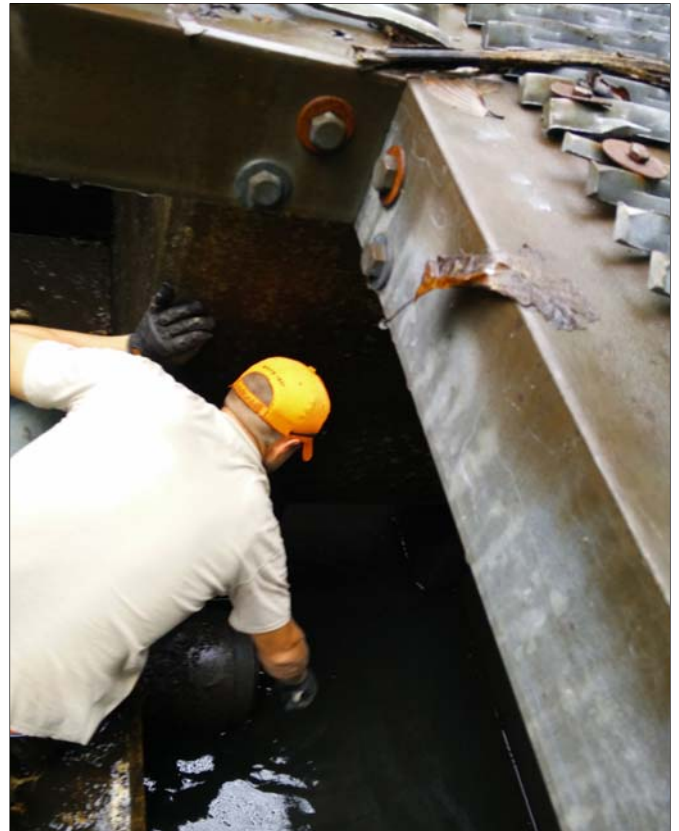
On 6/17/15, Daniel Guy and Ryan Mahony of BMI returned to the site to re-assess and address the outstanding issues relating to the cyclone screen. As described above, it had previously been determined that the best option to allow flow through the system was disengaging the siphon, which was accomplished by removing the drain plug to allow the entire system to flow through the siphon drain pipes. Organic material was also removed from the area surrounding the cyclone and moved through the forebay flush valve (not identified on plans) to allow for proper operation.
