**Bear Run Phase 1 Passive Treatment System**  
**SRI O&M TAG Project #10 Request #2**  
**OSM PTS ID: PA-306**

Requesting Organization: Indiana County Conservation District  
Receiving Stream: Unnamed Tributary to Bear Run  
Watershed: Bear Run  
Municipality/County: Banks Township, Indiana County.  
Latitude/ Longitude: 40°51'46"N / 78°50'53"W

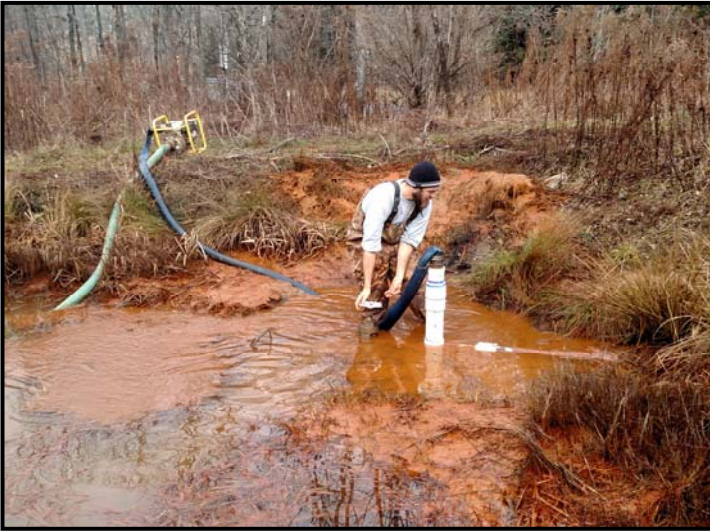
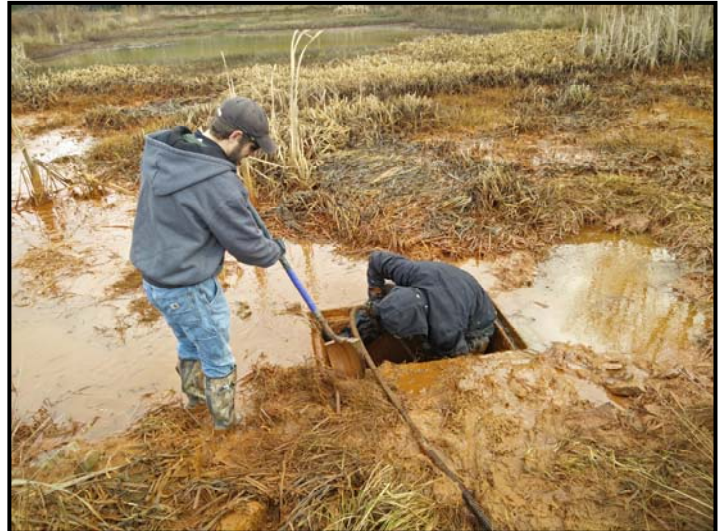
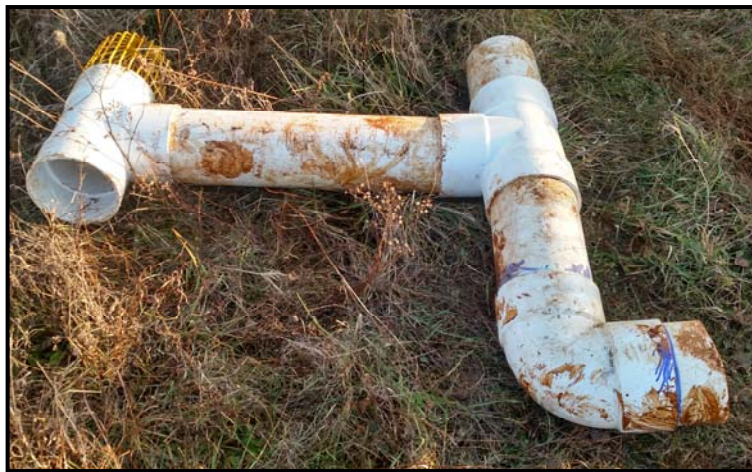
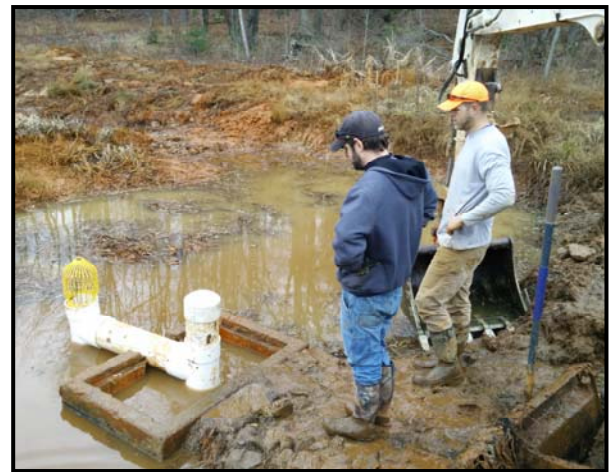
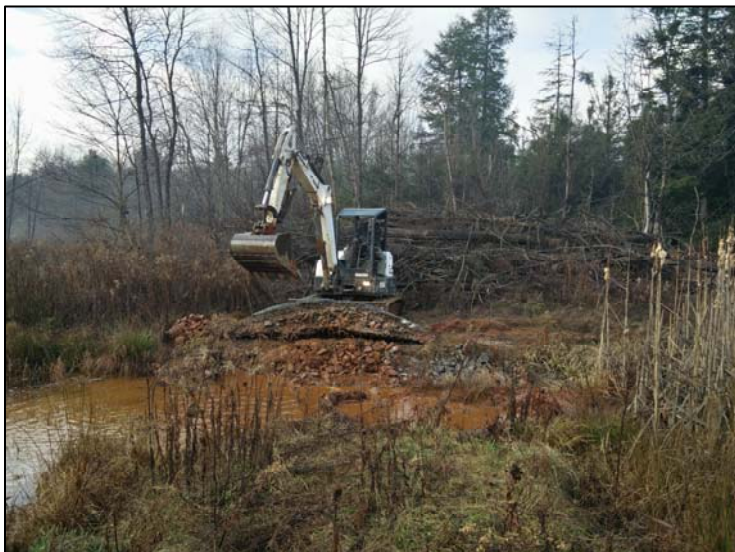
On multiple occasions, the inlet box and pipe plugged at the Bear Run Phase 1 Passive Treatment System causing the water level to rise in the wetlands. BioMost, Inc., worked with volunteers from the Indiana County Conservation District, Evergreen Conservancy, and the Susquehanna River Basin Commission to unplug the pipe (Top Left & Right). The inlet structure was modified by installing a riser pipe to reduce clogging (Center Left & Right). While on site, spillways were cleaned and the outlet of Cell C was lowered (Bottom Left).
