Camp Lutherlyn Passive Treatment System SRI O&M TAG Project #1 Request #1 OSM PTS ID: PA-100

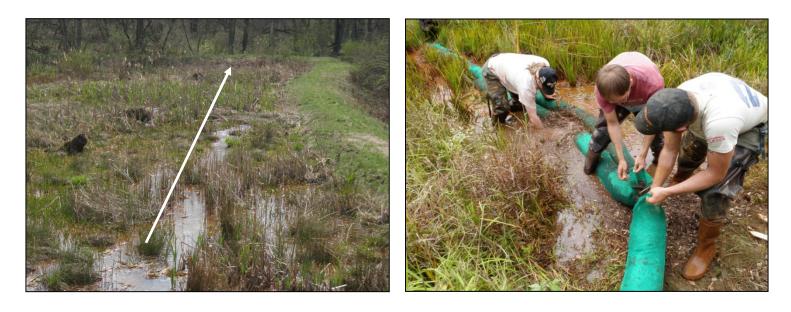
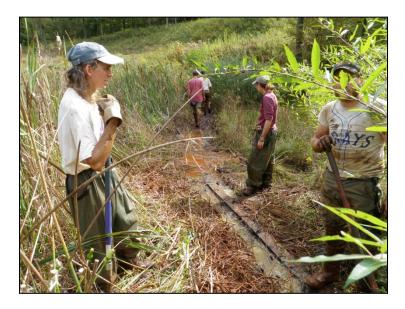
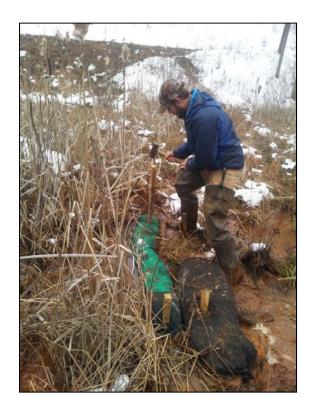
Inspection of the treatment wetland revealed there was significant channelization, which was resulting in short-circuiting and therefore large portions of the treatment wetland were not being utilized. In addition, flow was only going through a portion of the level spreader located in the middle of the treatment wetland due to a build-up of organic matter, sediment, debris, and plants which was likely causing additional short-circuiting to occur. At the effluent spillway, another level spreader, which is used to funnel water through a flume, had also accumulated sludge, sediment, debris, etc. The area behind the level spreader needed cleaning as much of the water was bypassing the flume making accurate flow measurements difficult.

Channelization in the treatment wetland *(top left)* was causing short-circuiting to occur resulting in decreased treatment efficiency. The channelization was disrupted by installing compost filter sox *(top right and bottom right)* to block flow paths and deflect water into other underutilized areas of the treatment wetland. Iron sludge, organic debris, plants, etc., had accumulated behind the level spreaders preventing the water from being evenly distributed *(bottom left)*. This area was cleaned out with much assistance provided by Camp Lutherlyn volunteers *(bottom left)*.

On September 26, 2011, Buck Neely, Bryan Page, Ryan Mahony, and Cliff Denholm from BioMost, Inc. and Stream Restoration Inc. met onsite with Todd Garcia-Bish, Maddy Kelley, and Patrick Maguire from Camp Lutherlyn. In order to address channelization within the wetland, 8-inch and 12-inch diameter compost socks were strategically placed by hand within the treatment wetland to block the preferential pathways as well as to function as baffles to direct the flow into unused portions of the wetland. The accumulated organic matter, sediment, debris, and plants associated with the two level spreaders were dug out by hand. Some of this material was used in the stabilization of the compost socks. The volunteers from Lutherlyn were all very helpful providing labor and the use of their skid-loader to offload and transport the two pallets of filter socks.
