**De Sale Phase II Passive Treatment System**  
**SRI O&M TAG Project # 22 Request #1**  
**OSM PTS ID: PA-114**

Requesting Organization: Slippery Rock Watershed Coalition (in-kind partner)  
Receiving Stream: Unnamed Tributary (Slippery Rock Creek Watershed)  
Hydrologic Order: Unnamed Tributary→Seaton Creek→Slippery Rock Creek→  
Beaver River→Ohio River  
Municipality/County: Venango Township, Butler County  
Latitude/Longitude: 41°08'39.9984"N / 79°49'54.9984"W  
Construction Year: 2000

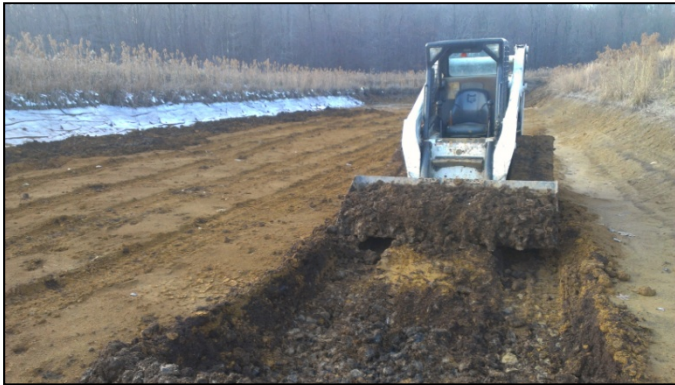
The top 1 to 2 feet of the VFPE treatment media was stirred with a skid loader (*top left*) to reduce short-circuiting and to improve permeability (*top right*). Vegetation, metal-bearing sludge, and other debris had accumulated in the VFP spillway (*middle left*) making water monitoring, especially flow measurement, difficult. The spillway was cleaned (*middle right*). Vegetation, sediment, etc. that had grown and accumulated in the wetland spillway (*bottom left*) would at times cause the water to bypass the HFLB, especially in the winter when ice would also accumulate. The vegetation and debris was, therefore, removed from the wetland spillway (*bottom right*).

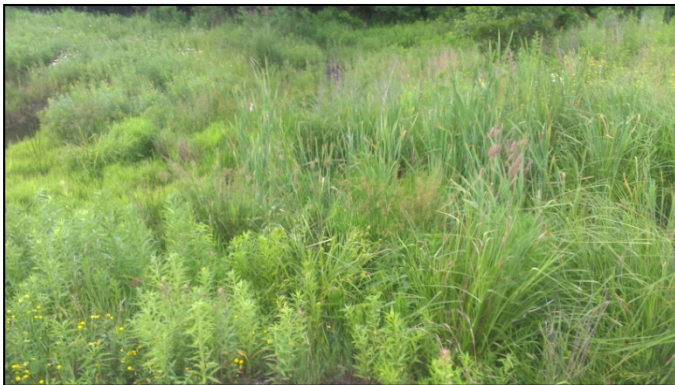
In addition, during the winter of 2012/2013, an SRWC monitoring volunteer reported that the outlet of the wetland became frozen and began to overtop the berm and bypass the HFLB due to an increase of plants, sludge, and organic matter in the outlet channel and that the channel needed to be cleaned. He also noted that the VFP outlet channel had become clogged with dense organic growth to the point that made water monitoring difficult and asked if the channel could be cleaned as well. In June 2013, BMI returned to the site to perform additional maintenance including cleaning the inlet and outlet of the forebay, clearing the VFP spillway of vegetation, clearing the wetland outlet of vegetation, and re-leveling the HFLB. Clearing the VFP outlet facilitated the measurement of flow rate and water quality sampling.
