**De Sale Phase III Passive Treatment System**  
**SRI O&M TAG Project # 23 Request #1**  
**OSM PTS ID: PA-117**

Requesting Organization: Slippery Rock Watershed Coalition (in-kind partner)  
Receiving Stream: Unnamed Tributary (Slippery Rock Creek Watershed)  
Hydrologic Order: Unnamed Tributary→Seaton Creek→Slippery Rock Creek→  
Beaver River→Ohio River  
Municipality/County: Venango Township, Butler County  
Latitude/Longitude: 41°08'31.9992"N / 79°50'16.0008"W  
Construction Year: 2002

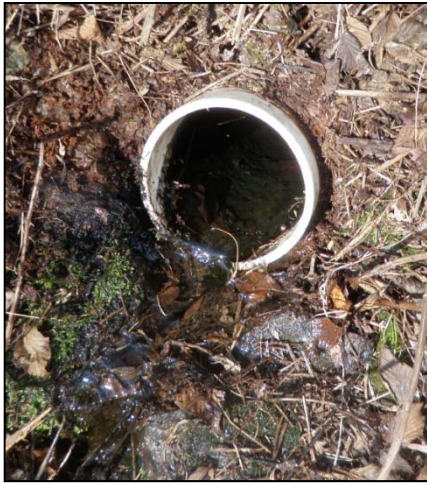
The Horizontal Flow Limestone Bed (HFLB) outlet pipe was not flowing (*top left*) causing the water level in the HFLB to increase and flow through the emergency spillway. The pipe was back-flushed with compressed air (*top middle*) and the pipe began to flow at full-pipe (*top right*) indicating that perforations within the manifold of the effluent pipe had become plugged. The HFLB was also stirred (*bottom left*) to increase permeability and an inlet trench was constructed to assist with flow distribution (*background - bottom right*).

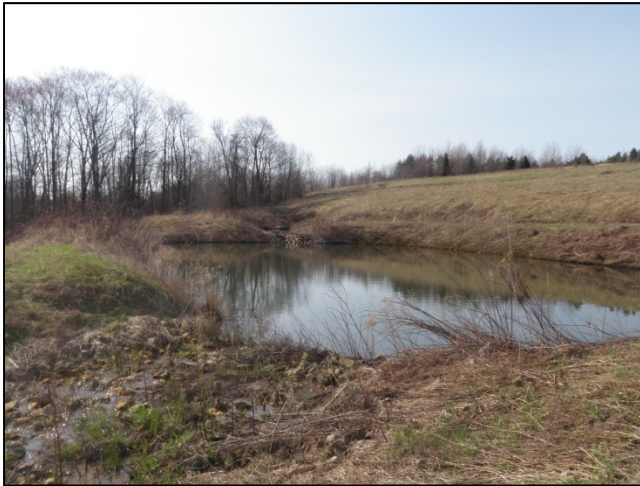
VFP1 was overflowing (*top left*) due to the accumulation of several inches of low pH iron solids on the compost layer (*middle left*). After removing the iron, the upper 1 to 2 feet of treatment media was stirred (*top right*) to reduce short-circuiting and to improve permeability (*middle right*). In addition, a new baffle curtain was installed in SP2 (*bottom left*) and the access road entrance repaired including installation of a culvert.
