**De Sale Phase 2 Passive Treatment System**  
**SRI O&M TAG Project #22 Request #2**  
**OSM PTS ID: PA-114**

Requesting Organization: Slippery Rock Watershed Coalition  
Receiving Stream: Unnamed Tributary to Seaton Creek  
Watershed: Slippery Rock Creek  
Municipality/County: Venango Twp., Butler Co.  
Latitude/Longitude: 41° 8' 40" N / 79° 49' 55" W

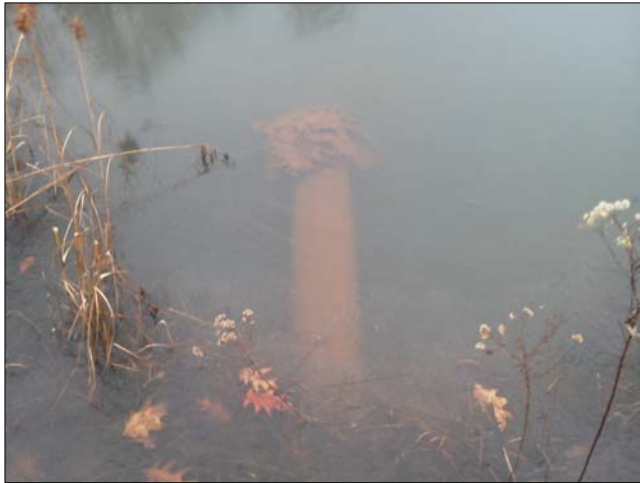
Previous O&M assistance had been provided under the O&M TAG 1 grant to stir Vertical Flow Pond East (VFPE), as well as cleaning the inlet and outlet of the forebay, clearing the VFP spillway of vegetation, clearing the wetland outlet of vegetation, and re-leveling the HFLB. A new request for maintenance was received by the SRWC in September 2014. Over the winter of 2013/2014, leaves, sticks and other debris had clogged the bar guard of the forebay pipe which splits flow between the two Vertical Flow Ponds. Ice built up quickly and water began to flow over the emergency spillway, bypassing the treatment system. In addition, volunteers had complained that the inlet of the pipe and bar guard were too far out in the pond to easily and safely clean. A plan was developed to address these issues.

**Top Left:** The bar guard on the Forebay effluent pipe was difficult to clean because of the length of the pipe that extended into the pond.  
**Top Right:** Effluent pipe was shortened and a tee with bar guard on top was added to provide two points of entry.  
**Bottom Left:** Water monitoring was conducted and a decision was made to backflush all of the VFP pipes, making it necessary to temporarily cap the outlet pipes.  
**Bottom Right:** The top 3-4 feet of treatment media within VFPW was stirred.

In December 2014, maintenance was conducted. The inlet side of the 10" forebay pipe was cut so that it would be easier to reach from the side of the pond and a 10" tee was installed to help prevent clogging and provide two different points of entry. The 8" flexible couplers (Ferncos) and 8" elbows that were used to balance the flow from the Forebay to the two VFPs were replaced with 8" x 6" reducers fitted with 6" shielded Ferncos and 6" 90-degree elbows to reduce the effort needed to adjust the flow. The emergency spillway of the Forebay was relocated to direct any future overflow events into VFPE instead of bypassing the water to the stream.

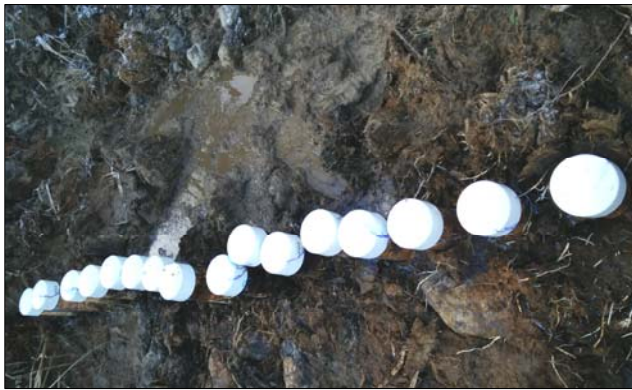
Before performing those modifications, water quality monitoring was conducted at both VFP outlets (8 pipes per VFP) and the wetland outlet. Each VFP pipe that was flowing was sampled individually to assess functionality of each cell. The VFPE upper tier of pipes had poor water quality, and the lower tier of pipes had better water quality. It is possible that during previous O&M activities, the upper tier of pipes had been compromised, which allowed short circuiting to occur, although the fact that the pipes are located near the top of the media does reduce residence time. The VFPW pipes were also sampled, and it was determined that stirring the pond would be beneficial to improve water quality of the effluent pipes.

Both VFPs were backflushed (8 pipes per VFP) using an excavator to power a 6" hydraulic-drive pump in an effort to clear the area surrounding the underdrain pipes from any materials which may have been preventing flow to the pipes. The VFP outlet riser pipes were capped during this process to allow sufficient pressure for the backflushing process. These caps were later removed from the lower tier of pipes and the outlet risers were reinstalled. Pressure from the backflushing process was high enough that some of the pipes connecting to the outlet valves were loosened. Those pipes were re-connected as needed. Visual inspection of both ponds were conducted during the backflushing activities for each pipe, but very little was able to be discerned due to a 1"+ layer of ice on both ponds. A plume of iron was noted under the ice upon flushing pipe #5, which is one of the upper tier pipes in VFPW. Water levels within both ponds rose noticeably during backflushing.
