Dents Run 3895 Passive Treatment System
SRI O&M TAG Project #32 Request #1
OSM PTS ID: PA-276

Requesting Organization: Bennett's Branch Watershed Association
Receiving Stream: Porcupine Run
Watershed: Bennett Branch Sinnemahoning Creek
Municipality/County: Bennezette Twp., Elk Co.
Latitude/Longitude: 41° 20' 24.72" N / 78° 20' 18.984" W

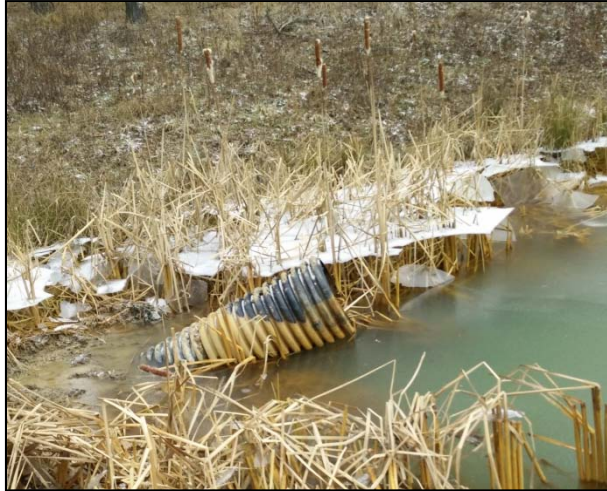
- The SB1 outlet pipe had shifted, changing the water outlet elevation which prevented water from flowing underneath the access road to the next treatment component. This caused the water level within the pond to rise and then flow out the emergency outlet riser directly into Porcupine Run thus bypassing the rest of the treatment system. This problem was probably caused by ice pushing against the outlet pipe elbow, causing it to rotate.
- Vegetation growing in OPC3 had also been an on-going issue causing water to backup into SB1.
- A low point in the berm of OPC3 needed to be built up to prevent over topping.

At Dents Run 3895, the elevation of the SP1 settling pond outlet pipe had shifted (Top Left) which prevented water from flowing into the Phase 2 portion of the passive system. This caused the water level to increase in the pond and then flow out through the emergency overflow riser (Top Right) bypassing the rest of the system. The SP1 outlet pipe was shortened and a downward facing elbow added (Middle Left) to restore proper flow. The low spot in the OPC3 berm was repaired by adding dirt to build up the berm (Middle Right) in order to prevent overtopping. Vegetation, metal sludge, and other debris that had accumulated in the OPC3 inlet spillway, (Bottom Left) were removed and the channel deepened to prevent water from backing up into SP1.

- The SB1 outlet pipe was cut shorter and a downward facing elbow installed to direct flow into the pipe that conveys flow underneath the road to the Phase 2 portion of the system.
- A section of OPC3 near the inlet was excavated to deepen the channel, which should reduce vegetation growth and maintain flow from Phase 1 to Phase 2.
- Dirt was placed and compacted along the low spot of the OPC3 berm to prevent overtopping.
