**Coal Pit Run Upper & Lower Passive Treatment Systems**  
**SRI O&M TAG Project #37 Request #1**  
**OSM PTS ID: PA-126**

Requesting Organization: Blacklick Creek Watershed Association  
Receiving Stream: Coal Pit Run  
Watershed: Blacklick Creek  
Municipality/County: Blacklick Twp., Cambria Co.  
Latitude/Longitude: 40° 29' 56.0004" N/78°49'58.0008" W

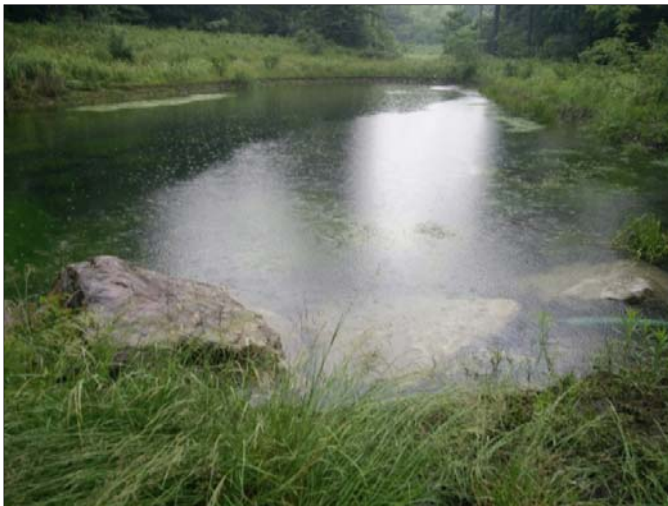
**Top Left:** The Vertical Flow Pond of the Upper System had become plugged and at times a large portion of the water was flowing through the emergency spillway.  
**Right:** During the site visit, the flush valve was opened with difficulty, but the VFP drained very slowly indicating that permeability of the treatment media had significantly decreased and likely the cause of the problem.  
**Bottom Left:** Once drained, the vertical flow pond was stirred to restore full flow through the system components.

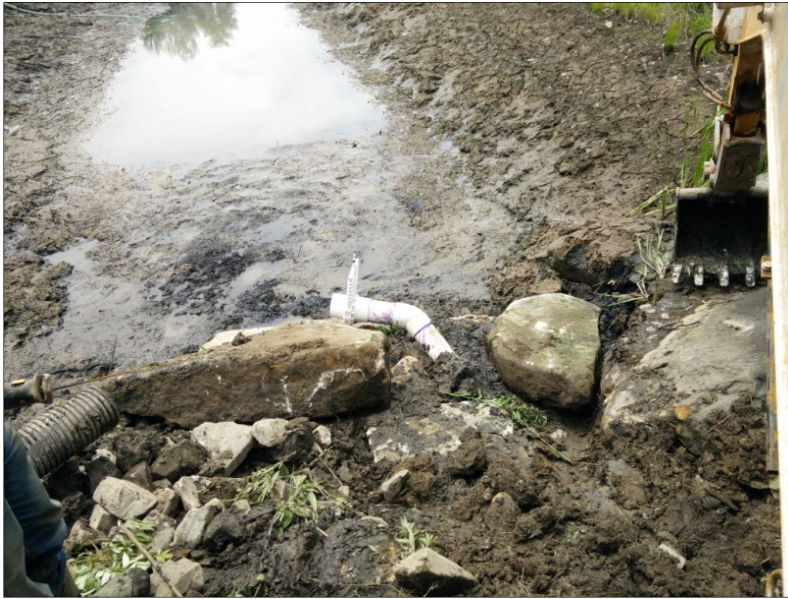
**Top Left:** Due to the difficulty to close the flush valve, a new valve was installed.

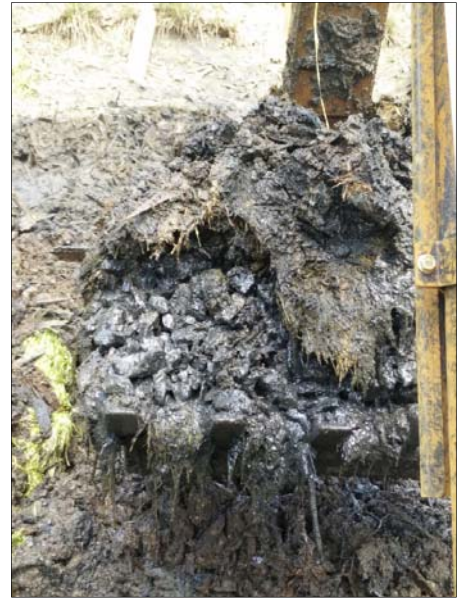
**Top Right:** An excavator stirred the top 2-3 feet of treatment media in the Vertical Flow Pond to increase permeability and promote better utilization of the treatment media.

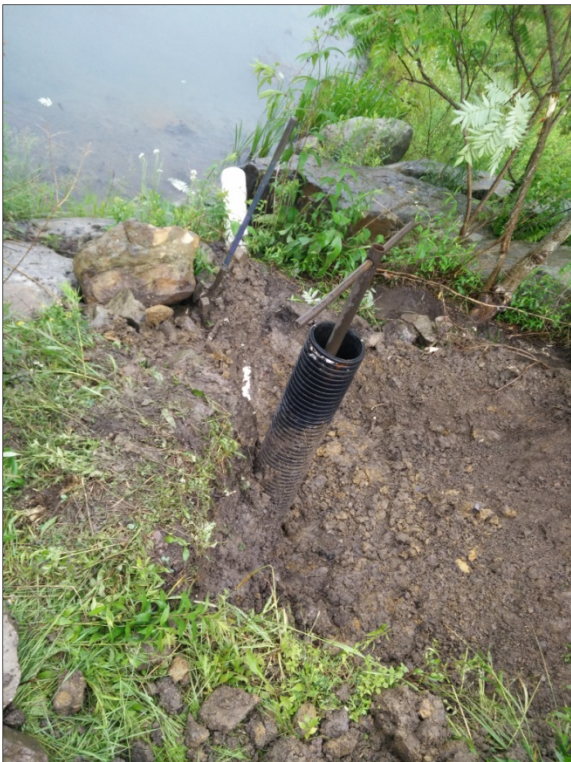
**Bottom Left:** The old flush valve was backfilled and abandoned because it could not be closed.

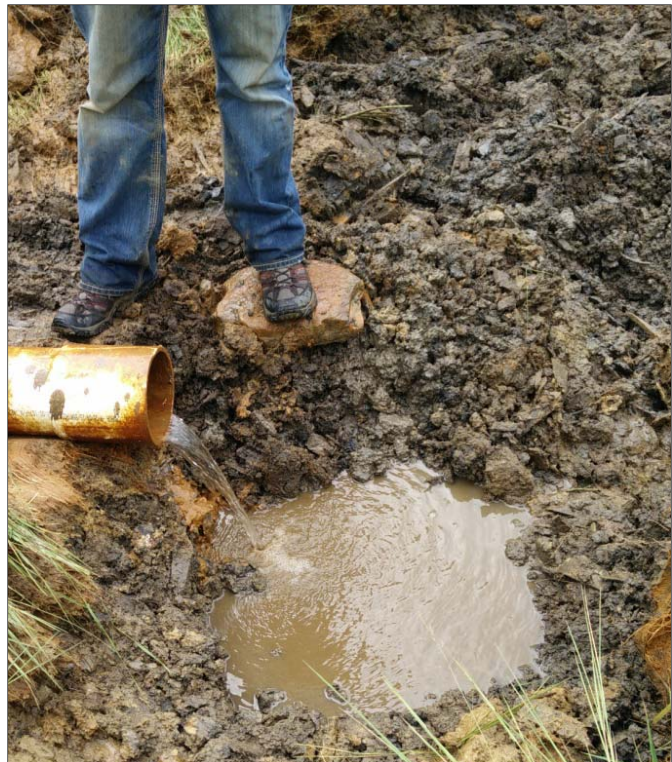
**Bottom Right:** The raw water inlet at the Lower System was cleared to allow for flow measurements and sampling.
