MIDDLE LOYALHANNA CREEK WATERSHED

SECTION 2

Section 2 – Middle Loyalhanna Creek Watershed

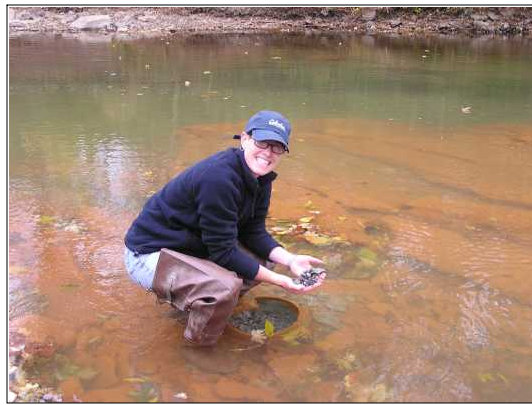
LWA staff member shown at the site of Adelphoi Borehole. As of fall 2004, it was plugged with gravel and debris from flooding

Five hundred feet downstream of the Loyalhanna Creek confluence with Monastery Run, two discharges each contribute 130-150 gpm into the Loyalhanna Creek. The first is a borehole drilled into the middle of the stream. The borehole, referred to as the Adelphoi Borehole, was drilled in order to relieve basement flooding in nearby homes in the 1950s or 1960s. As of late fall 2004, the borehole was plugged with gravel, cobble, and various debris from flooding. As a result of the borehole and other discharges, iron staining is visible along the Loyalhanna Creek streambanks and substrate. The second discharge, known as the Adelphoi Pipe, flows from the bank directly above the borehole. Both discharges are located directly behind the Adelphoi Village school complex. Flowing from a large storm drain, one more discharge enters the stream 500 feet from the two Adelphoi discharge locations. Its source is the Latrobe Mine and Coke Works in Lloydsville. Because it flows

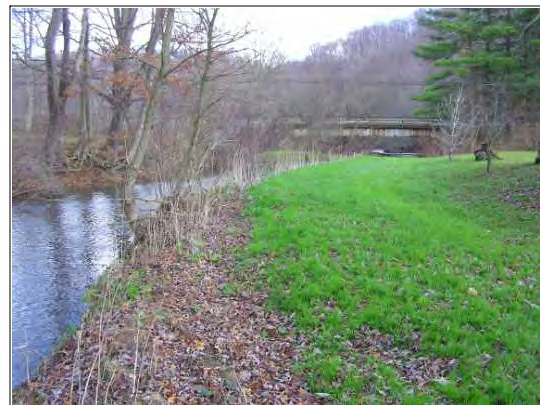
Field and park along Fourmile Run where the riparian area has been removed

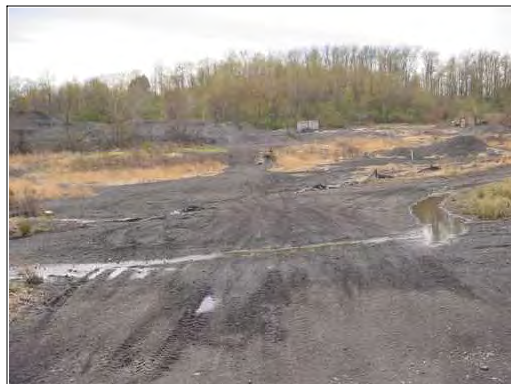
As Ninemile Run continues north, an unnamed tributary enters from the west. The tributary flows from the community of Whitney, where the presence of homes increases. A refuse pile, from a mining operation once located in Whitney, has been partially removed. At the time of the assessment, the refuse pile had no visible impact upon the stream.

Partially reclaimed refuse pile located in Whitney along UNT5W

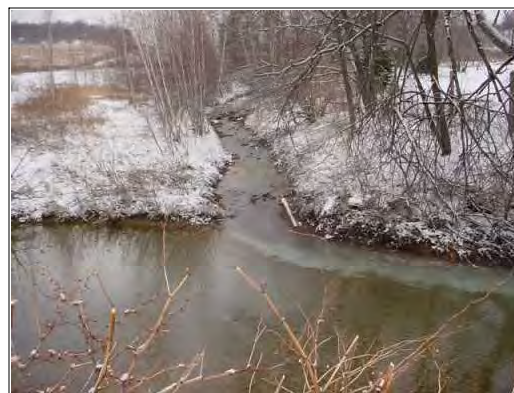
As Ninemile Run flows through Baggaley, it is flanked by a road on one side and residences on the other. Trash, sand, silt, and very little cobble are present along the stream substrate. In addition, algal growth is noticeable along the edge of the stream and on the substrate.

Aluminum precipitates where UNT3W enters the main stem of Ninemile Run

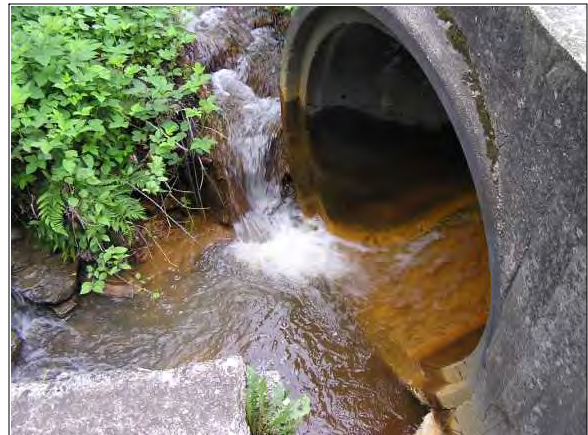
Saxman Run main stem and the West Derry Discharge meet at Valley Road culvert

discharge is covered with bright green filamentous algae. The discharge is currently sampled quarterly by the LWA. Downstream of the confluence with the discharge, Saxman Run flows through an area thick with green briar, multiflora rose, and Japanese knotweed. Flowing the color of orange soda, the stream continues west toward Bradenville following Route 217. The substrate of the stream, comprised primarily of gravel and cobble, is embedded with iron oxide, some aluminum, and mud.
