Tanoma South Passive Treatment System
SRI O&M TAG Project #14 Request #3
OSM PTS ID: PA-60

Requesting Organization: Evergreen Conservancy
Requesting Organization Representative: John Dudash
Municipality/County: Rayne Township, Indiana County
Dates of O&M work performed: 7/15/2021 to 7/20/2021

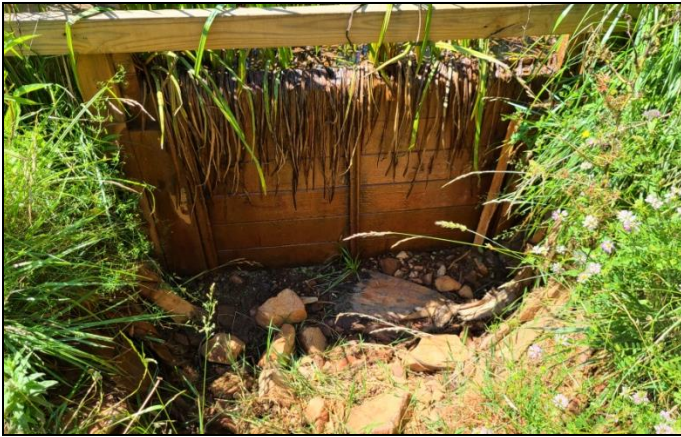
Work Completed: Equipment was mobilized to the site in July 2021. Both outlet weirs (Pond 10 overflow and trompe outlet) showed signs of erosion. The trompe wetland weir appeared to have been compromised by muskrat activity. The Pond 10 overflow weir was eroding on the downstream side. Geotextile was placed and riprap was installed on the Pond 10 overflow weir outlet. Riprap was also placed up the sides of the weir to deter future muskrat activity. On-site clay and bentonite were used to repair the outlet weir before lining with geotextile and enforcing both sides of the weir with riprap. The staff gauges at Pond 1, Pond 10 overflow, and the trompe weirs were checked and adjusted as needed.

- Top Left:** Pond 10 overflow weir eroded on downstream side (7/2/21).
Top Right: Geotextile and riprap placed at Pond 10 overflow weir to prevent erosion (7/20/21).
Bottom Left: Trompe outlet weir eroded around side of weir (7/2/21).
Bottom Right: Trompe outlet weir repaired with riprap placed to prevent erosion (7/20/21).
