**SR 286 Passive Treatment System**  
**SRI O&M TAG Project #16 Request #3**  
**OSM PTS ID: PA-241**

Municipality/County: Center Township, Indiana County

Dates of work performed: 7/7/21- 7-13-21

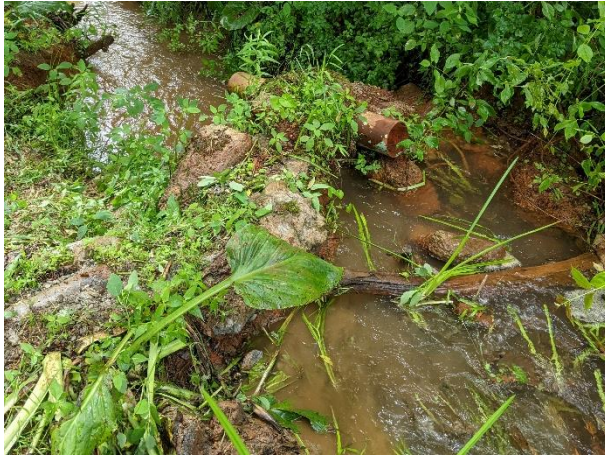
Initial Request: On 2/22/2021, AWARE reported that the outlet flow control and effluent pipe of the SR286 passive system had been damaged and washed away. The damage likely occurred during a flood event.

Initial Site Visit, Observations, and Identified Needs: Previous maintenance activities completed under request #2 included clearing sludge, re-establishing flow at the system outlet monitoring pipe, raising the wetland outlet elevation to increase settling capacity, and installing directional baffle curtains to increase retention time. After that work was completed, high flow events may have compromised the existing flow measurement pipe and supporting structure.

**Top Left:** System outlet flow monitoring pipe was compromised, and flow was not able to be properly measured (7/8/21).

Work Completed: After attempting to repair the outlet dam during previous maintenance events, it was determined that a v-notch weir would be a more appropriate long-term solution. The existing structure was dismantled and a v-notch weir was installed with a staff gauge for flow measurement. The wetland outlet channel was further cleared of debris, vegetation, and accumulated sediment as needed to improve future flow measurement capabilities.

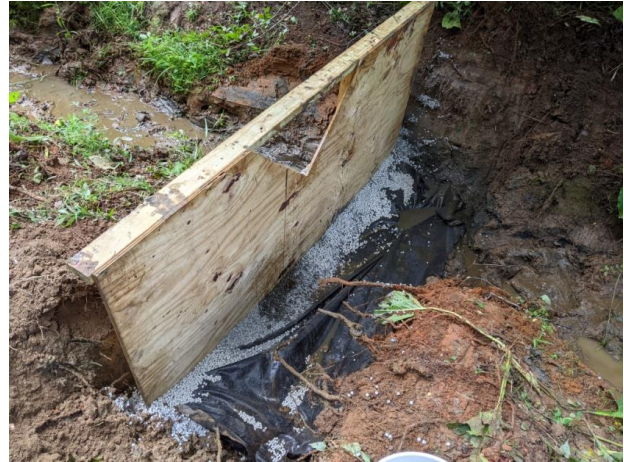
**Top Right:** New weir was constructed to provide for flow control and measurement (7/8/21).

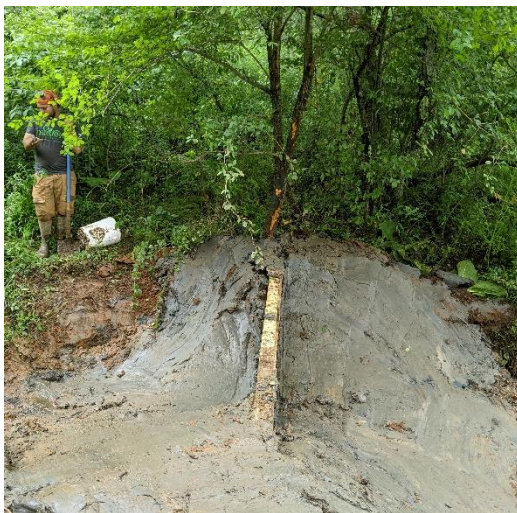
**Bottom Left:** Weir installed with on-site clay and bentonite used to backfill and seal (7/8/21).

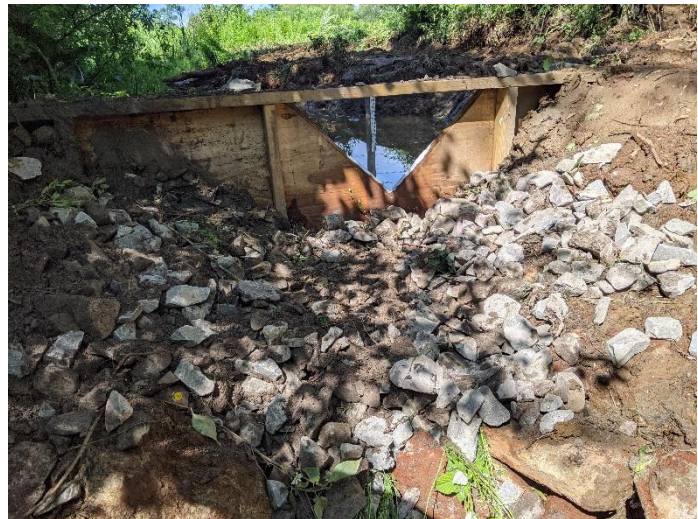
**Bottom Right:** On site stockpiled stone was used to stabilize the weir outlet (7/13/21).
