Slippery Rock Passive Treatment Rehab & Maintenance

A Slippery Rock Watershed Coalition Project

Final Report

Appendix 1
Photographs

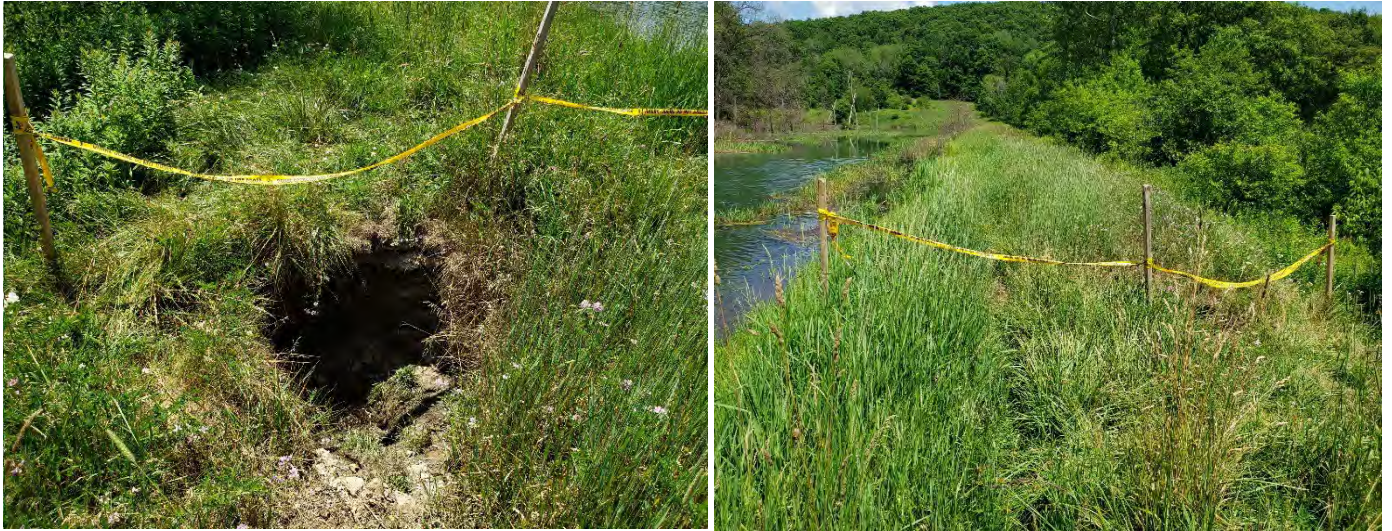
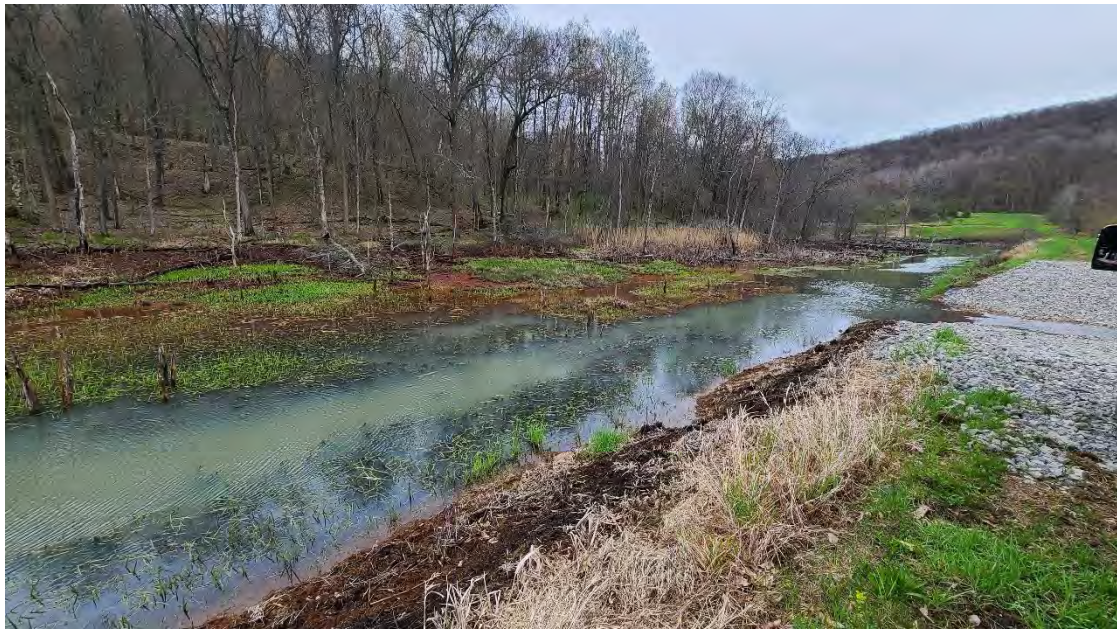
Top Photos: During the 2020 snapshot, a large hole was discovered to have formed within the access road after the culvert pipes conveying flow from Wetland 1 to Wetland 2 had become compromised (2020). While not part of the original project, project partners developed a plan to address this issue. The culvert pipes were removed and replaced with a drivable rock-lined spillway. The spillway permits continued access to the Ferris JP (SR87/SR88) passive treatment system while eliminating recurring issues associated with the original culvert.

Bottom Photo: Wetland 1 at the newly constructed rock-lined spillway that replaced the compromised culvert.

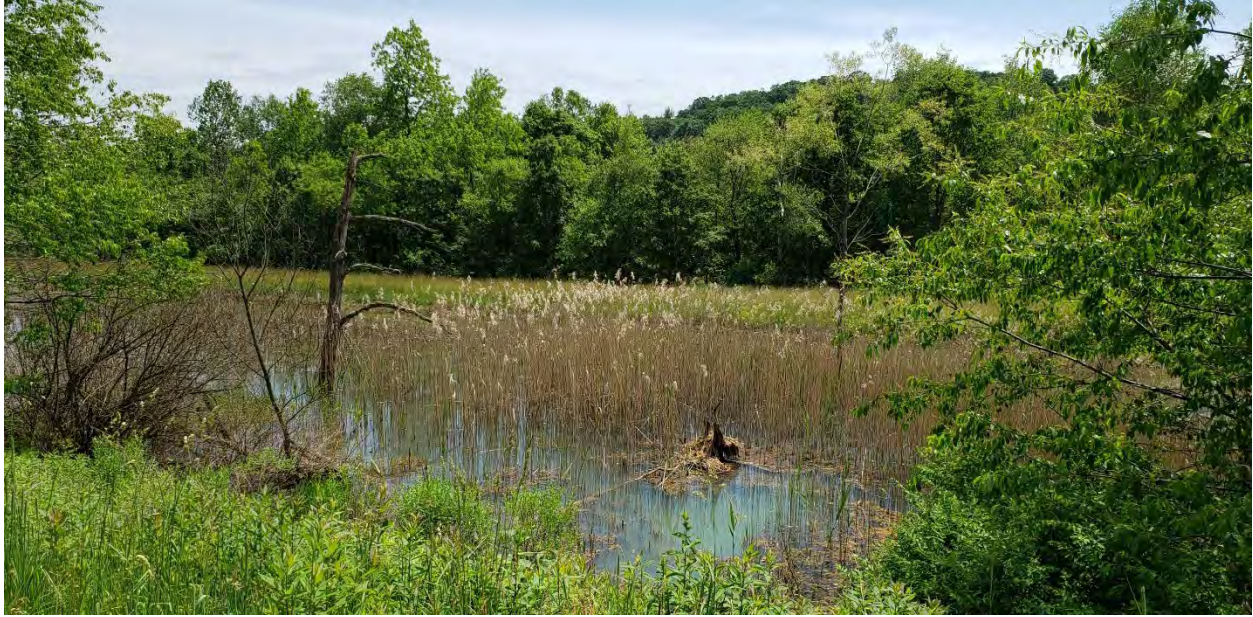
Top Photo: Wetland 2, the final treatment component, prior to the rehabilitation project. (2020)

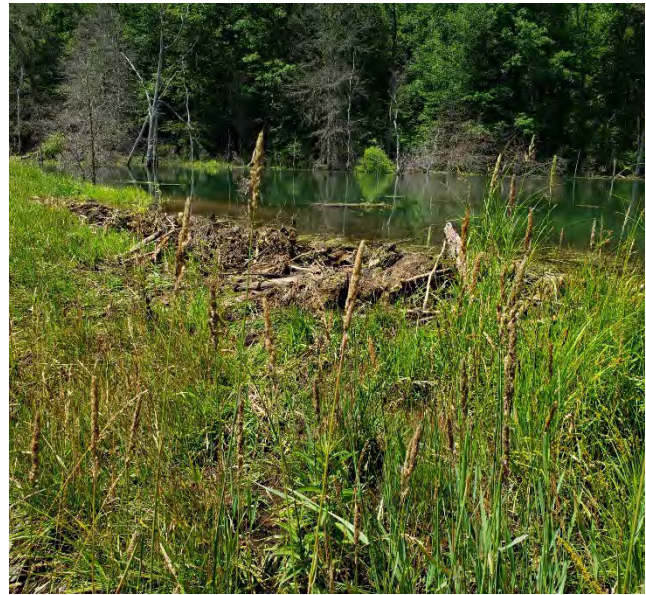
Bottom Right: Beaver were regularly damming both the culvert outlet pipes and the emergency spillway in Wetland 1. This on-going activity caused the effluent of the treatment system to overtop the embankment and likely contributed to the hole in the access road noted above. (2020)

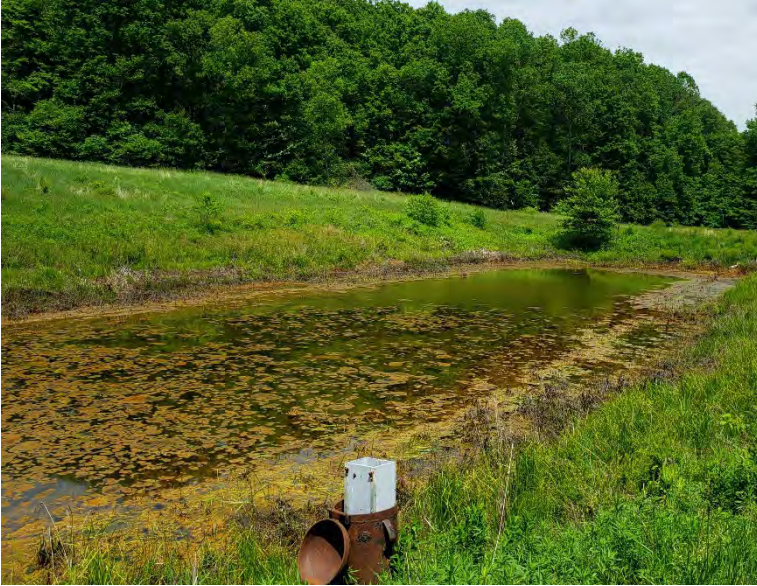
Top Left: Pre-rehabilitation photo of VK2 (JVFP West), the limestone-only vertical flow pond that followed VK1. Due to clogging issues of VK1, the water was directed to bypass the VK1 treatment media and enter directly into VK2 until rehabilitation could take place. The Agri Drain outlet structure (foreground) had numerous stop logs stuck and was no longer fully operational. (2020)

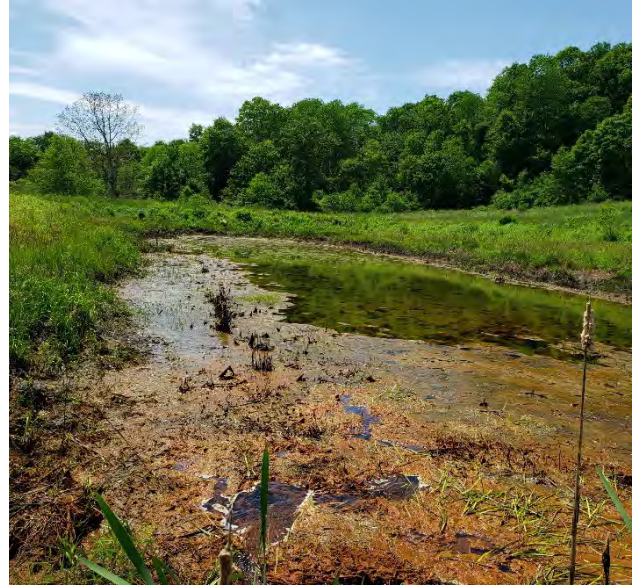
Top Right: Sediment, debris, and algae had accumulated in VK2 after 23 years of operation. (2020)

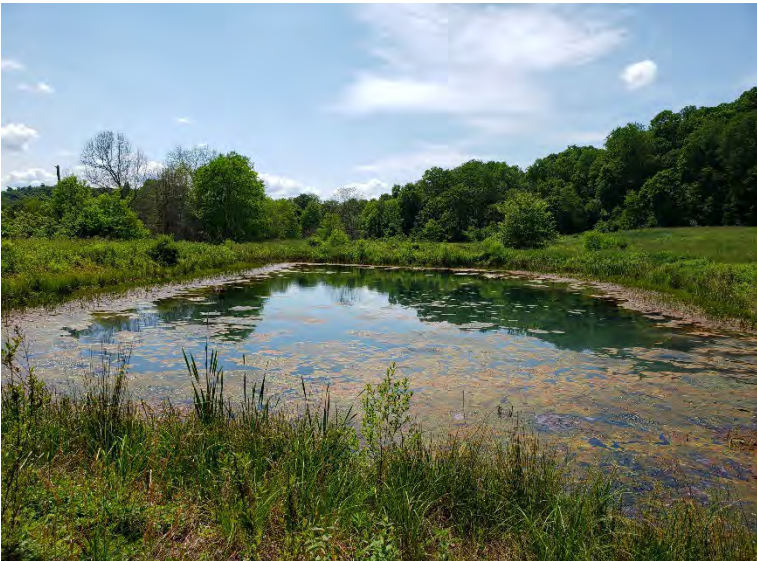
Bottom Left: Pre-rehabilitation photo of VK1 (JVFP East). The treatment media had degraded over two decades to the point where almost no flow was able to pass through the treatment media. (2020)

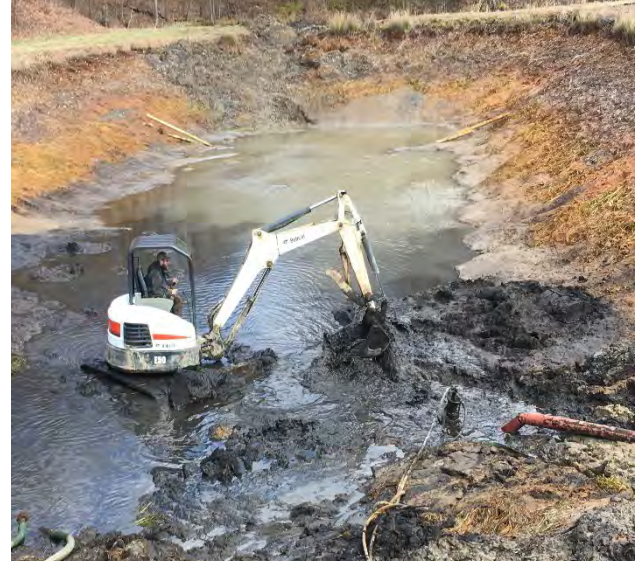
Bottom Right: During previous maintenance efforts the media of VK1 (now JVFP East) was found to be in poor condition with low permeability. (2017)

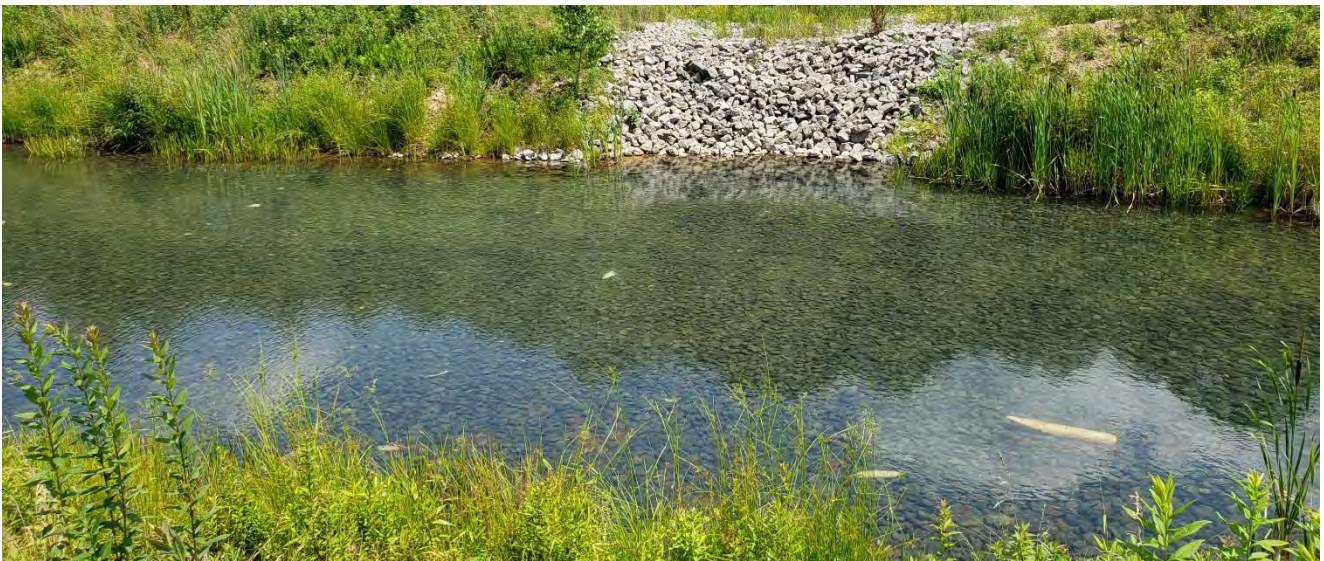
Bottom: The Ferris East passive treatment system was also rehabilitated. New pipes were installed to permit flow measurement as the discharges enter the system. The first cell was found to be essentially exhausted, and the spillway was improved to permit flow to enter the second limestone-only cell. The limestone was washed to restore treatment efficacy. (2023)

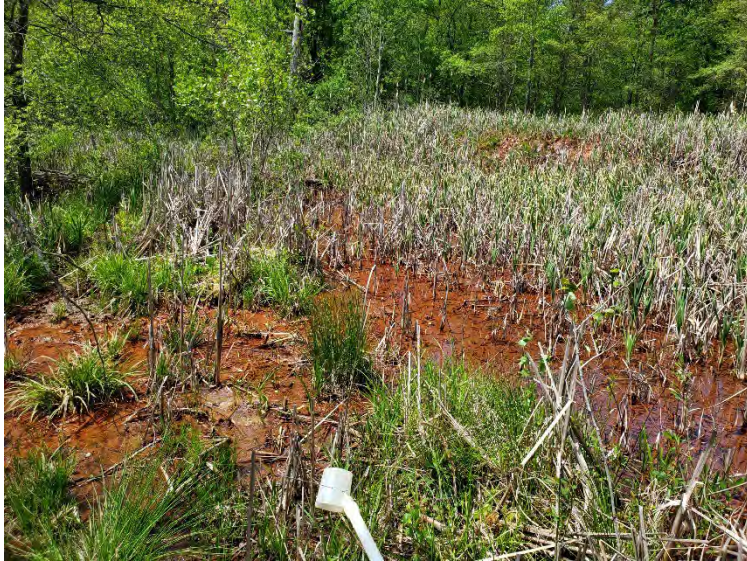
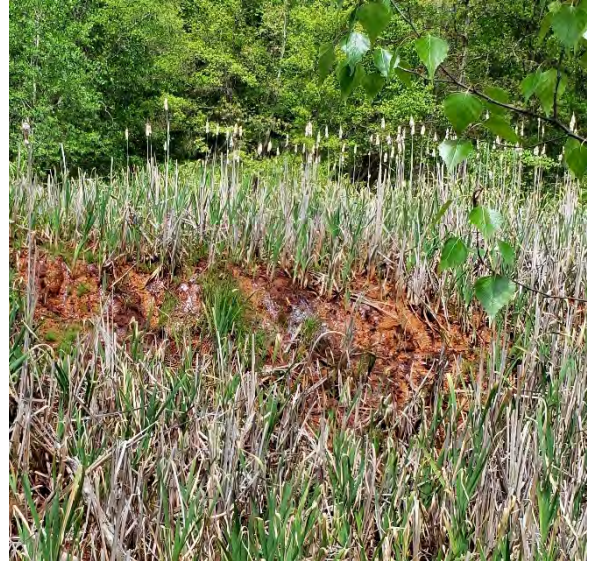
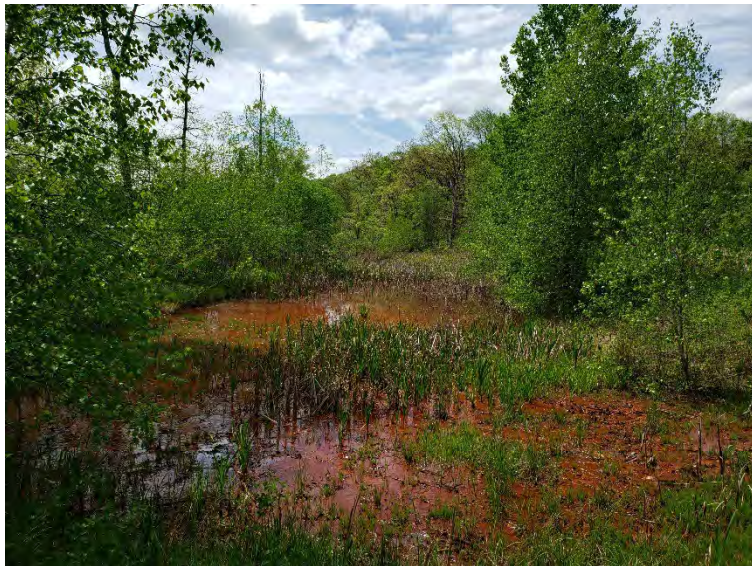
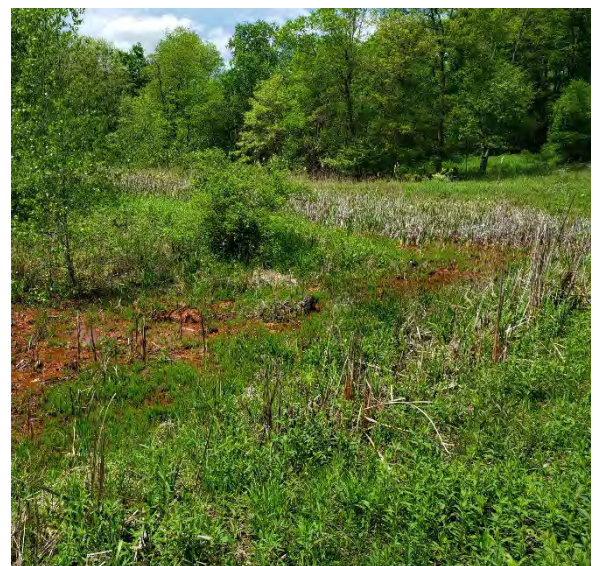
Above Photos: After 22 years of operation, the ponds and wetlands of the SR101A treatment system were essentially filled with iron precipitates. The system has functioned as intended by preventing the iron from entering Slippery Rock Creek. (2020)

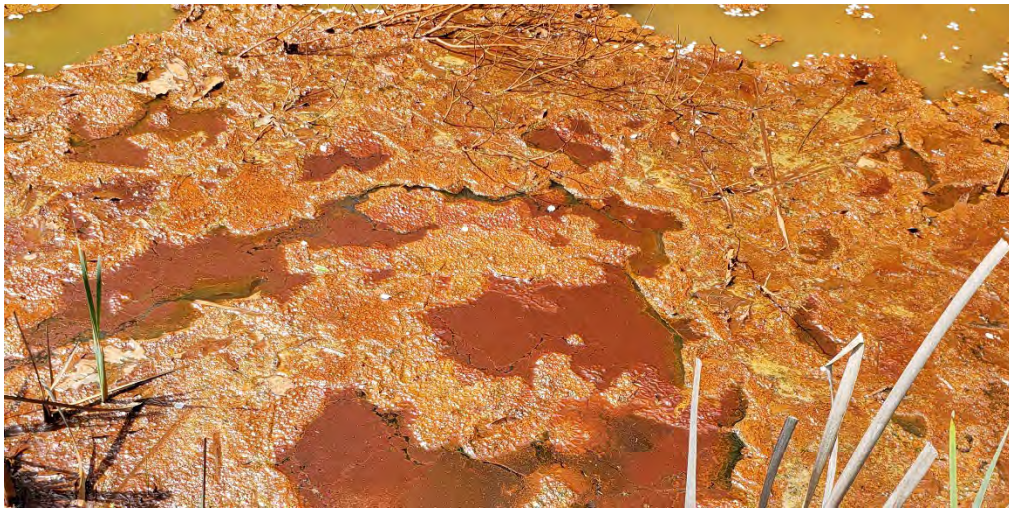
Top Left: Pre-rehabilitation photo of the settling pond at SR101A containing a yellow-orange color due to precipitated iron in the settling pond. (2020)

Top Right: Photo of the settling pond on the other side. Clumps of iron sludge with algae can be seen floating across the surface of the settling pond. (2020)

Bottom: Close-up of clumps of iron solids and biofilms at the surface of the settling pond. (2020)

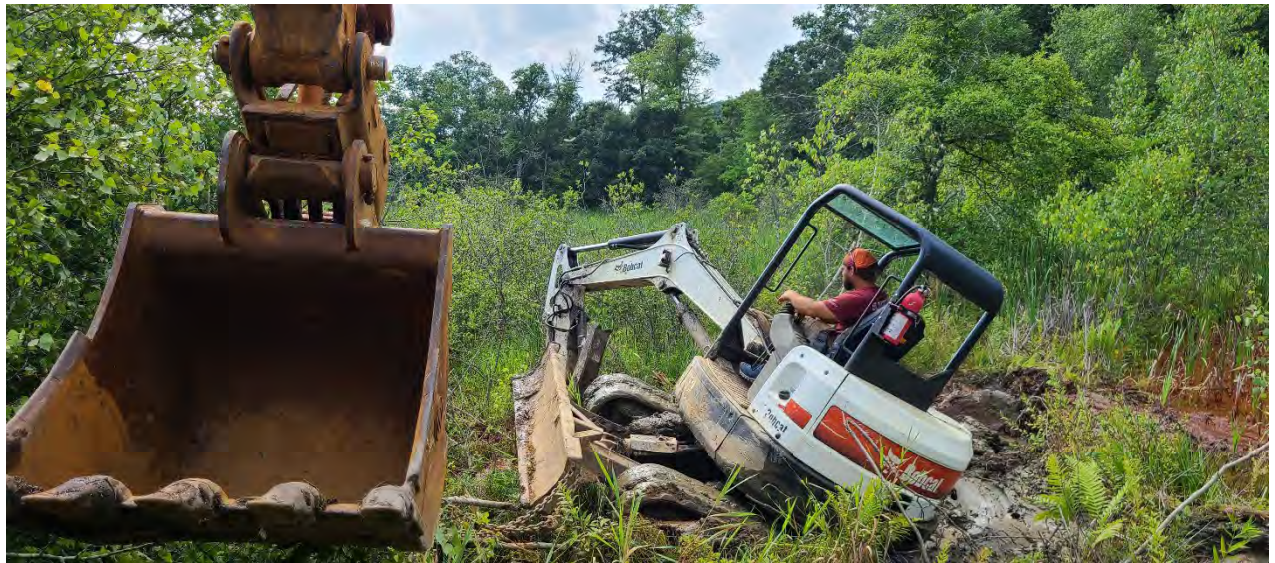
Top Left: SR101A wetland with vegetation and sludge in it prior to rehabilitation. (2021)

Bottom: Due to the high water levels caused by accumulated iron precipitates, the embankment of Wetland 2 was saturated causing a five-ton excavator to sink at the beginning of rehabilitation efforts. (2021)

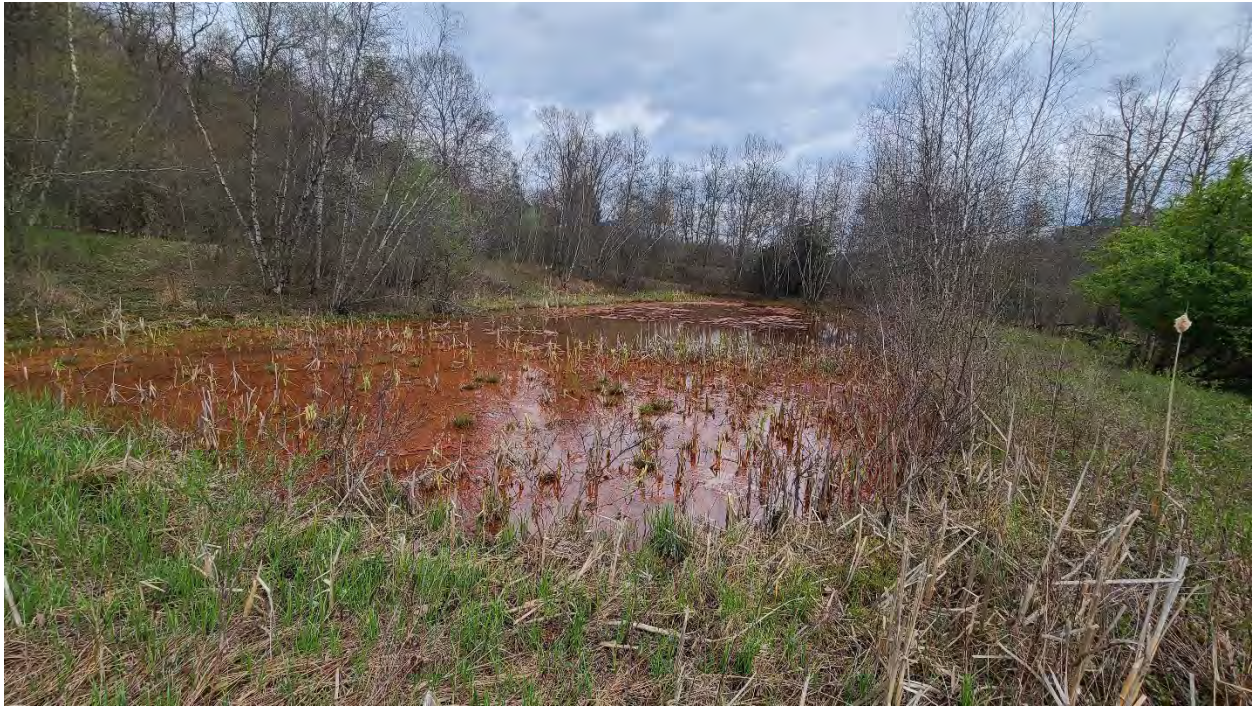
Top: Pre-rehab photo of Wetland D2 (WL D2). After 26 years of operation the component was filled with iron precipitates and vegetation. (2021)

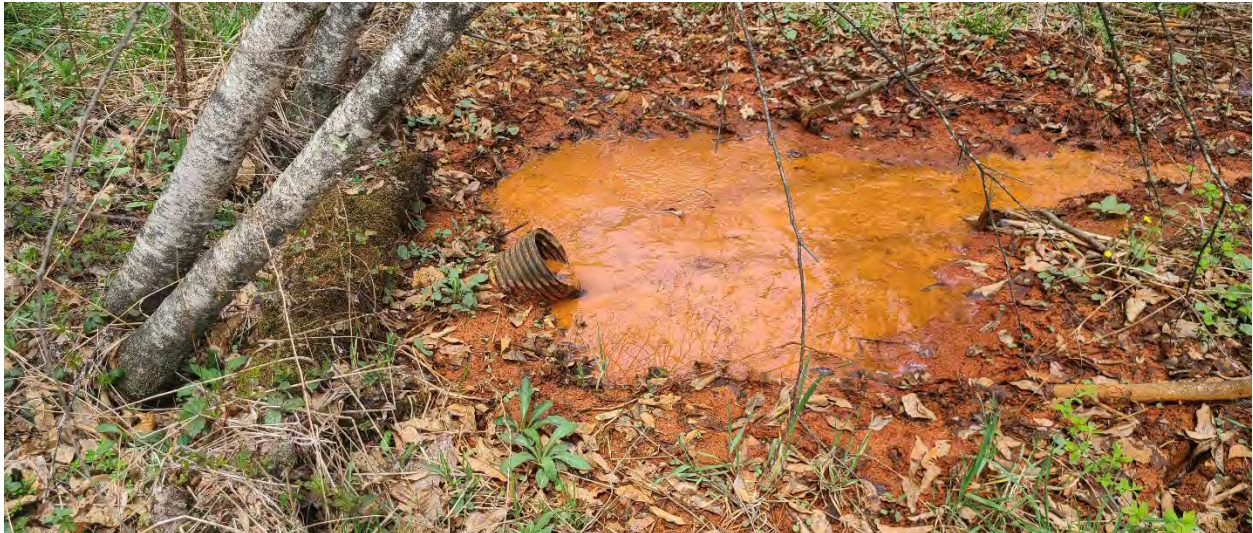
Bottom: Pre-rehab photo of ALDB outlet pipe. The channel was filled with iron precipitates. (2021)

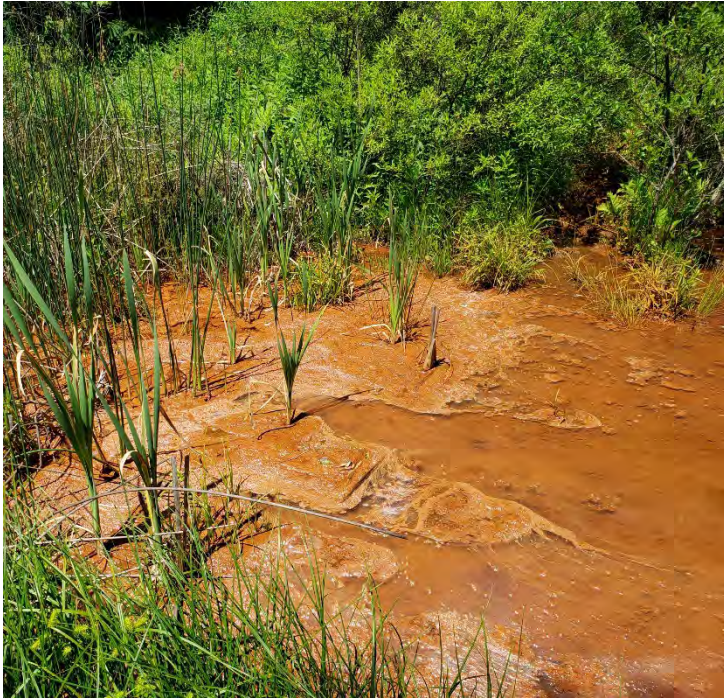
Top Pictures: Pre-rehab pictures of wetlands in SR114D system filled with iron sludge. (2020)

Bottom Left: First of the three wetlands in SR114D, named Wetland D2, with iron sludge build-up. (2020)

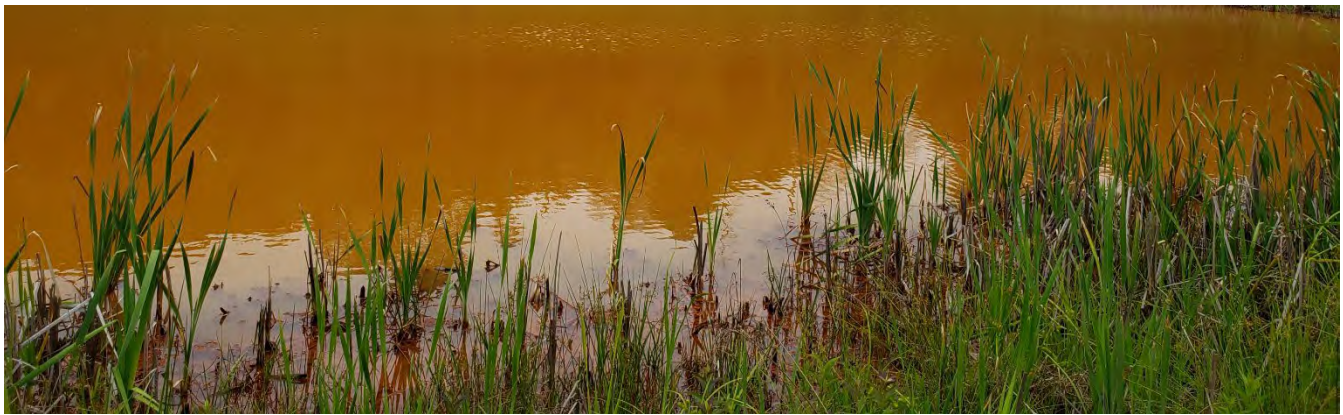
Top Left: Photo of settling pond at SR81 passive treatment system prior to rehabilitation. (2020)

Bottom: Close-up photo of thick iron-laden water in the settling ponds. Red-orange sludge is built-up around the vegetation. (2020)

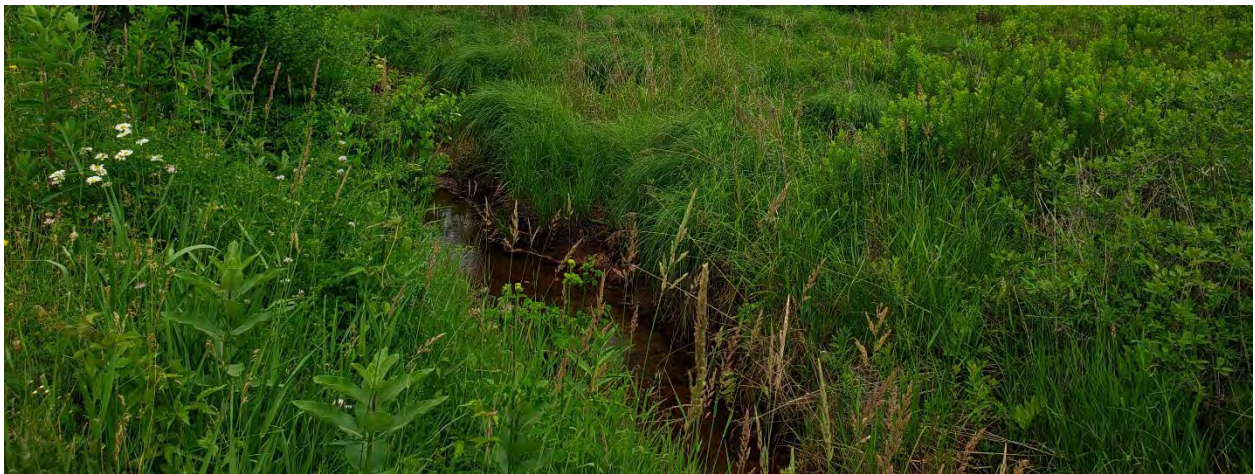
Top Left: Vegetation overgrowth SR81 wetlands prior to rehabilitation. (2020)
