Laurel Run #1 Passive Treatment System
SRI O&M TAG Project #29 Request #2
OSM PTS ID: PA-191

Requesting Organization: Blacklick Creek Watershed Association
Requesting Organization Representative: Dennis Remy
Municipality/County: Rayne Township, Indiana County
Dates of work performed: 5/20/2019

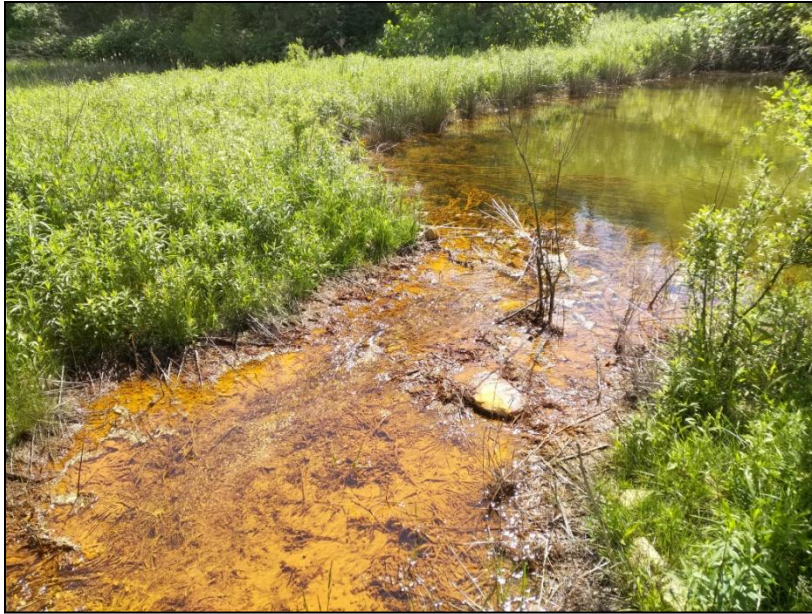
Top Left: Water level of the VFP-E high due to impermeable media (5/20/19).

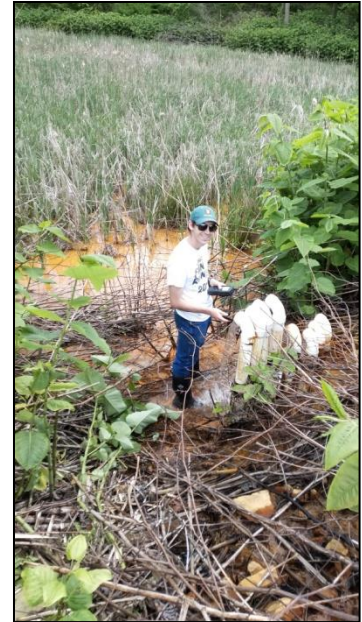
Top Right: Water quality was assessed throughout the system (5/20/19).

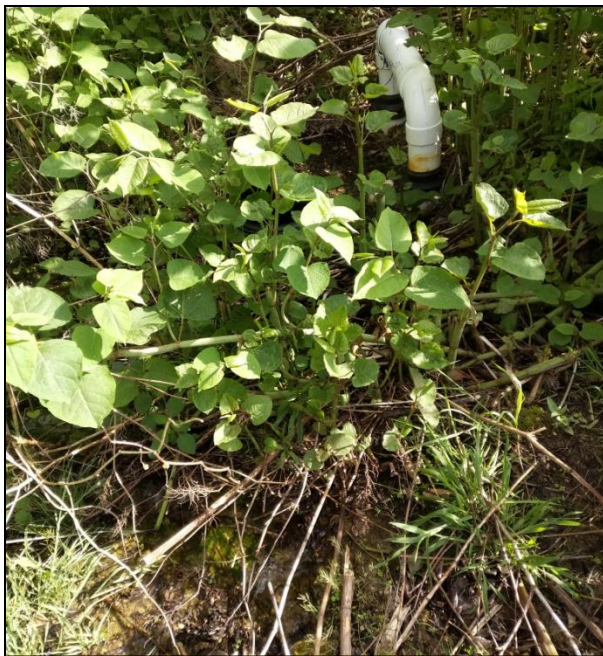
Bottom Left: VFP-N was drained and a break was found in the outlet piping (5/20/19).

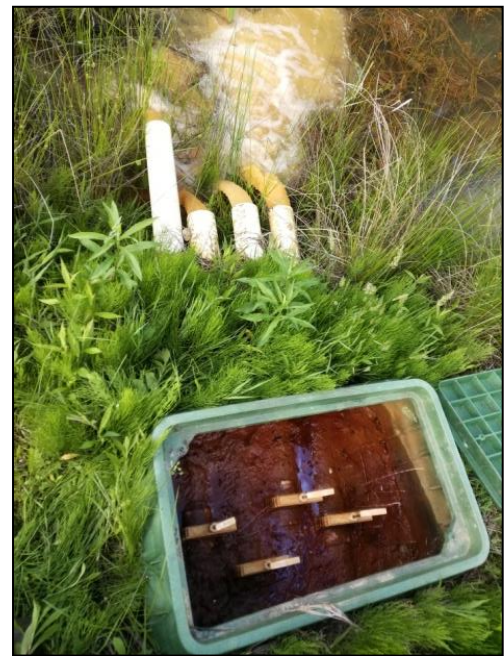
Bottom Right: VFP-W & VFP-E were flushed to rule out an airlock as the cause of lack of permeability (5/20/19).

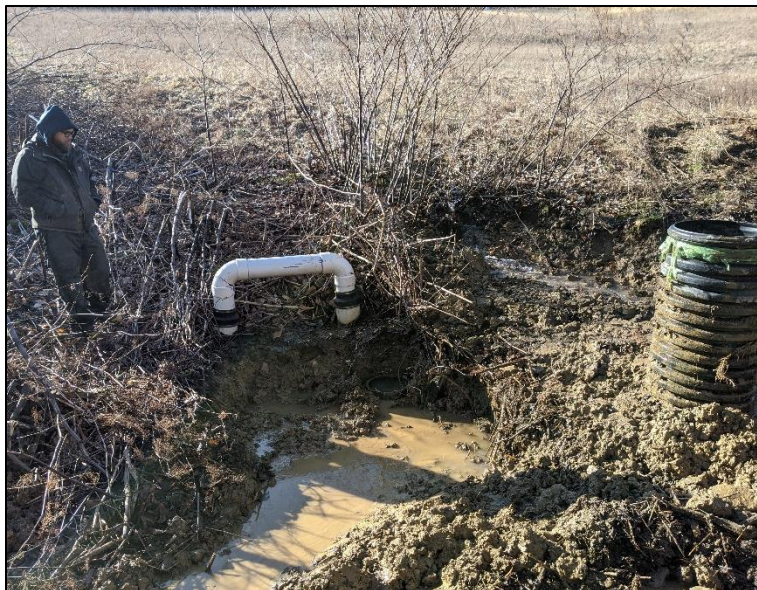
Work Completed: A decision was made to conduct maintenance to try to improve performance while seeking/waiting for funding to rehabilitate the system. An additional request was received concerning water short circuiting the treatment system and maintenance was conducted in February 2020. After testing water coming out of the ground near the pipe manifold for the east/ west systems, it was determined from 6-6.5 pH water (53 field alkalinity on 2/20/20) that it was likely not raw mine water but a spring which had developed. Excavation near the VFP North outlet piping revealed that there was a break which had developed, likely due to settling after construction. The break was repaired.

Top Left: Excavation near the VFP-N outlet pipe revealed there was a break (2/19/20).

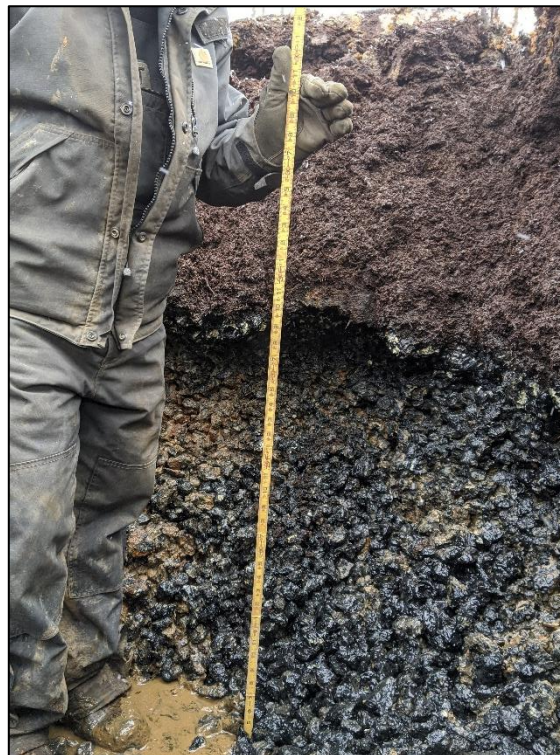
Top Right: Test pit in VFP-N to check media condition (2/20/20).

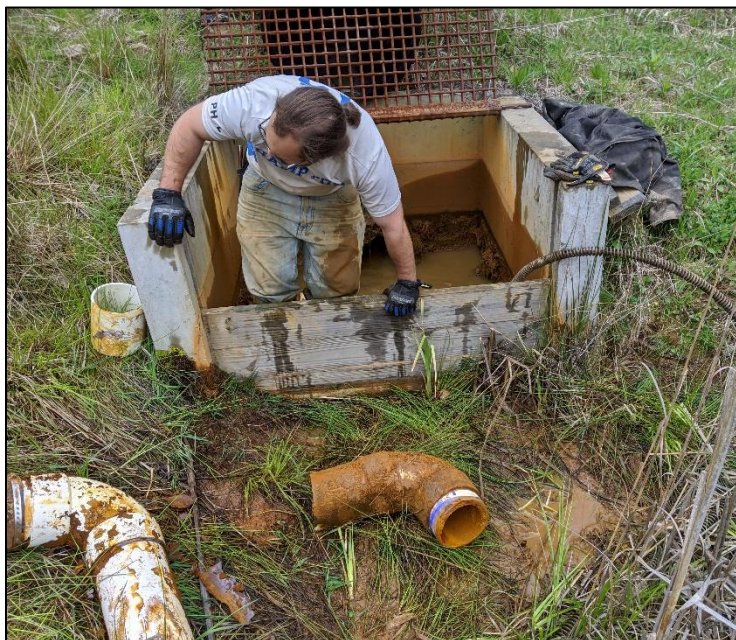
Low pH iron accumulated within the inlet flow control box had begun to clog the distribution pipes. Flow to the VFP-N was not reaching the inlet pipe, indicating that there was low pH iron clogging the pipe. The O&M crew returned on 5/1/20 with additional equipment to snake out the inlet pipe of VFPN and restore flow to the treatment pond.

Bottom Left: The inlet pipe to VFP-N was cleaned with mechanical snake (5/1/20).

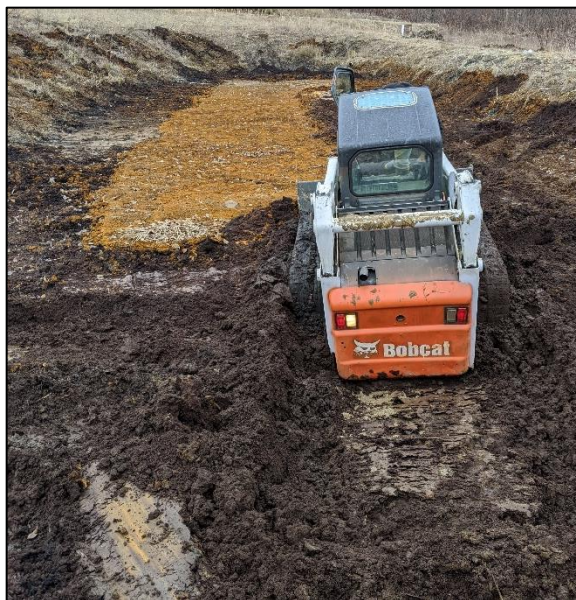
Bottom Right: All three VFPs were stirred to try and improve permeability (2/25/20).
