Miller Run #1 Passive Treatment System
SRI O&M TAG Project #30 Request #3
OSM PTS ID: PA-284

Dates of Work Performed: 9/29/20 – 9/30/20

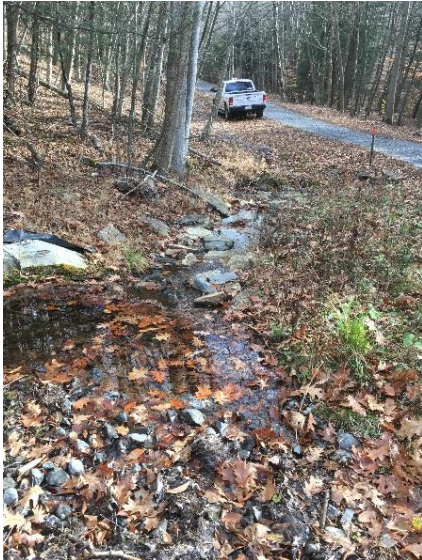
Top Left: Emergency spillway overflowing to the culvert under the game land access road before maintenance.

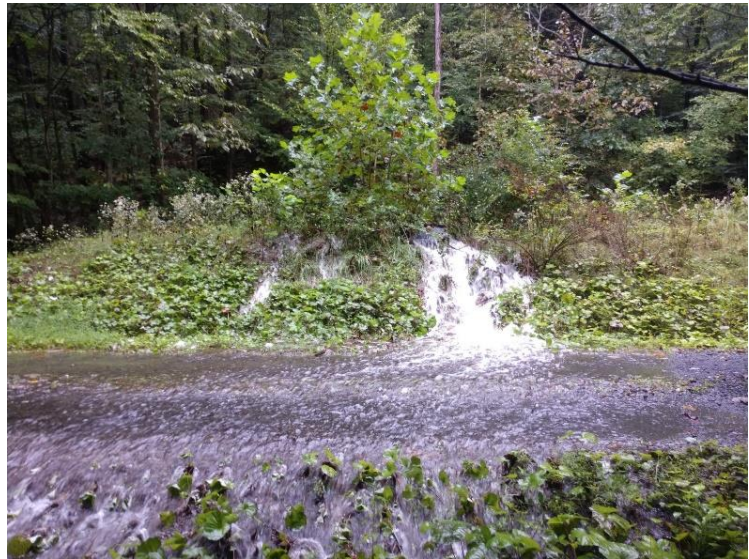
Top Right: Stormwater overflowing the embankment and flow across the game land access road before maintenance.

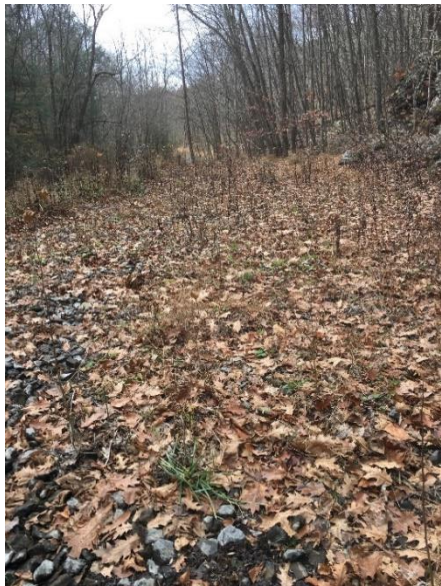
Bottom Left: Leafy debris and vegetation growing on top of the limestone media before maintenance.

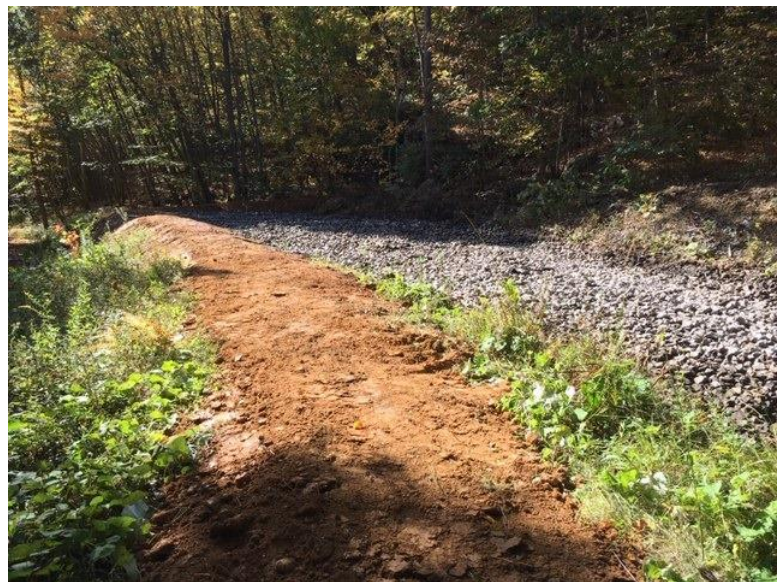
Bottom Right: Limestone bed after raising the height of the berm and cleaning.
