**Miller Run #2 Passive Treatment System**  
**SRI O&M TAG Project #66 Request #1**  
**OSM PTS ID: PA-263**

Dates of Work Performed: 9/30/2020 – 10/01/2020

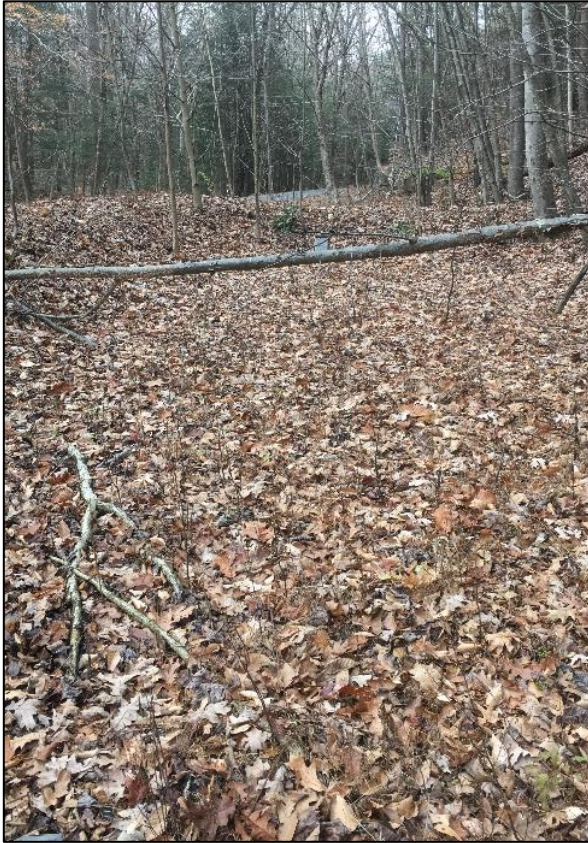
Initial Site Visit, Observations, and Identified Needs: The initial investigation was conducted that same day. The Miller Run #2 treatment system appeared to have significant leaf litter established in/on the treatment stone and needed to be cleaned to improve hydraulic conductivity through the component. Cleaning the stone would aid in improving the system's effluent water quality. Volunteer trees and woody vegetation were established on the embankments of the system. Removal of this vegetation was beneficial to the treatment system by reducing the number of leaves present in the fall.

**Top Left:** Leafy debris on top limestone treatment media & volunteer trees / woody vegetation along embankment & fallen across the treatment component (before maintenance)

Work Completed: Earth Shapers, LLC was hired as a sub-contractor to complete the maintenance and mobilized to the area in September 2020. The limestone treatment media was cleaned. Volunteer trees and woody vegetation was cut from the system's embankments and placed in on-site windrows.

It is recommended to keep annual leaf litter from accumulating on/in the treatment component. This will aid in extending the longevity of the limestone treatment media between cleanings. Water quality monitoring shall continue to evaluate the long-term treatment effectiveness of the system. Additionally, the contractor found that the piping in the bottom of this pond was broken in places (probably from previous maintenance activities) but still functional. The next maintenance activity at this site should include replacing the piping. Future sludge management also needs to be considered. Due to very limited space available with no on-site room for sludge placement, either pumped water filter bags/geotubes, or a vacuum truck would be needed to effectively clean the sludge out of the Miller Run #2 system. There is only 2-3 feet of stone remaining in this bed which has room to accommodate another couple feet of stone. This should be considered when the system undergoes further maintenance or a system re-build.

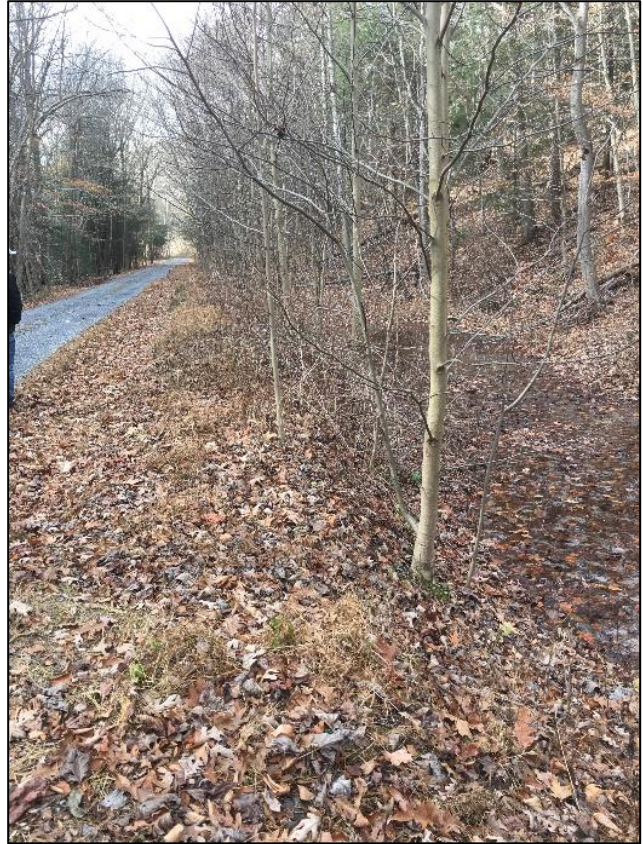
**Top Right:** Volunteer trees / woody vegetation along embankment (before maintenance).
