# Richard Passive System Rehabilitation

Cherryhill Township, Indiana County, Pennsylvania  
41°03'28"/79°17'02"

## Final Report

December 2021

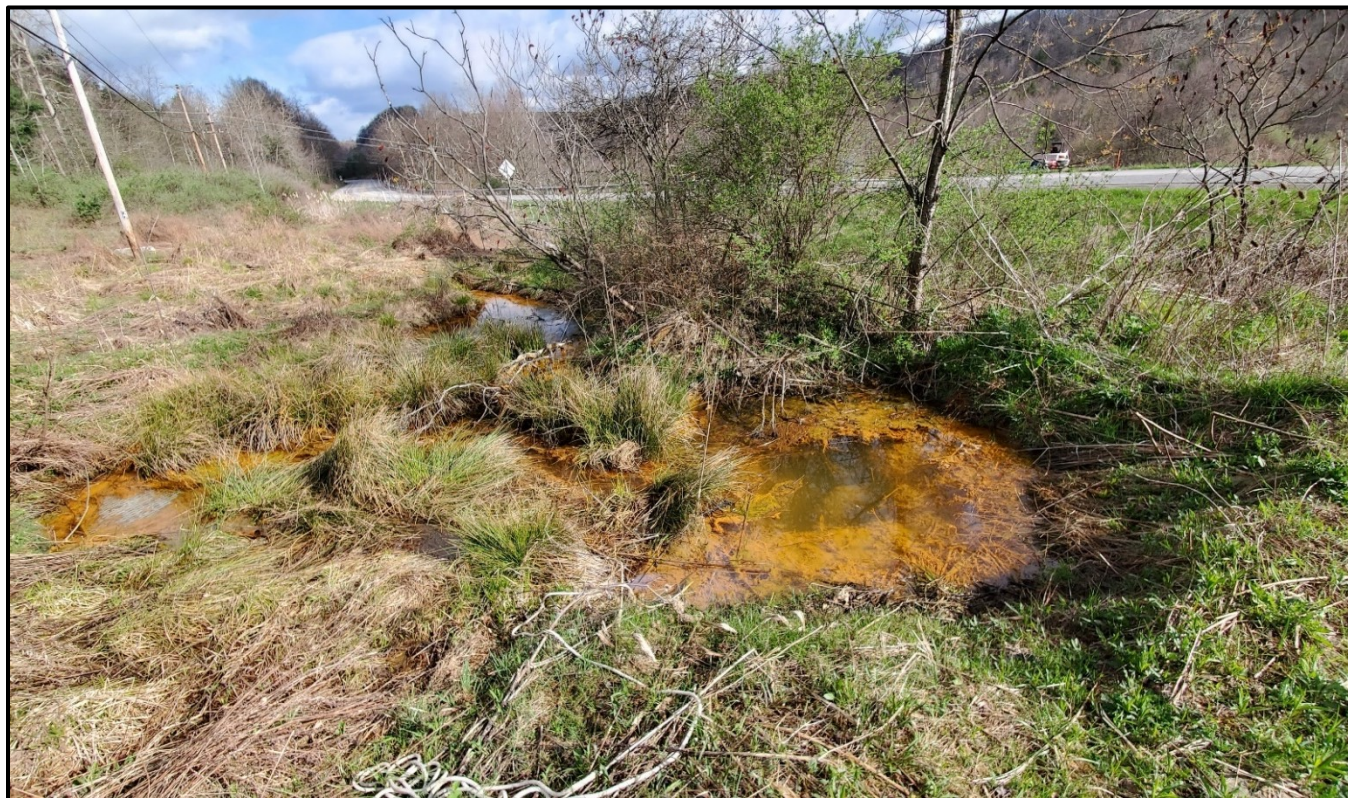
**Top:** AMD emanates from an existing concrete riser on the far left and should flow into a concrete catch basin at the center right of the image. Due to plugging issues of the pipe that extends under SR-403 water flowed around the pipeline inlet and bypassed the treatment system by flowing down an existing channel directly to Two Lick Creek (4/14/20).

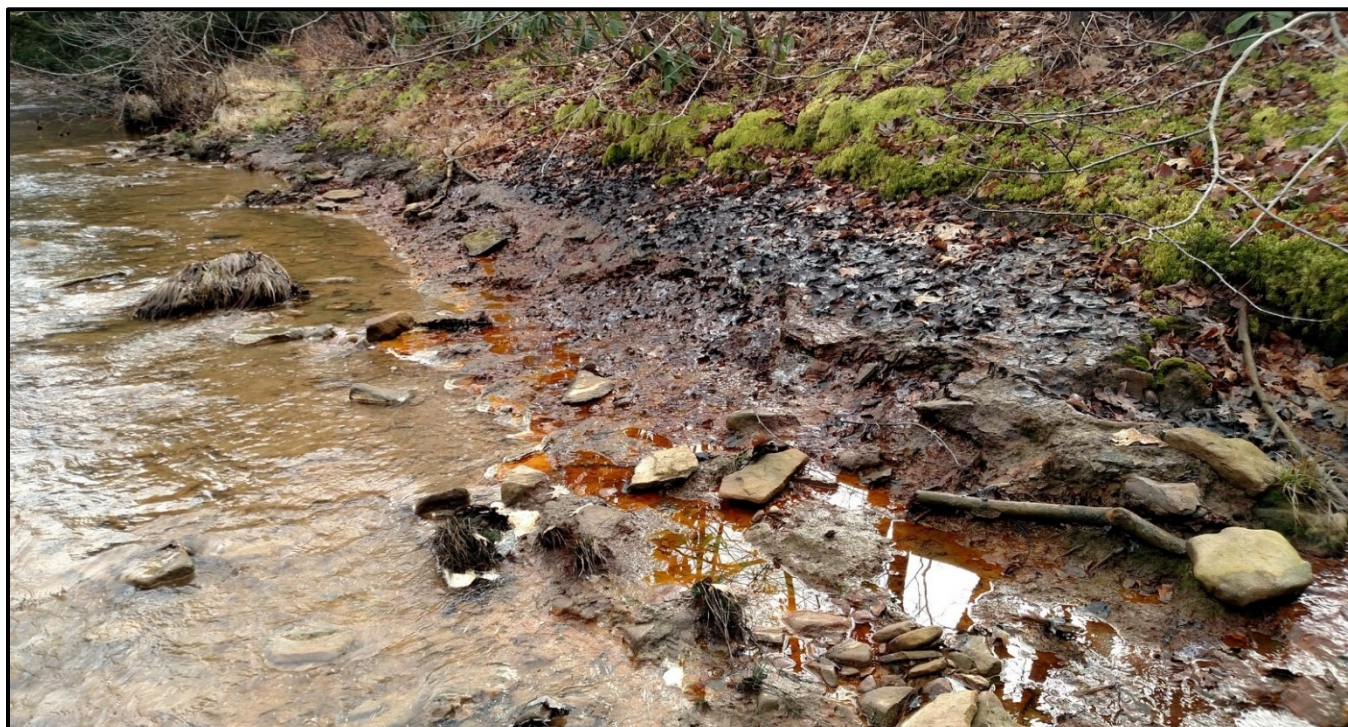
**Bottom:** Two Lick Creek shown with AMD seeping from the bank (12/21/15).

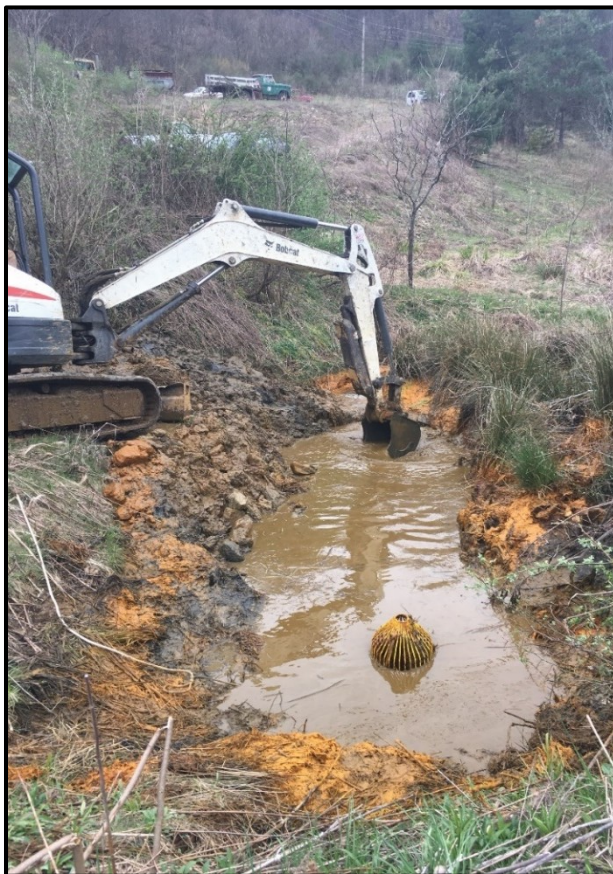
**Top Left:** Clearing the channel between the Mine Drain and the catch basin that began the existing Raw Water Pipeline that should convey the AMD to the treatment system (4/14/20).

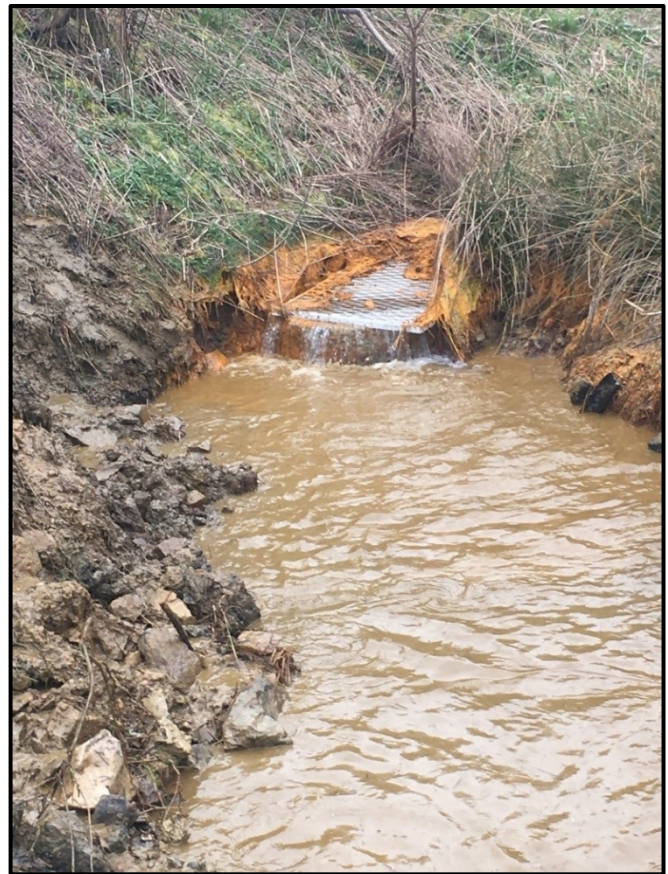
**Top Right:** Discharge of AMD from the Mine Drain (4/14/20).

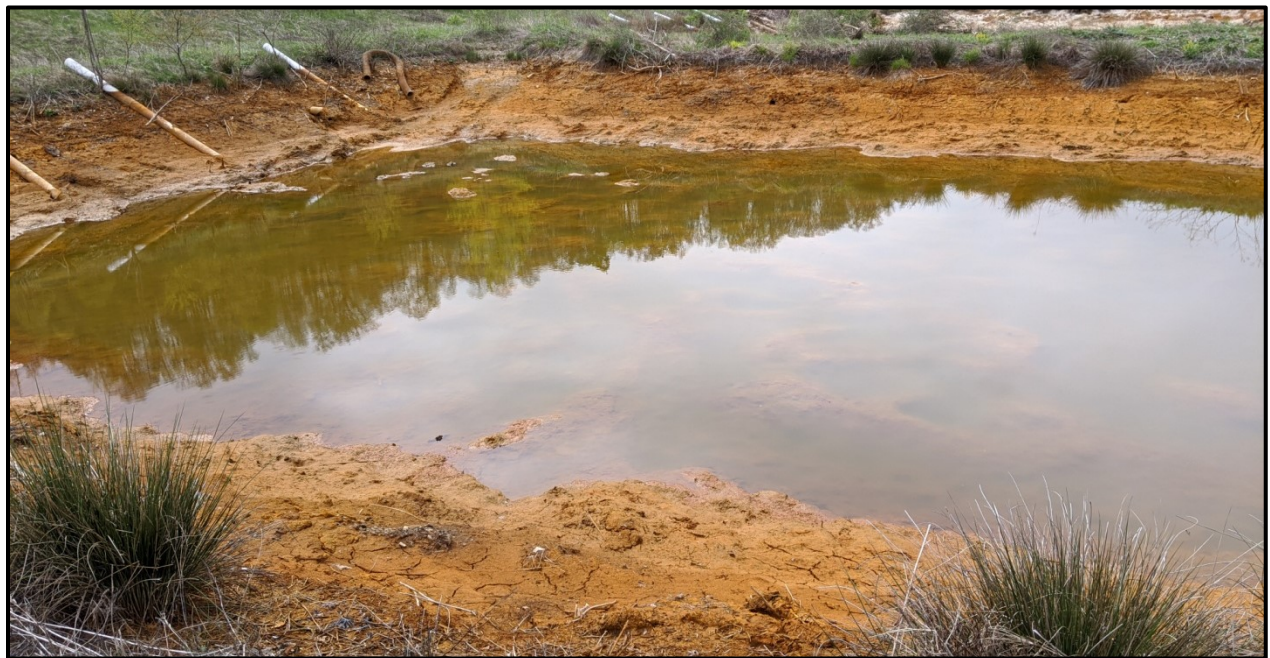
**Bottom:** VFR 2B drained to expose iron oxide on top of treatment media (4/14/20).

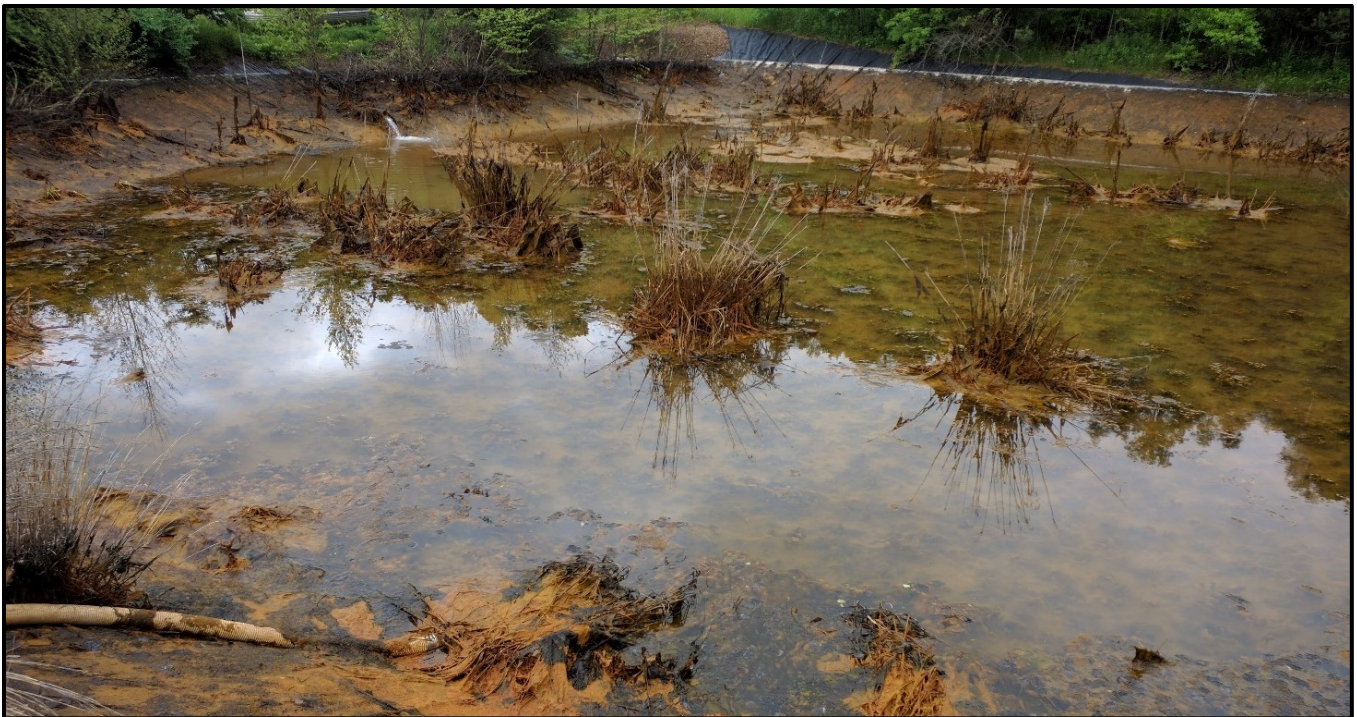
**Top:** VFR 1 was clogged with vegetation and sludge, no treatment of water through the media (7/23/18).

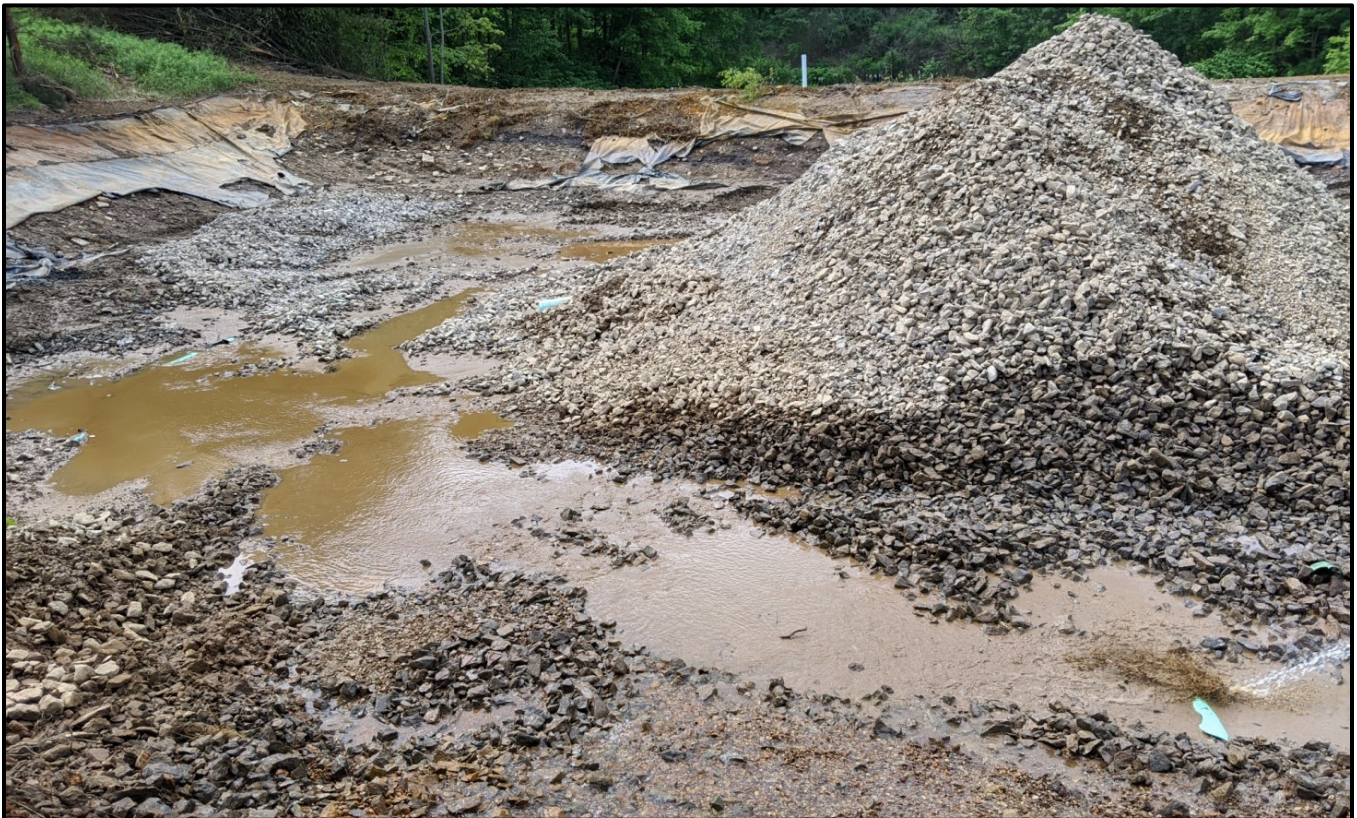
**Bottom:** VFR 1 sludge was removed, and existing stone was cleaned for re-use (6/5/20).

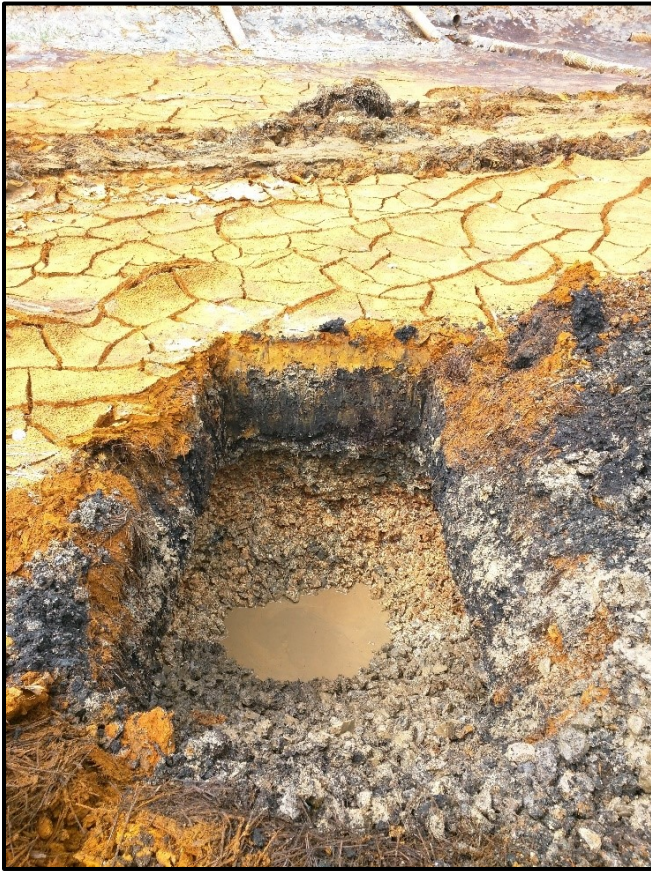
**Top Left:** Test pit for VFR2A media showed poor permeability was caused by clogging by sludge, accumulation of solids in the media, and breakdown of organic material (5/1/20).

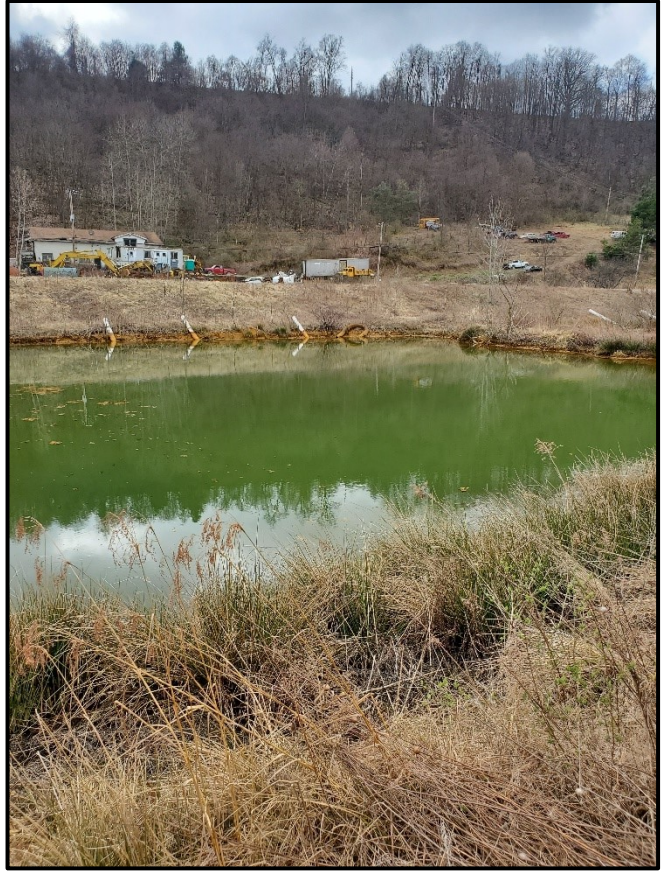
**Top Right:** Lack of VFR permeability after stirring indicated that the media needed to be replaced (3/27/20).

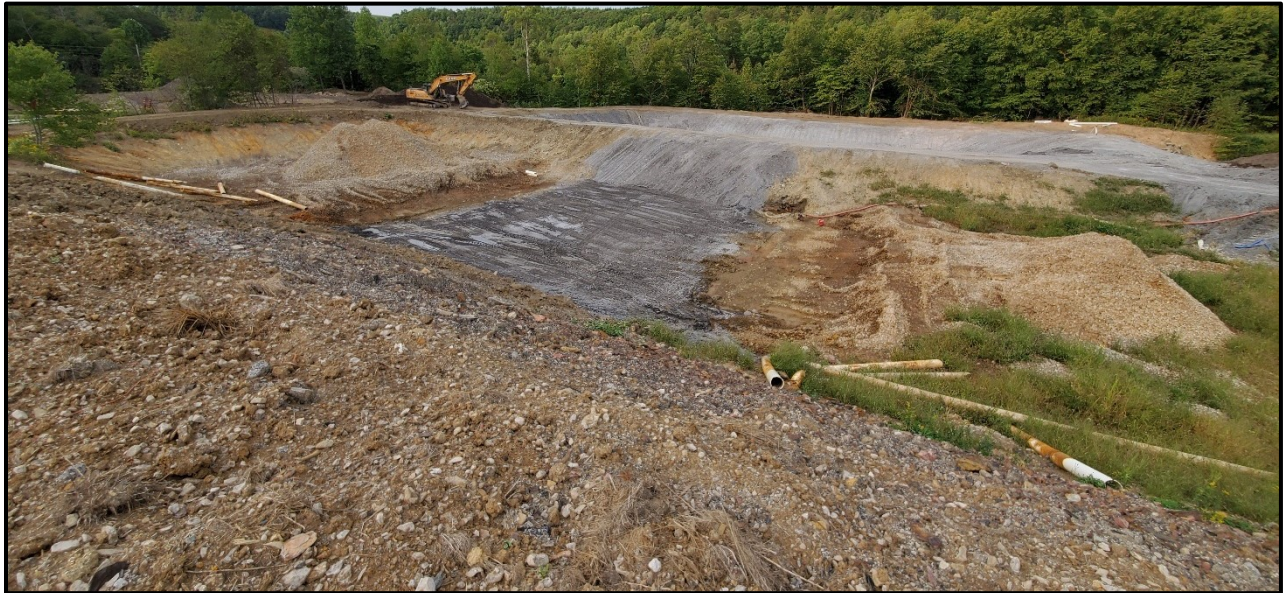
**Bottom:** Expansion of VFR2A & 2B to create JVFP2 included removal of an embankment and lining with mineral CSA (9/15/20).

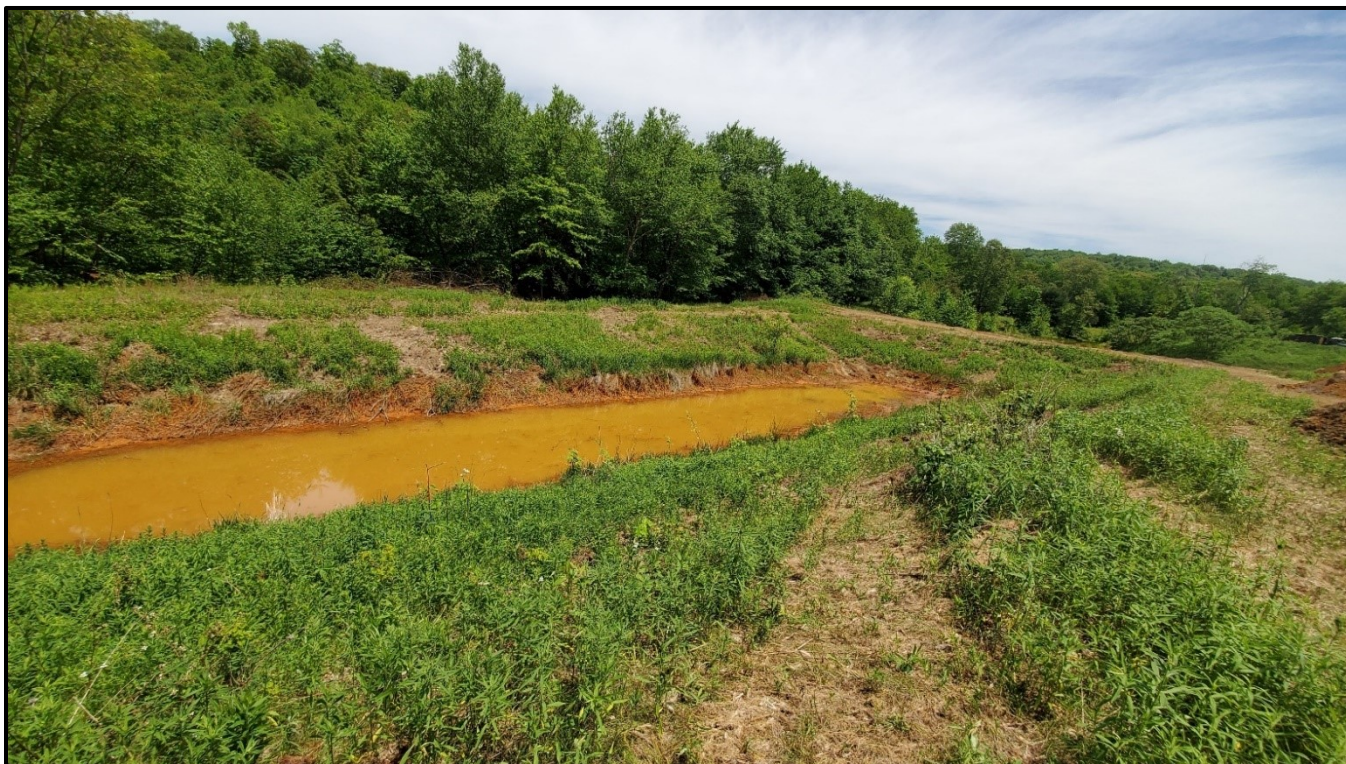
**Top:** Sludge Pond that is to be expanded and reconfigured as JVFP3 (6/9/20).

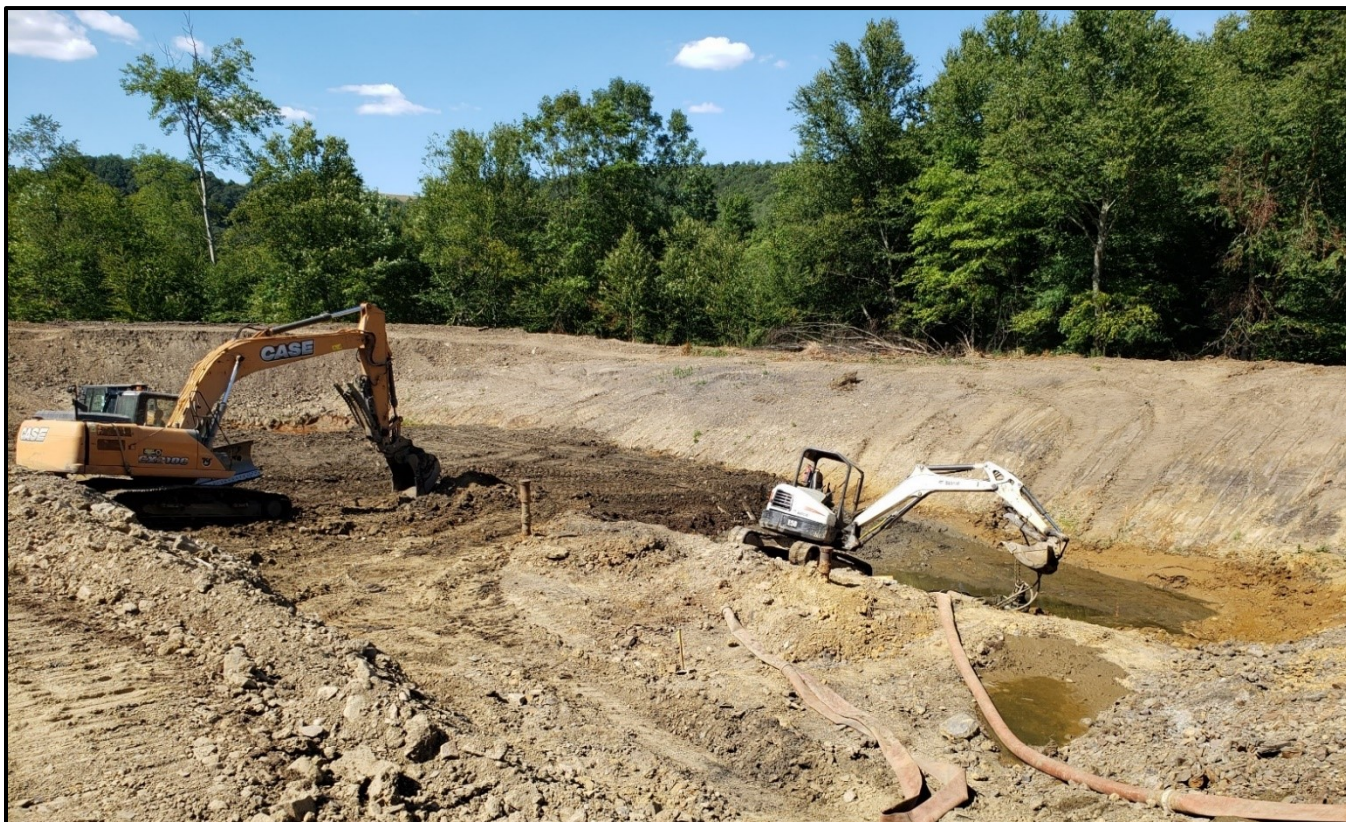
**Bottom:** The Sludge Pond excavated and expanded to become JVFP3 (8/20/20).

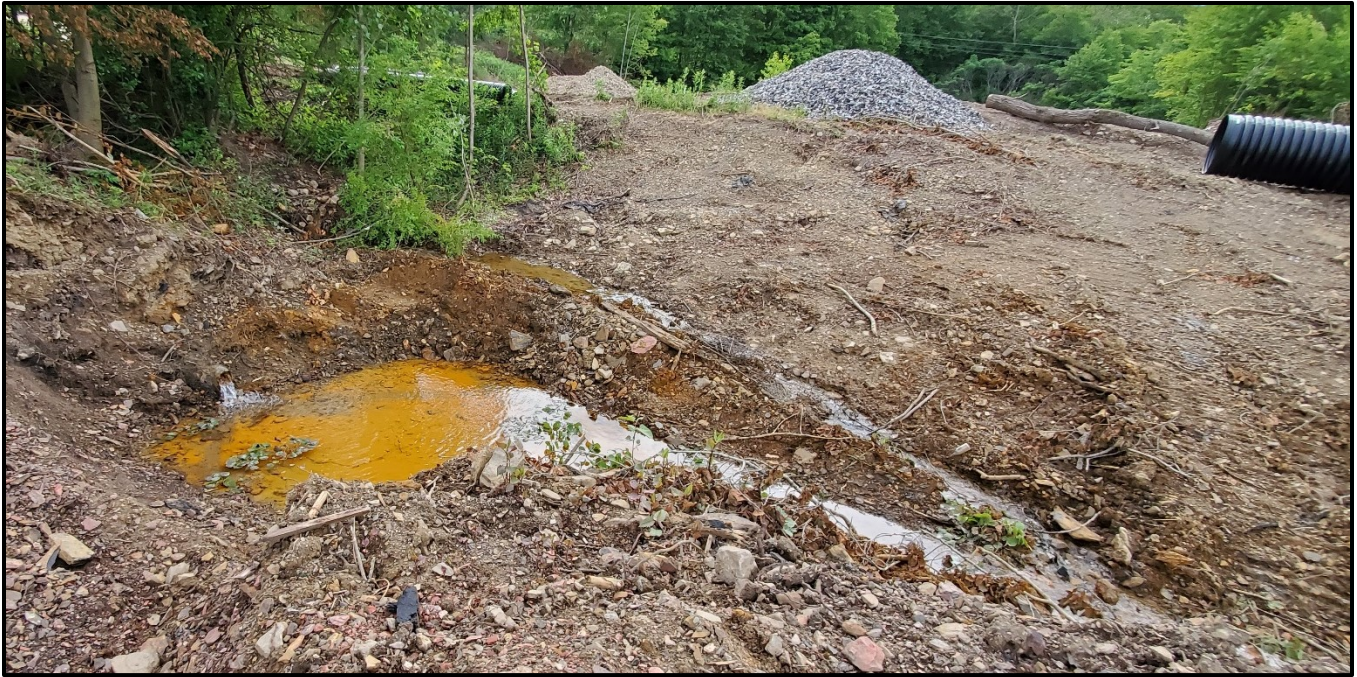
**Top:** A flowing 6" Terracotta pipe was encountered along the right descending bank of the mine drainage conveyance channel (left side of image) in the area near where the Seep discharge was sampled, cleaned stone in JVFP1 and 36" culvert prior to installation can be seen in background and (6/23/20).

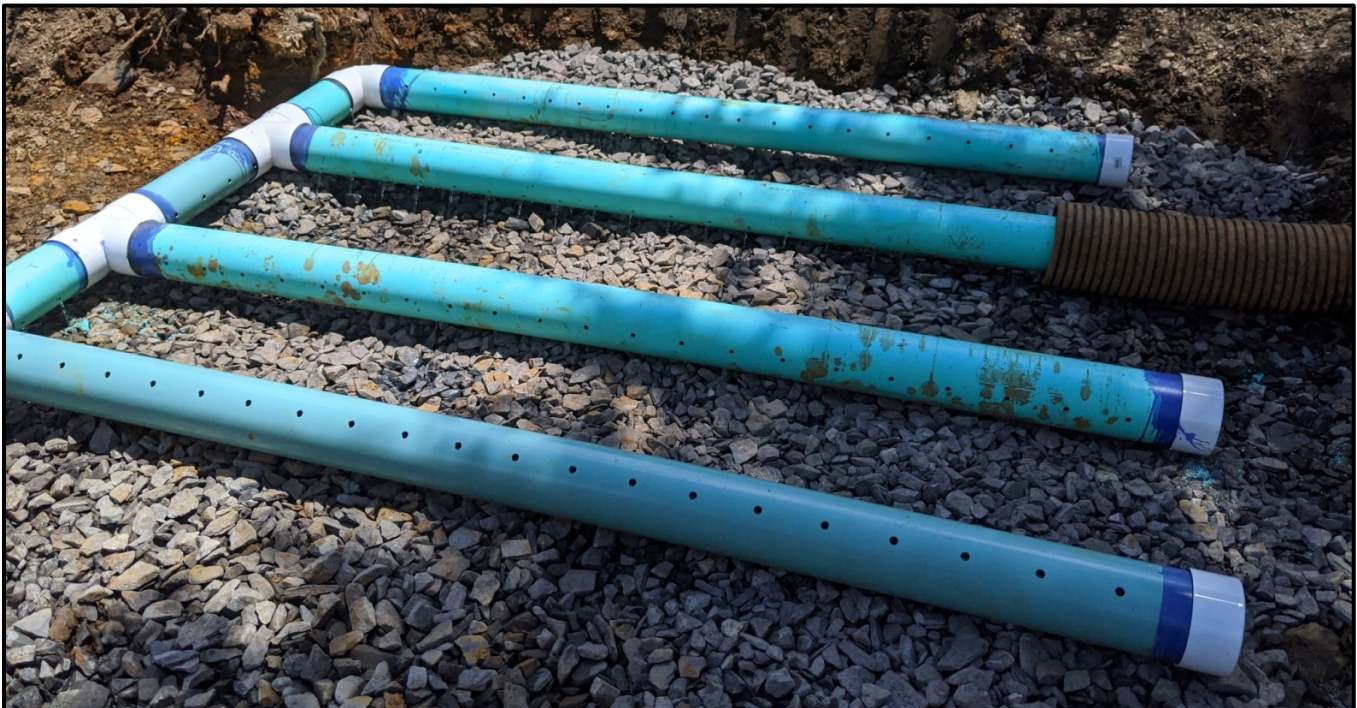
**Bottom:** French drain installed near the source of the Seep, the 6" terracotta was plumbed directly into one of the 6" PVC pipes using 8" CPP as shown (6/25/20).

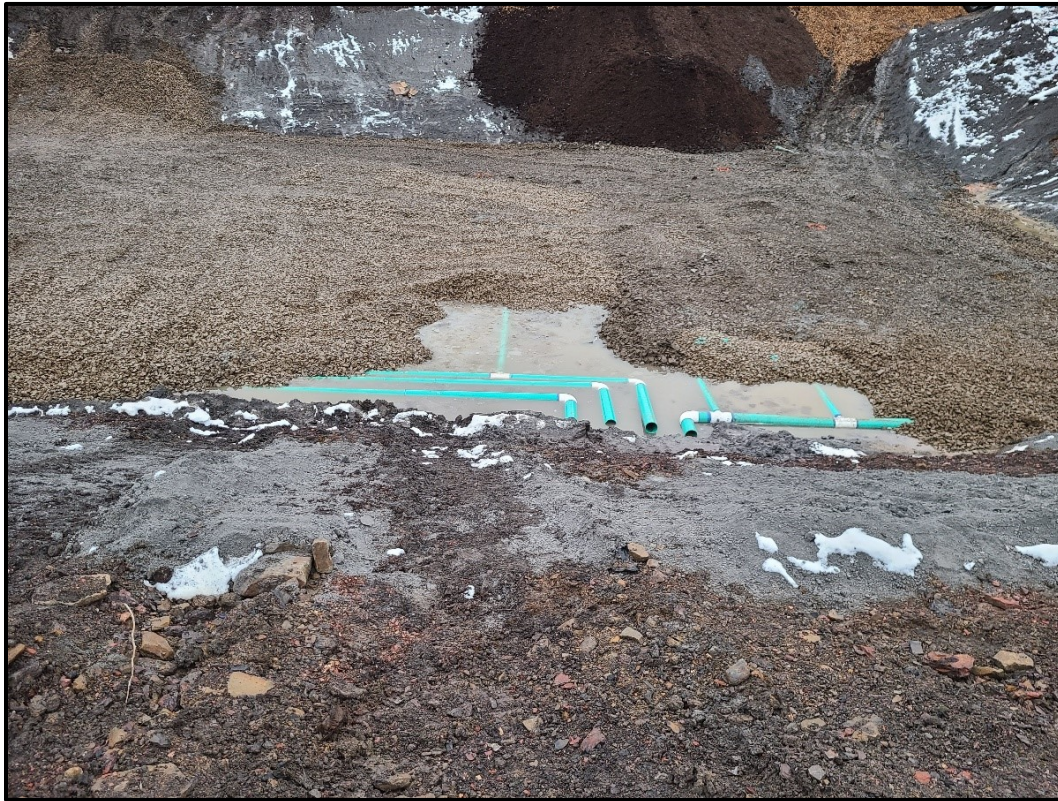
**Top:** JVFP1 with exposed underdrain outlets pipes before pipe was installed through the berm, filter stone was installed and leveled except for the area near the exit, and stockpiled media can be seen in the background (12/04/20).

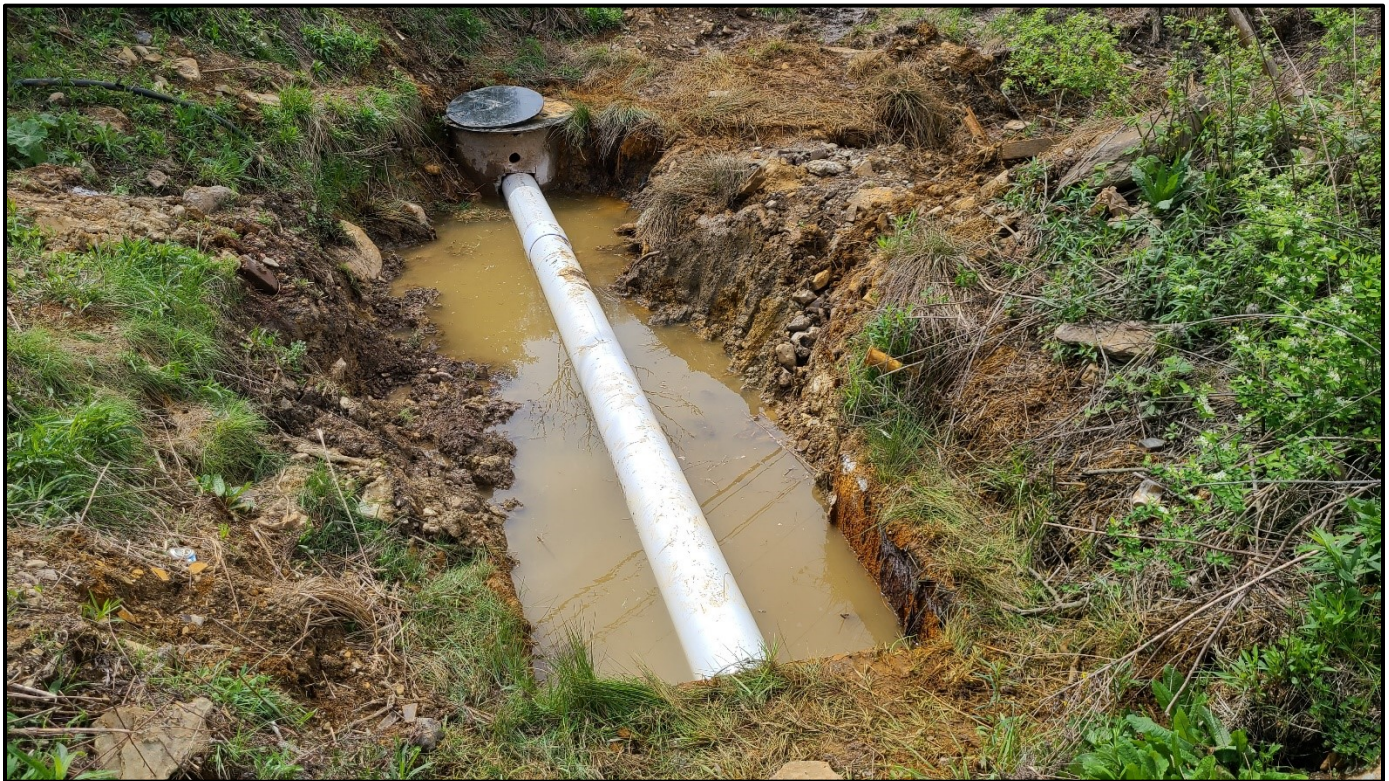
**Bottom:** 12" Raw Water Pipeline plumbed between concrete riser (Mine Drain) and existing 12" PVC pipe carrying water under SR-403 (5/6/21).
