Cessna Run Passive Treatment System
SRI O&M TAG Project #61 Request #1
OSM PTS ID: PA-3

Requesting Organization: Indiana County Conservation District

Dates of O&M work performed: 2/28/2020 to 3/12/2020

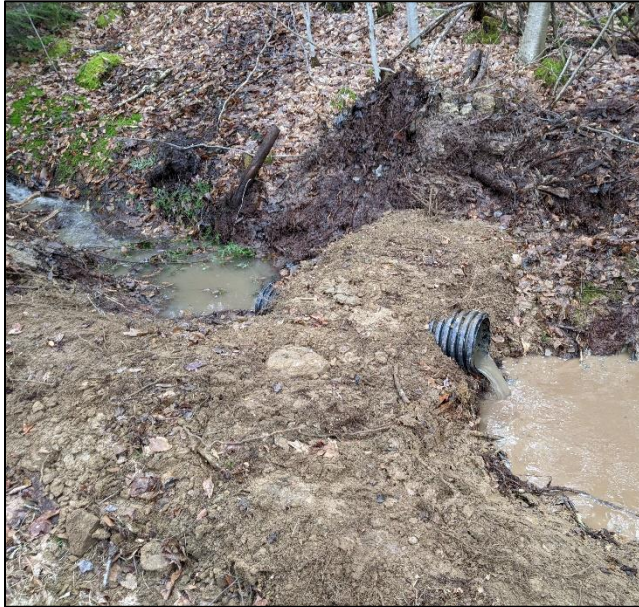
Top Left: Flow measurement pipe installed at the D2 discharge (3/5/20).

Work Completed: BioMost mobilized to the site on 2/28/20 to conduct the maintenance. Flow measurement pipes were installed above D2 within the system collection channel as well as upstream of the D3 capture point. This will help data collection and loading calculations for better water quality sampling in the future by including raw flow data for each system respectively.

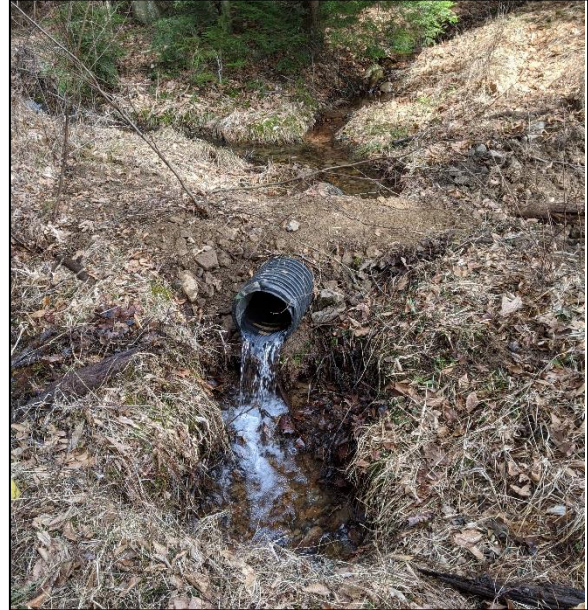
Top Right: Flow measurement pipe installed at the D3 discharge (3/6/20).

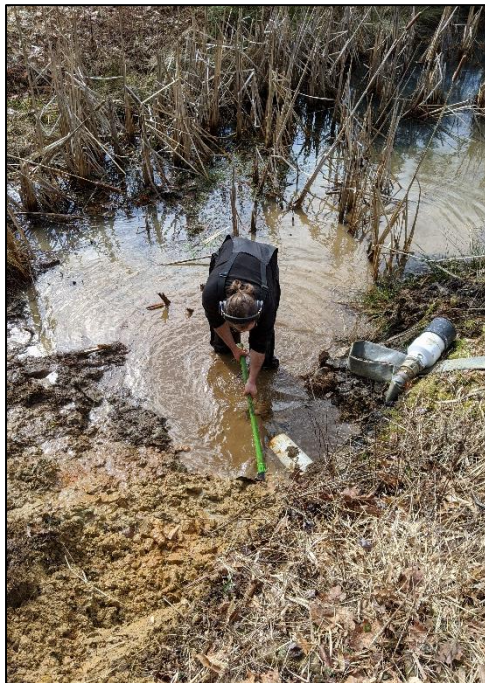
Bottom Left: The outlet pipe from the D3 siphon vault was excavated to remove accumulated vegetation and sediment (3/4/20).

The outlet pipe from the D3 siphon vault was excavated to remove accumulated vegetation and sediment. The pipes and inlets between each settling pond were cleaned/dredged as applicable to return to design water elevations and desired flow patterns. Perforations were added to riser pipe outlet guard for the D3 settling pond to extend the amount of time before the outlet pipe will clog.

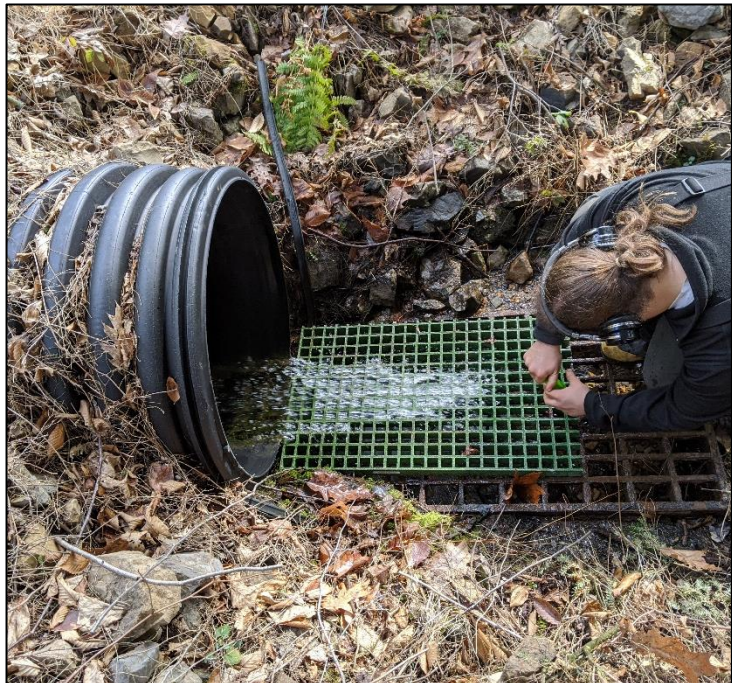
Bottom Right: Fiberglass grate fastened to D3 grate to reduce material entering the box (3/5/20).

Due to upstream conditions and apparent high flow events, a large amount of stone was present in the D3 Type M box. The lid was lifted and this material was removed. A piece of fiberglass grating was secured to the steel grating with the hope of shedding leaf debris as well as diverting additional rocks away from the inlet box, primarily during the fall leaf drop and high flow events in the spring. Since the fiberglass grating has smaller holes than the steel grate it should help to divert rocks from entering the inlet much better while still accepting flow to the system for treatment. This was tested and it was observed that rocks bounced away from the box to the overflow channel due to the energy and force of the water flowing from the road culvert pipe into the inlet box.

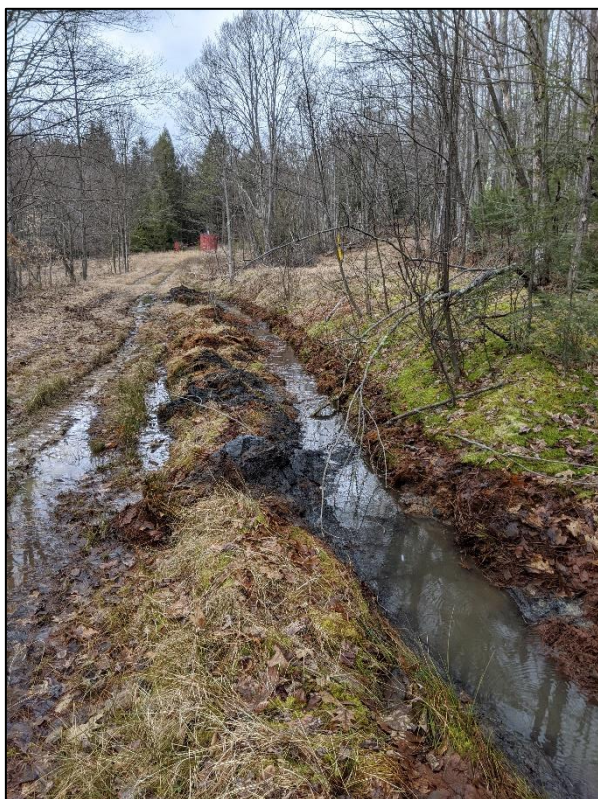
Top Left: The collection channel above D2 was excavated (3/6/20).

The collection channel above D2 was excavated to re-establish full flow of the discharge to the D2 discharge capture point and the “French drain” infiltration stone around the capture point was cleaned. Once the leaf litter was removed the stone appeared to be in very good condition with few precipitates from the water, indicating minimal low pH iron removal at that particular part of the system.

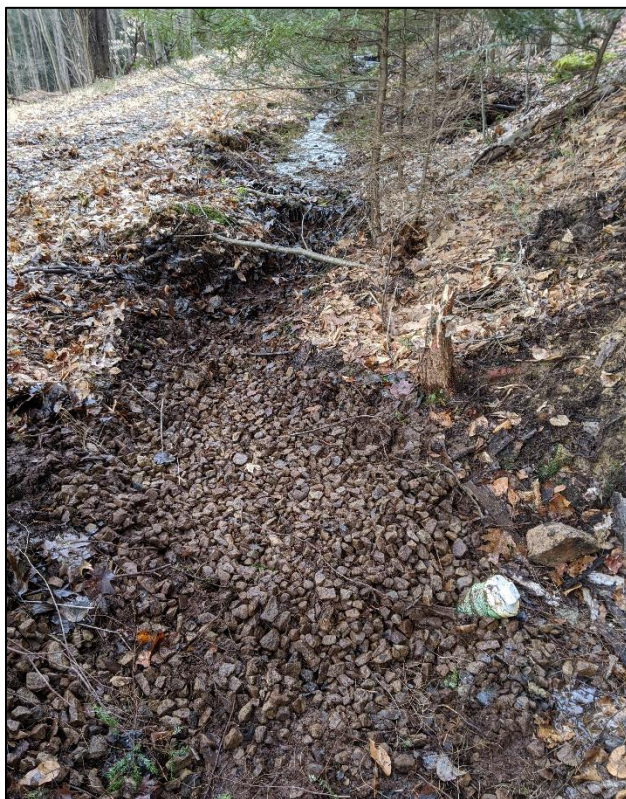
Top Right: The "French drain" was cleared of leaf litter (3/6/20).

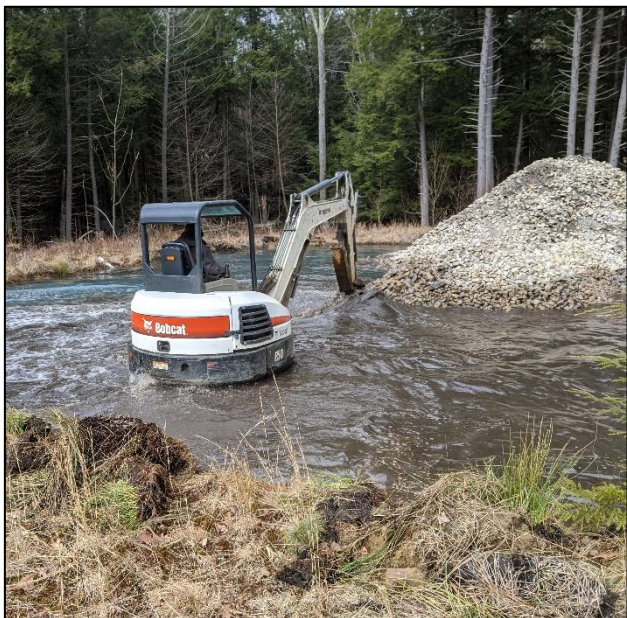
Bottom Left: Washing D3 VFP stone (3/4/20).

Limestone was washed and the underdrain was repaired as applicable for both D2 and D3 vertical flow ponds. The emergency spillway for D3 was lowered so that water would flow to the settling ponds instead of short circuiting the pond embankment if the underdrain becomes clogged in the future.

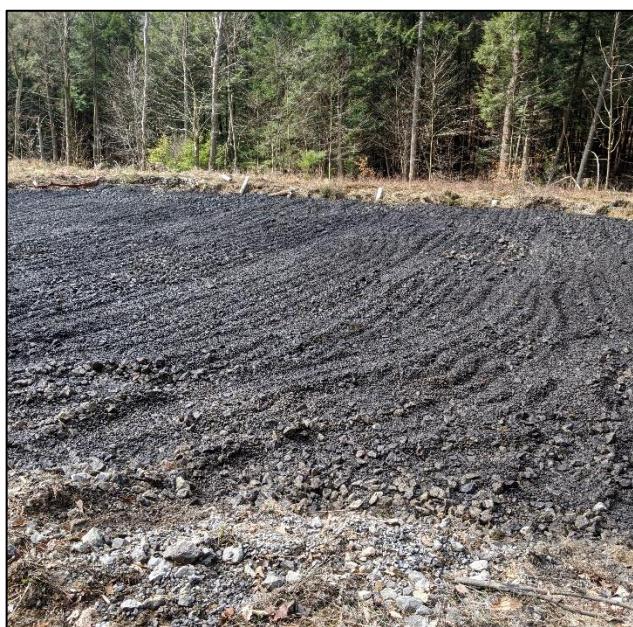
Bottom Right: D3 VFP stone was cleaned and re-placed as media (3/12/20).

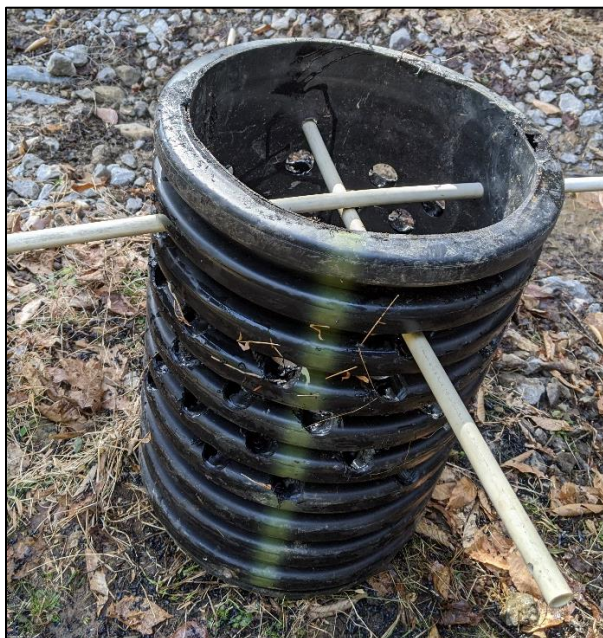
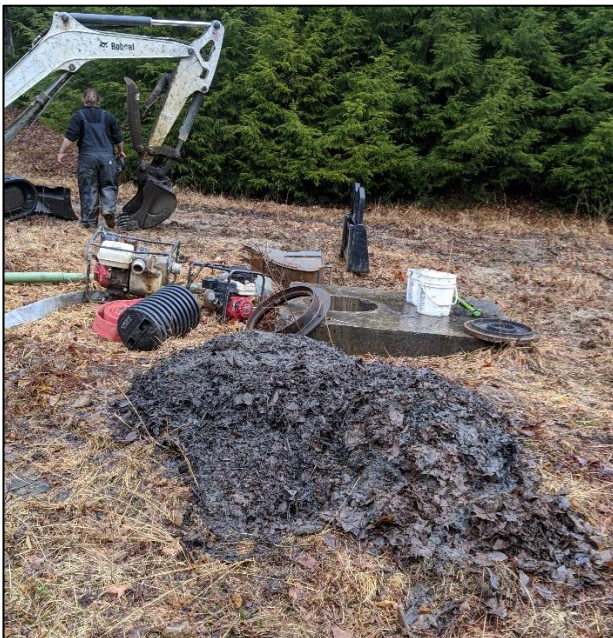
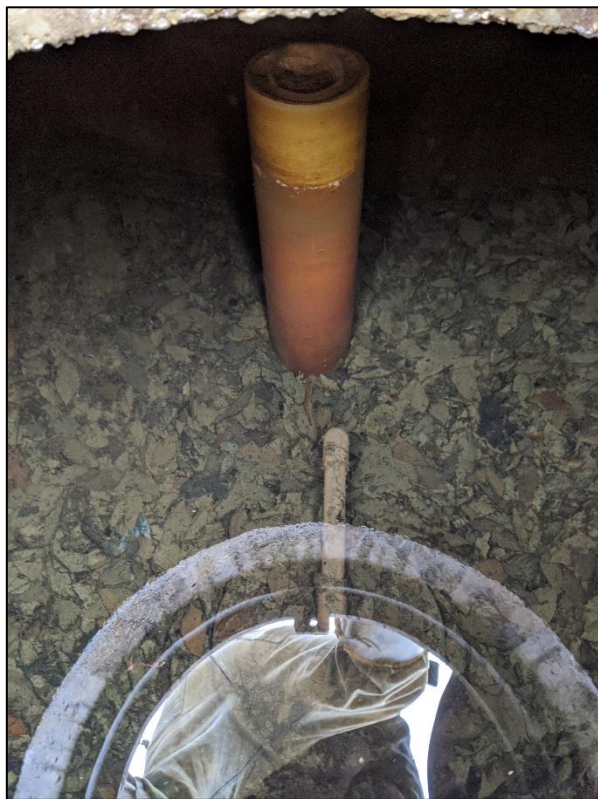
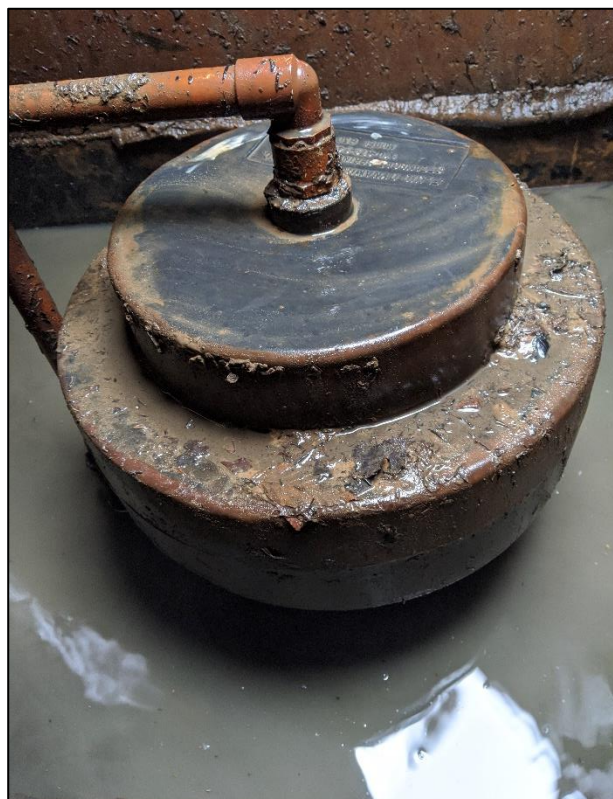
Both siphon vaults were filled with leaf litter and the siphon bells were clogged with material, preventing the D2 and D3 vertical flow ponds from being able to flush as designed. This material was removed from the siphon vaults. Siphon triggers were removed to confirm they were free of blockages. Flush valves for the D2 and D3 ponds were exercised to confirm functionality.

Top Left: Perforations were added to riser pipe outlet guard for the D3 settling pond (3/5/20).
Top Right: Both siphon vaults were filled with leaf litter (D3 pictured) (3/3/20).
Bottom Left: D3 siphon vault prior to cleanout (2/25/20).
Bottom Right: D3 siphon vault after cleanout (3/3/20).
