Shamokin Creek Site 48 Passive Treatment System
SRI O&M TAG Project #5 Request #1
OSM PTS ID: PA-36

Requesting Organization: Northumberland County Conservation District &
Shamokin Creek Restoration Alliance (in-kind partners)
Receiving Stream: Unnamed tributary (Shamokin Creek Watershed)
Hydrologic Order: Unnamed tributary→Shamokin Creek→Susquehanna River
Municipality/County: Coal Township, Northumberland County
Latitude / Longitude: 40°46'40.152"N / 76°34'39.558"W
Construction Year: 2003

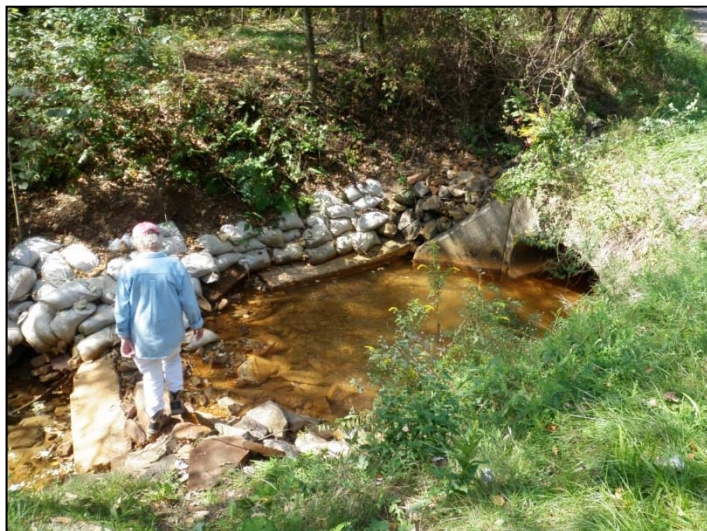
The Site 48 system was experiencing issues with the system intake and sedimentation due to channel erosion (*top left*). A meeting with the watershed organization was conducted (*top right*) to explain maintenance activities that were going to be conducted. Ecology Blocks were placed in the channel to increase flow into the treatment system (*middle and bottom left*) and limestone riprap placed along the bank and below the Ecology Blocks to control erosion (*middle right*). A bar guard was also installed on the intake pipe (*middle right*) to reduce the sediment and debris from entering the treatment system.

In June 2013, BioMost, Inc. performed site work, which included multiple updates to the treatment system inlet structure. Previously, watershed volunteers had lined the stream channel near the system with sandbags to stabilize the banks. During high flow events, however, this was not sufficient to control erosion. To remediate this issue, BioMost Inc. placed riprap along the stream banks and improved existing erosion control measures. As during high flow events a significant amount of water circumvented the treatment system, as part of the project, Ecology Blocks were positioned within the stream channel to create a pool to divert a large portion of the water into the treatment system. An Agridrain bar-guard was also installed onto the intake pipe to prevent large objects such as rocks and sticks from entering the system. A settling pool upstream of the system was also improved to help reduce sediment loading entering the system.
