Clinton Road Treatment System
SRI O&M TAG Project #6 Request #2
OSM PTS ID: PA-36

Requesting Organization: Montour Run Watershed Association (in-kind partner)
Receiving Stream: West Fork of Enlow Run (Montour Run Watershed)
Watershed: West Fork of Enlow Run→Enlow Run→Montour Run→Ohio River
Municipality/County: Clinton Township, Allegheny County
Latitude/ Longitude: 40°29'42"N / 80°16'21"W
Construction Year: 2004

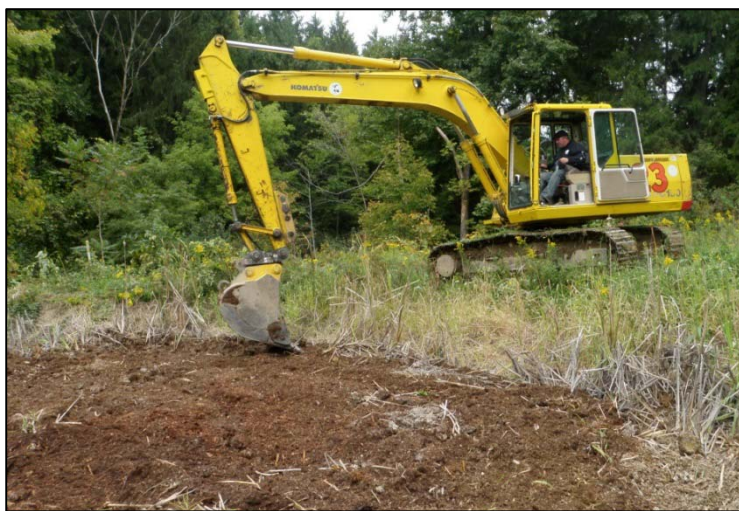
The Pittsburgh Airport Authority provided an excavator and operator to stir the treatment media within the VFPs (Left). Unfortunately because of the piping system, only the top foot of material could be stirred. Aluminum solids coated the limestone of the Upper VFP (Right). There will likely be a need to reevaluate this system in the near future and potentially rehabilitate the VFPS.

On 9/24/12 and 9/25/12, Kevin and an equipment operator from the Pittsburgh Airport Authority met with Buck Neely from BMI on site to perform system repairs. The excavator operator stirred the first foot or so of the treatment media, but was not able to go very deep into the ponds because of the piping system. Vegetation and sediment was also removed to allow raw water to freely enter the treatment system. Buck Neely assisted with assorted tasks on site. The longterm effectiveness of this maintenance is not certain and there may be a need to replace the treatment media in the near future.

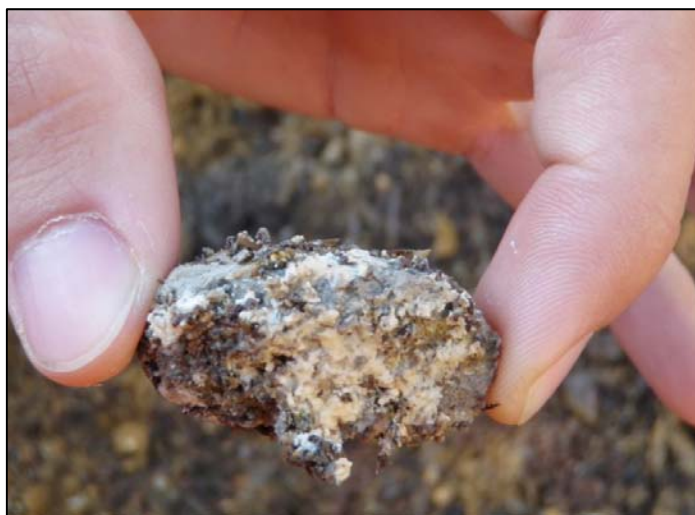
On 5/22/12 Mark Fedosick, Amy, and Ryan of the MRWA revisited the site to examine the treatment media and take photos. They found several inches of thick, clay like iron sludge on top of the compost layer and aluminum solids coating the limestone of the Upper VFP. The Lower VFP did not have an accumulation of iron solids on top of the mixed media but aluminum solids were found to be coating the limestone.

A proposed solution was provided on 6/18/12 by BioMost (BMI) which included separate suggestions for both the upper and lower ponds. For the upper pond, BMI suggested performing iron removal, examining and extending the pond cleanouts, and conducting multiple flushing cycles to try to improve permeability. Similarly for the lower pond, BMI suggested extending the cleanouts and examining them to make sure they are not perforated. It was decided that stirring the treatment media would be beneficial as long as the underdrain pipes are not compromised.
