Pine Forest Passive Treatment System
SRI O&M TAG Project #8
OSM PTS ID: PA-225

Requesting Organization: Schuylkill Headwaters Association, Inc. (in-kind partner)
Receiving Stream: Mill Creek
Hydrologic Order: Mill Creek→Schuylkill River→Delaware River
Municipality/County: St Clair Borough & East Norwegian Township, Schuylkill Co.
Latitude/ Longitude: 40°43'02.3916"N / 76°10'33.6828"W
Construction Year: 2005

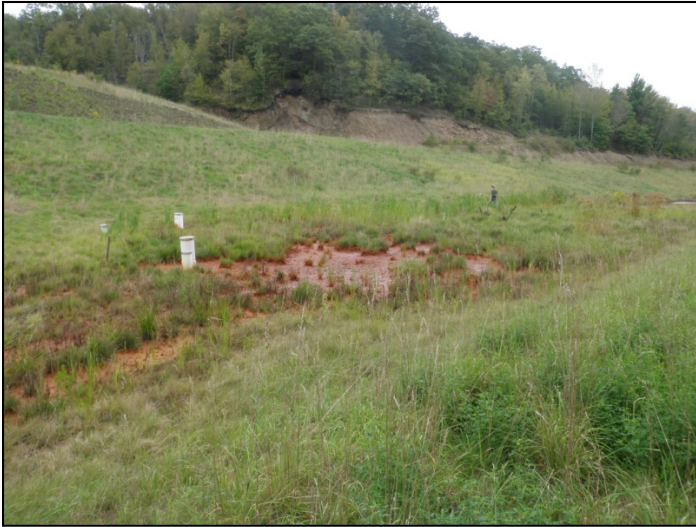
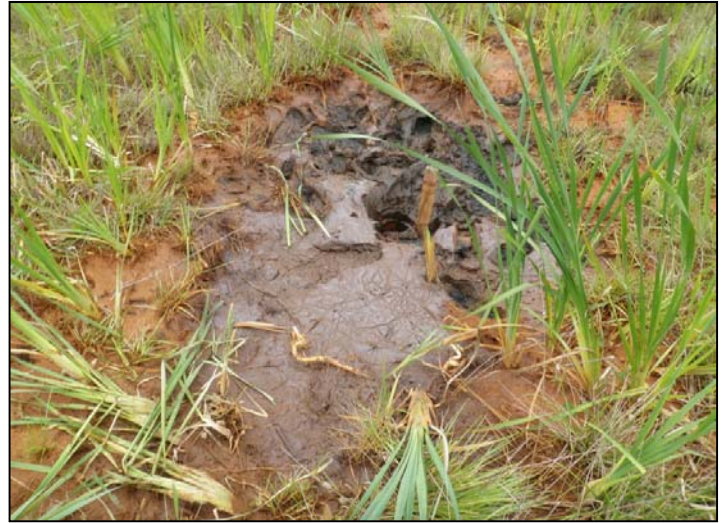
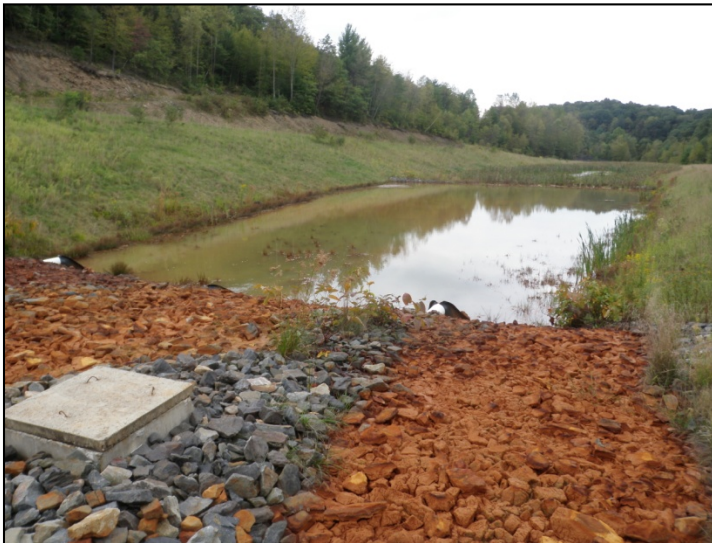
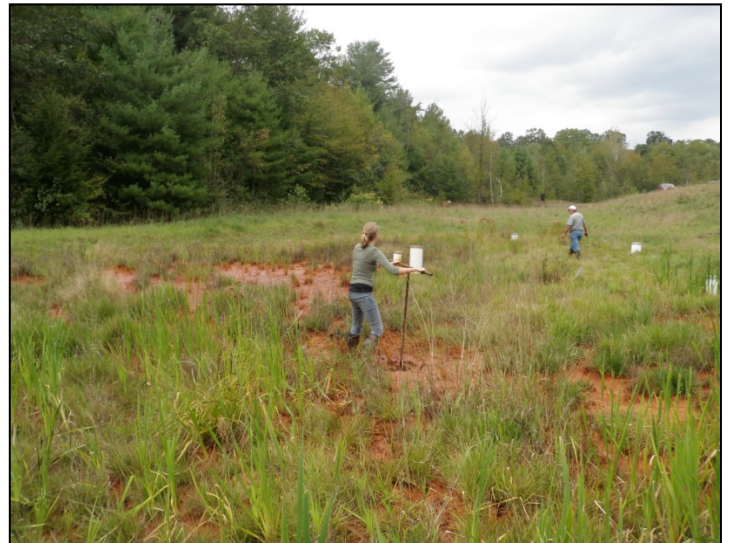
The bacteria *Gallionella* is growing and clogging the limestone aggregate within the Oxidic Limestone Drain causing the water to rise to the surface and flow over top of the system (*top left & right*) and then flow over the spillway (*bottom left*) into the next pond instead of through the OLD. This problem requires flushing of the bed (*bottom right*) on an essentially weekly basis which is quite time consuming.

Excavate and install a 12" X 6' SmartDrain box which would be connected to the center flush drain. Then all the valves that are typically opened to flush the system would be kept open to allow the SmartDrain to control the flushing. The SmartDrain can be programmed to allow whatever flushing schedule the group would like. In this case, at least once per week would be recommended, but could be increased to daily if desired. This would then eliminate the need to travel to and from the site to open the valves and return the next day to close the valves on such a frequent basis. The cost of the unit would be approximately \$4,500 with installation costs estimates of \$4,000 to \$5,000.

- Install SmartDrain or siphon-based flushing system
