Hamilton Passive Treatment System
SRI O&M TAG Project # 15 Request #1
OSM PTS ID: PA-30

Requesting Organization: Washington County Conservation District (in-kind partner)
Raccoon Creek Watershed Association (in-kind partner)
Independence Conservancy (in-kind partner)
Receiving Stream: Unnamed Tributary (Raccoon Creek Watershed)
Hydrologic Order: Unnamed Tributary→Potato Garden Run→
Raccoon Creek→Ohio River
Municipality/County: Findlay Township, Allegheny County
Latitude/Longitude: 40°28'26.0004"N / 80°17'43.0008"W
Construction Year: 2003

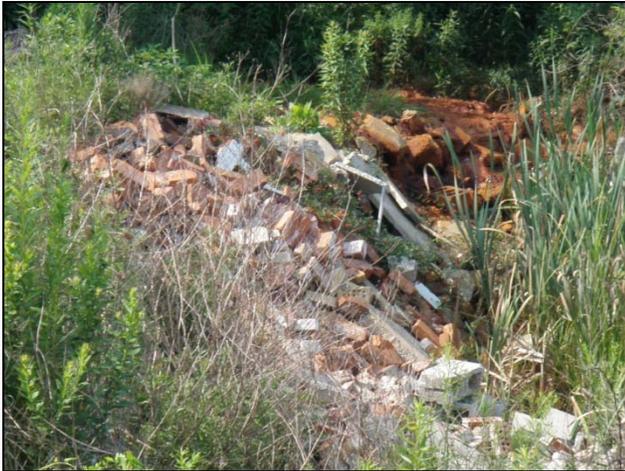
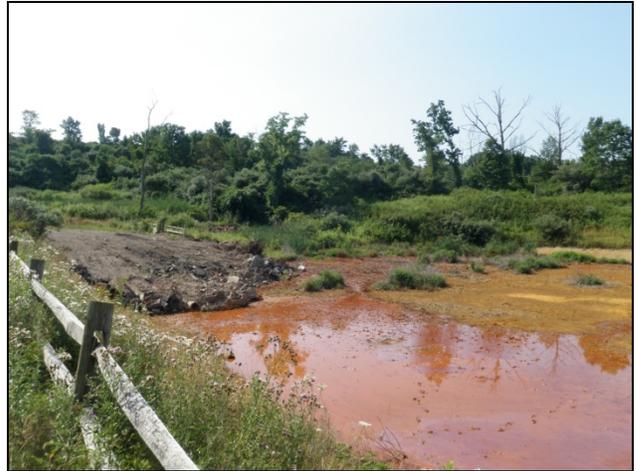
Construction and miscellaneous debris (*top left & right*) including bricks and furniture were dumped into the VFP and SP and needs to be removed. The existing outlet structures (*middle right*) of the VFP and SP need to be replaced along with the SP sampling dock (*middle left*). Iron sludge (*bottom left*) on top of the VFP will need to be removed. Water monitoring & field tests are being conducted of the system and streams to enable for further evaluation (*bottom right*).

- The existing outlet structures of the VFP and SP need to be replaced.
- The sampling dock at the existing SP needs to be replaced or removed.
- Construction/misc. debris dumped into the VFP and SP needs to be removed.
- Iron sludge on top of the VFP will need to be removed in the future.
- Sections of the split-rail fencing and gates needs repaired/replaced.
- Large brush and trees along the fence line needs to be cleared.
- Existing access road is in need of repair including placement of additional stone.
