**SR-286 Passive Treatment System**  
**SRI O&M TAG Project #16 Request #1**  
**OSM PTS ID: PA-241**

Requesting Organization: Aultman Watershed Association for Restoring the Environment  
(AWARE) (in-kind partner)  
Kiski-Conemaugh Stream Team  
Receiving Stream: Aultmans Run (Aultmans Run Watershed)  
Hydrologic Order: Aultmans Run→Conemaugh River→Kiskiminetas River→  
Allegheny River→Ohio River  
Municipality/County: Center Township, Indiana County  
Latitude/Longitude: 40°33'23.0004"N / 79°15'33.0012"W  
Construction Year: 2004

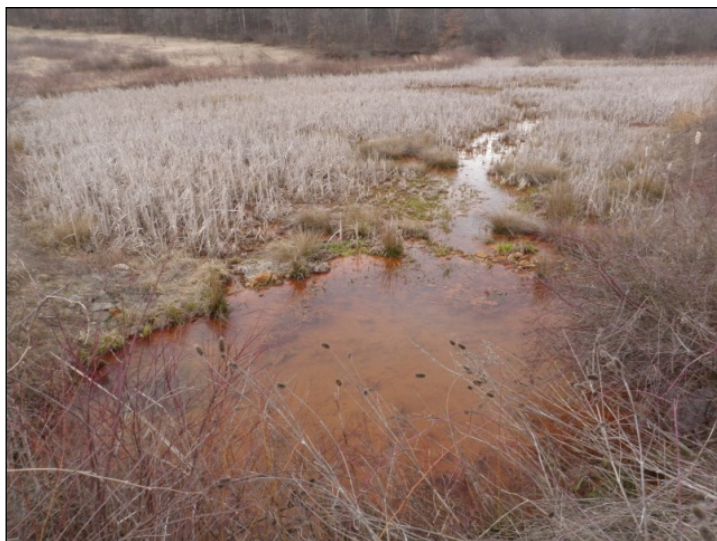
- Preferential flow paths had formed within the treatment wetland over time partly due to channels within the forebay level spreader. These channels were created from riprap being removed from several areas of the level spreader, most likely by local children, along with vegetation growing within the forebay.

Channelization within the treatment wetland (*top left*) of the SR-286 PTS is apparently in response to the uneven build-up of vegetation within the forebay level spreader. Volunteers helped to replace rocks and to remove vegetation in order to re-establish the level spreader (*top right*). Compost filter socks were installed to replace the hay bales that had been previously installed in 2004 to increase storage capacity of the wetland and to reduce short-circuiting (*bottom left & right*).

On 9/21/12, a group of AWARE volunteers and Shaun Busler from BioMost, Inc. performed the maintenance at the passive system. A trail was blazed to the outlet of the treatment wetland. To raise the water level in the treatment wetland, approximately 50 feet of 8" compost filter sock was installed by hand at the outlet to replace the deteriorated hay bales. The compost filter sock, a readily-available product used for erosion control, was selected as the longevity is typically greater than for hay bales. In addition, riprap was rearranged and vegetation removed within the forebay level spreader in order to re-establish the water level and to distribute the flow across the entire level spreader.

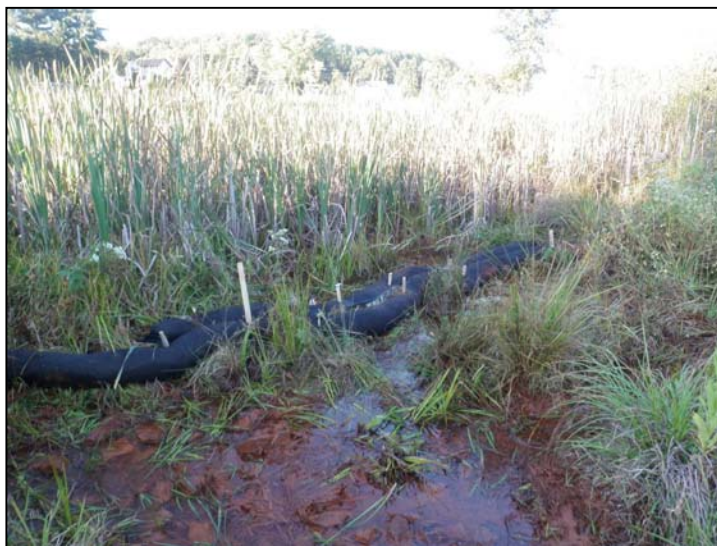
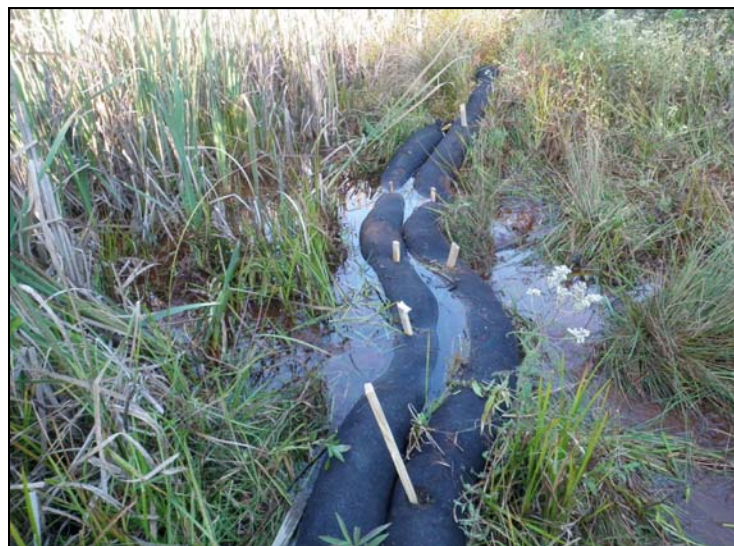
- The water level within the treatment wetland had lowered due to the deterioration of hay bales placed at the outlet in 2004 in order to increase the storage capacity of iron solids and to reduce short-circuiting.

It is recommended that AWARE continue to monitor the raw discharge, the treatment wetland effluent, and the wetland channel effluent on at least a quarterly basis to determine the necessity of additional maintenance. If needed, additional compost filter sock, proven to create effective baffles in other passive treatment wetlands, may be installed to aid in distributing the flow to all portions of the treatment wetland.

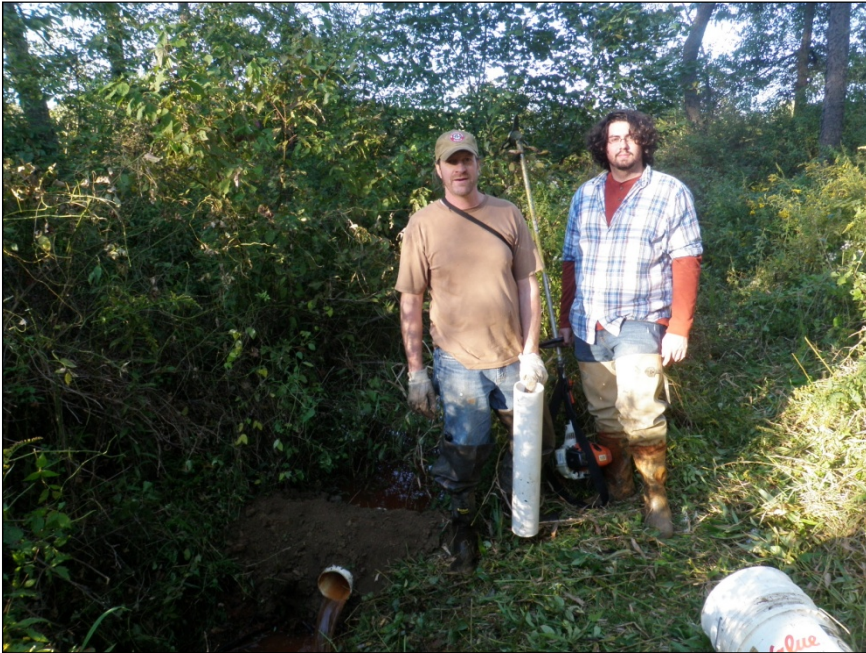
Brian Okey, IUP professor and President of AWARE, and Ryan Cunningham, IUP student and AWARE intern (*above*), standing by the hand-installed outlet pipe for flow measurements. Unfortunately, the pipe was apparently washed away during high flow events (*right*). IUP student volunteers helped at the site in April 2013 by carrying and placing bags of concrete to install protection for the new outlet pipe for the existing channel wetland (*below*).

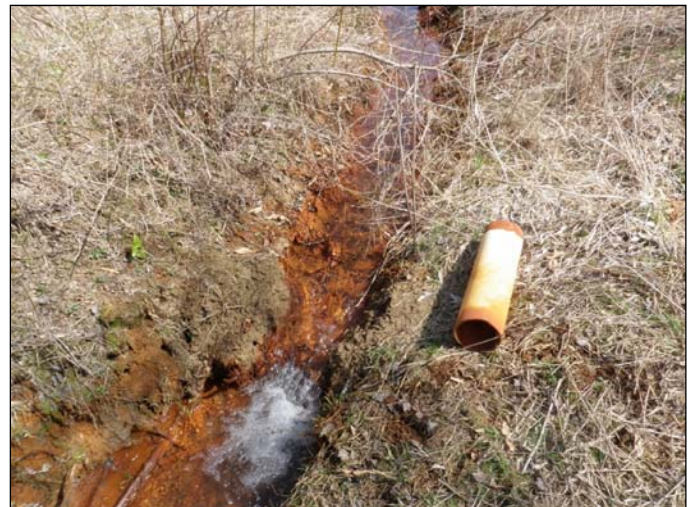
- The water level in the existing channel wetland had also been lowered due to erosion at the effluent end of the component. In addition, the outlet pipe, installed by hand in order to take flow measurements, was missing apparently also due to erosion forces.

A replacement pipe was installed at the outlet of the existing wetland channel on 9/21/12; however, high flows within Aultmans Run again carried the pipe downstream. On 4/9/13, with the help of Indiana University of Pennsylvania (IUP) students, concrete bags were carried to the outlet and stacked carefully within the channel in order to help protect the current outlet pipe

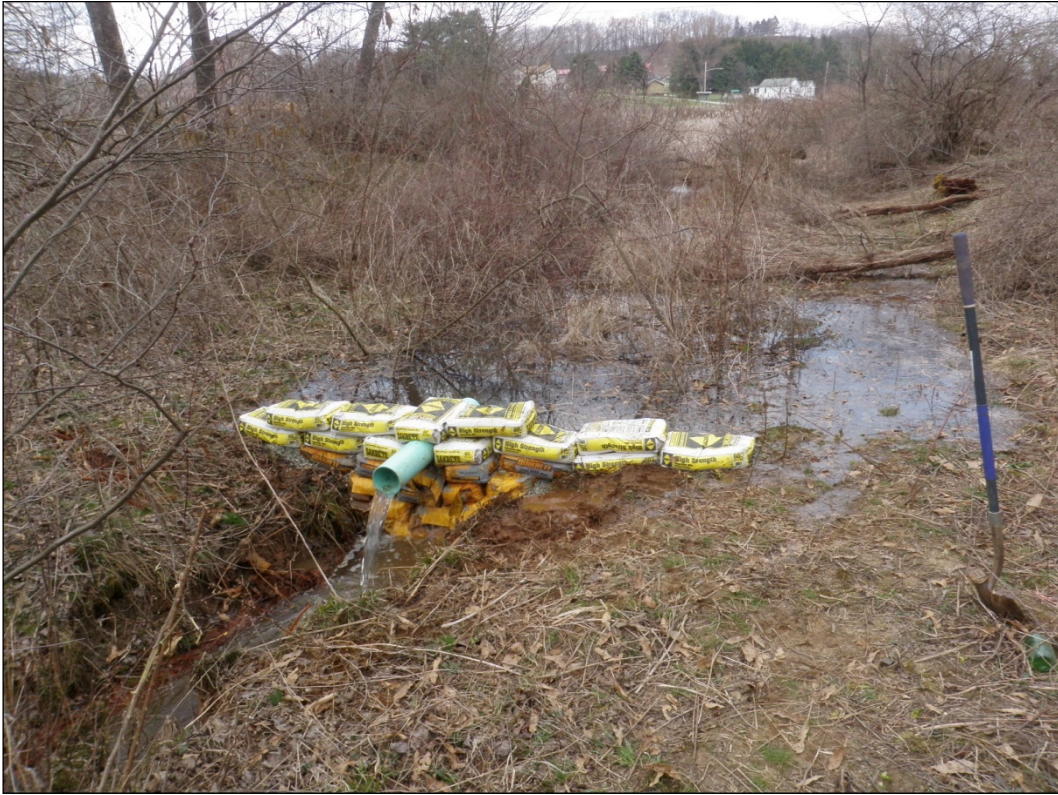
Concrete bags, with bentonite used to seal void spaces between bags, were used on 4/9/13 to protect the existing wetland channel outlet replacement pipe (*above*). On 6/17/13, outlet pipe remained in place and water level had risen (*below*).

from being dislodged by erosive forces. Void spaces between the concrete bags noted during placement were sealed with bentonite chips. A subsequent monitoring event on 4/16/13 indicated that the channel wetland had returned to the design water level and that water was flowing through the outlet pipe.
