Jones Mine Passive Treatment System
SRI O&M TAG Project # 19 Request #1
OSM PTS ID: PA-183

Requesting Organization: Beaver County Conservation District (in-kind partner)
Receiving Stream: Brady Run (Beaver River Watershed)
Hydrologic Order: Brady Run→Beaver River→Ohio River
Municipality/County: Patterson Township, Beaver County
Latitude/Longitude: 40°44'52.6848"N / 80°20'20.5404"W
Construction Year: 1995

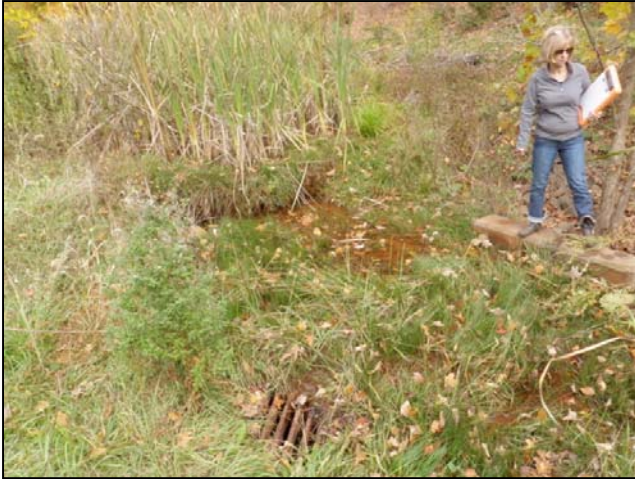
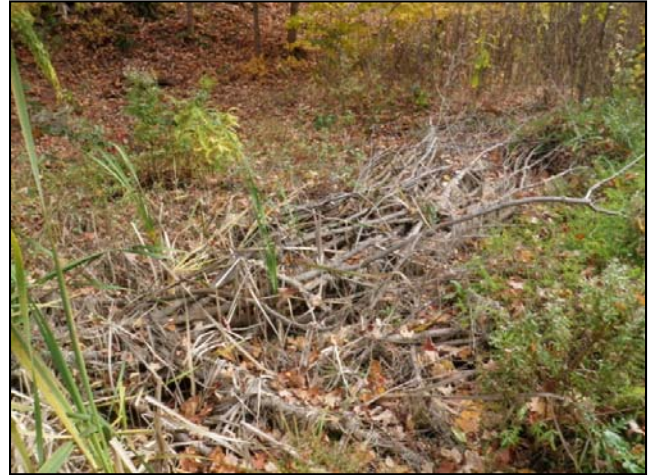
The Jones Mine treatment wetland was clogged with plants, iron sludge, and debris (*top left and right*). The material was excavated to restore treatment capacity (*middle left*). Accumulated material within a channel near a storm water grate caused short-circuiting of the AMD and was removed (*middle right*) to return full utilization of the treatment system. Sludge, vegetation, and debris were also removed from the weir (*bottom left*). The site sign was cleaned, repaired, and re-installed as an in-kind service of BioMost, Inc.

In July 2013, Marty met on-site with Bryan Page and Ryan Mahony of BioMost, Inc. (BMI) to perform the maintenance. The accumulated iron and organic matter were excavated from the system channels. Select excess material was placed along the berm to increase capacity of the system. A grate, which was designed to collect road runoff along the site, was also clogged and flow from the system was short-circuiting and entering the grate. Material that had built-up around the grate was also removed so that flow from the treatment system would remain within the system. The channel for storm water entering the grate was re-graded and modified to convey runoff to the storm drain instead of into the treatment wetland. Brush and trees which had been dumped into the system over the years were restricting and altering flow within the system. This debris was removed. Over time, the treatment system weir had also become clogged with debris and sediment. This was also removed and the weir was cleaned to allow for proper system flow measurements. The sign for the treatment system was cleaned, repaired, and re-erected on site using time donated by BMI.
