**Erico Bridge Passive Treatment System**  
**SRI O&M TAG Project # 25 Request #1**  
**OSM PTS ID: PA-187**

Requesting Organization: Slippery Rock Watershed Coalition (in-kind partner)  
Receiving Stream: Seaton Creek (Slippery Rock Creek Watershed)  
Hydrologic Order: Seaton Creek→Slippery Rock Creek→Beaver River→Ohio River  
Municipality/County: Venango Township, Butler County  
Latitude/Longitude: 41°07'31.0008"N / 79°51'38.0016" W  
Construction Year: 2003

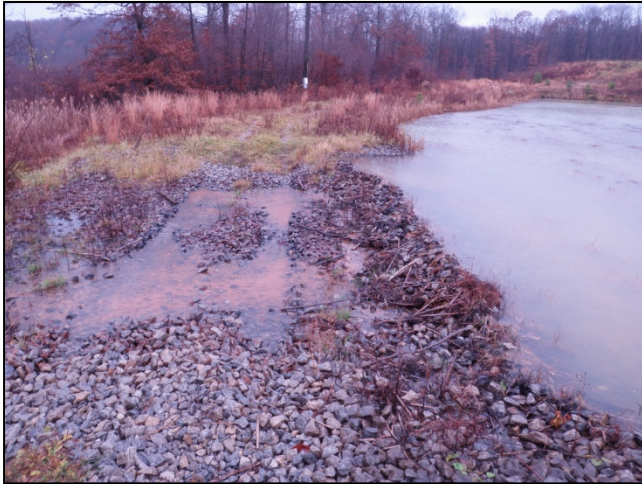
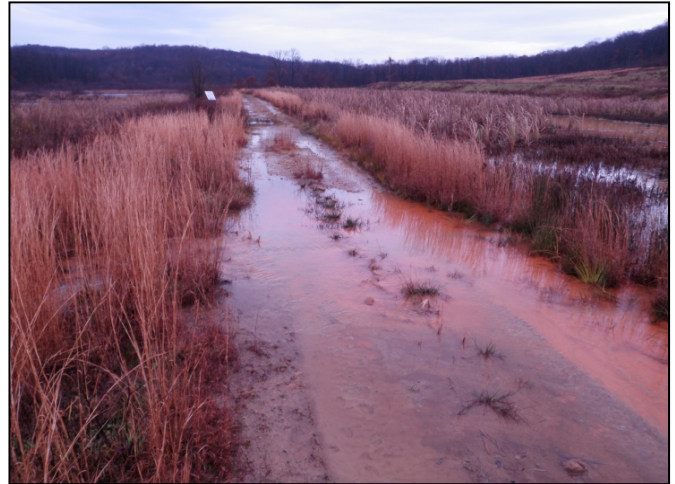
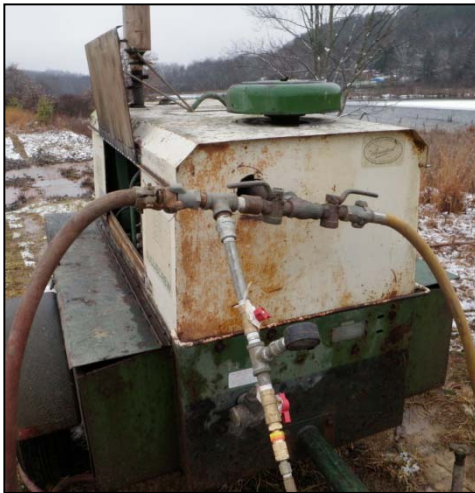
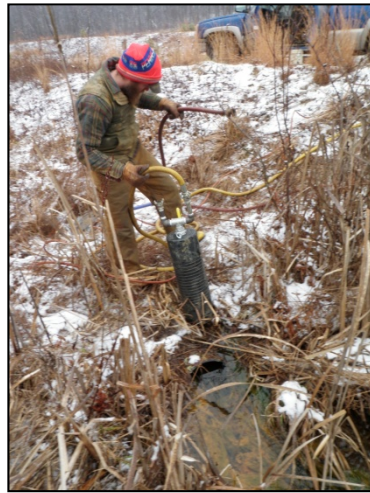
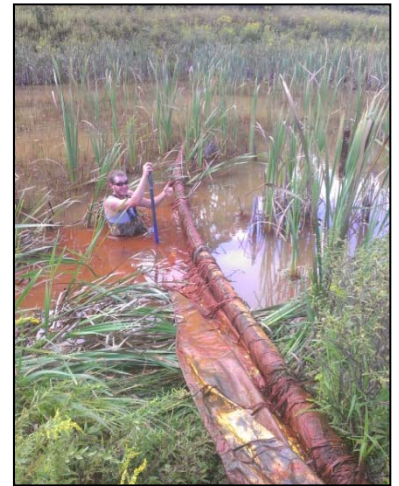
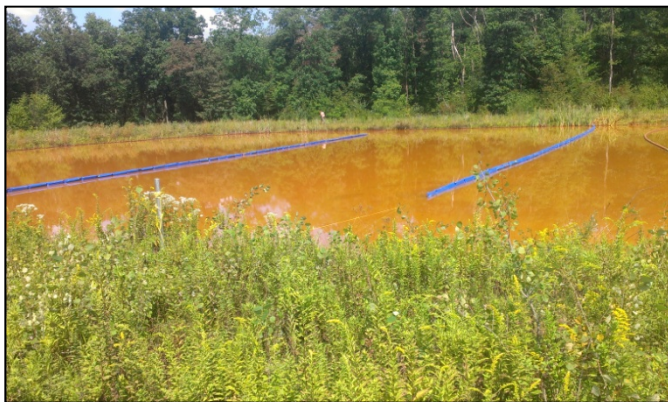
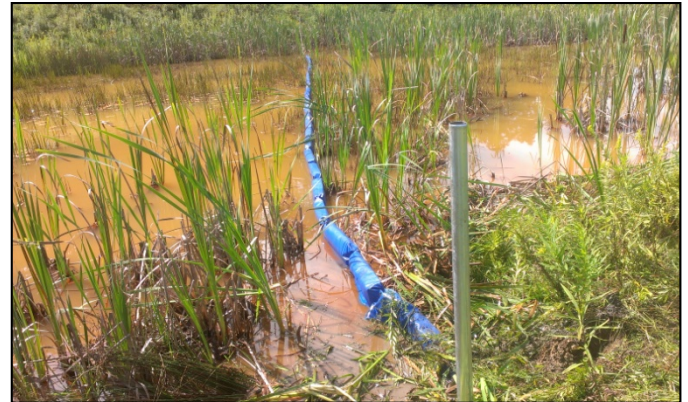
At the Erico Bridge PTS, water was discharging over the HFLB emergency spillway (*top left*) indicating either the piping or limestone aggregate was plugged. In addition, beaver had built a dam across the spillway (*top left*) causing the water level within the treatment wetland to rise and, in places, flow over the berm, flooding the access road (*top right*). The HFLB pipe was back-flushed (*center*) using an air compressor (*middle left*). New baffle curtains were also installed (*middle right*) in Settling Pond 1 (*bottom left*) and Settling Pond 3 (*bottom right*).

On 1/16/13, Ryan Mahony and Bryan Page of BMI traveled to the site to back-flush the HFLB. Little improvement, however, was realized from back-flushing, indicating that the problem was substantially related to plugging of the treatment media by iron and manganese precipitates. After back-flushing the HFLB, a brief site inspection was completed. During the inspection, the baffle curtains in Settling Ponds 1 and 3 were observed to be in disrepair or nonfunctional and needed to be replaced. In August 2013, new baffle curtains were installed.

BMI recommended that the limestone aggregate in the HFLB needed to be at least stirred if not washed to remove the precipitates in order to increase permeability and restore treatment performance. As the HFLB was designed to contain 9000 tons of limestone aggregate, the work to rehabilitate the bed was beyond the scope of the O&M TAG grant; therefore, additional funding was needed. In July 2013, the SRWC and SRI submitted an ACT 13 grant application to the Pennsylvania Department of Community and Economic Development (PA DCED) that included funding to rehabilitate the HFLB. SRI was awarded the grant. The new landowner executed the required access forms and work to rehabilitate the HFLB is to be conducted in the summer of 2015.
