Miller Run #1 Passive Treatment System
SRI O&M TAG Project # 30 Request #1
OSM PTS ID: PA-284

Requesting Organization: Huntingdon County Conservation District (in-kind partner)
Receiving Stream: Miller Run (Shoup Run Watershed)
Hydrologic Order: Miller Run→Shoup Run→Juniata River→Susquehanna River
Municipality/County: Carbon Township, Huntingdon County
Latitude/Longitude: 40°13'44.5944"N / 78°10'39.3420" W
Construction Year: 2007

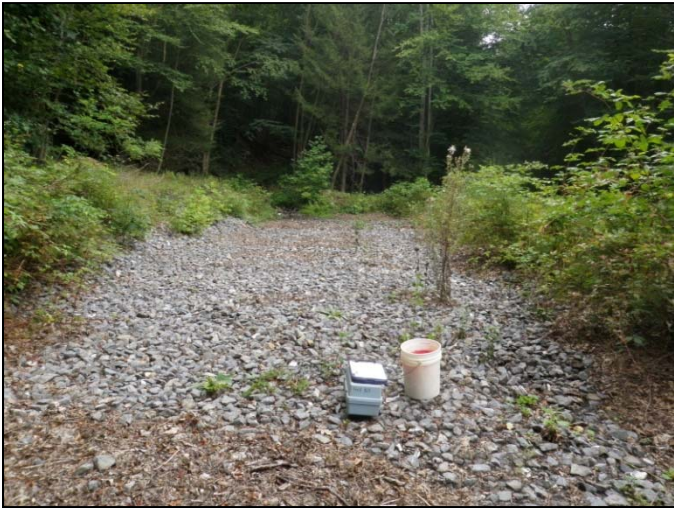
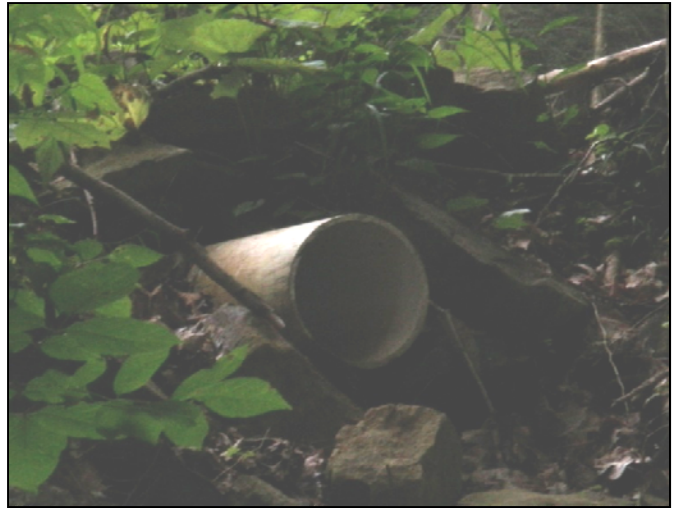
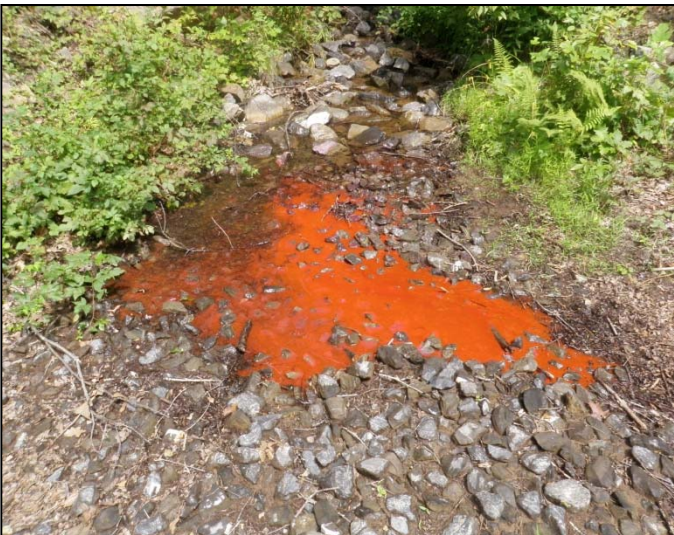
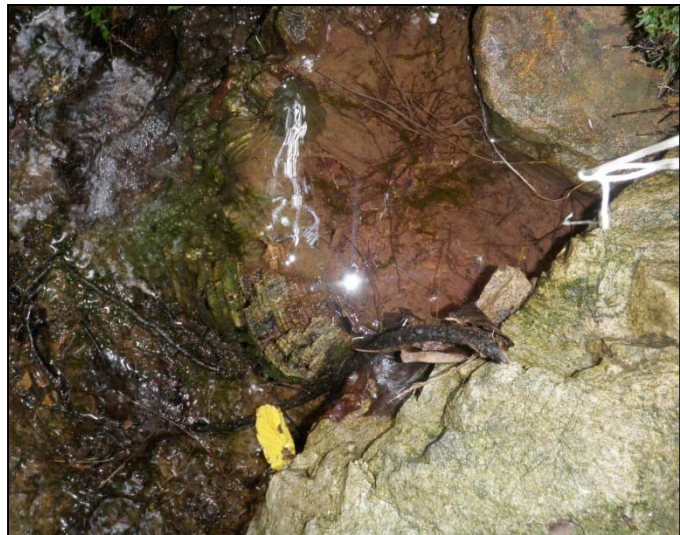
During the site visit, samples of the raw water and two seeps located below the limestone bed along the stream were collected and a dye test was conducted in order to determine if the source water for the seeps was from the leaking pond. The quality of the raw water and seeps were found to be similar, indicating a leak. Approximately 1 hour after adding dye to the influent of the limestone pond, dye was observed at Seep 1 and thirty minutes subsequent, at Seep 2 confirming that the bed was leaking. With such a short retention time, substantial water quality improvements to the discharge would not be expected.

The Miller Run #1 Limestone Bed (*top left*) was experiencing leakage of poor water quality and was not discharging from the effluent pipe (*top right*). A dye test was conducted by placing dye at the inlet of the bed (*bottom left*) to aid in determining if the seeps along the stream bank were indeed AMD from the leaking limestone bed. The dye began to appear at Seep 1 (*bottom right*) after 1 hour and at Seep 2 at 1.5 hours indicating that the pond was not only leaking, but also severely short-circuiting.

BioMost, Inc (BMI) prepared a plan to repair the treatment system (See attached plan.), which included removing and stockpiling the limestone aggregate, installing a geosynthetic clay liner (GCL) along the bottom and sides of the pond and inlet channel and then carefully replacing the stone. It was also recommended that the limestone be cleaned if possible. The cost was estimated to be about \$19,400. The cost was beyond the scope of the O&M TAG program and other funding sources would need to be sought. The HCCD was able to obtain a \$25,000 grant from the EPA 319 program and completed the repair. According to the HCCD, the repair was successful as the bed no longer leaks and the pH of the final effluent during the monitoring snapshot was greater than 7.
