De Sale Phase 2 Passive Treatment System
SRI O&M TAG Project #22 Request #3
OSM PTS ID: PA-114

Requesting Organization: Slippery Rock Watershed Coalition
Receiving Stream: Unnamed Tributary to Seaton Creek
Watershed: Slippery Rock Creek
Municipality/County: Venango Twp., Butler Co.
Latitude/Longitude: 41° 8' 39.9984" N / 79° 49' 54.9984" W

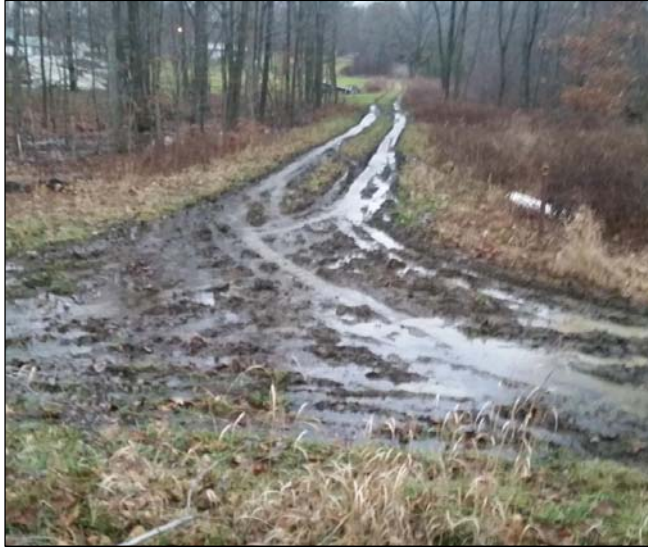
At the De Sale Phase 2 passive system, beaver built dams within the spillways (top left) of the wetland and settling pond. Multiple attempts were made to lower the dam and/or install small corrugated piping (top right). Unfortunately, the beaver kept raising the dam until it began to overflow the wetland and down the access road (bottom left). In December 2015, Biomost, removed the dam completely (bottom right) and installed 2 large 12" culvert pipes with both the inlets and outlets submerged underwater to eliminate sound.

In December 2015, BioMost returned to the site. To fix this issue, the beaver dam was removed to allow flow to enter the HFLB and lower the water elevation in the wetland. As a more permanent solution to the problem, two 12" culvert pipes were installed with inlets and outlets under water to reduce the sound of running water. The pipes were installed parallel to the designed spillway. Normal flow operation was restored. While equipment was on site, the system forebay inlet and outlet pipes were inspected and cleared of sediment.
