**Penn Hills #2 Passive Treatment System**  
**SRI O&M TAG Project #35 Request #2**  
**OSM PTS ID: PA-132**

Requesting Organization: Blacklick Creek Watershed Association  
Receiving Stream: Two Lick Creek  
Watershed: Blacklick Creek  
Municipality/County: Center Twp., Indiana Co.  
Latitude/Longitude: 40° 38'15" N/ 79°2'16" W

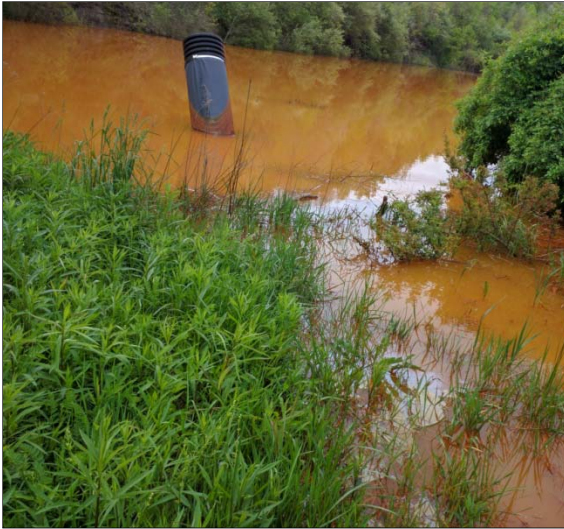
**Top Left:** AMD was overtopping the berm of the collection pond due to the conveyance pipe being plugged and the emergency overflow pipe detached and floating.

In May 2017, BioMost, Inc. mobilized to the site to address the issue. The flow splitter box was inspected and iron solids accumulating within the splitter were removed. The pipe extension sticking out of the water was believed to be part of the conveyance pipe to the splitter box and was removed for the purpose of lowering the water level in the pond. This caused additional flow to bypass the system, which indicated that the pipe must be an overflow pipe and that the conveyance pipe to the system must be plugged and located somewhere else. Further investigation was needed. The collection pond was pumped down to reveal the conveyance pipe which was plugged. This pipe was cleaned and a tee was installed to help reduce debris entering the pipe and provide two entry points which should help prevent the problem occurring in the future. Concrete blocks were placed on top of the overflow pipe to prevent floating. Flow to the system was restored. In addition, the access road was repaired where erosion had occurred when flow was bypassing the system.

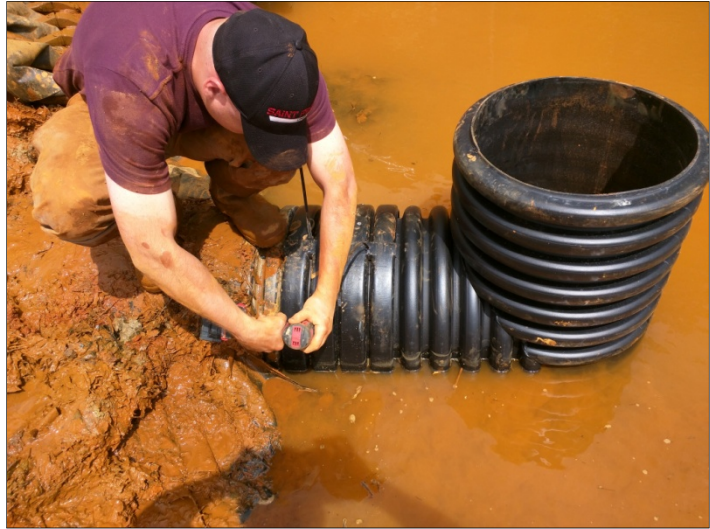
**Top Right:** Once the collection pond outlet pipe was located and cleaned, a Tee was installed to reduce debris entering the pipe and provide two points of entry.

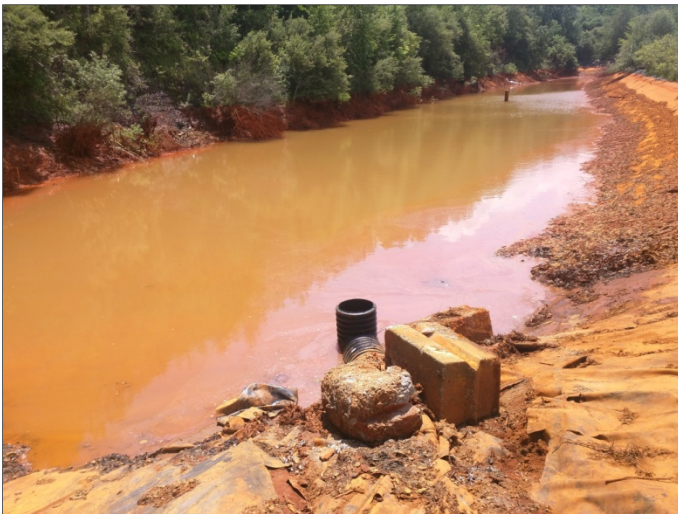
**Bottom Left:** Concrete blocks were placed on the outlet pipe to keep it from floating.

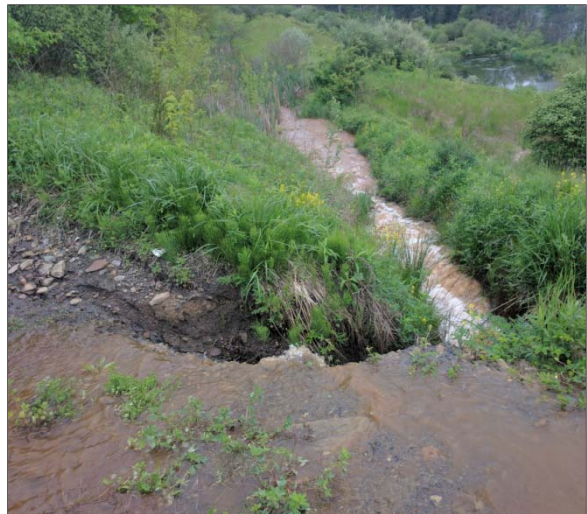
**Bottom Right:** Repairs to the access road were necessary due to increased flow overflowing the pond.
