**Old Never Sweat AMD Remediation System**  
**SRI O&M TAG Project #40 Request #1**  
**OSM PTS ID: PA-234**

**Dates of Work Performed:** 3/11/19-3/13/19

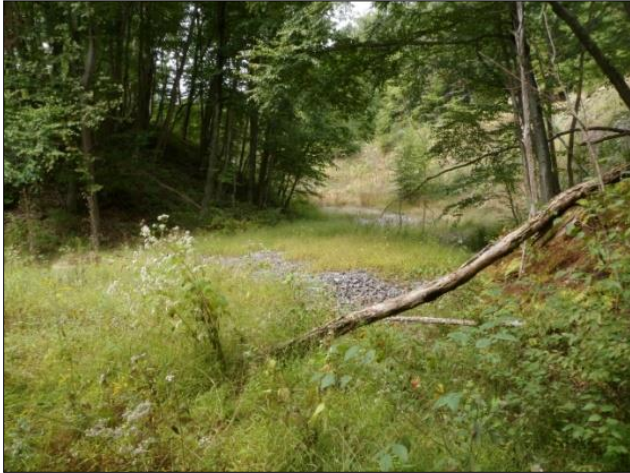
**Top Left:** 600-ton limestone bed with dosing siphon. Vegetation growing in large portions of the bed.

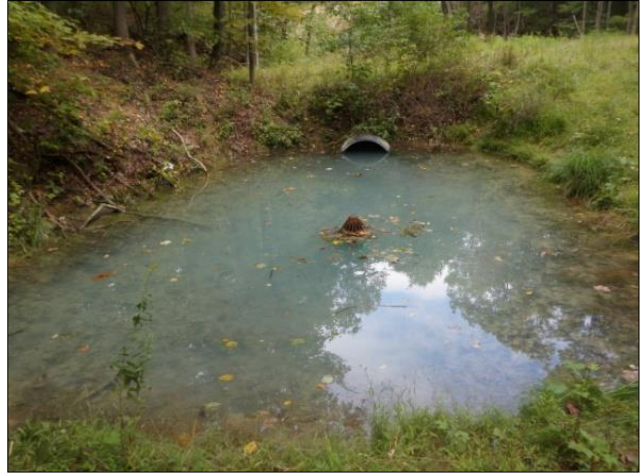
**Top Right:** Settling pond with cloudy water due to aluminum precipitates.

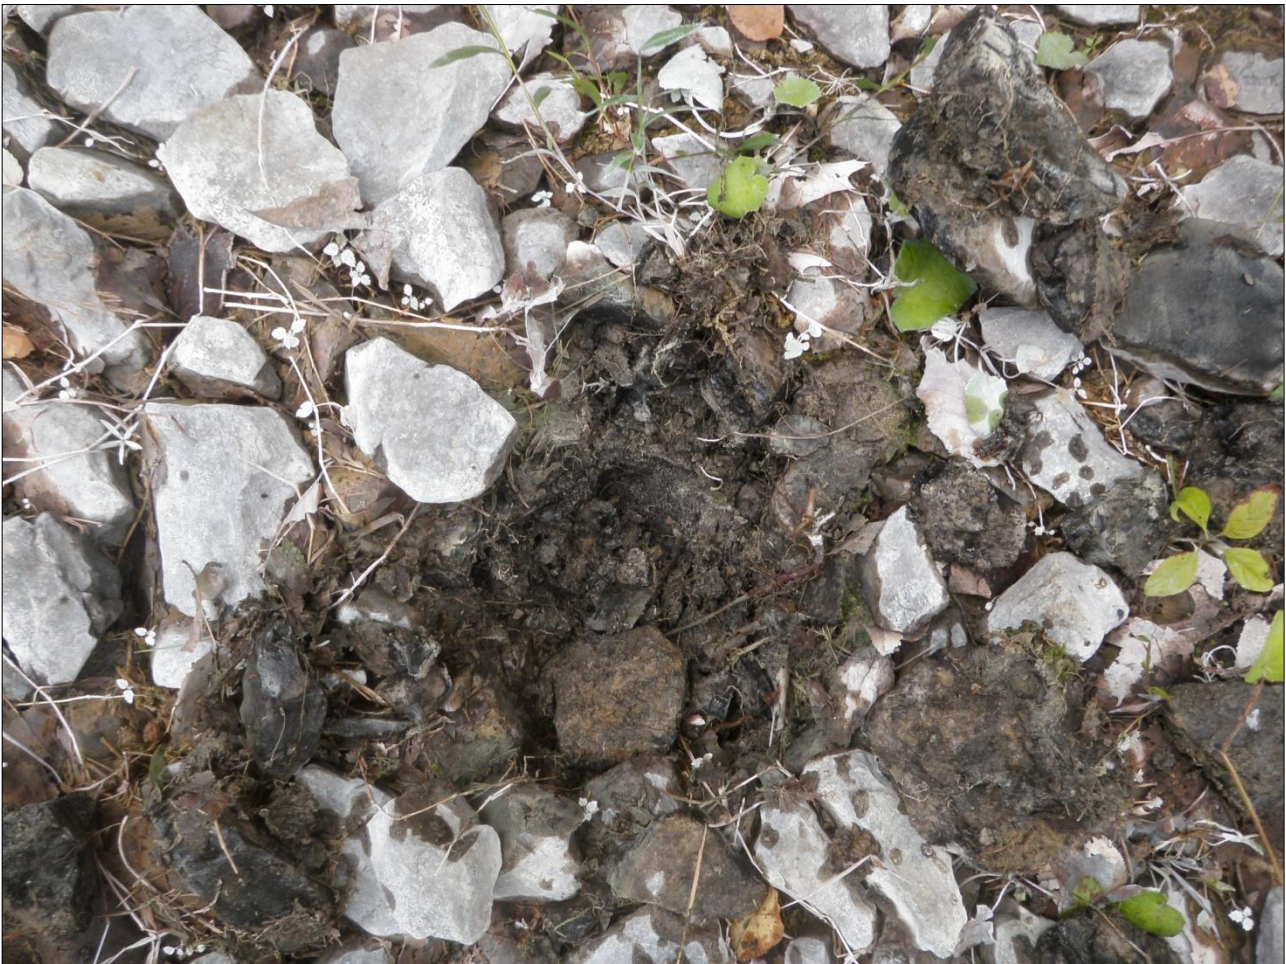
**Bottom:** Limestone media within the northern portion of the system showing signs of void spaces filling with metal precipitates, vegetation, and sediment.

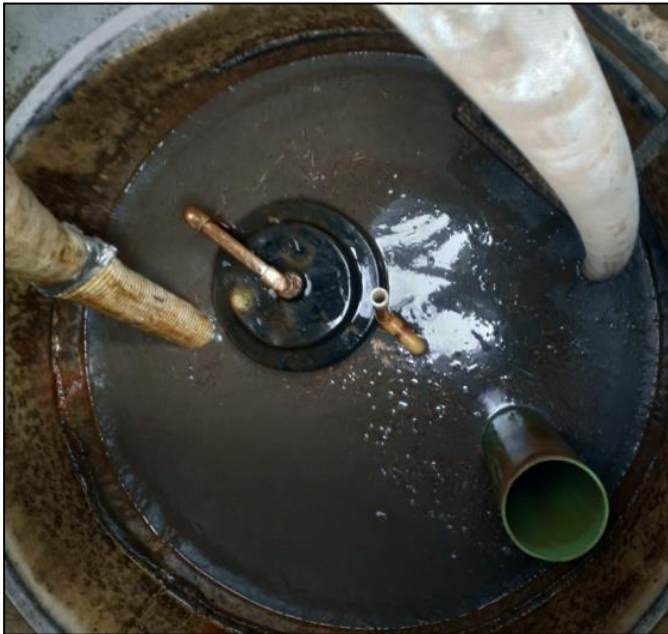
**Top Left:** Cleaning sediment from the dosing siphon with a pump and fire hose.

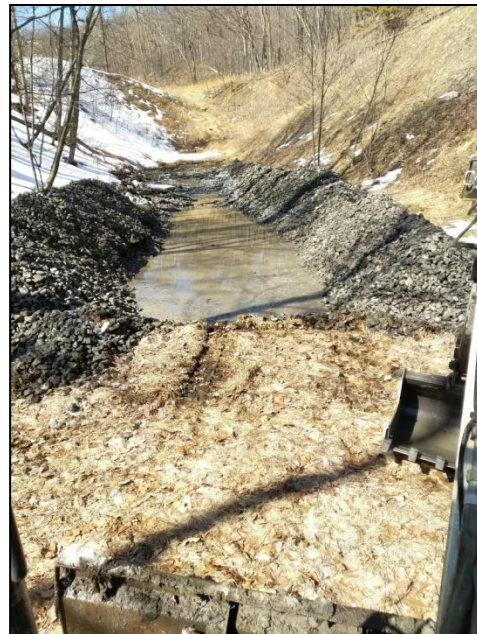
**Top Right:** Stirring and washing the limestone bed.

- Washed and stirred limestone bed. Approximately 2 feet of water was maintained within the bed to wash the limestone more effectively.
- Sediment-laden water flushed/ pumped to the settling pond prior to installation of new underdrain.

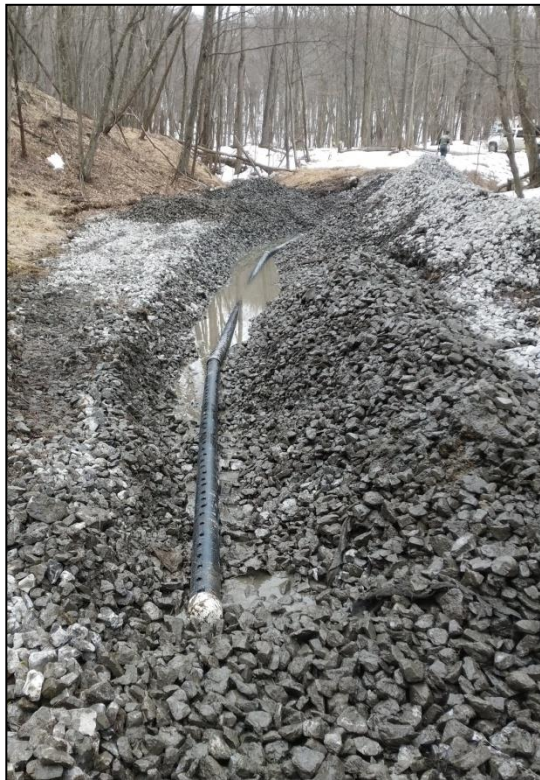
**Bottom Left:** New underdrain installed in the limestone bed.

- 120 feet of 6" DR-11 HDPE pipe perforated with 1.25" holes spaced 6" apart was plumbed onto the original SDR 35 underdrain pipe connected to the siphon vault to extend the pipe the entire length of the bed to provide for more effective flushing.

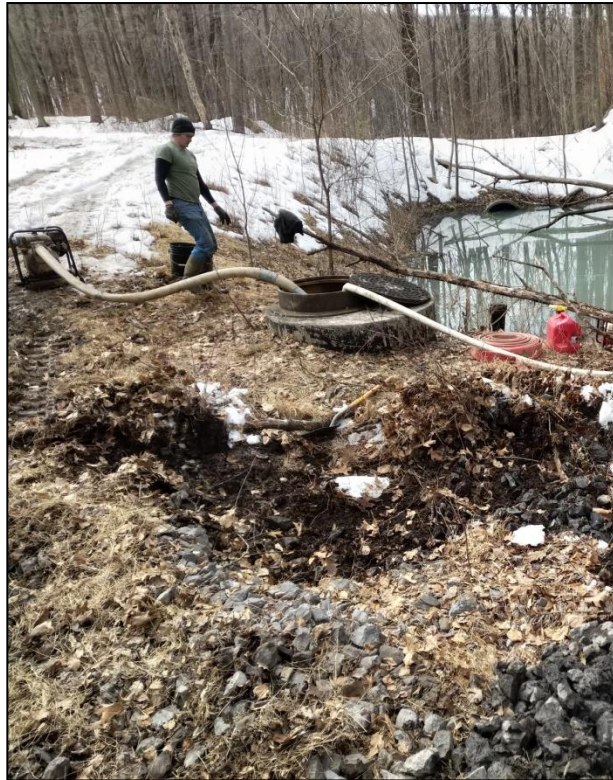
**Bottom Right:** Cleaning sediment from the siphon vault.
