Re: **Fox Run Restoration Area – Phase 2 Final Report**

Final Report Fox Run Restoration Area Phase II Stream Restoration Incorporated

FOX RUN Restoration Area - PHASE II: FINAL REPORT **Jackson Township, Mercer County, PA**

PASSIVE TREATMENT SYSTEM for FOX RUN RESTORATION AREA - PHASE II

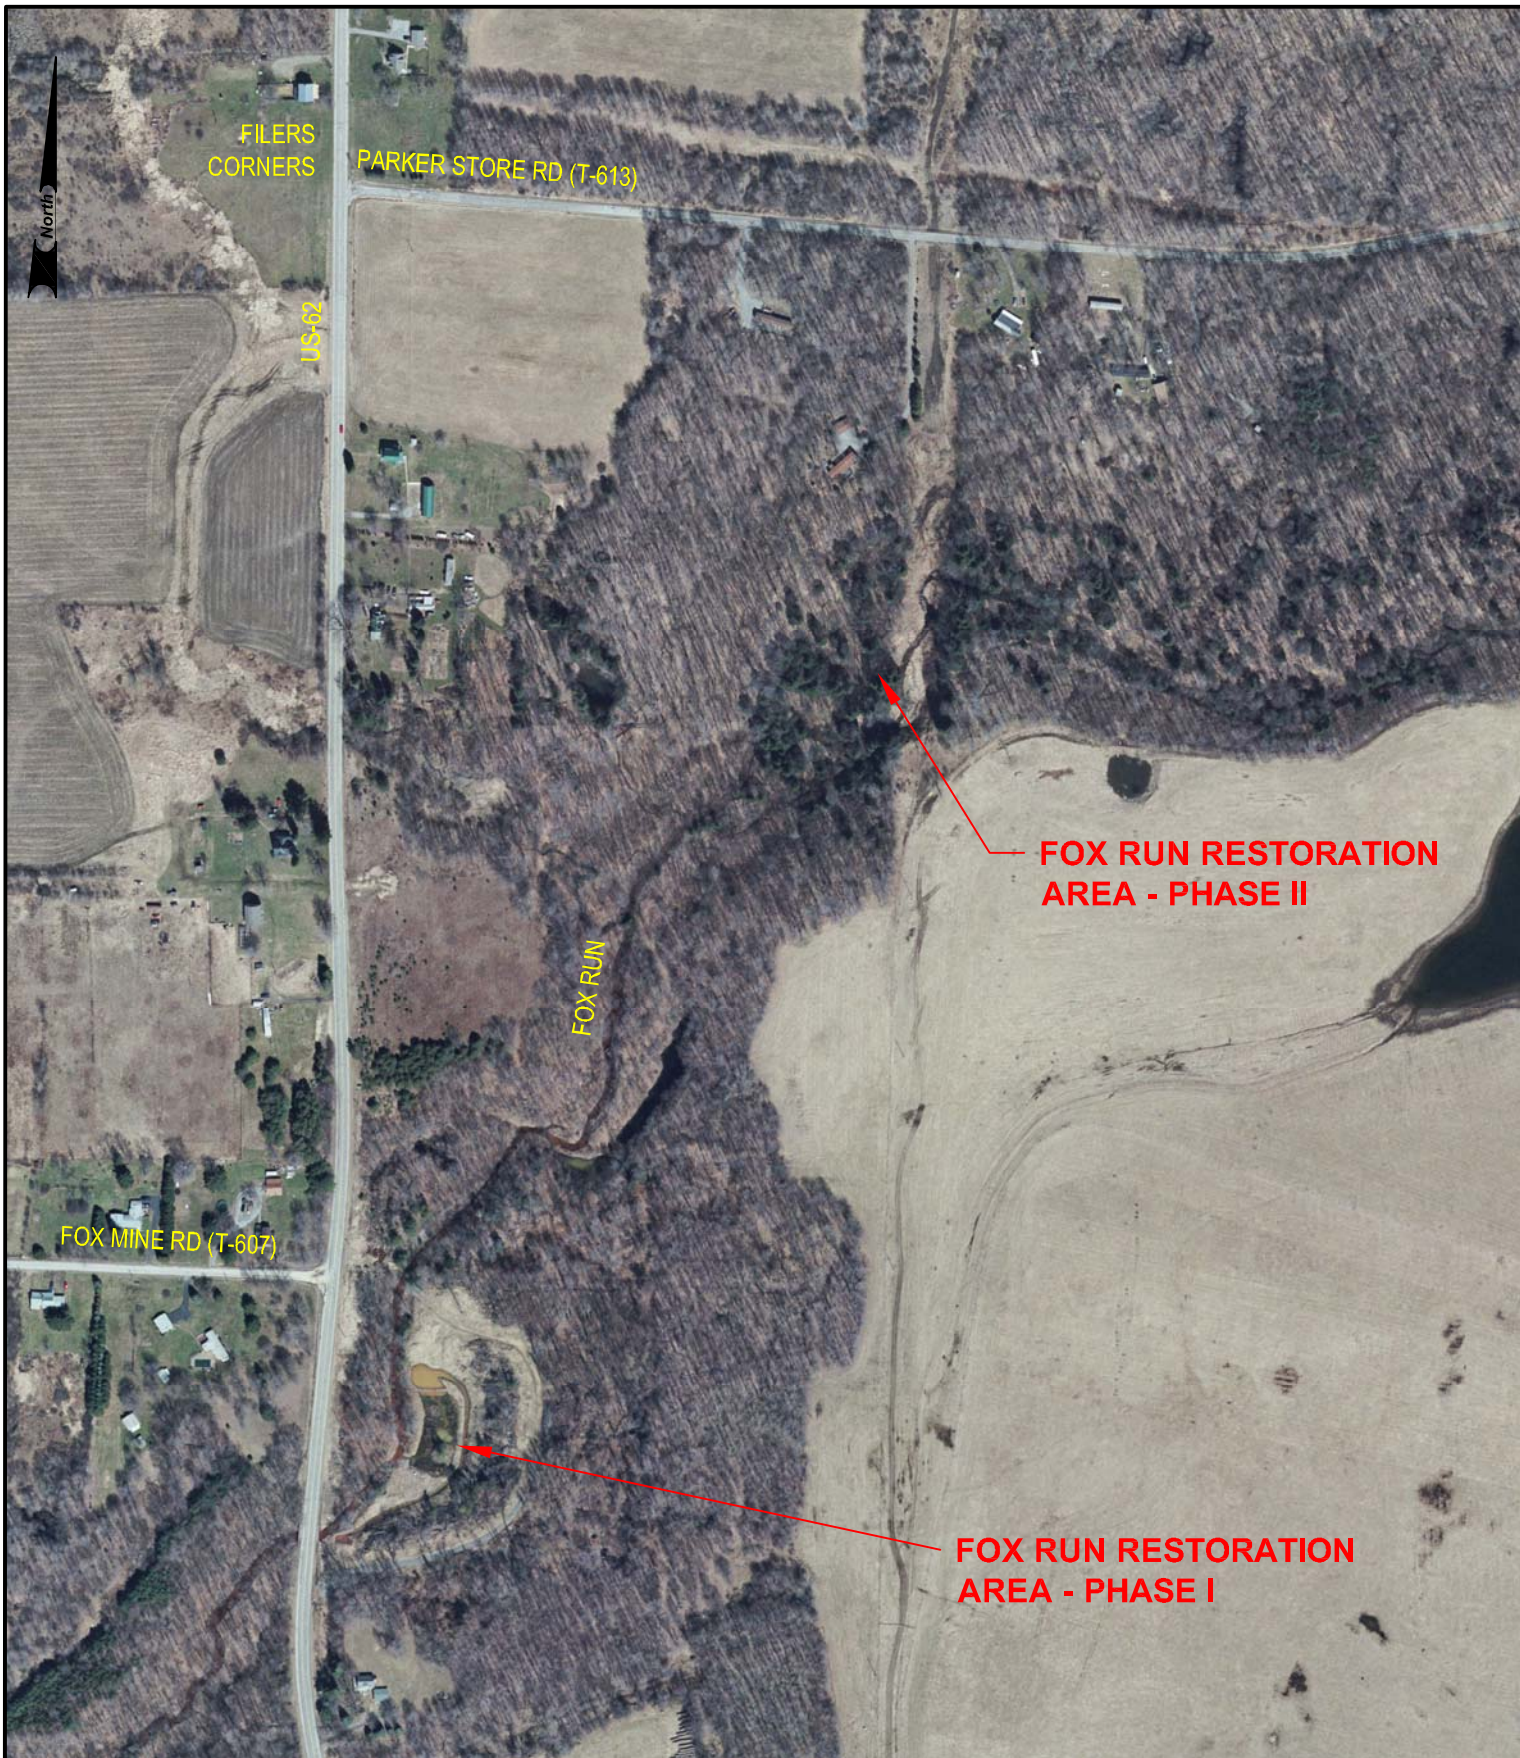
PROJECT LOCATION - PAMAP DIGITAL ORTHOPHOTO (3/2006)
FOX RUN RESTORATION AREA - PHASE II

Approximate Center of Project (deg-min-sec)
41-18-06 latitude 80-07-20 longitude

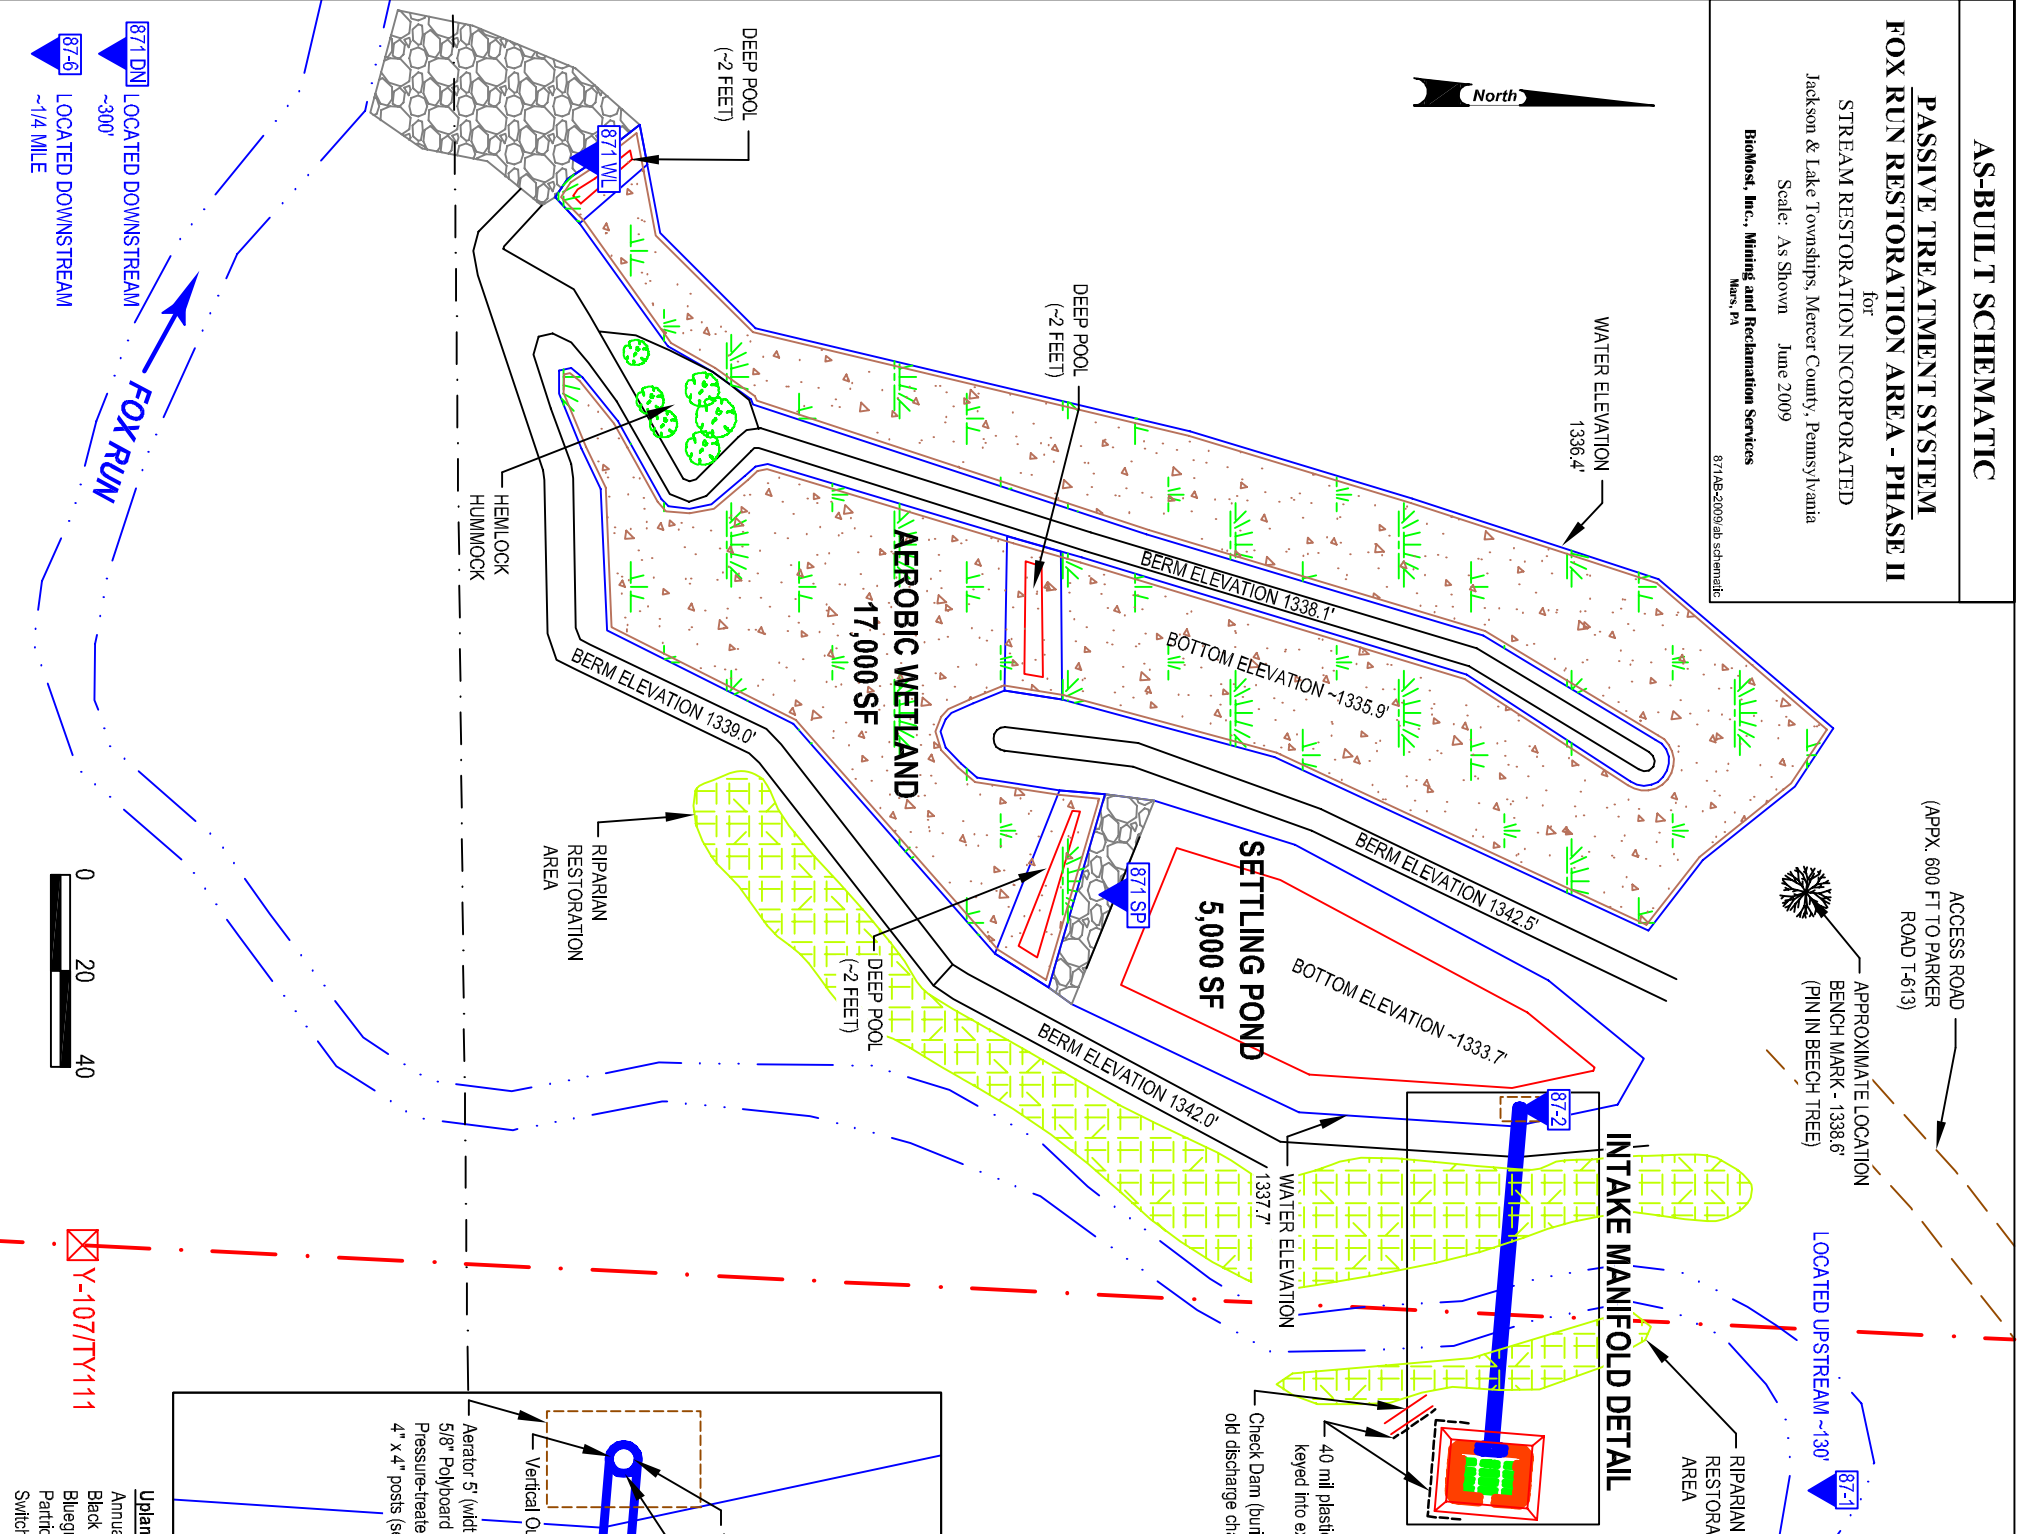
Notes:
As-built information from 09/26/08 field inspection by BioMost, Inc. and Mercer County Conservation District using post-processed sub-meter GPS unit & laser level, and 06/22/09 site inspection by BioMost, Inc. as well as design information and is a reasonable representation of actual field conditions.
Water elevations may vary due to outlet spillway, weather and other factors.
Passive treatment system built on property of Richard & Barbara Kish.
All pipe is SDR35 PVC.
Stream location from aerial photography taken for the PAMAP program (Spring 2006) and sub-meter GPS unit.
Settling pond and wetland areas shown measured at top of water.
Total wetland area "foot print" ~3/4 Acre.

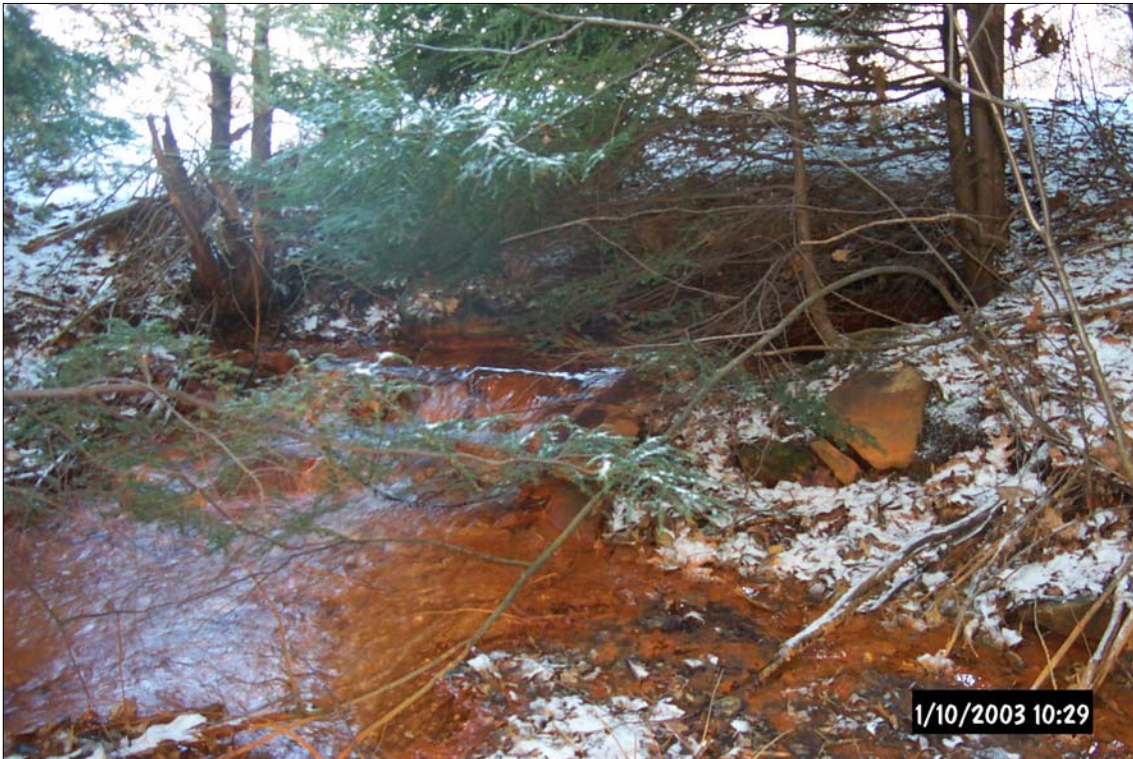
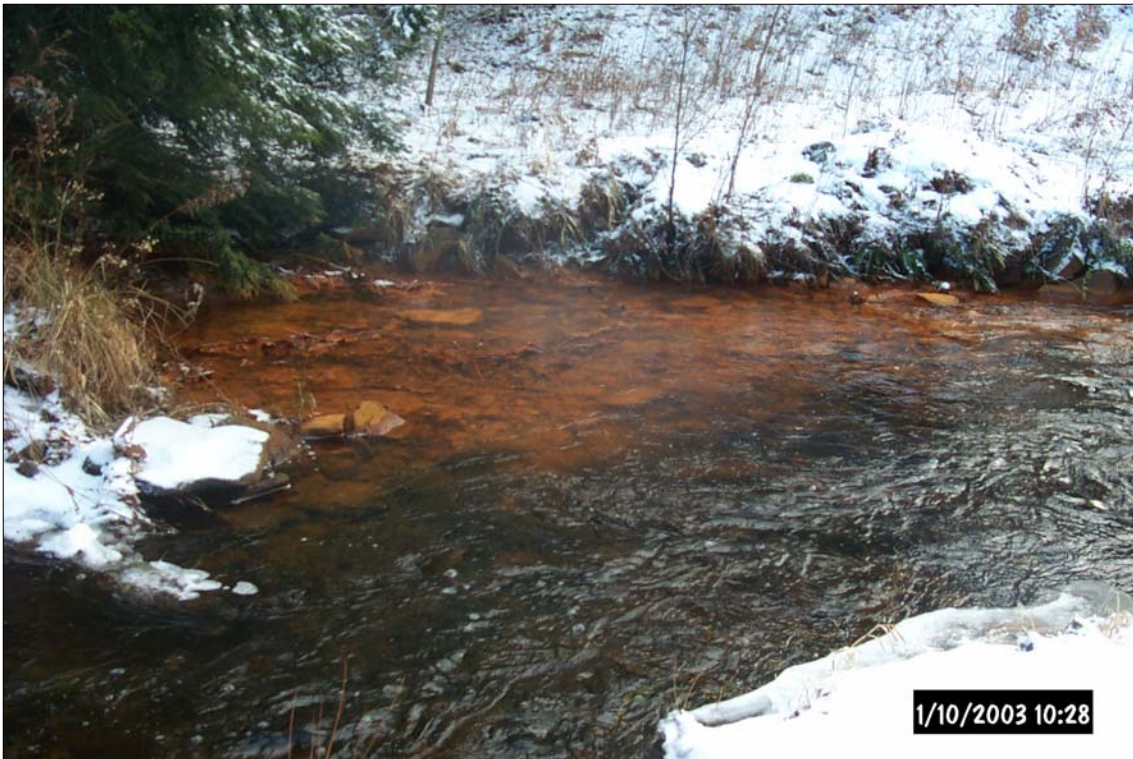
Pre-Construction

Discharge 87-2 (Above) from an abandoned underground coal mine flowed directly into Fox Run (Below) prior to installation of the Phase II system.

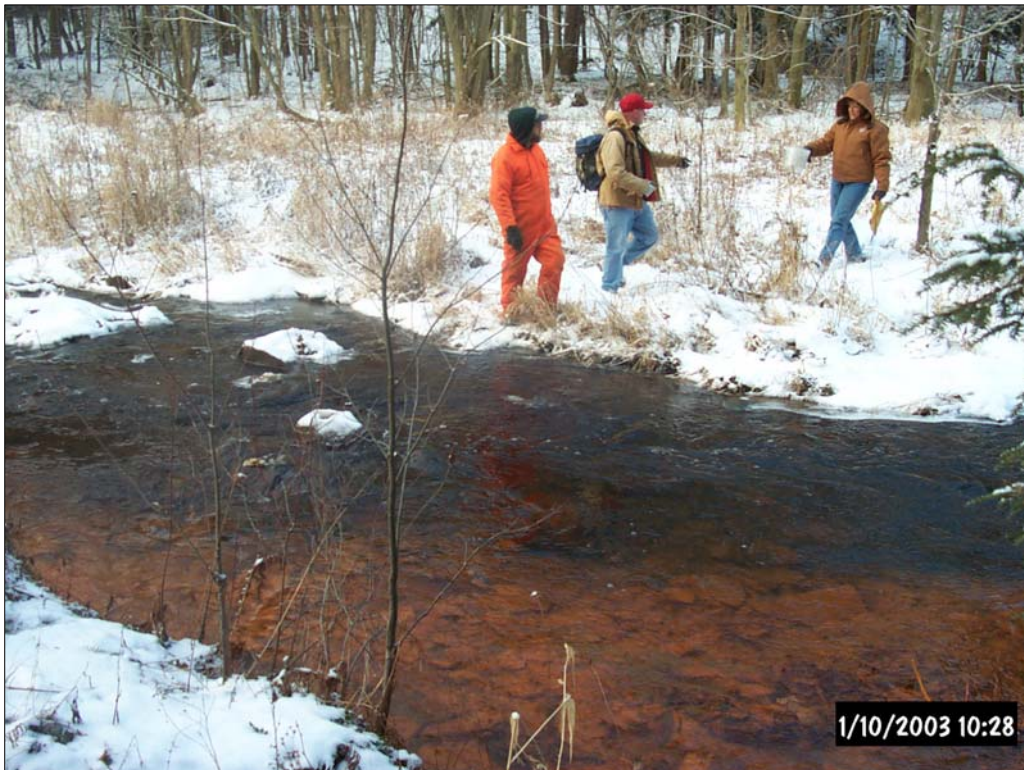
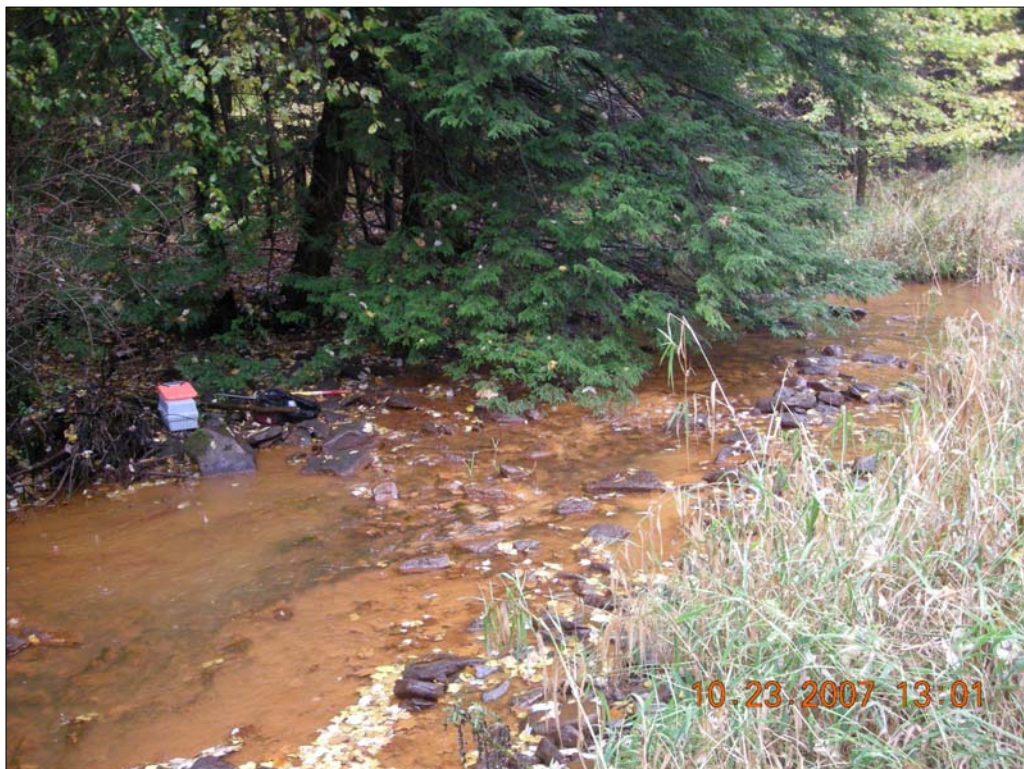
Pre-Construction

The 87-2 abandoned mine discharge significantly impacted Fox Run. During low flow periods, the discharge is the primary contributor of flow to the headwaters portion of the stream.

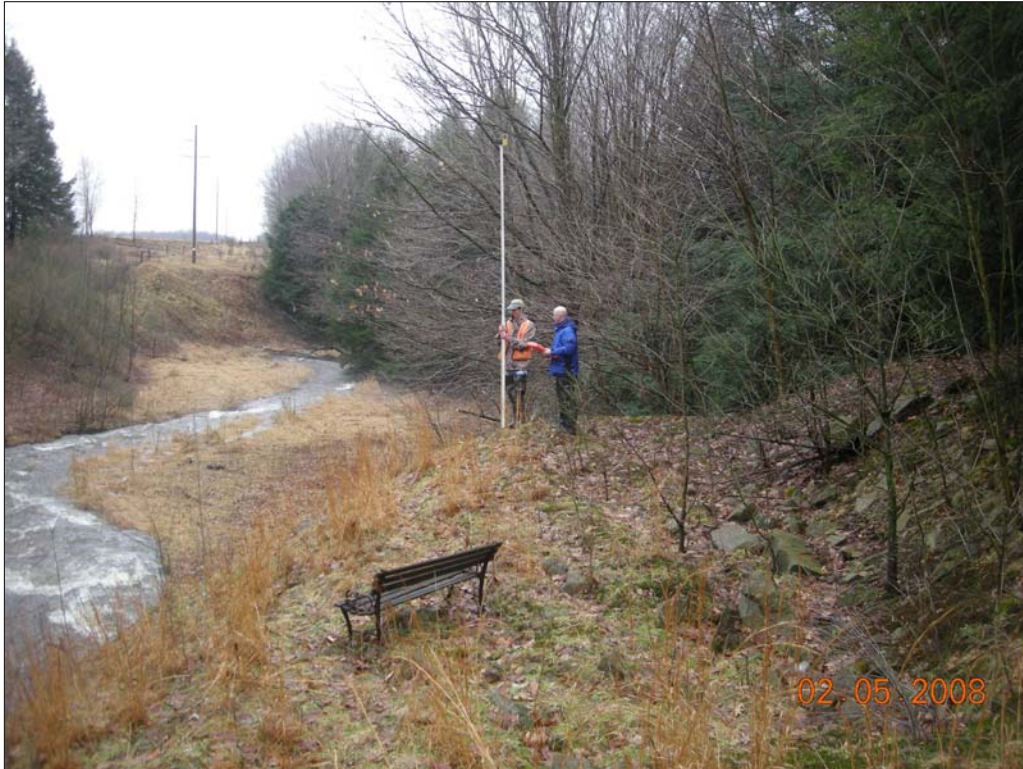
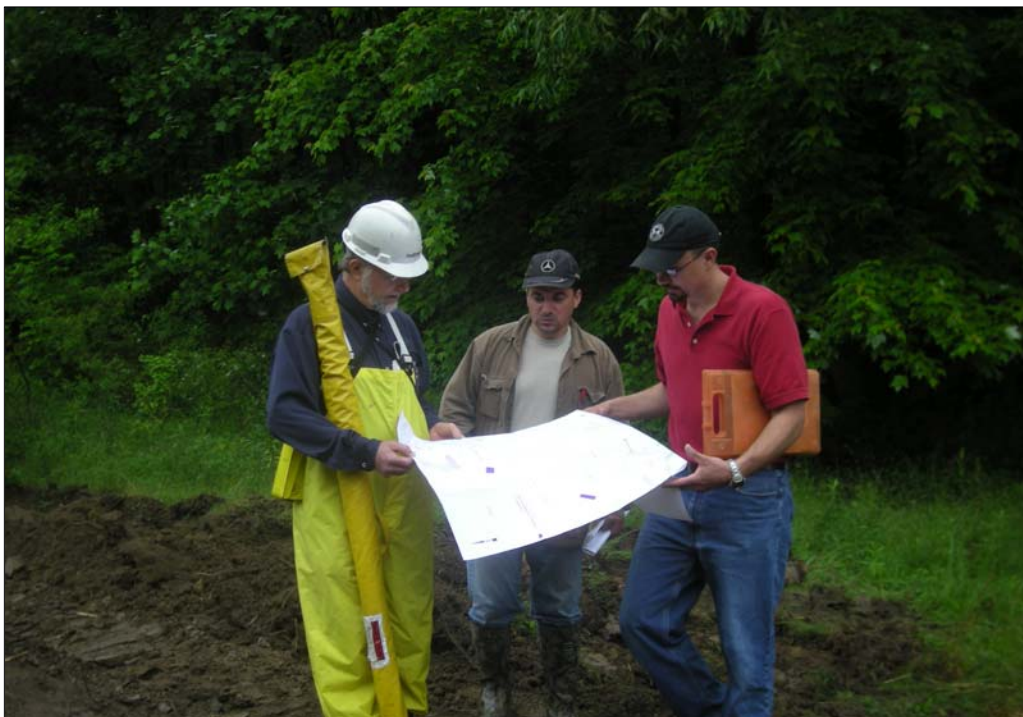
Pre-Construction

Working with the Mercer County Conservation District prior to construction, a wetland delineation, construction control point establishment, and 6/4/08 meeting with First Energy personnel were conducted to ensure a successful project.

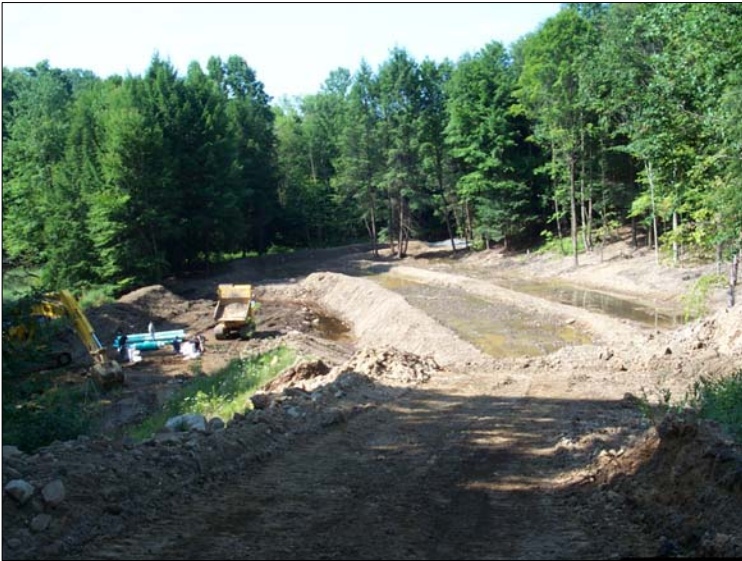
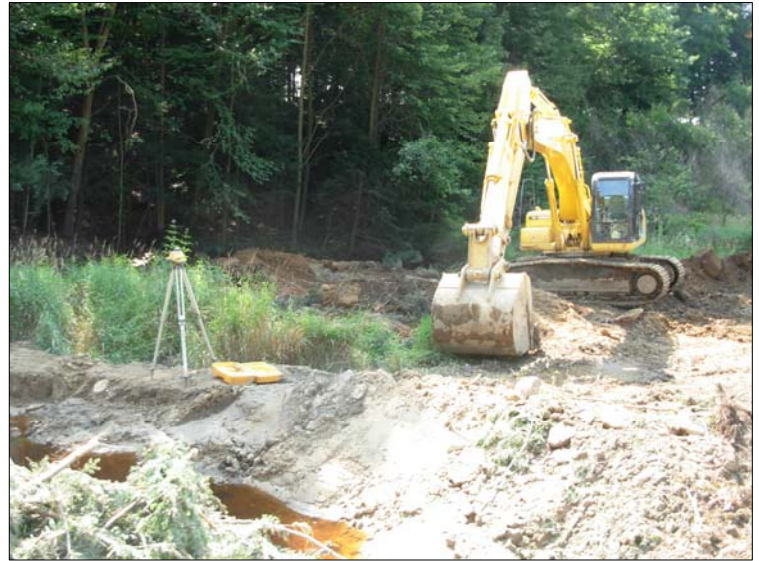
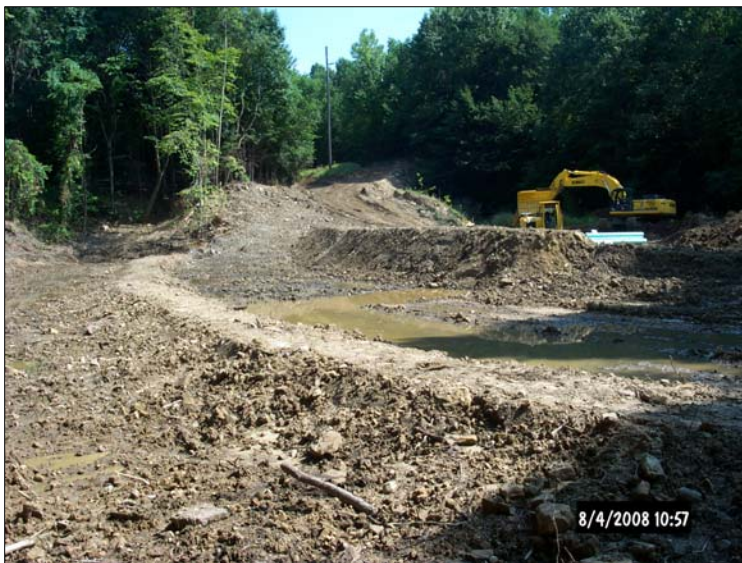
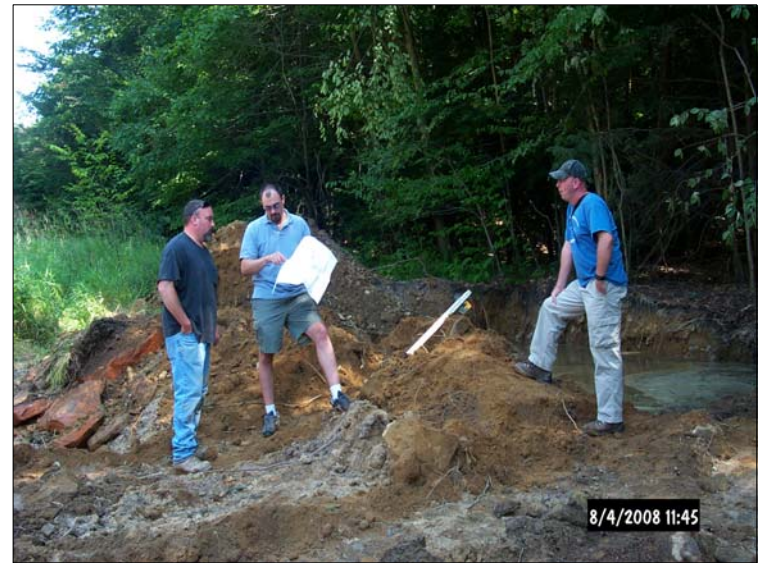
Construction

Following completion of the design and permitting, the passive treatment system was constructed by project partner Quality Aggregates, Inc. Field meetings and inspections were conducted by project partners including BioMost, Inc., Mercer County Conservation District, and Quality Aggregates, Inc.

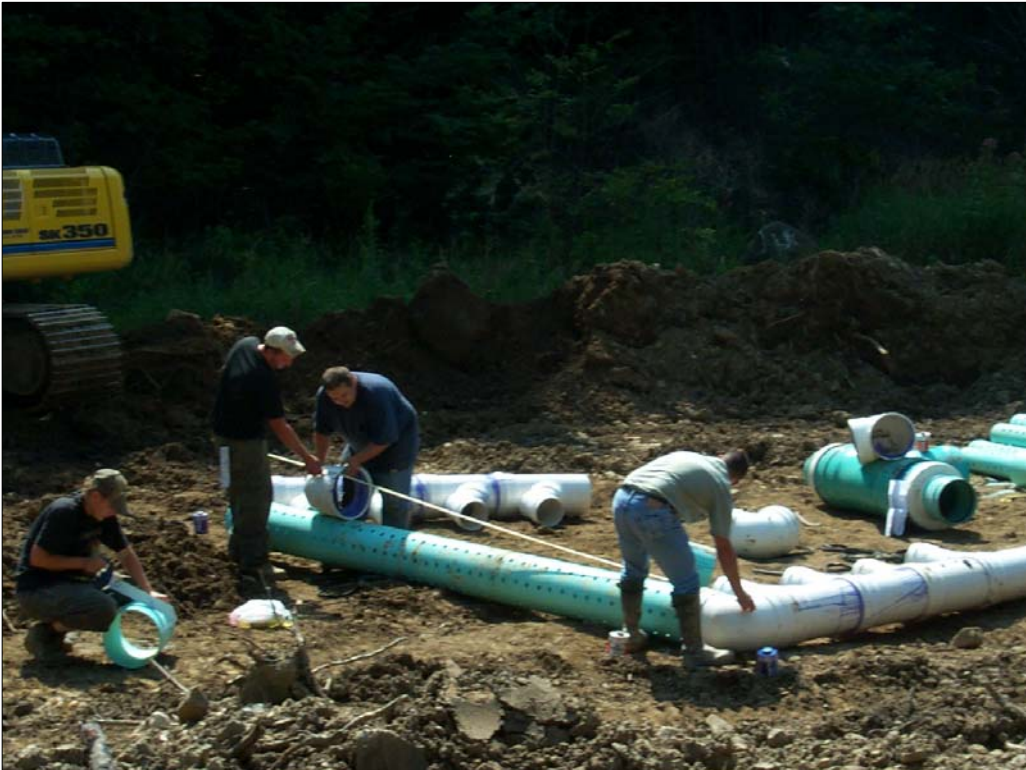
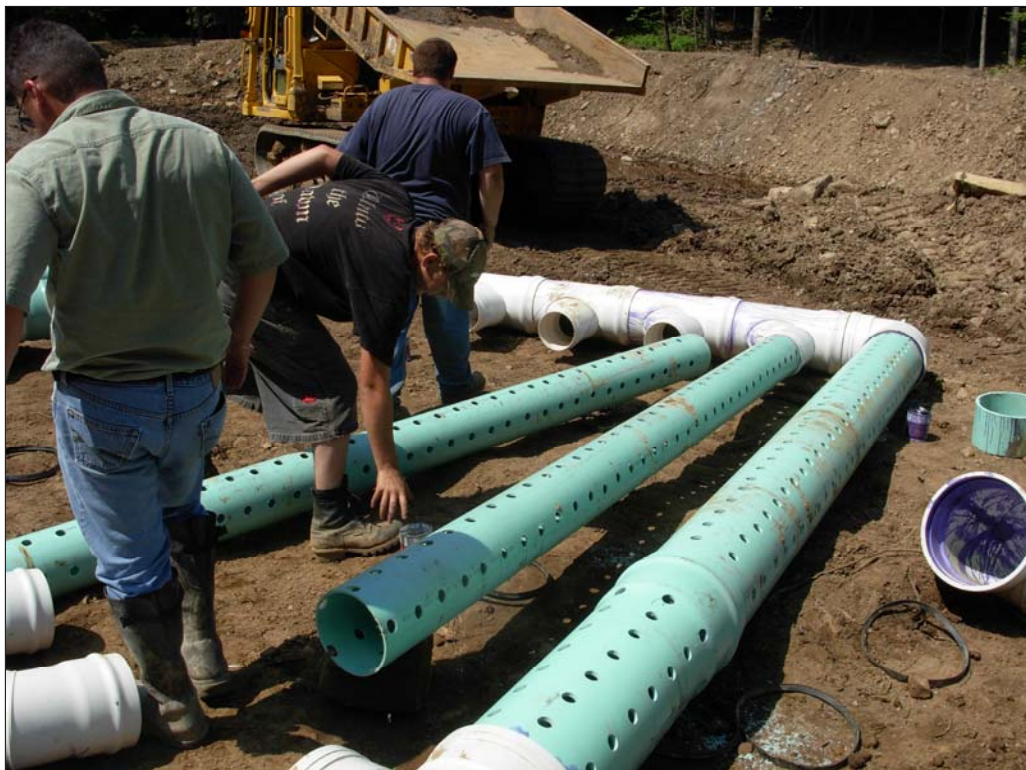
Construction

Assembling the Intake Manifold to capture and convey the 87-2 discharge under Fox Run to the passive system (Summer 2008).

The **Intake Manifold** was installed to collect the abandoned mine discharge (87-2) and convey the mine water underneath Fox Run to the passive system. The intake manifold (see As-built schematic) consists of several 8-inch and 12-inch perforated pipes interconnected with Tee-Wyes to collect the 87-2 abandoned mine discharge and feed into an 18-inch solid pipe which outlets into the settling pond.

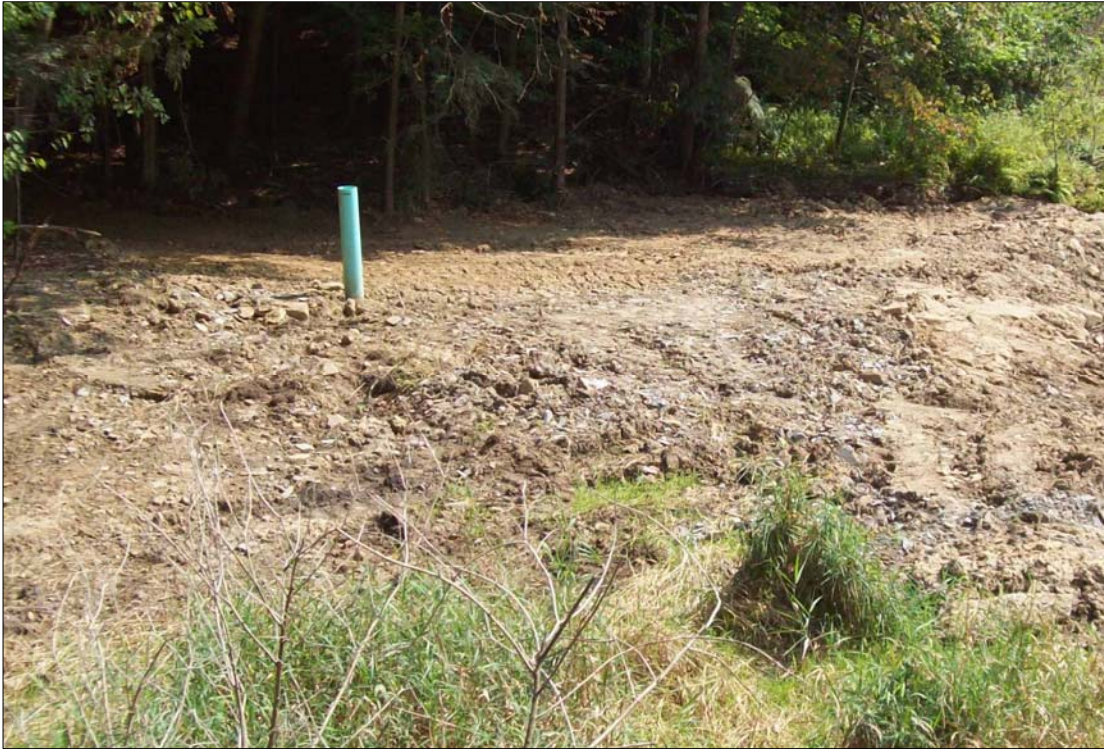
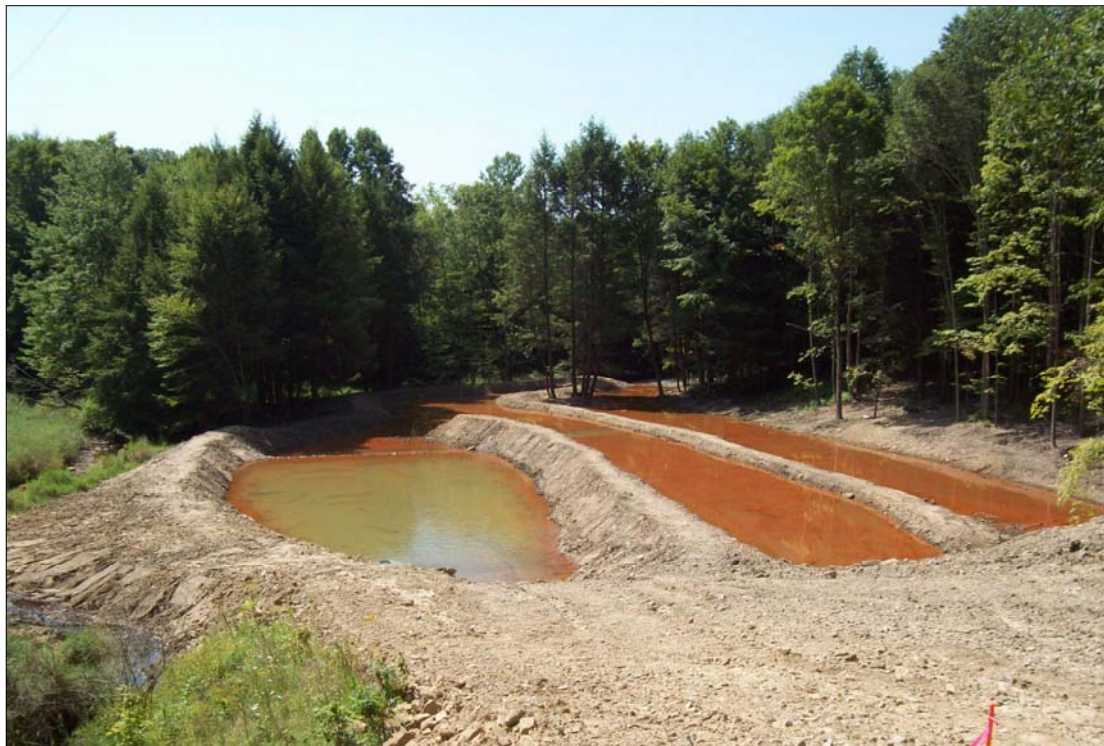
Construction

The only evidence of the buried Intake Manifold is the observation riser (Above). The discharge is conveyed to the passive treatment system (Below) consisting of a settling pond and aerobic wetland. (Summer 2008)

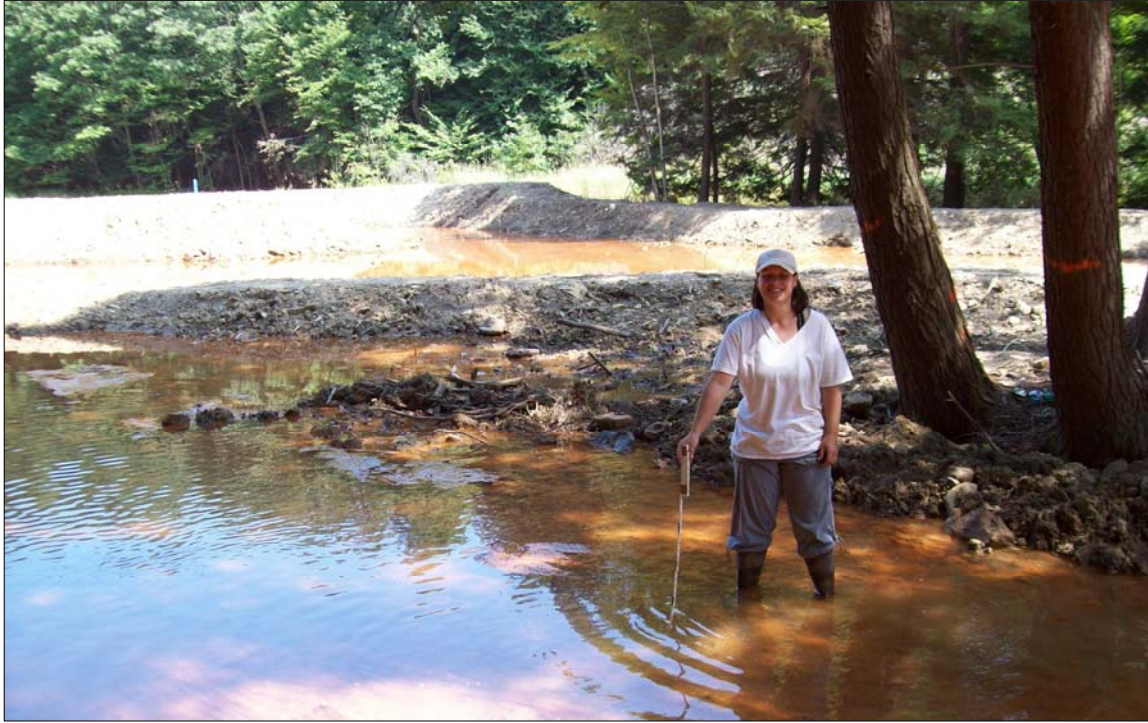
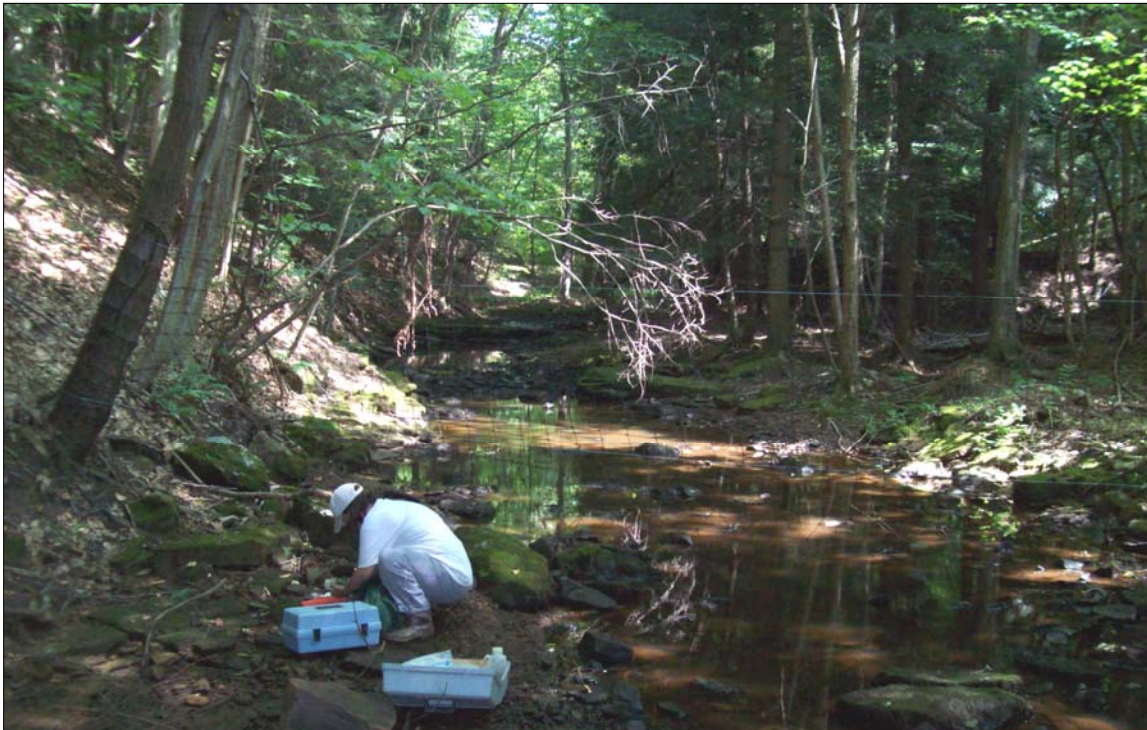
Post- Construction

Water monitoring of the passive treatment system and Fox Run was conducted after completion of the passive treatment system. (Summer 2008)

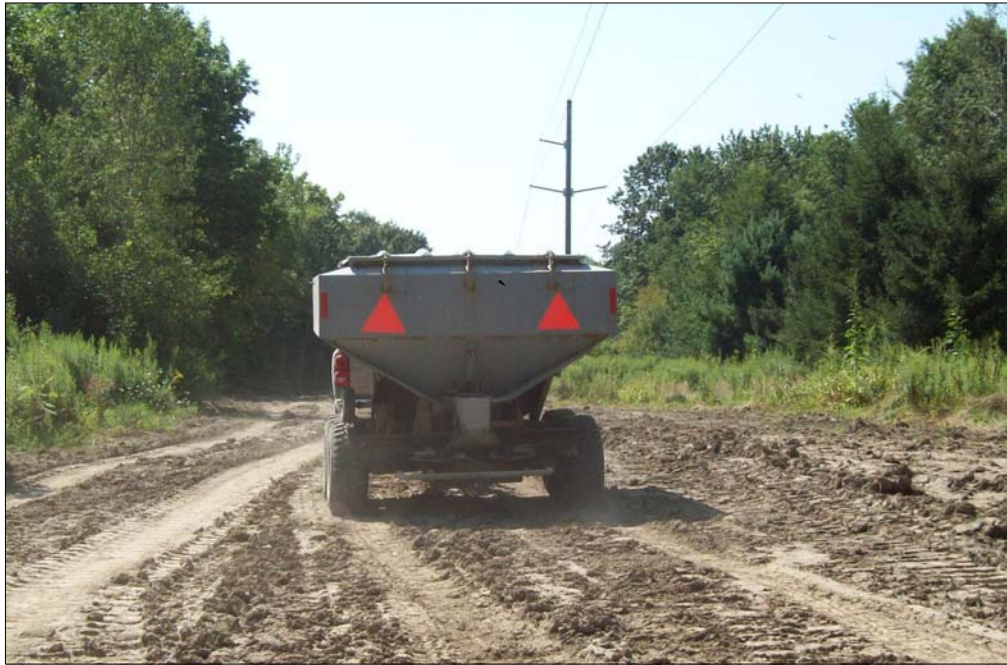
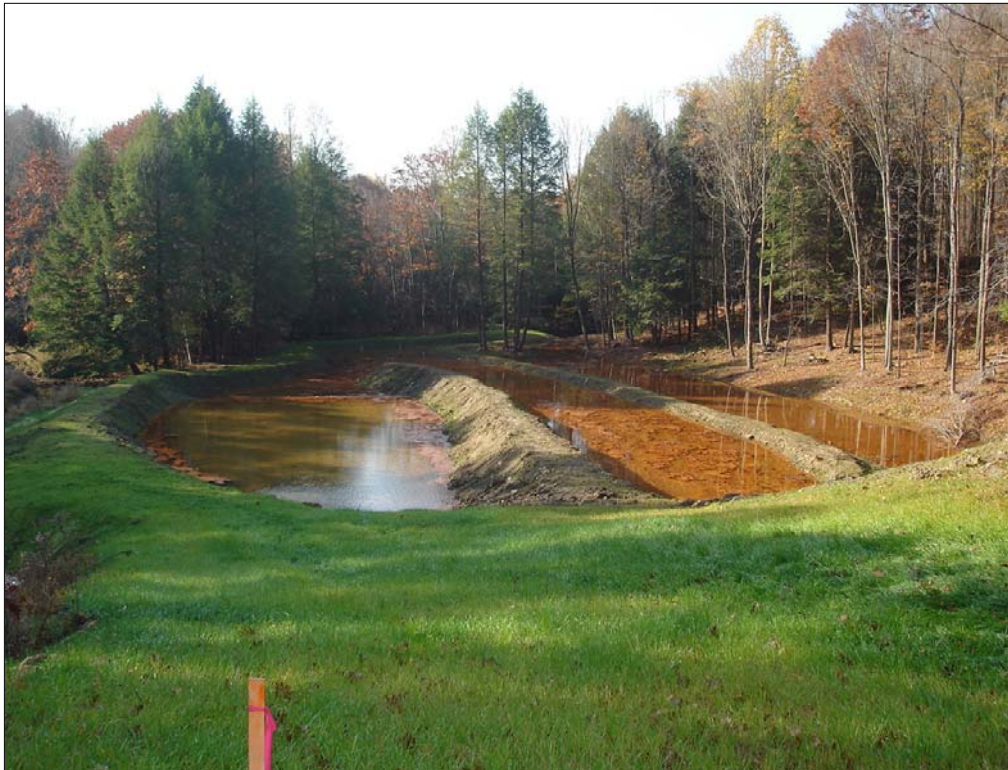
Post- Construction

Above: Following construction, the entire site including the utility right-of-way used for access was seeded and mulched (Summer 2008). Below: View of the vegetated uplands (November 2008).

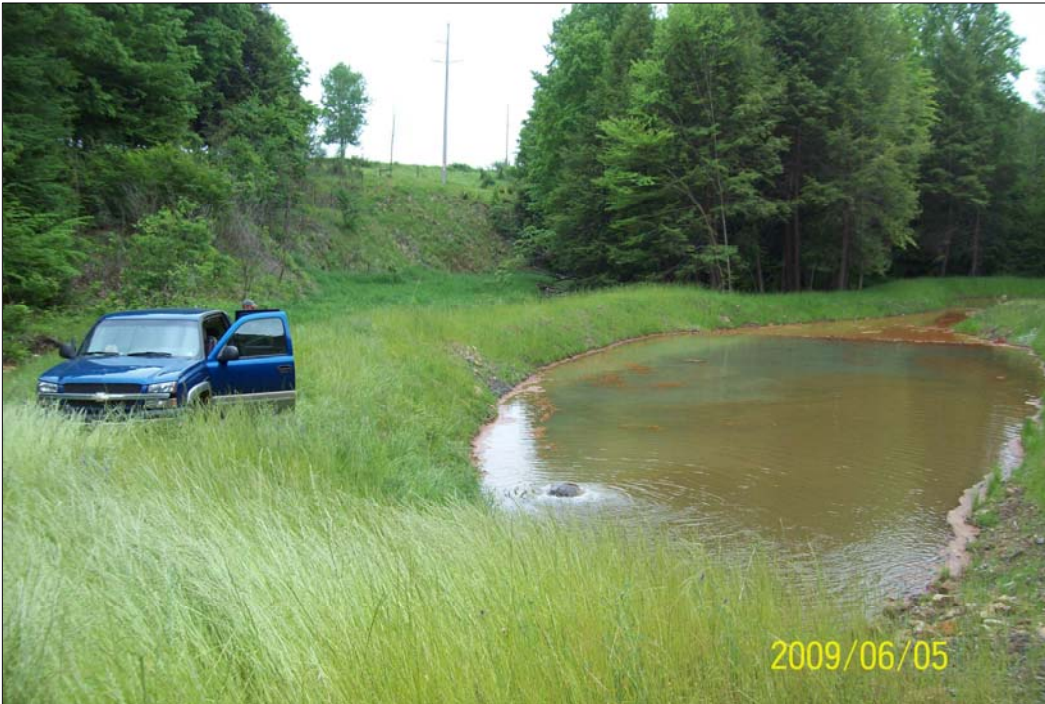
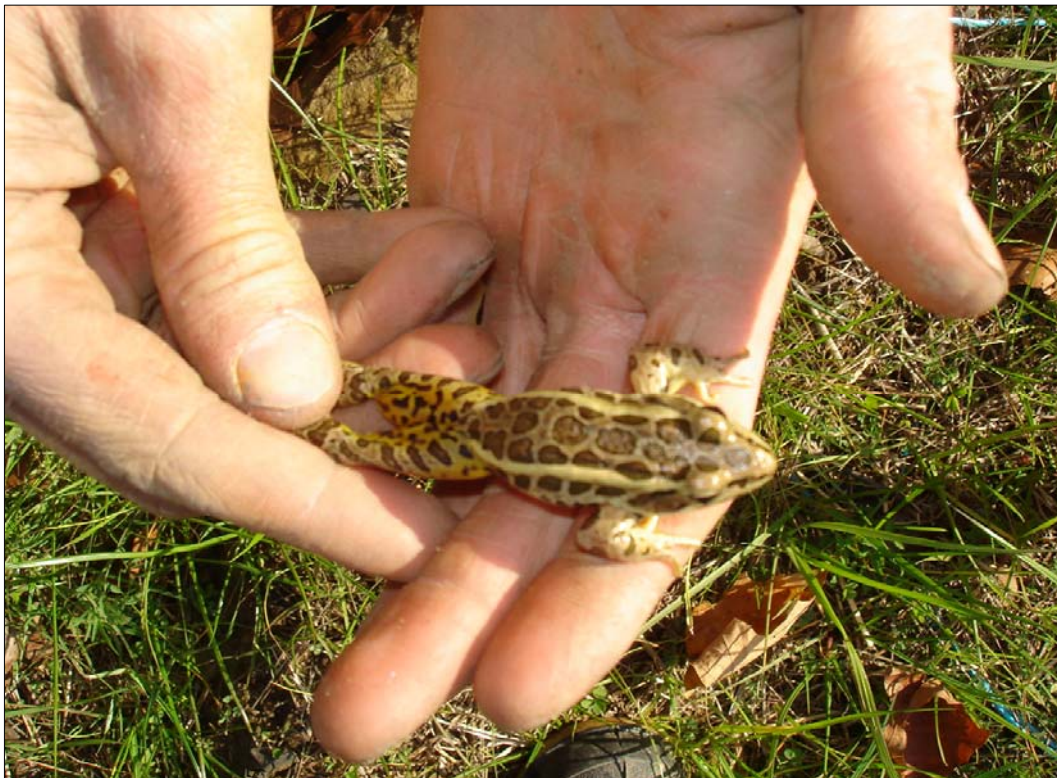
Post- Construction

Above: Site inspections are conducted on a regular basis to insure that the passive system is stable and functioning properly.
Below: Numerous Pickerel Frogs were observed 11/04/08.

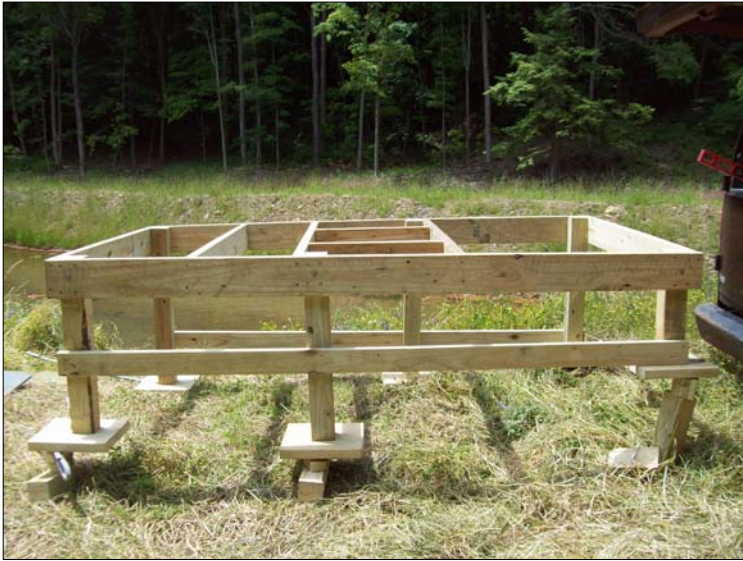
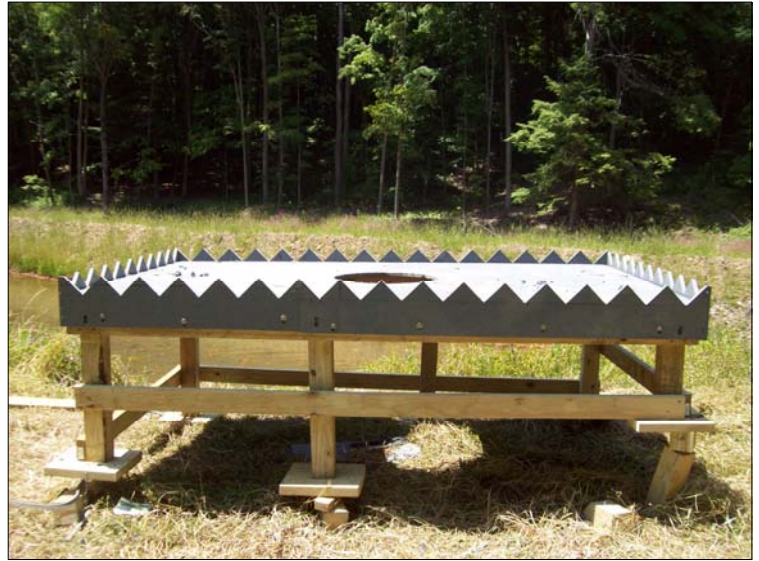
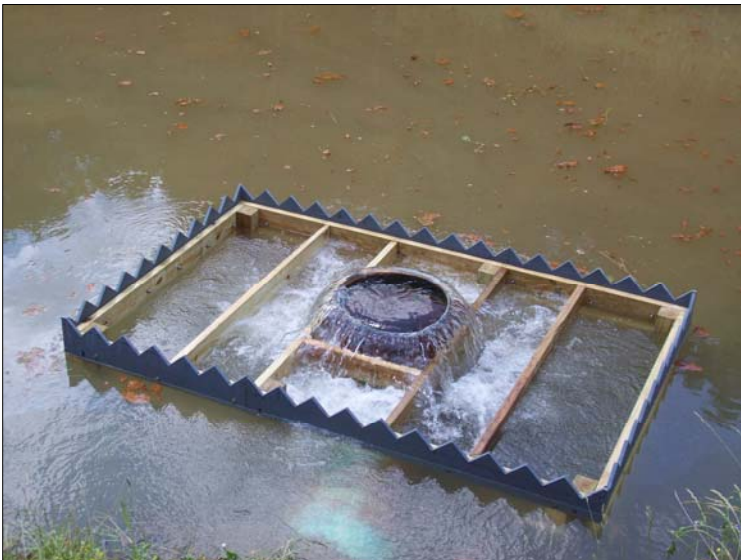
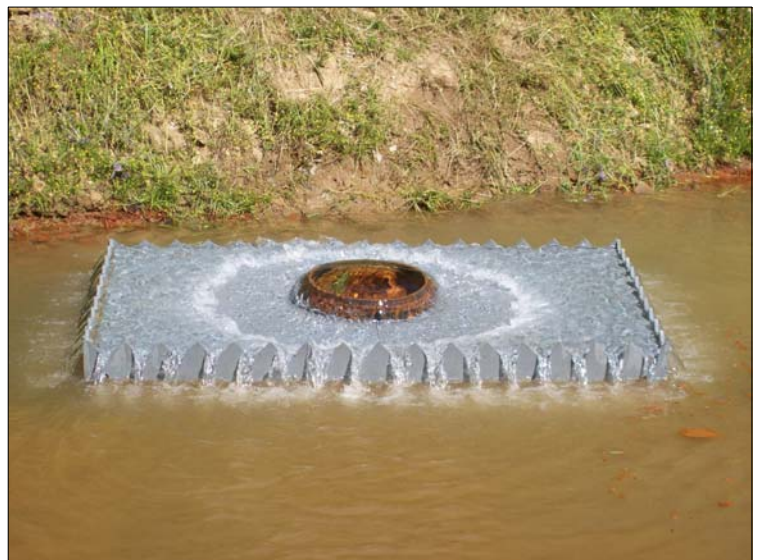
Post- Construction

In order to enhance iron removal by the passive system, an aeration device consisting of a platform and saw-toothed weirs was installed. The aeration device encourages the degassing of CO₂, a raise pH and an increase iron oxidation rates as well as introducing dissolved oxygen into the water. (Summer 2009)
