Re: **Fox Run Restoration Area – Phase 2 Final Report**

Final Report Fox Run Restoration Area Phase II Stream Restoration Incorporated

FOX RUN Restoration Area - PHASE II: FINAL REPORT **Jackson Township, Mercer County, PA**

PASSIVE TREATMENT SYSTEM for FOX RUN RESTORATION AREA - PHASE II

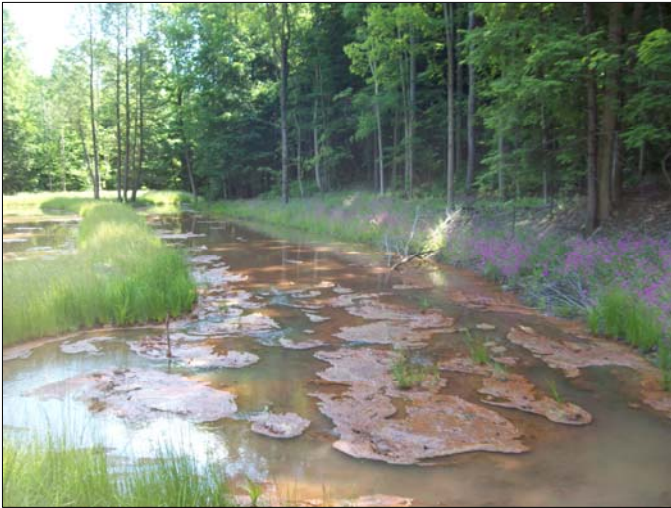
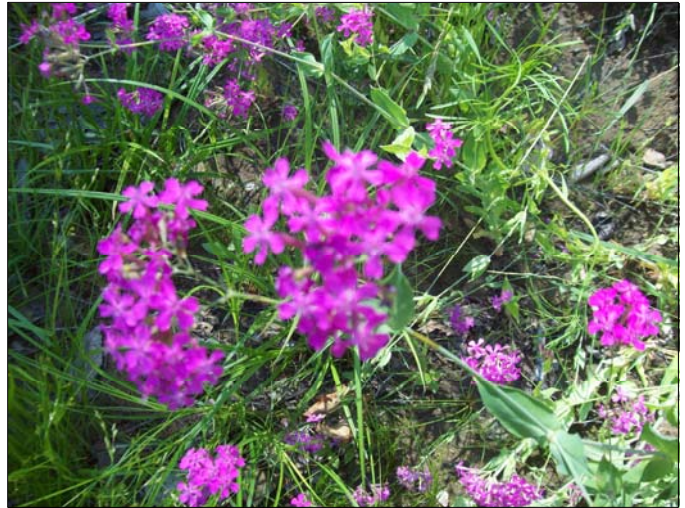
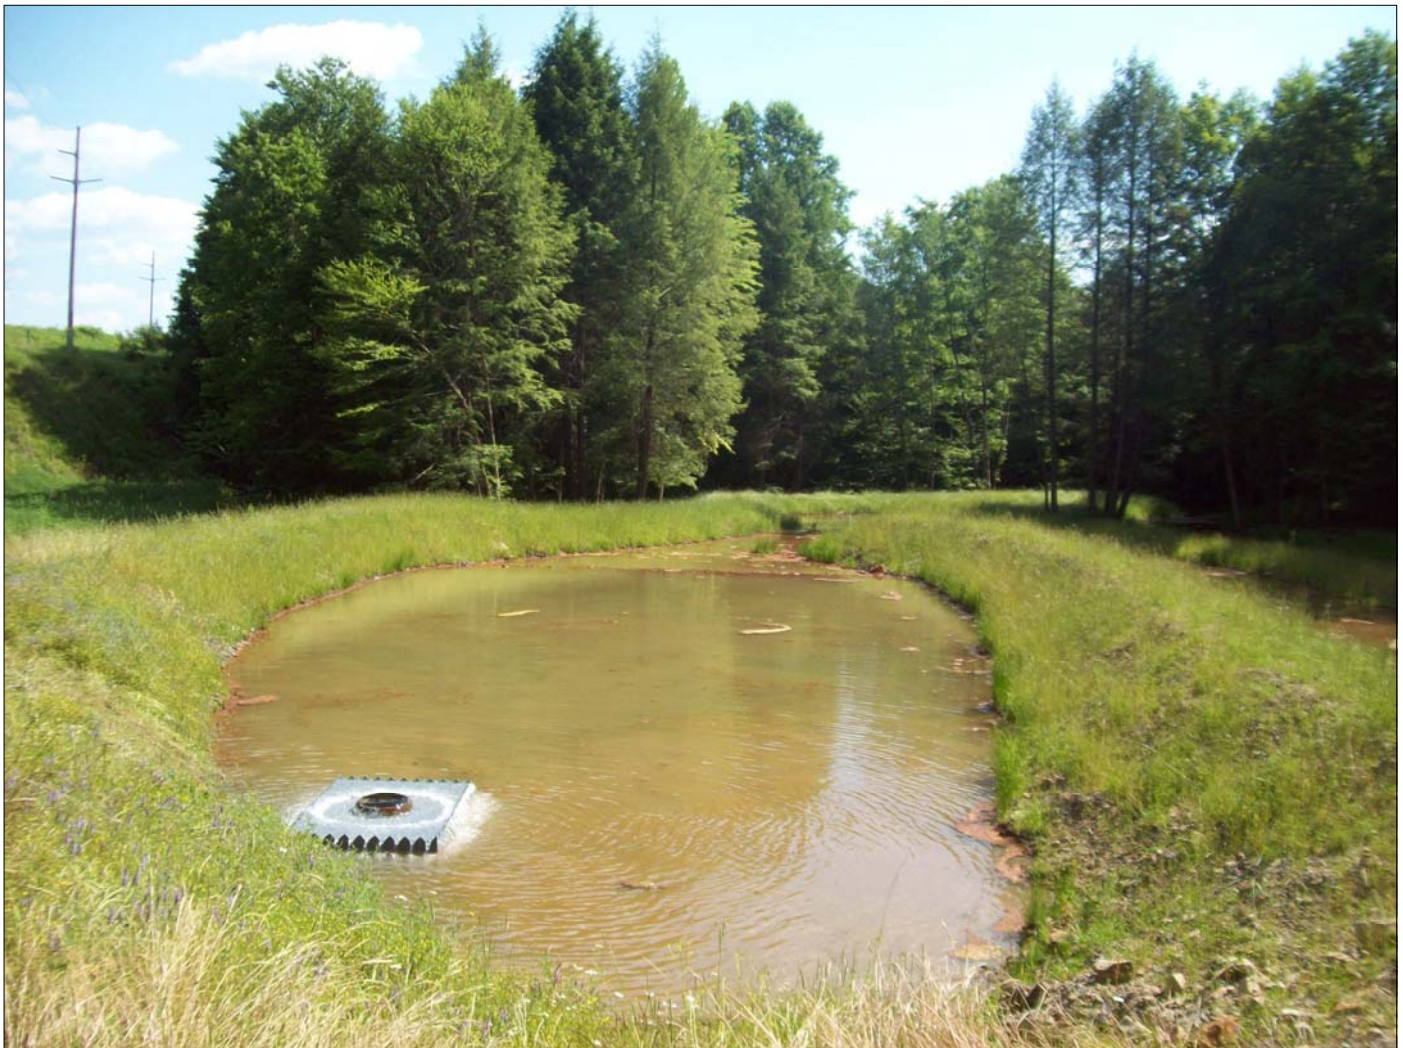
Post- Construction

Above: Wildflowers were included within the seed mix. (Summer 2009)
Below: View of Settling Pond following installation of the aerator. (Summer 2009)

The conveyance pipe discharges to a 5,000 square-foot **Settling Pond** (871-SP) which discharges to a 17,000 square-foot constructed aerobic **Wetland** (871 WL) via a riprap (i.e. rock lined) spillway. The Settling Pond and Wetland are used to allow for the oxidation, precipitation, and accumulation of metal iron solids that occur when alkaline drainage issues from a minesite or after acidic drainage has passed through an alkalinity-generating treatment component. Often Settling Ponds contain some type of baffle to maximize retention and prevent short-circuiting within the pond. An **Aerator** was installed at the inlet pipe of the settling pond to

degas CO₂ and increase dissolved oxygen in order to increase iron oxidation rates. Wetlands

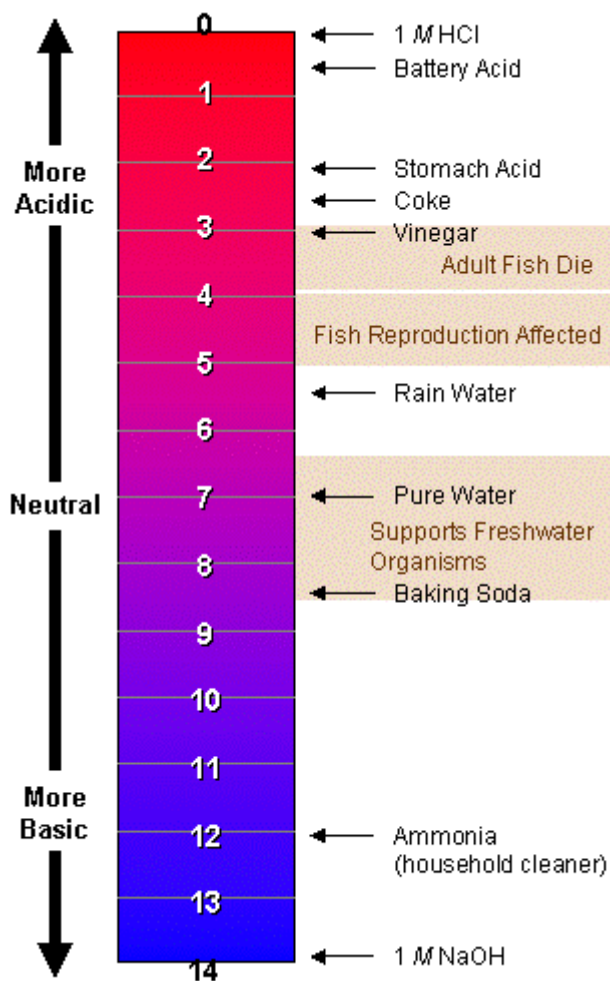
The pH Scale

pH is a measured value that indicates whether a solution is acidic, neutral, or basic (alkaline). pH is a way to express the hydronium (H₃O⁺)-ion [a.k.a., hydrogen(H⁺)-ion] concentration. The pH scale ranges from 0-14 with 0 being the most acidic, 7 being neutral, and 14 being the most basic. Note on the scale that vinegar has a pH of around 3 while household ammonia has a pH of around 12 and blood around 7.4. As pH is a negative log of the hydrogen-ion concentration, a change in one unit represents a 10-fold increase or decrease in hydrogen ions. For example, a solution with a pH of 4.0 has 10 times more hydrogen ions than a solution with a pH of 5. pH can be measured by using litmus paper, a color indicator solution (used in field kits), or with a calibrated, electronic pH meter.

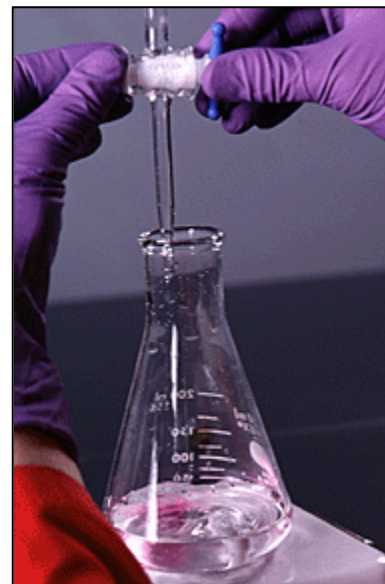
Laboratory Titration

To measure alkalinity in most mine water, a relatively weak solution of sulfuric acid (H_2SO_4) is added “drop-by-drop” to a specified volume of water in order to lower the pH to 4.5. At pH 4.5, all bicarbonate alkalinity (HCO_3^-) has been consumed. (Bicarbonate alkalinity may be generated by natural processes including the weathering of limestone or other carbonate rock and/or bacterial reactions with sulfate and organic material.) The endpoint of pH 4.5 may be determined by a meter/kit or by a color change from green to pink after dissolving bromcresol green (an indicator powder) in the water. Alkalinity is usually expressed in milligrams of calcium carbonate per liter (mg $CaCO_3/L$). Calcium carbonate is the primary constituent of limestone and Tums© stomach antacid.

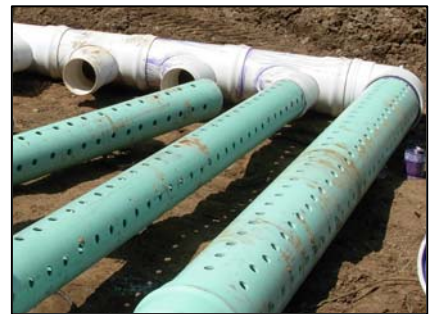
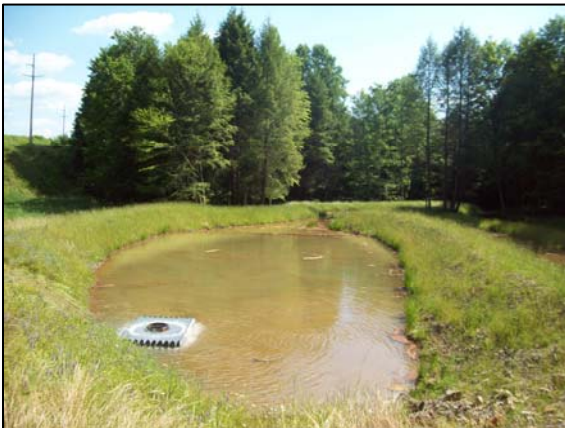
The **Intake Manifold** was installed to collect the abandoned mine discharge (87-2) and convey the mine water underneath Fox Run to the passive system. The intake manifold (see As-built schematic) consists of several 8-inch and 12-inch perforated pipes interconnected with Tee-Wyes to collect the 87-2 abandoned mine discharge and feed into an 18-inch solid pipe which outlets into the settling pond.

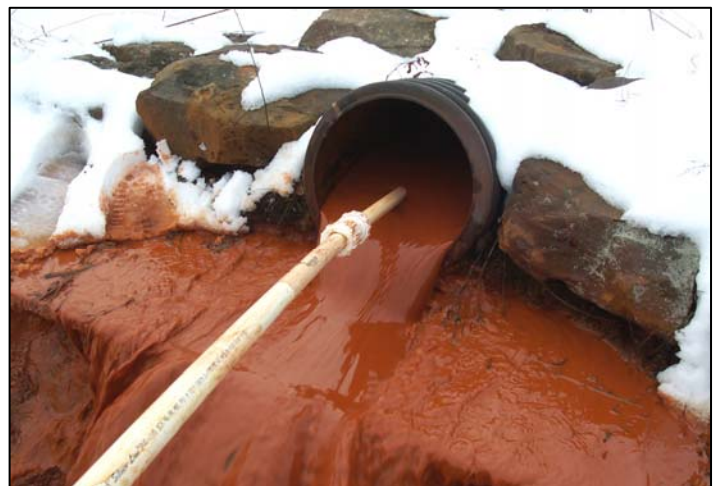
Pipe Clean-Out Tool

Most passive treatment systems have piping. For optimum treatment, these pipes should be relatively clear and free-flowing. Often these pipes accumulate metal precipitates, sediments, algae, and other debris. In some cases these pipes can be flushed, backflushed, or in extreme cases cleaned with a power snake. Other times, a simple clean-out tool can be used. A clean-out tool can be made using 1" (or similar size) PVC pipe. The clean-out tool is then pushed into the pipe to break up and/or dislodge the debris causing the blockage. When a longer clean-out tool is needed, multiple pieces of pipe can be connected using compression-type unions. It is recommended to have at least 50 feet of pipe available. PVC pipe and unions can be purchased at a local hardware store.

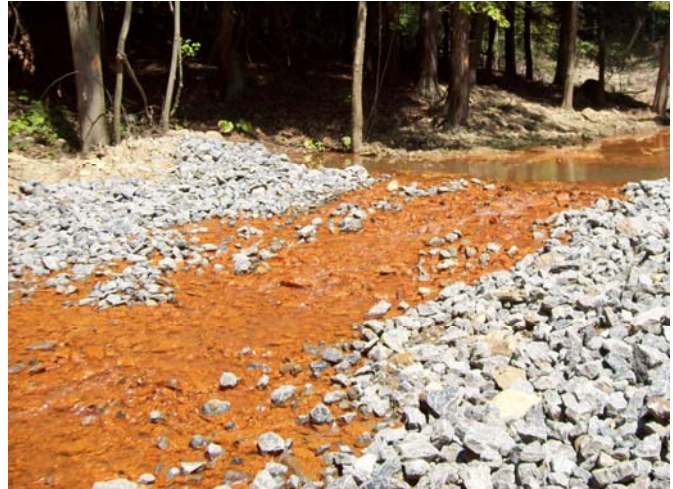
All channels, ditches, and spillways should be inspected and maintained to minimize erosion and insure proper water handling. The channels should be kept free of obstructions/debris that would restrict water flow as this can cause the water to back up and overflow the berm. Any debris/obstructions should be removed. If disturbed or eroded areas are present, then these areas should be stabilized as soon as possible with riprap or plantings. Channels or ditches that carry mine drainage should be cleaned when precipitates reduce the capacity by one half. Particular attention should be paid to the stability of rock-lined channels and spillways to assure that the rock lining is intact. Vegetation should be removed from spillways.

Particular attention should be paid to the stability of rock-lined channels and spillways to assure that the rock lining is intact. Vegetation should be removed from spillways.

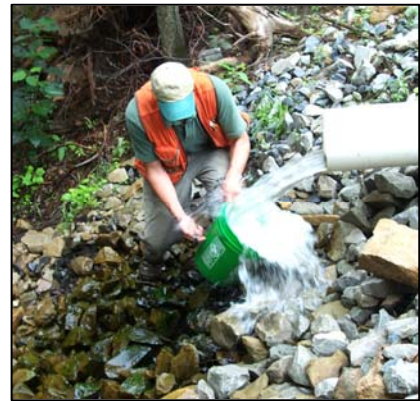
Four methods of measuring flow rate are described. In general, the "Bucket-and-Stopwatch" Method will be the most commonly used for monitoring the passive treatment system; However at Fox Run Phase 2 the vertical pipe weir method will be used at the inlet to the settling pond.

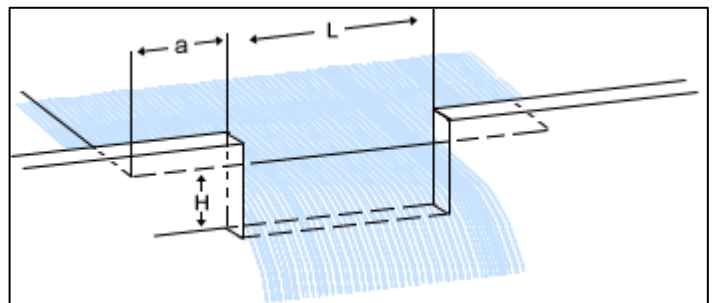
Formula: $Q = 3.33(L - 0.2H)H^{1.5}$

- Where:** Q = flow of water in cu. ft. per sec.
 L = width of weir opening in ft.
 (4 to 8 times H)
 H = head of weir in ft.
 (measured at least 6 ft. back of weir opening)

a = at least 3H

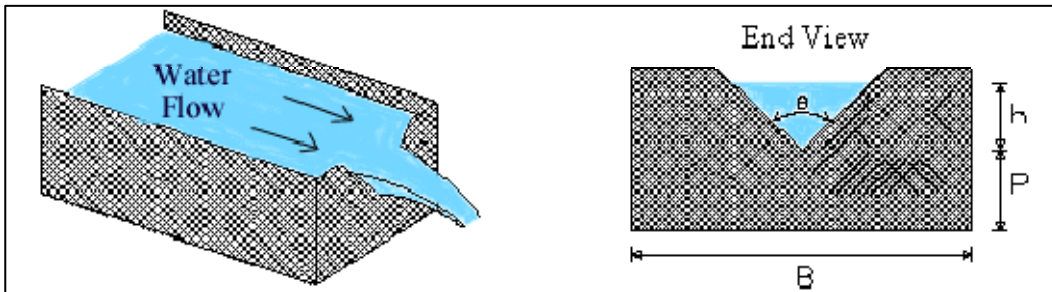
V-Notch Weirs

Flow measurements can be made using a V-Notch Weir.

Like the Rectangular Weir, height of water should be measured with a staff gauge placed several feet behind the v-notch in the pool; however, height of water in the V-Notch is often measured. $Q = 2.50H^{2.50}$

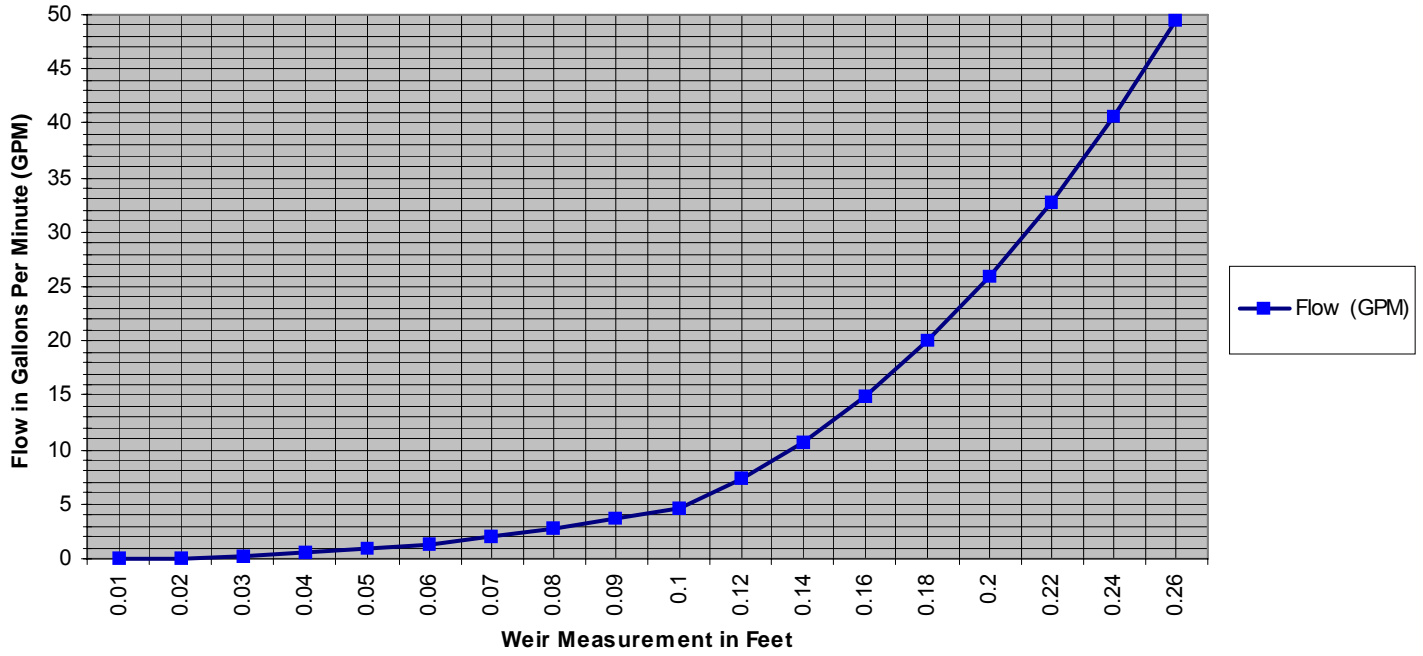
**90-Degree V-Notch Weir Direct Read Flow Measurements
 For Low Flow (0-50 Gallons Per Minute) Conditions**

Measurement (ft)	Flow (gpm)	Measurement (ft)	Flow (gpm)	Measurement (ft)	Flow (gpm)
0.01	0.02	0.14	10.74	0.36	110.28
0.02	0.09	0.16	14.93	0.38	126.01
0.03	0.24	0.18	19.96	0.4	143.00
0.04	0.49	0.20	25.88	0.5	247.93
0.05	0.85	0.22	32.74	0.6	388.68
0.06	1.33	0.24	40.57	0.7	568.43
0.07	1.94	0.26	49.43	0.8	790.11
0.08	2.70	0.28	59.34	0.9	1056.40
0.09	3.61	0.30	70.35	1.0	1369.83
0.10	4.68	0.32	82.48		
0.12	7.34	0.34	95.78

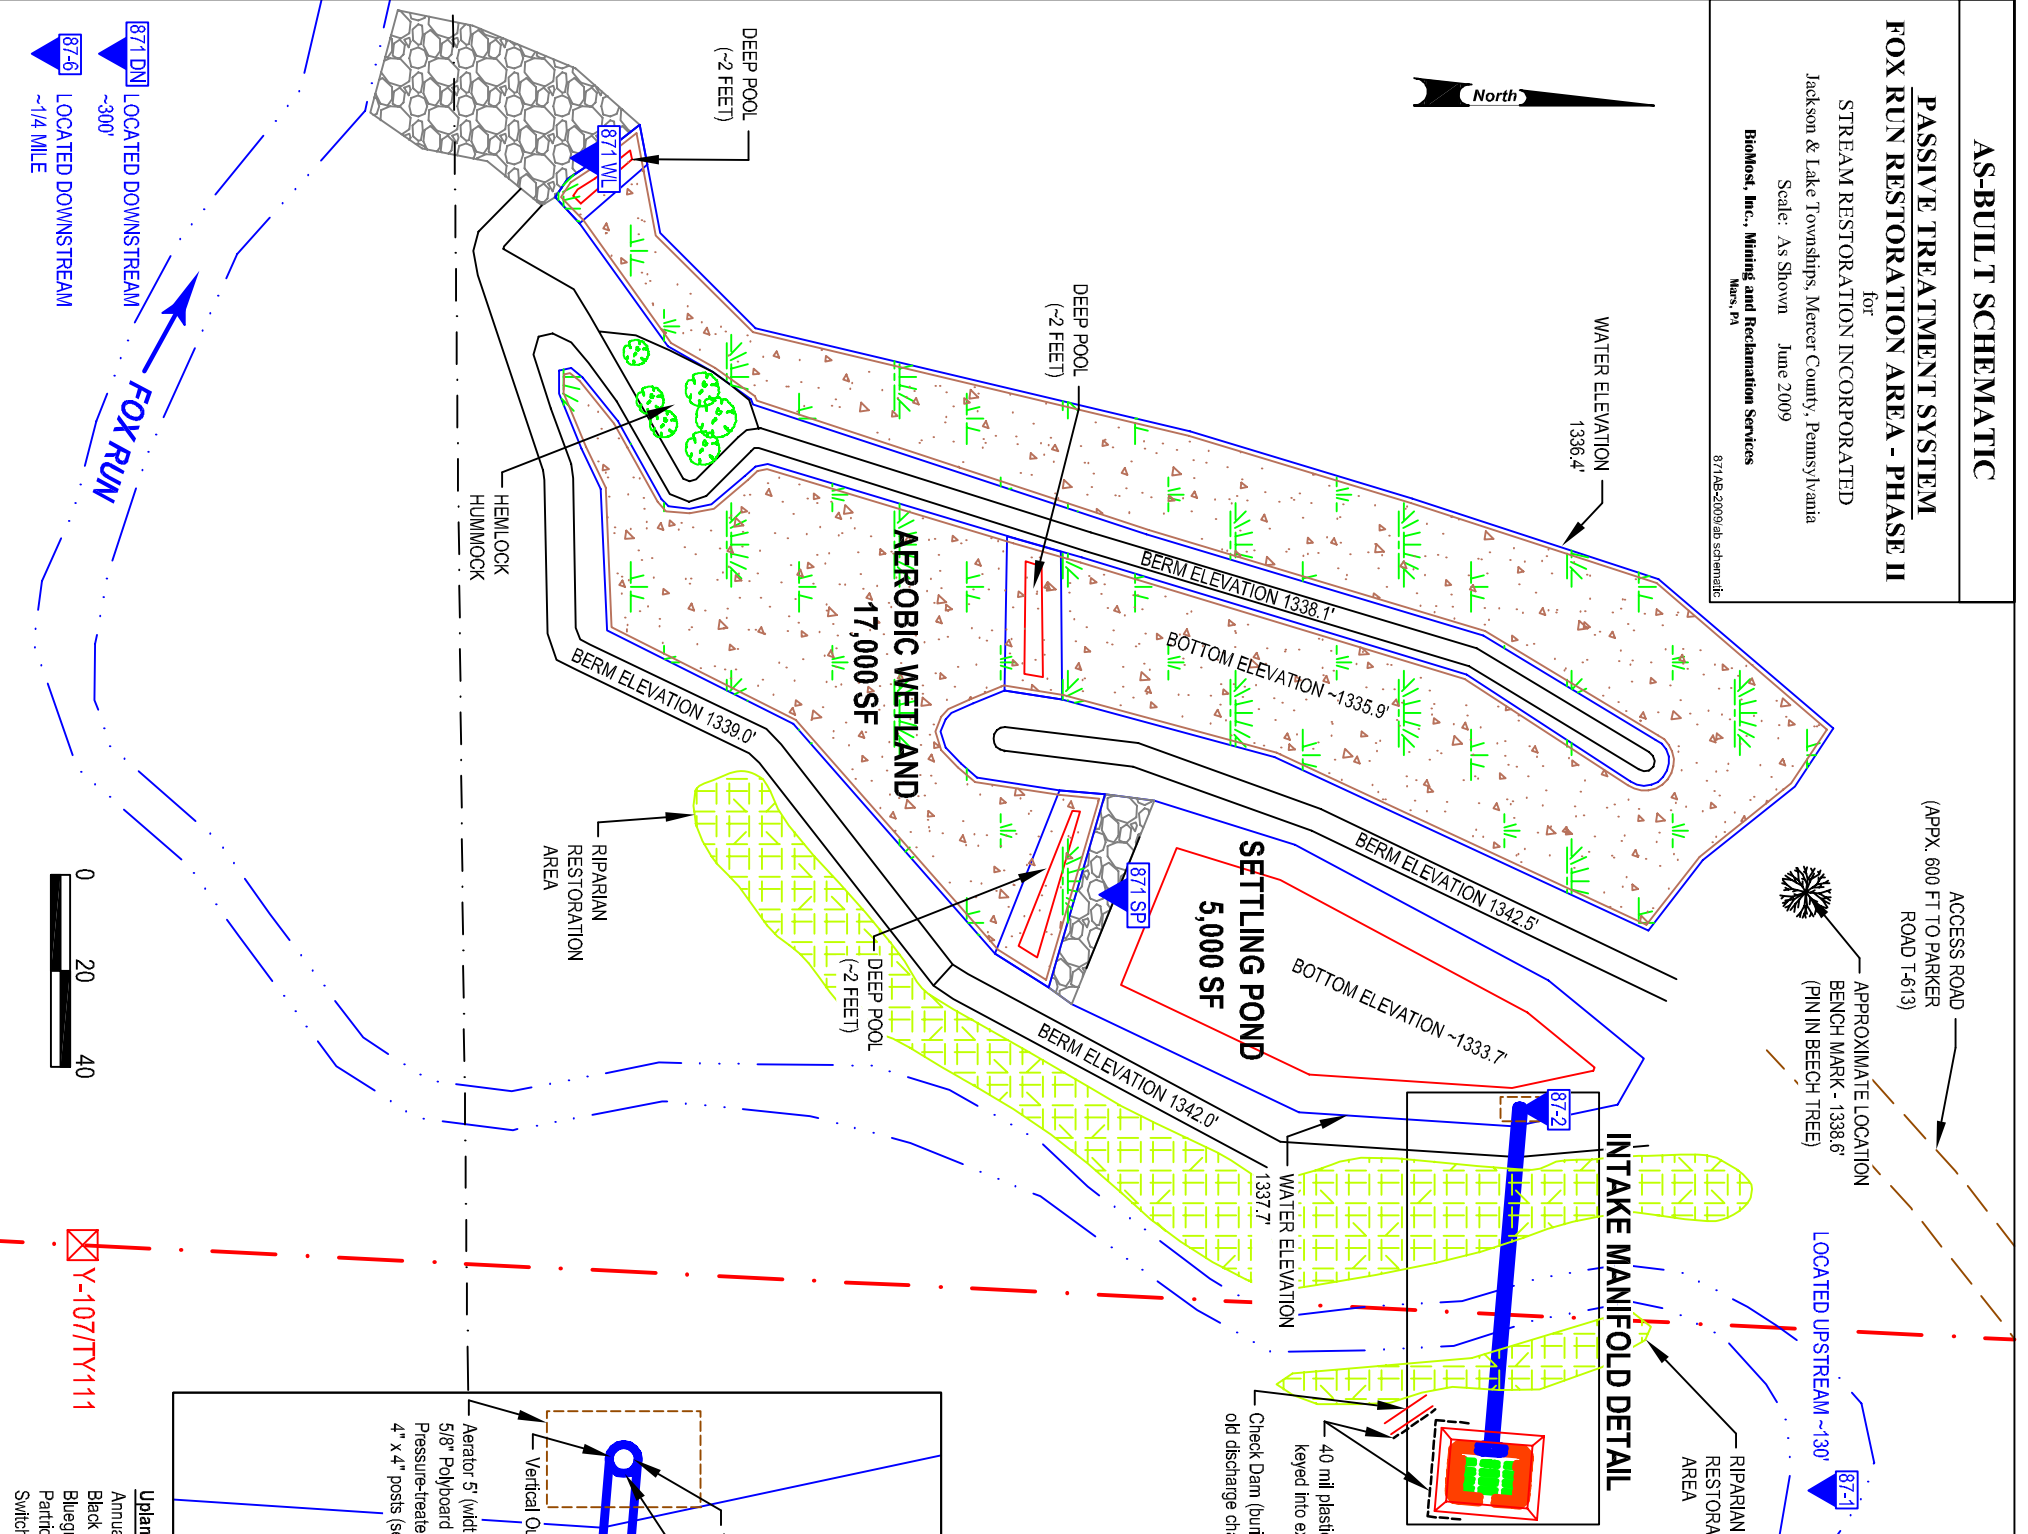
PASSIVE TREATMENT SYSTEM for FOX RUN RESTORATION AREA - PHASE II

Notes:
As-built information from 09/26/08 field inspection by BioMost, Inc. and Mercer County Conservation District using post-processed sub-meter GPS unit & laser level, and 06/22/09 site inspection by BioMost, Inc. as well as design information and is a reasonable representation of actual field conditions.
Water elevations may vary due to outlet spillway, weather and other factors.
Passive treatment system built on property of Richard & Barbara Kish.
All pipe is SDR35 PVC.
Stream location from aerial photography taken for the PAMAP program (Spring 2006) and sub-meter GPS unit.
Settling pond and wetland areas shown measured at top of water.
Total wetland area "foot print" ~3/4 Acre.
