**SCHUYLKILL CONSERVATION DISTRICT
1206 AG CENTER DRIVE
POTTSVILLE, PA 17901**

**AUDENREID MINE TUNNEL AMD TREATMENT SYSTEM
FINAL REPORT
DOCUMENT # 4100021568**

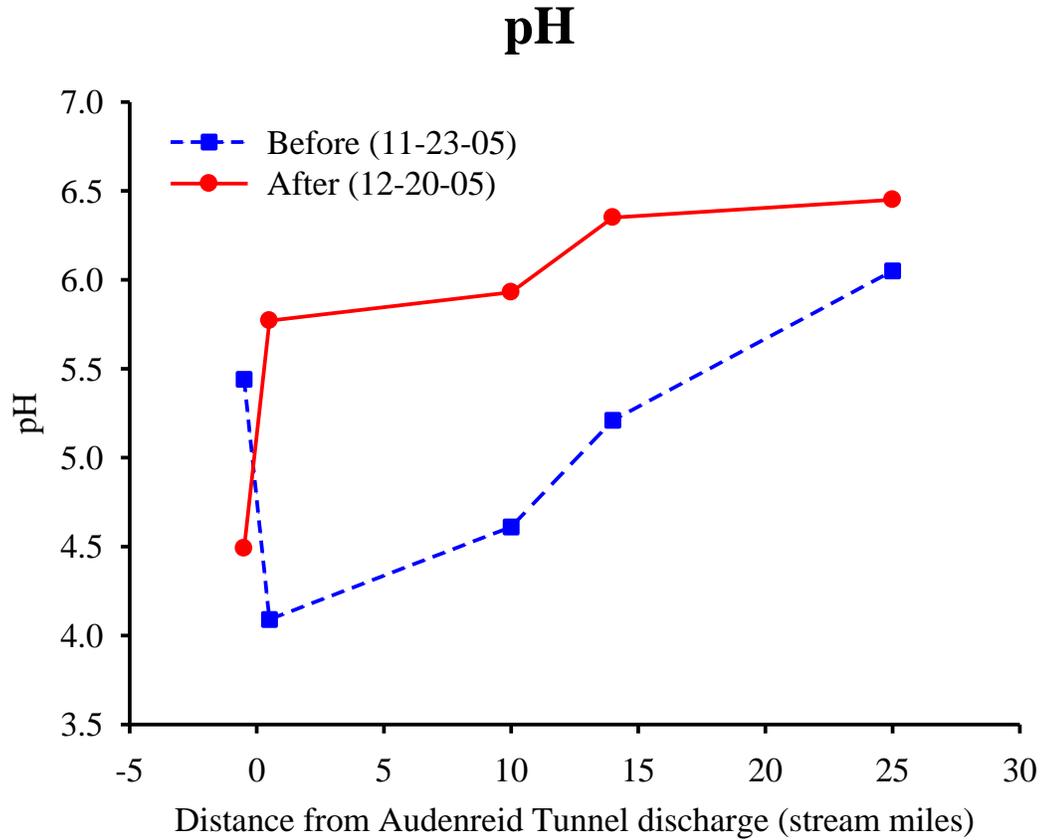
Figure 1. pH at various sampling points (stream miles) along the Cattawissa Creek before and after construction of the Audenreid Treatment System.

BAMR sampled the Audenreid Mine Tunnel several times after the completion of the project in December 2006 (Table 2 & 3). The data for sample dates 03/29/2006 and 06/05/2006 show an improvement in pH, Al, Fe, alkalinity, acidity between the discharge and the outflow of the settling pond (Table 2 & 3). A decrease in concentrations of Fe, Al, and Mg was observed in the settling pond outflow compared to Fe, Al, and Mg concentrations in untreated discharge water before treatment (Table 2&3). Increases in pH and alkalinity while a decrease in hot acidity was observed in the samples taken at the discharged compared to the outflow of the settling pond. Although data is lacking after treatment system completion it appears when comparing data at Phinneyville bridge site both before (Table 1) and after (Tables 2&3) treatment system completion that water quality in the Cattawissa Creek improved.

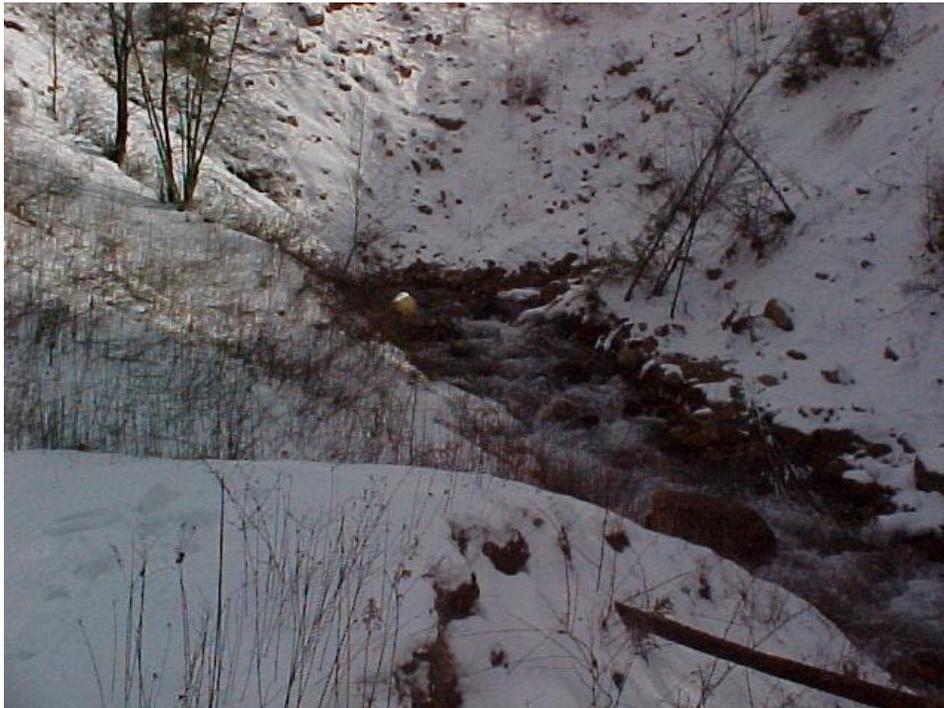
Picture 1. Preconstruction conditions of the Audenreid mine tunnel opening

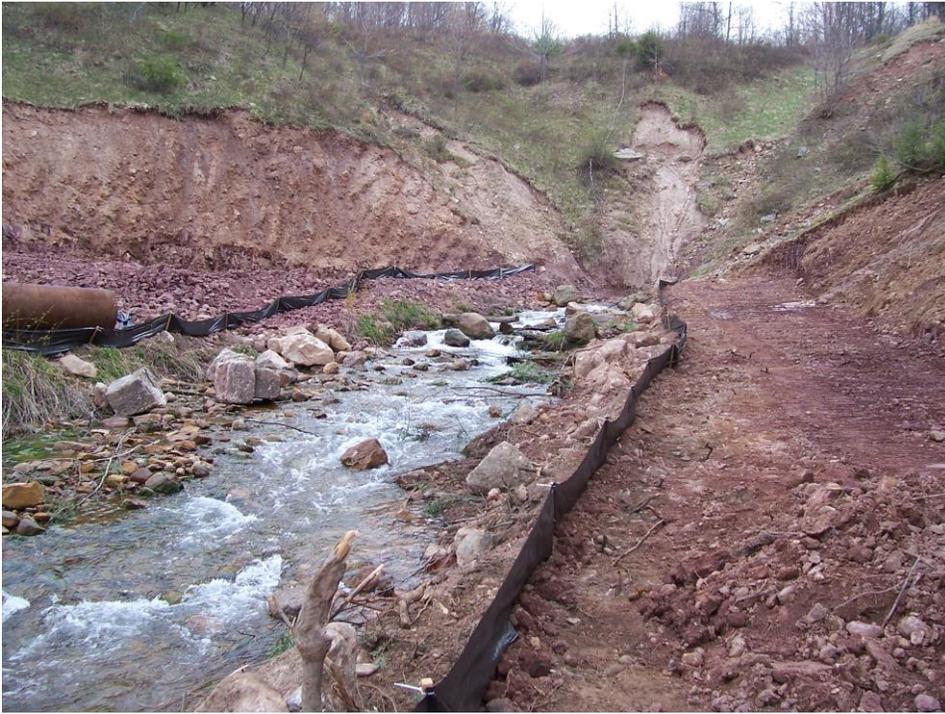
Picture 2. Preparing the mine opening and surrounding area for intake system with proper E&S controls being utilized.

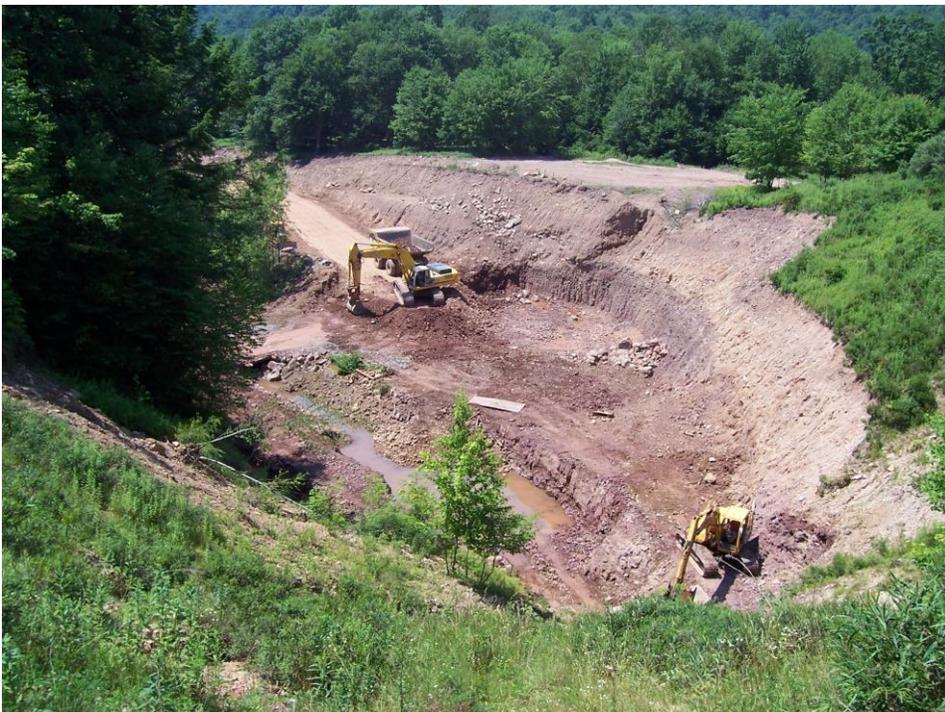
Picture 3. Above view of the mid-point in construction and site preparation for the audenreid mine tunnel opening and treatment system intake.

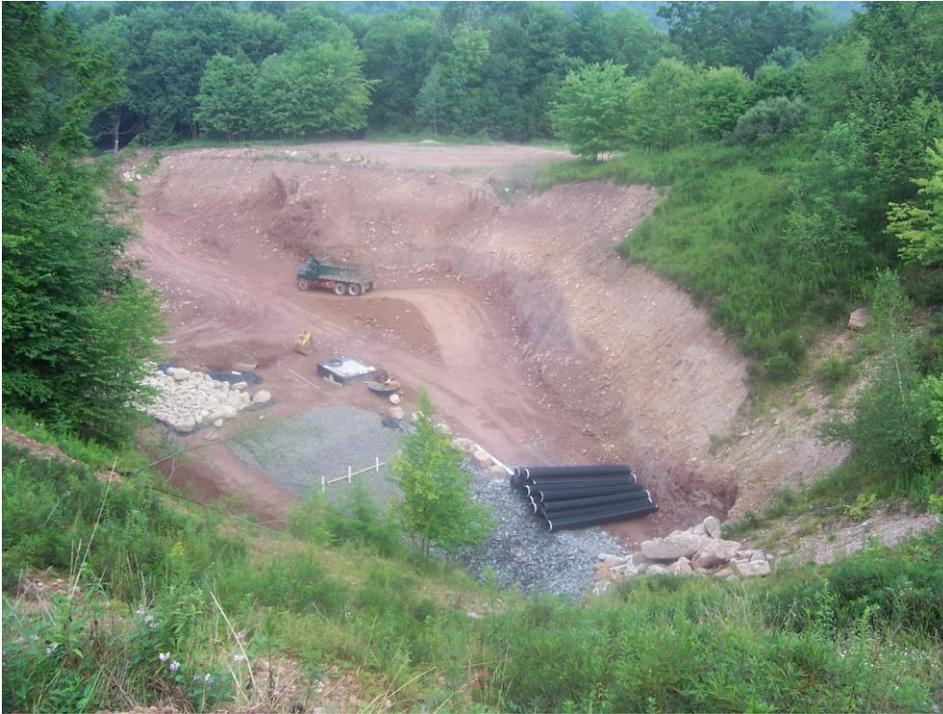
Picture 4. View from above the Audenreid mine tunnel opening showing the completed rock filter, rip-rap lined overflow channel and cleared mine opening with water being diverted around the intake system.

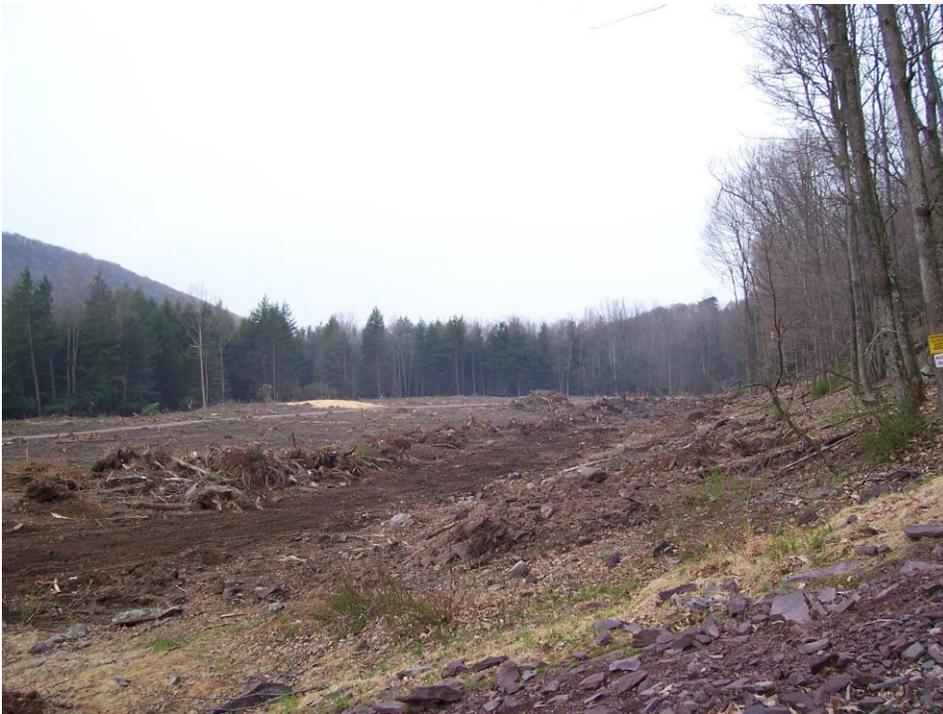
Picture 5. Limestone tank and settling pond site preparation through clearing and grubbing .

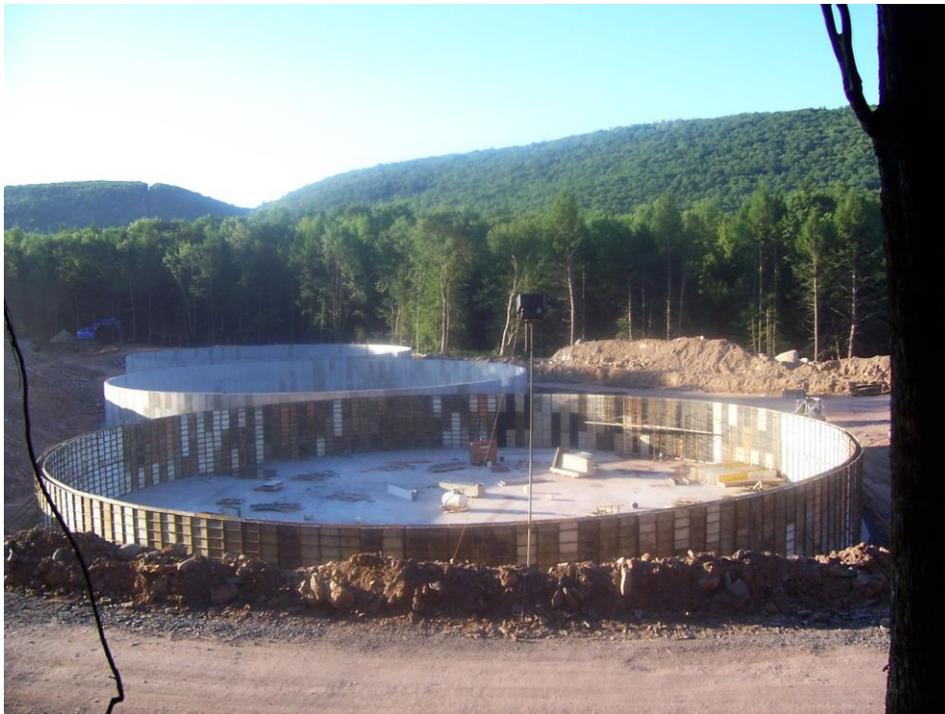
Picture 6. View of two completed concrete limestone tanks in background while recently poured concrete is “setting up” in tank mould in the foreground.

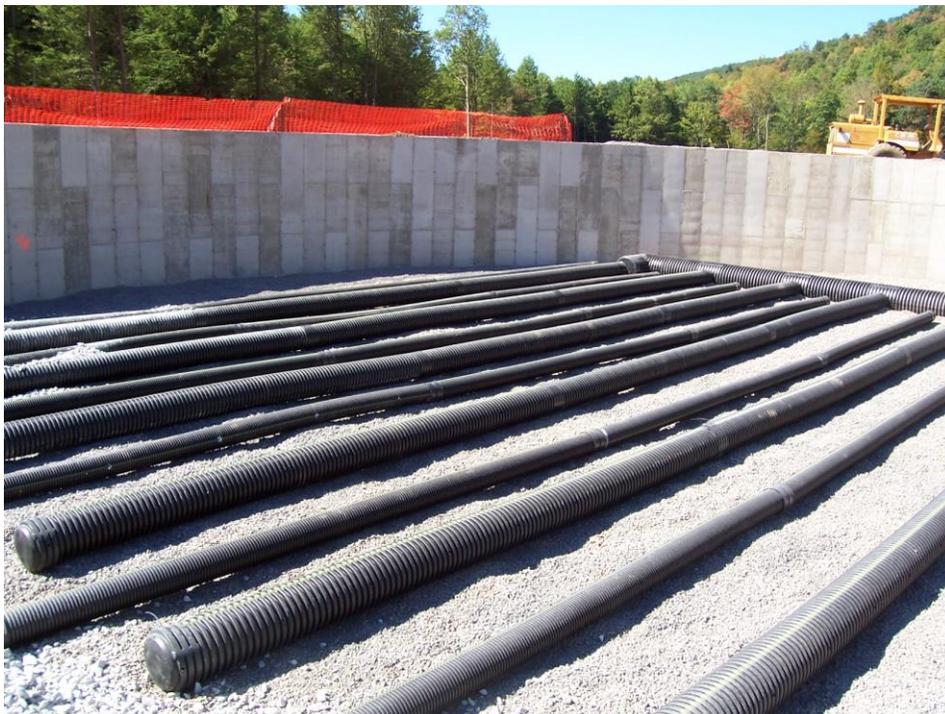
Picture 7. View perforated pipes on top of non calcareous rock bed for the flushing system piping (large diameter pipes) and water intake piping (small diameter pipe) in the limestone tanks.

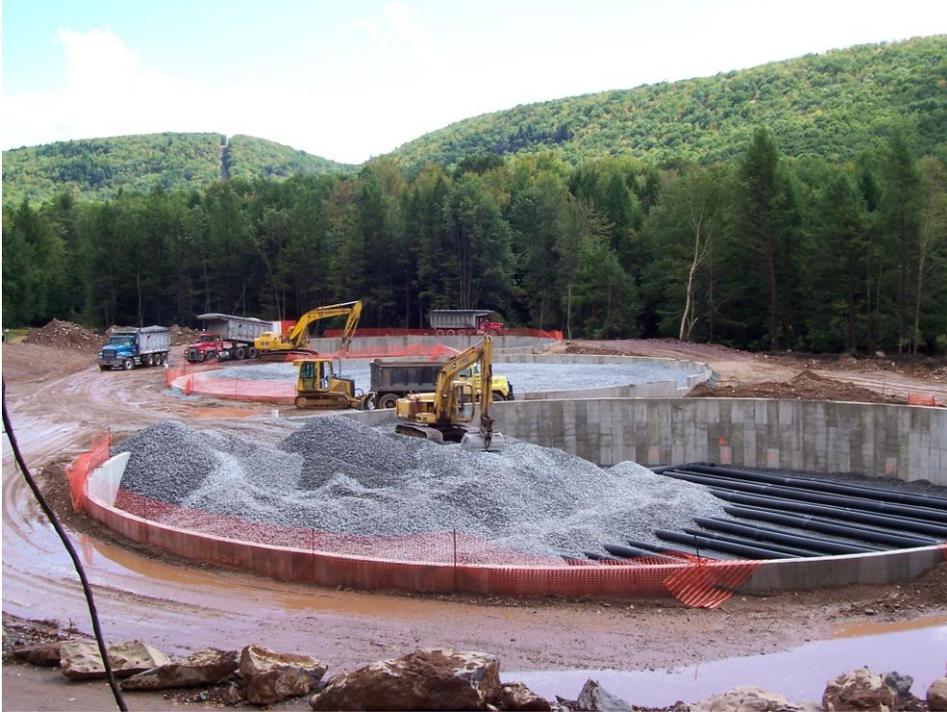
Picture 8. Limestone additions to tanks.

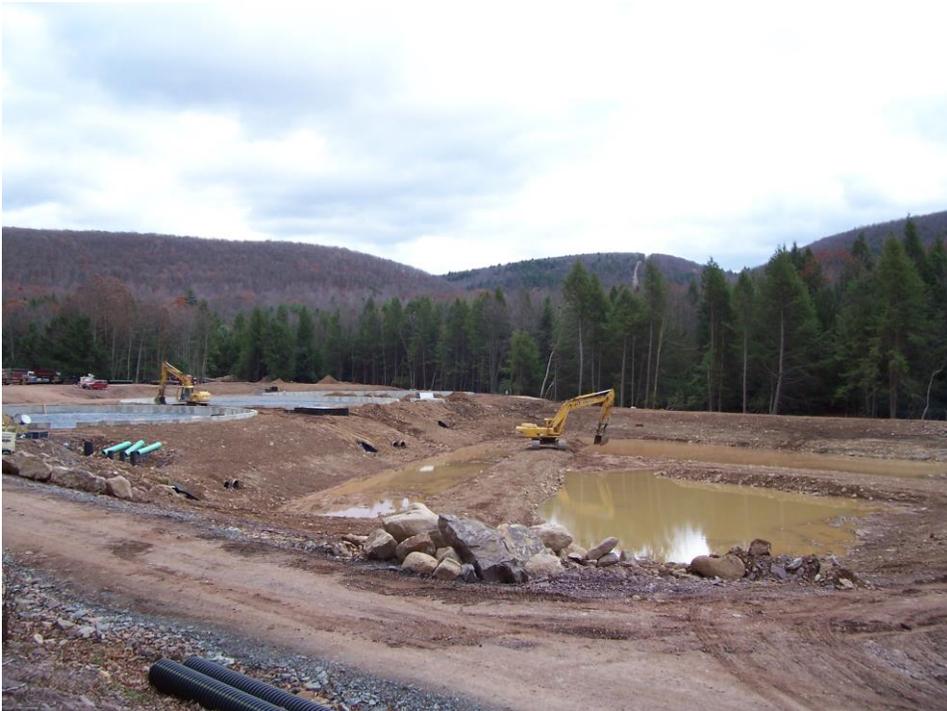
Picture 9. View of first settling pond before stabilization and berm construction was completed.

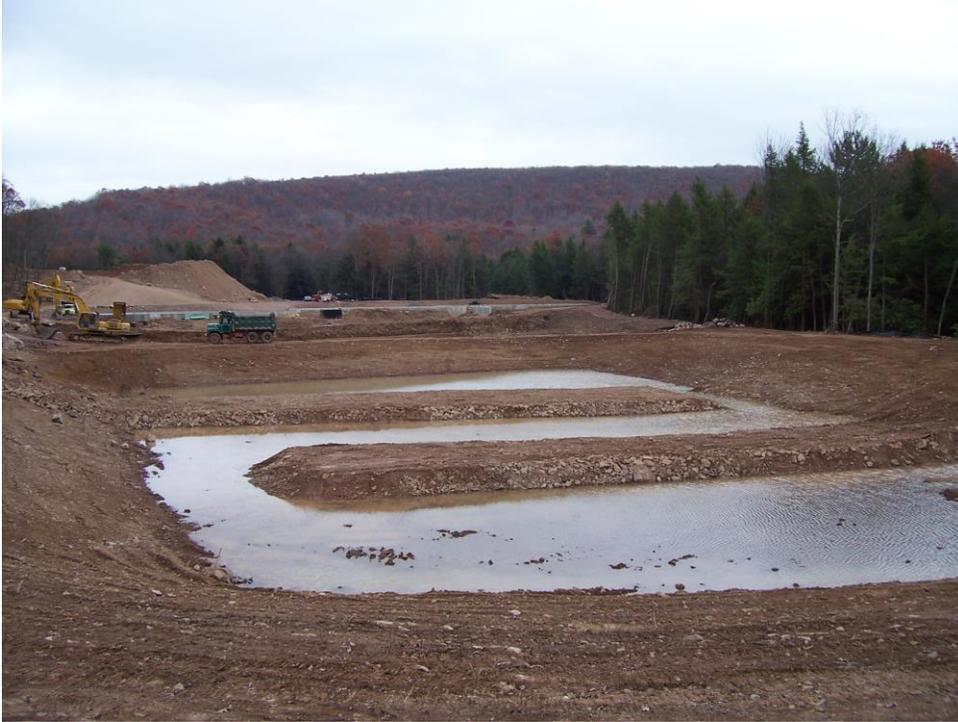
Picture 10. View of second settling pond before bank stabilization.

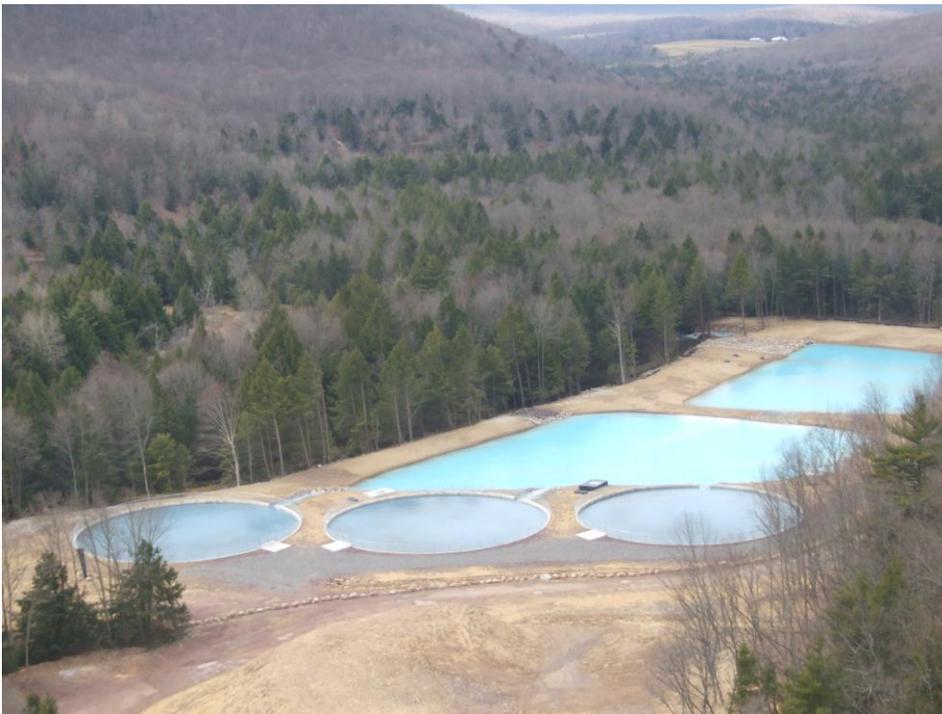
Picture 11. Aerial view of limestone tanks, and two settling ponds while system was in operation.

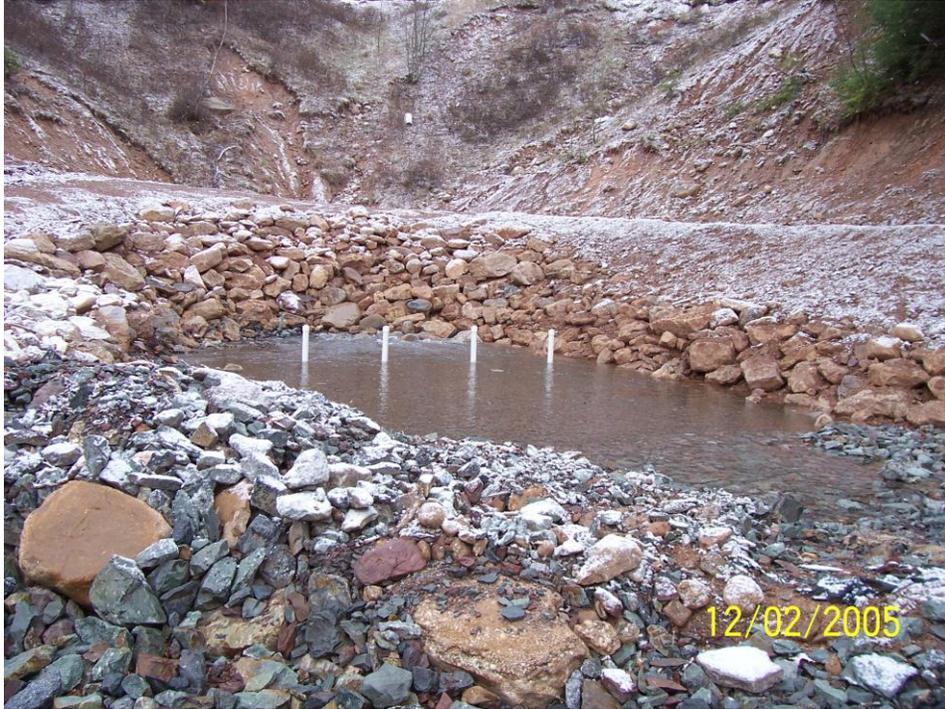
Picture 12 View of intake system with tunnel opening in back ground while system was in operation.

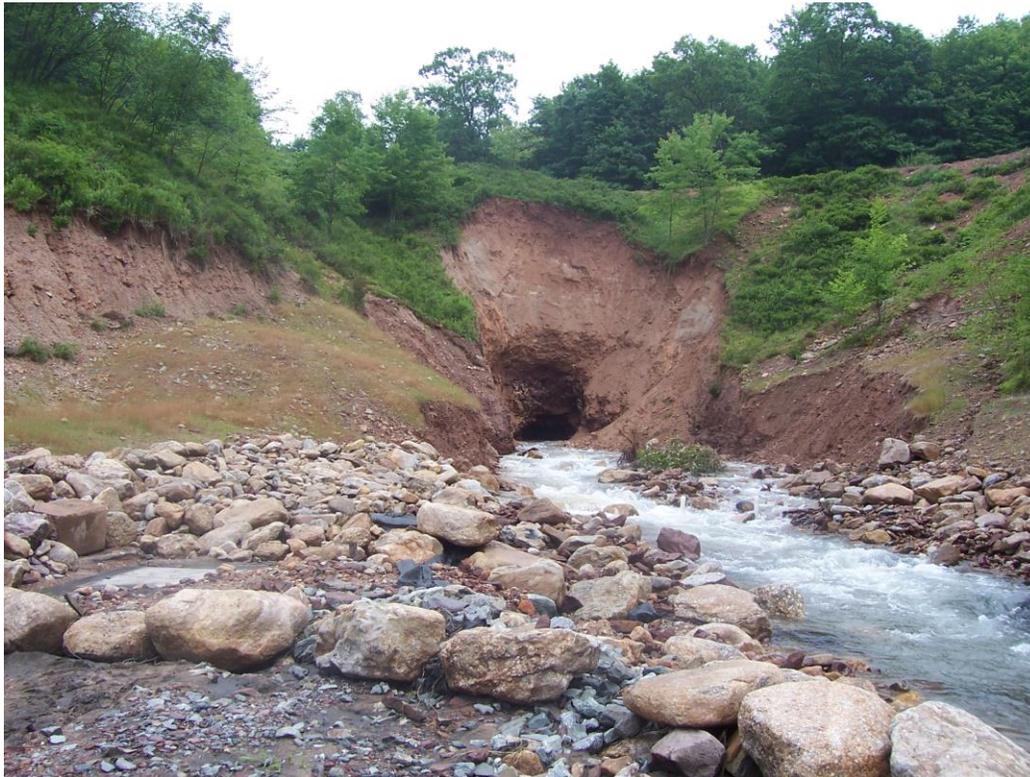
As a result of the Floods of 2006 the influent collection system was nearly destroyed, and sediment clogged the piping in the system disabling the system. The Floods of 2006 also caused a large portion of the end of the Mine Tunnel to collapse due to the high flow rates and back pressure created by placing large boulders in front of the mine entrance to prevent access into the tunnel.

An approximate graphical representation of the extent of the erosion and collapse of the Mine Tunnel opening was completed along with the calculations of the volume of material lost. The calculations were made by assuming the area lost formed a vertical wall and obtaining the area at every other contour. These numbers were then used to calculate volume by average area resulting in a volume of 7,200 cubic yards. This damage caused large amounts of sediment to be washed downstream and into the influent collection system, influent lines and into the treatment cells disabling the treatment system by clogging it with the sediment. As a result of the erosion the Mine Tunnel opening has moved back into the mountain approximately 70 feet toward a dirt road system and has created a nearly 60 foot unstable vertical wall of soil and very brittle rock. The influent collection system berm was destroyed by the raging flood waters. The constructed berm was approximately 25 feet wide, had a clay core, and was lined with stone found on-site which was approximately R-6 sized. This berm provided a pool over the collection system to allow sufficient head for the water to penetrate into the influent collection system piping.

Picture 13. Damage to intake system and mine opening during the June 2006 flooding.

The first step in repairing the system will be to stabilize the slope above the tunnel. This will need to be completed before any other work can start due to the possibility of further collapse of the area and a danger to work being completed on the influent collection system. A drainage channel will also be placed just above the tunnel opening to divert any water falling on the slope above the discharge to an outlet below the reconstructed influent collection berm. A channel similar to this existed prior to the flood damage. The slope will need to be stabilized with erosion control blanket to allow the vegetation to germinate and become established. Once the slope is cut back to a safe slope work can begin on stabilizing the Mine Tunnel Opening.

The Mine Tunnel Opening will be kept open to prevent back pressure within the tunnel from creating additional problems. This will be accomplished by excavating back to stable rock and stabilizing with a concrete structure and shot-creting of any exposed rock outside this structure. A pre-cast structure will need to be anchored into place by a method to be determined to prevent the structure from possibly being pushed out of place by high flow rates. The structure will need to be fitted with a gate to restrict individuals from walking into the tunnel. Additionally, the gate will need to allow high flows to pass with little restriction and allow any large debris such as fallen timbers from within the tunnel to pass through the gate. It is thought that a gate hinged at the top and swinging outward from the tunnel would allow debris to pass by the water pressure behind the gate pushing the gate open to release the debris and closing upon release of the debris. The gate will need to be adequately supported, be heavy enough to prevent a person or persons from lifting the gate and be made of stainless steel to prevent corrosion due to the acidic waters exiting the tunnel.

The influent collection system will be reconstructed as it was originally built, modifications to allow high flows to safely pass through the system will be done to the surface of the influent collection system. The modifications will include placing riprap on top of the influent collection system this will prevent the smaller stone from being washed downstream but still allow the water to pass into the collection system. The PVC inspection ports, approximately 2'-6" in length and six-inch diameter, will be encased with stainless steel sleeves to prevent them from being broken off by high flows. The influent collection system berm width will be increased if feasible due to site constrictions; this will reduce the depth of flow over the berm and reduce the erosive effects. The berm will be constructed to the same cross-section complete with the keyed-in clay core but the riprap lining will be grouted in place to make the entire berm one monolithic structure. The reconstruction on the influent collection system will clean and/or repair items such as the valves, manhole, and influent flow chamber. Additionally any piping or other structures which can be salvaged will be, but it is assumed that all piping upstream of Manhole #1 is destroyed and any piping through the berm was damaged. The valves will be cleaned of any sediment and serviced by a manufacturer's representative if necessary. The manhole and influent flow chamber will be cleaned by hand, vacuum devices, and/or mechanical methods.
