De Sale Restoration Area Phase III

Re: Final Report for ME# 351407; Project # NW10324
De Sale Restoration Area Phase III, Venango Twp., Butler Co., PA
630102/FR-trans

DE SALE RESTORATION AREA: PHASE III FINAL REPORT

**Seaton Creek Watershed, Slippery Rock Creek Headwaters
Venango Township, Butler County, PA**

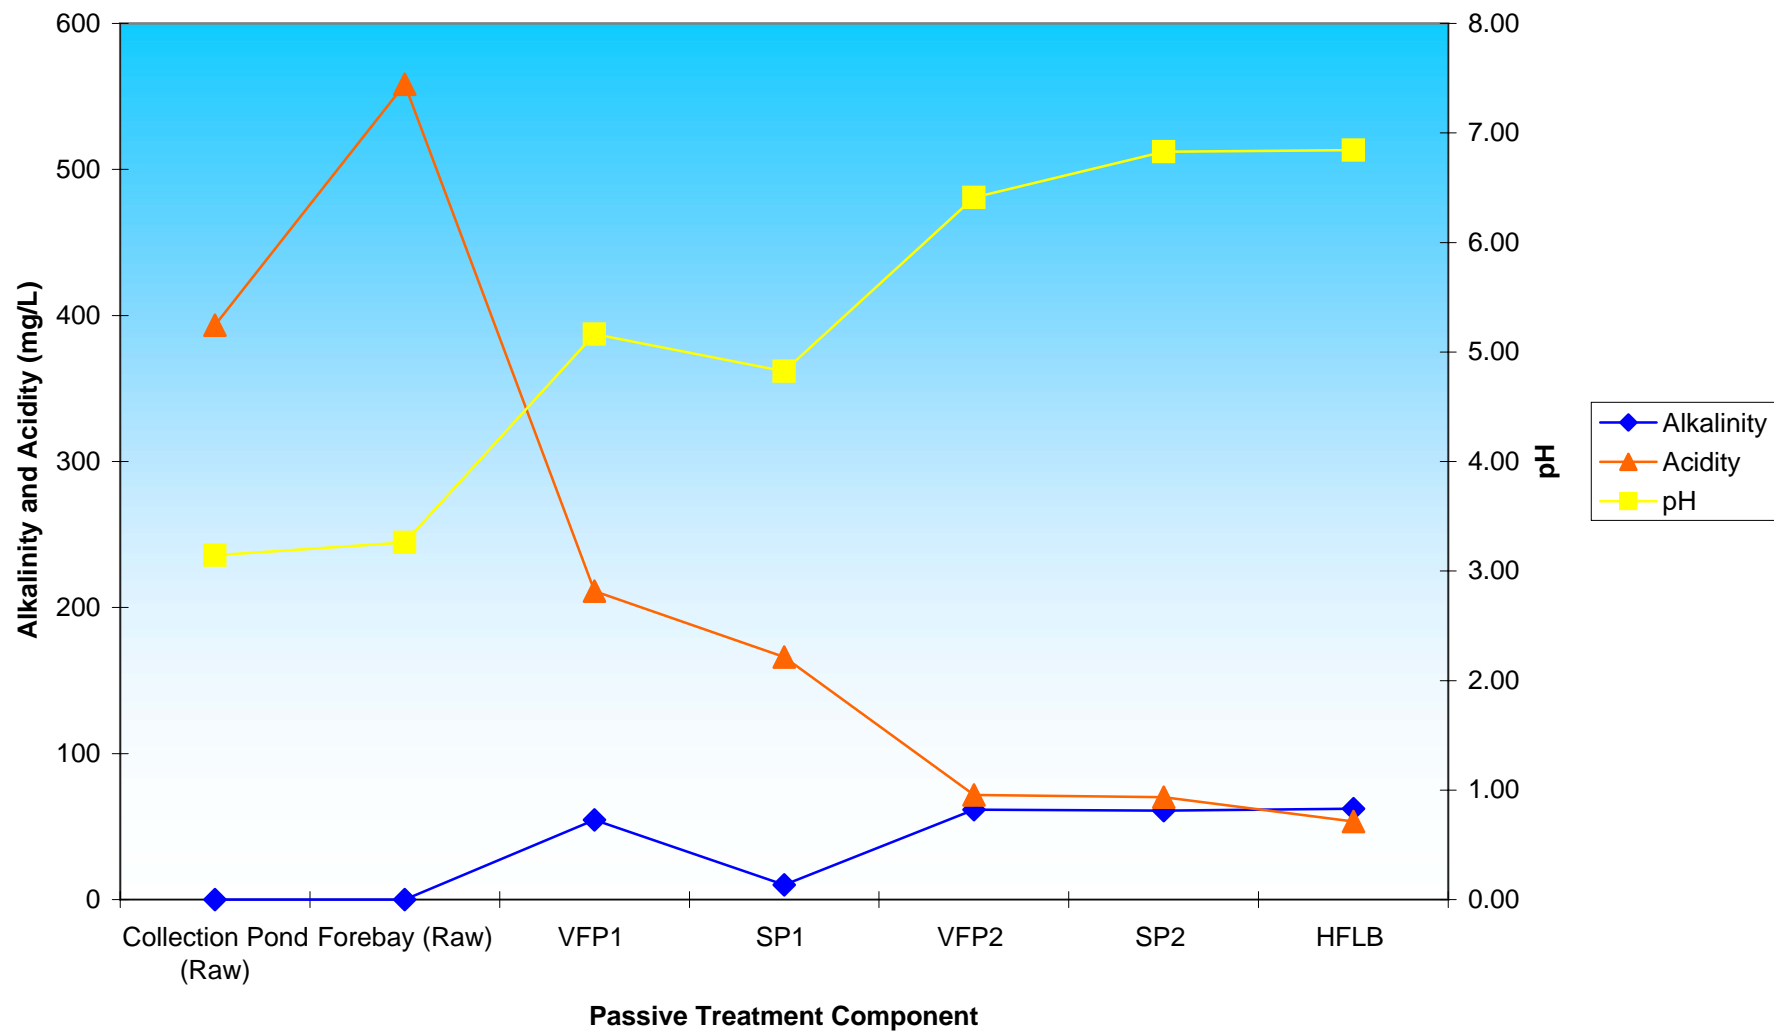
Figure 2.

Comparison of pH, Alkalinity, and Acidity Through the Passive Treatment System (Average Values)

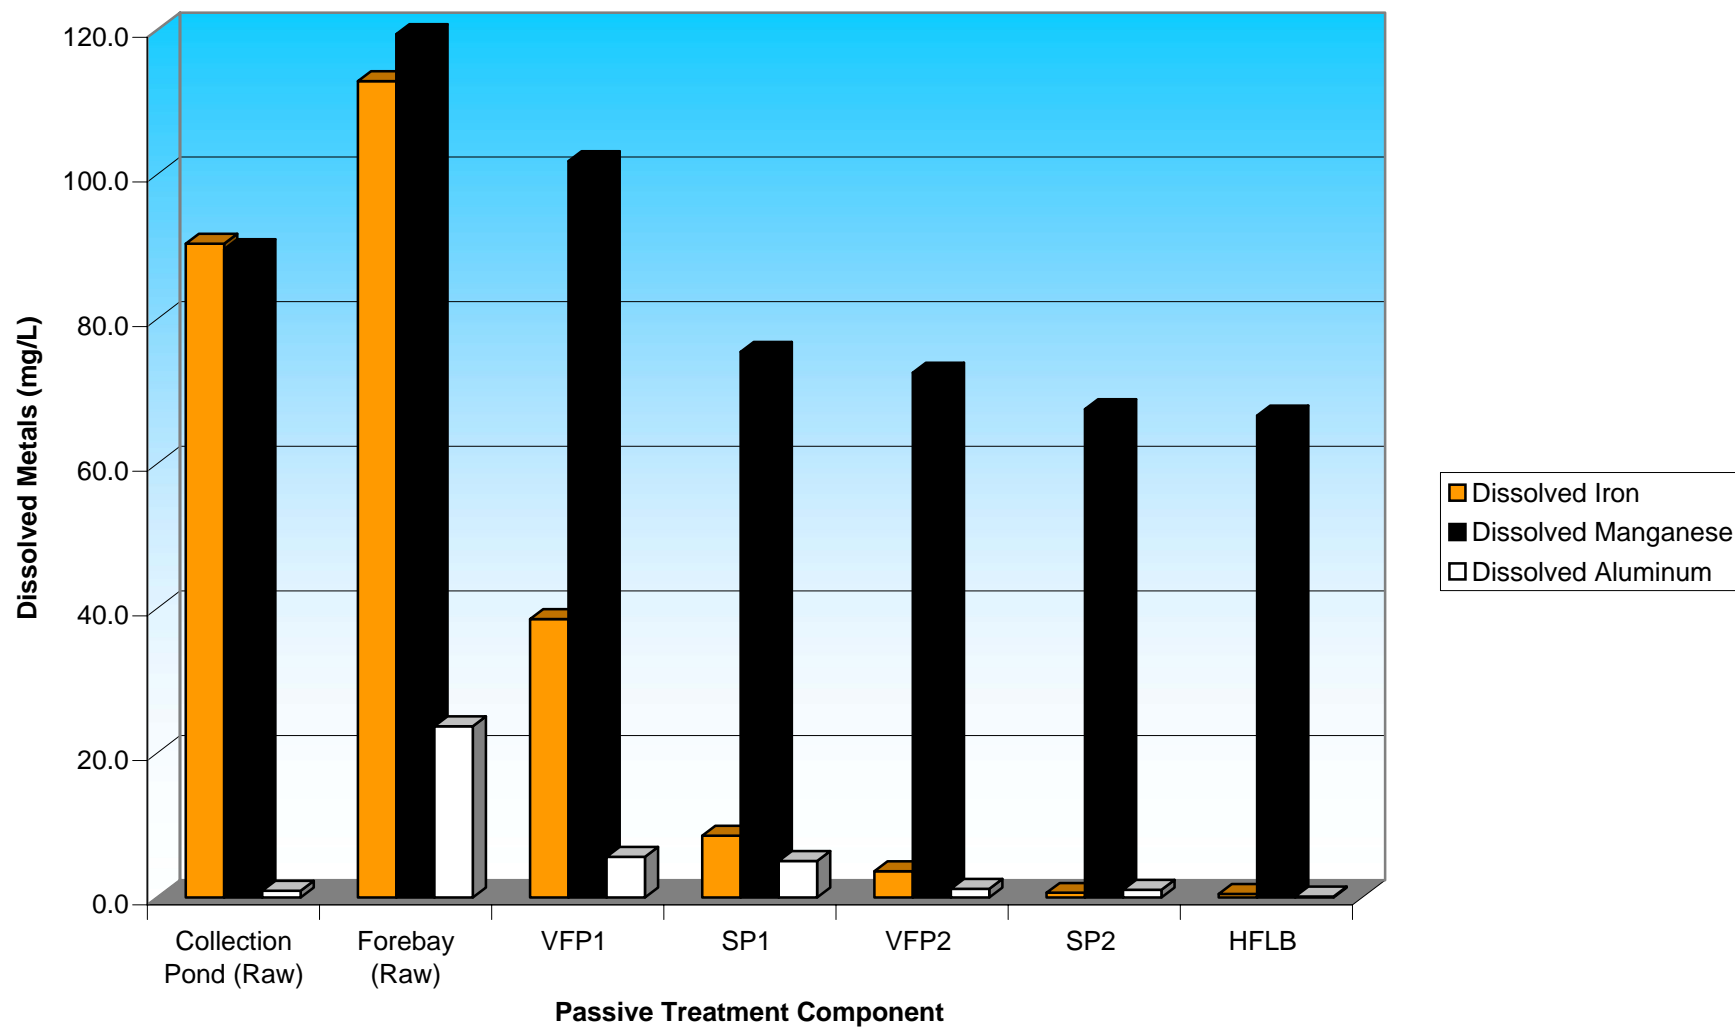
Figure 3.

**Comparison of Dissolved Metals Concentrations
Through the Passive Treatment System (Average Values)**

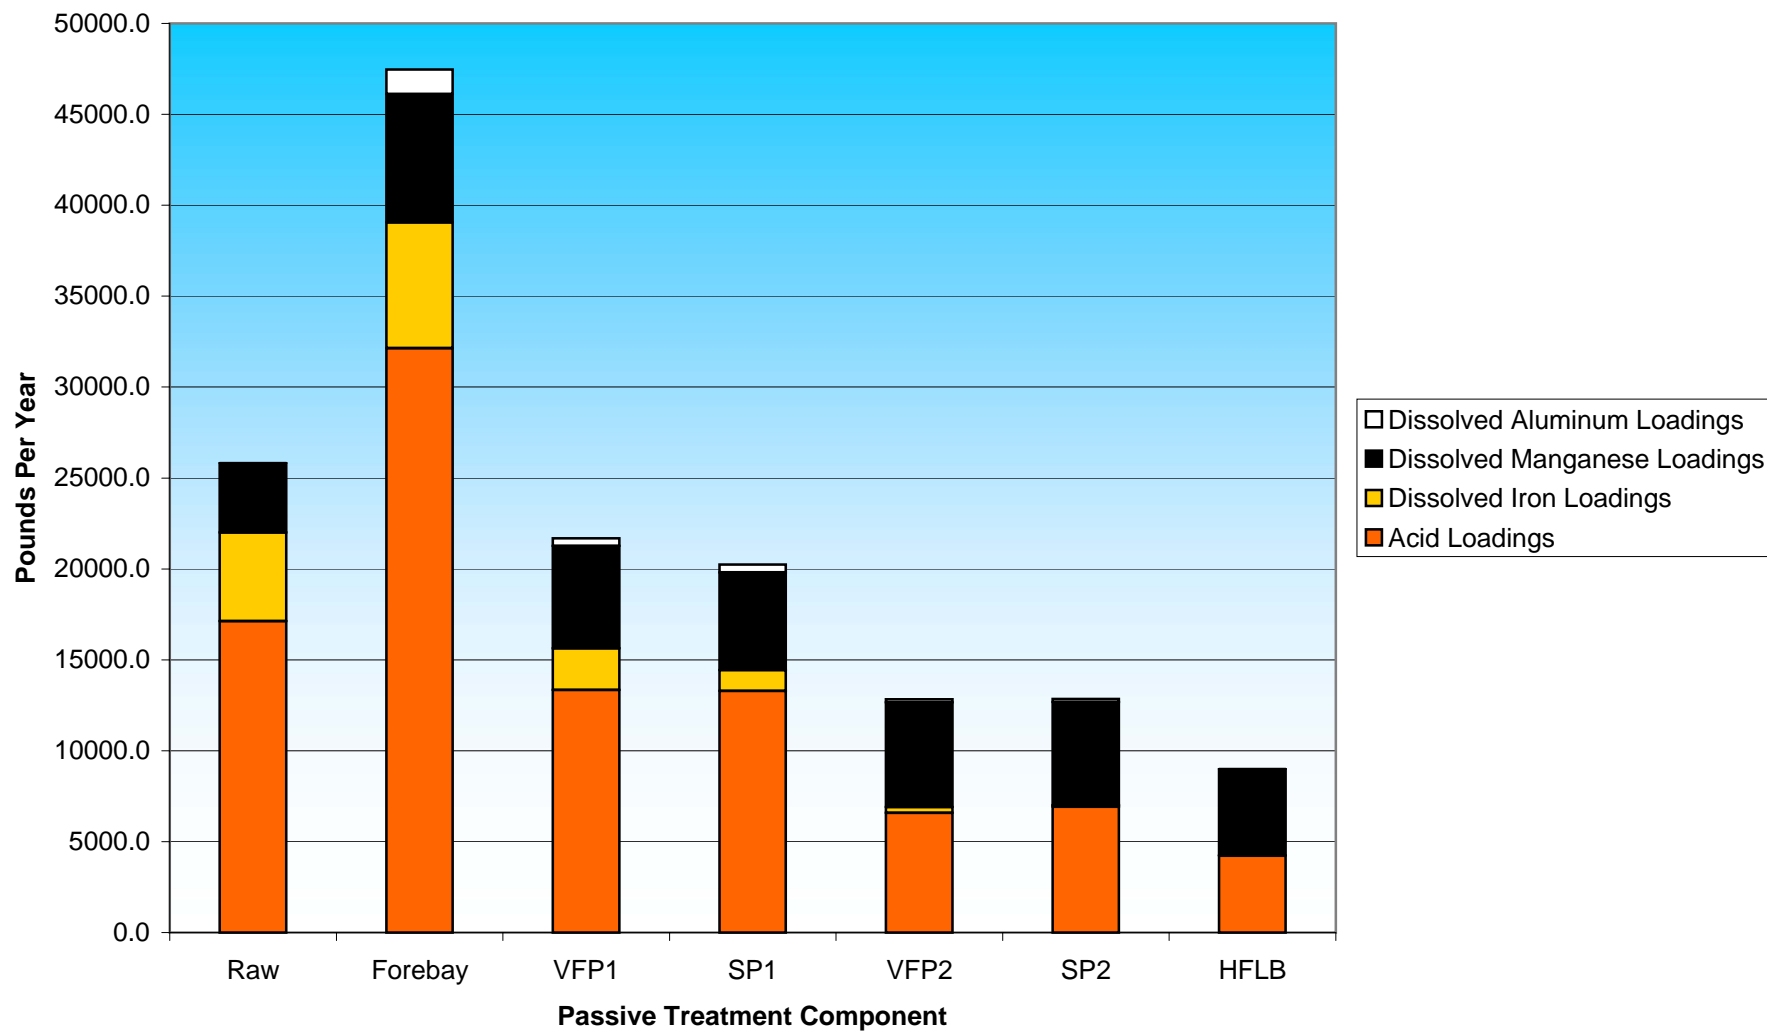
Figure 5.

**"Stacked" Comparison of Pollutant Loadings Through
the Passive Treatment System in Pounds Per Year**

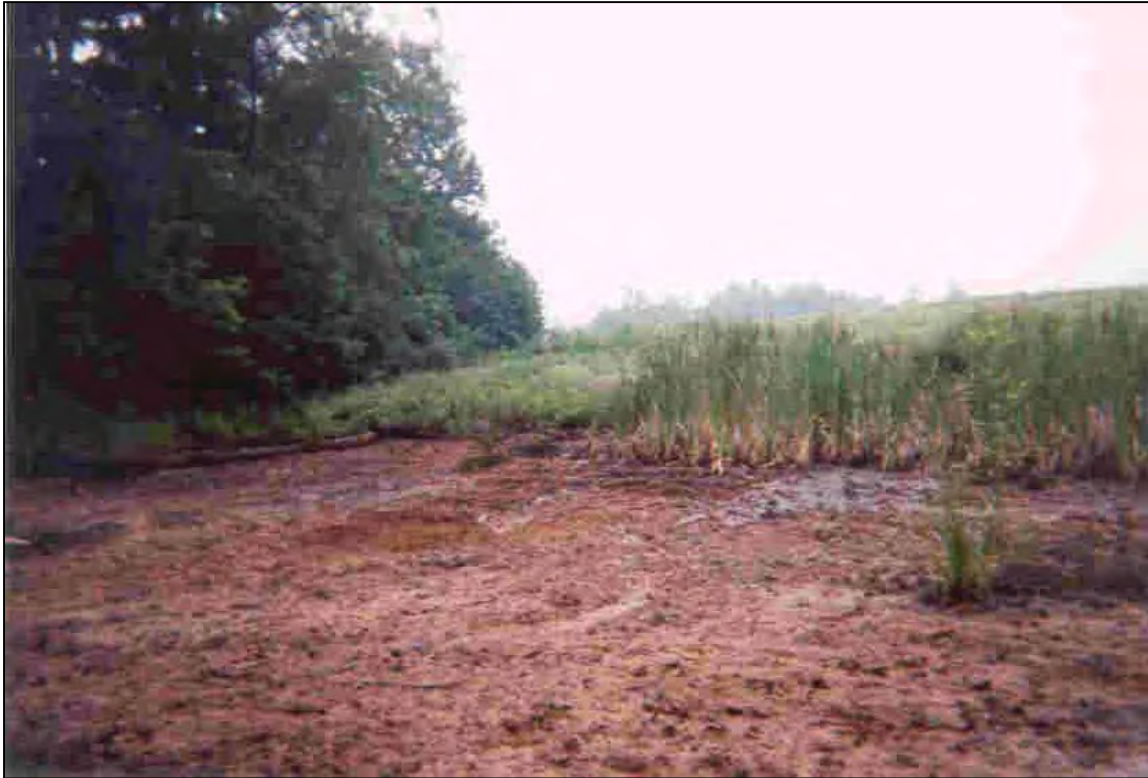
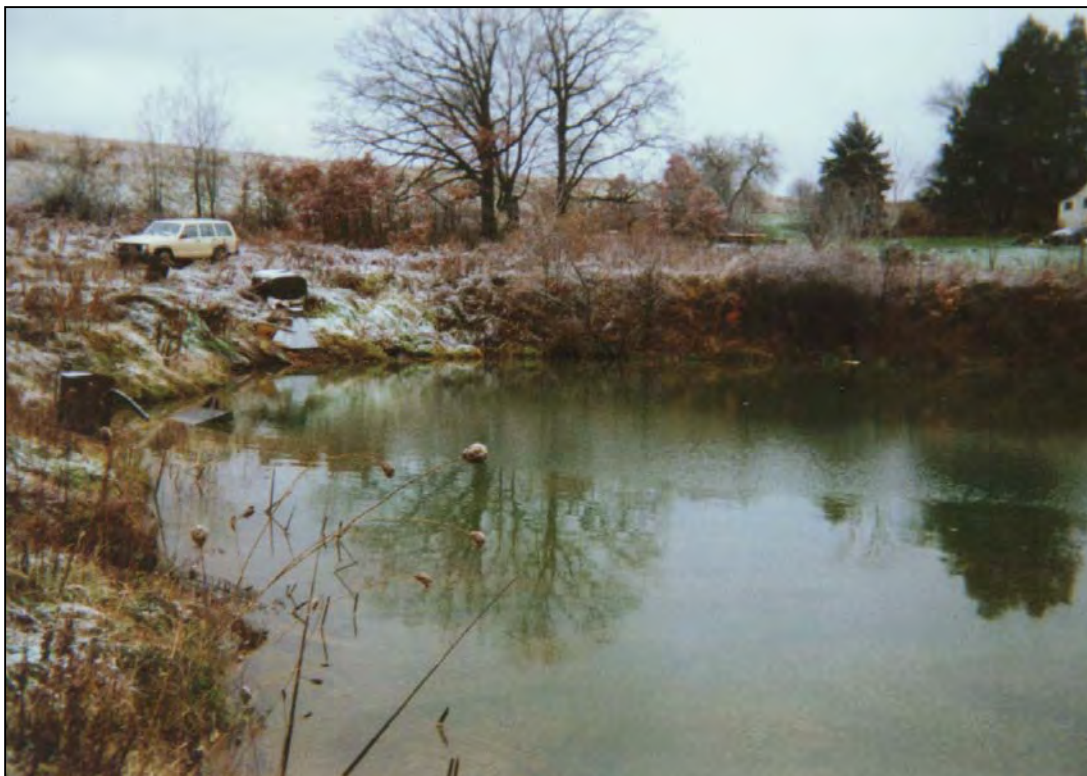
A surface coal mine operation previously conducted by the former Pengrove (Adobe) Coal Company resulted in two post-mining discharges **(Above)** which were actively treated while the company was operating **(Below)**.

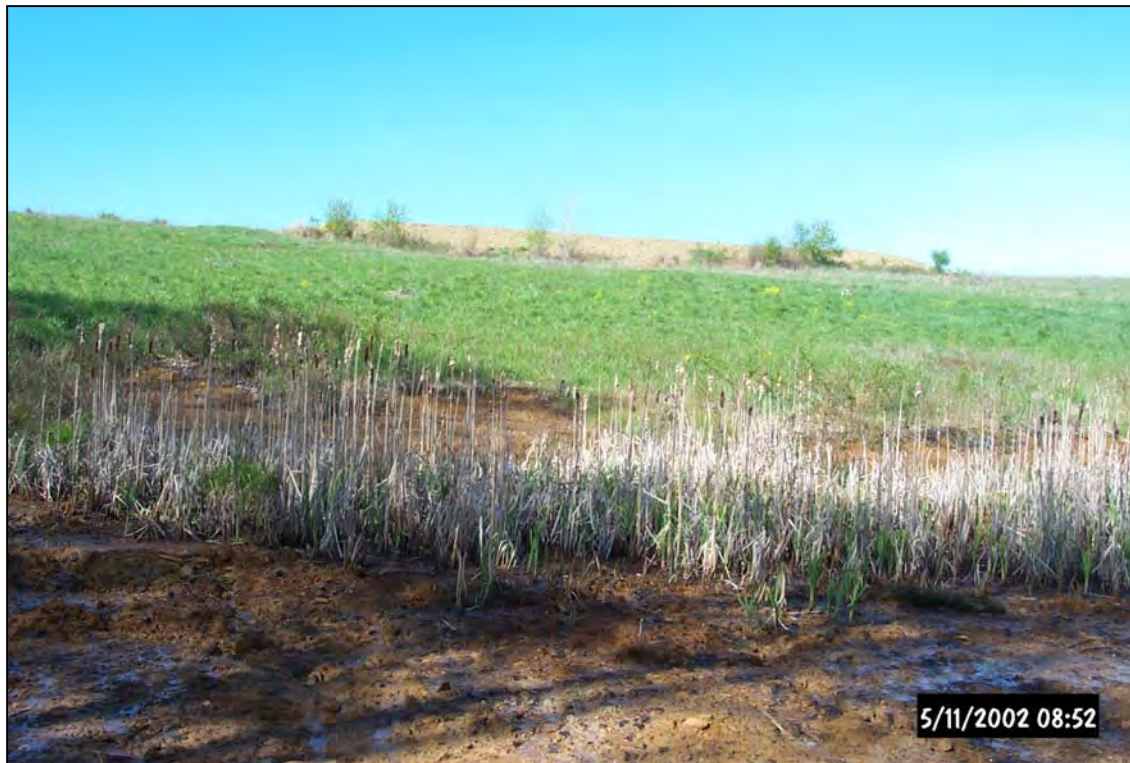
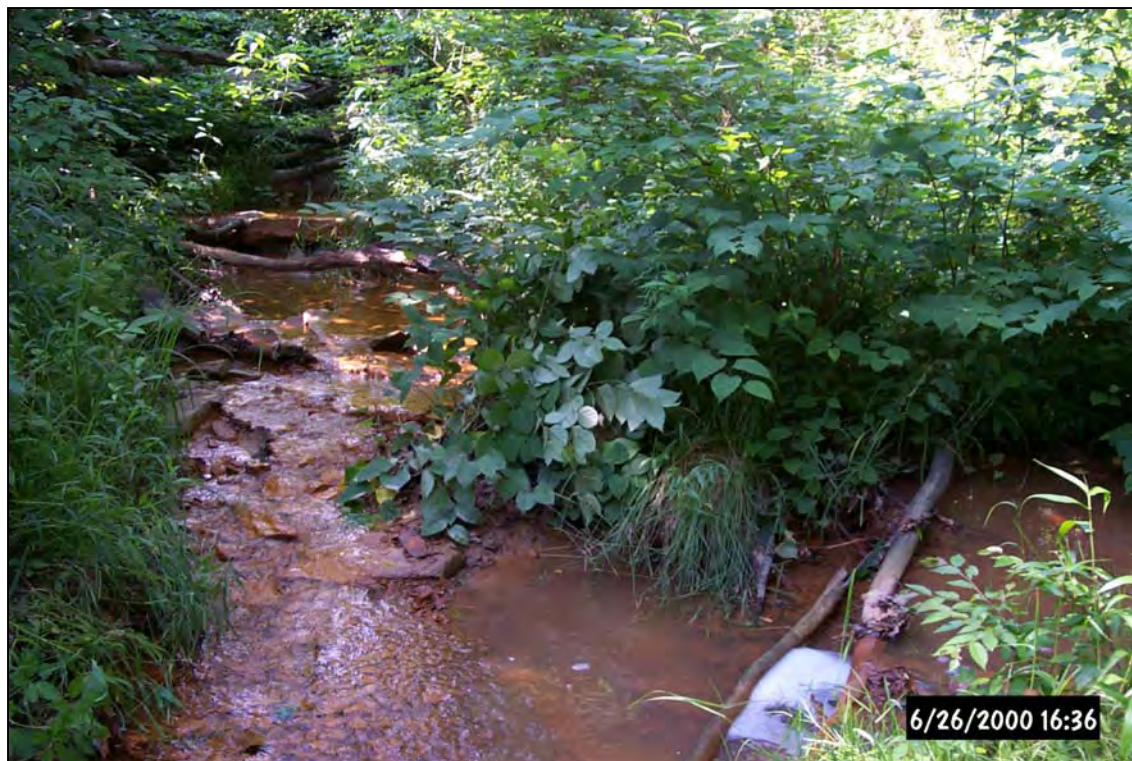
View of a portion of the “kill zone” associated with a diffuse seep zone in the foreground and sludge drying ponds in the background **(Top)**. The mine drainage from the site entered one of the unnamed headwater tributaries of Seaton Creek **(Below)**.

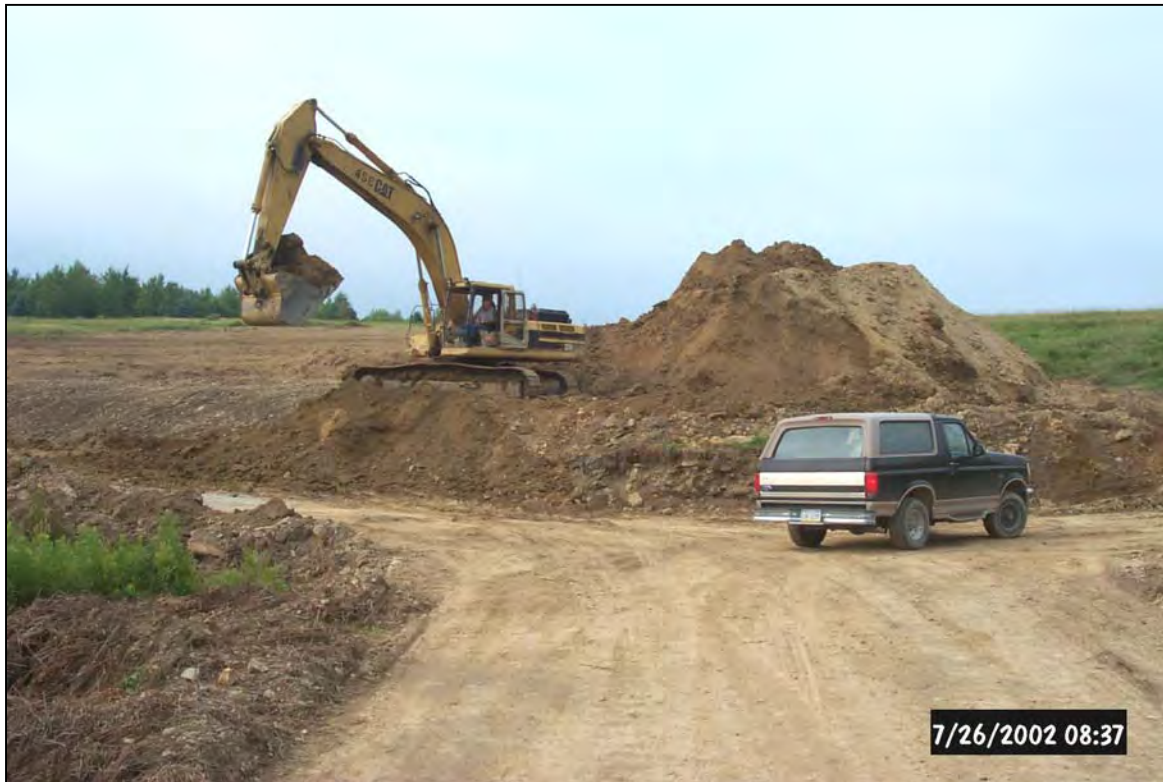
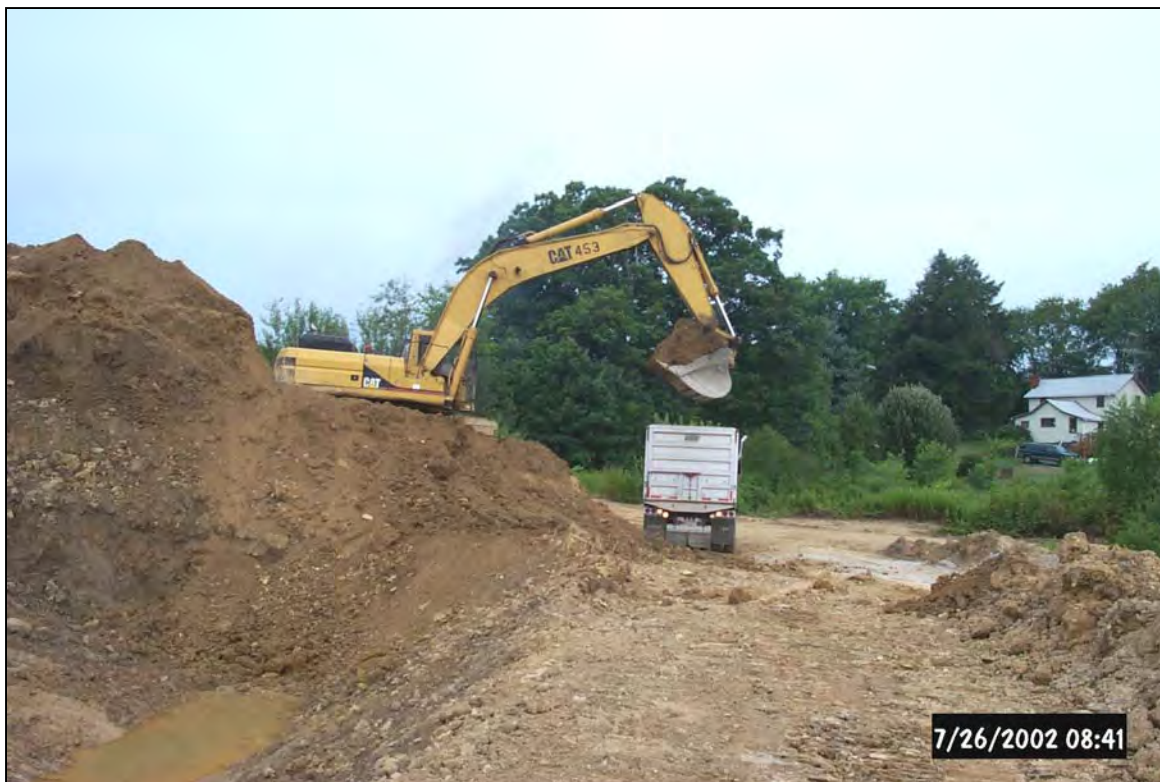
The passive treatment system was designed by BioMost, Inc., and constructed by Amerikohl Mining, Inc. The installation of the collection ditch can be seen in both the top and bottom photos.

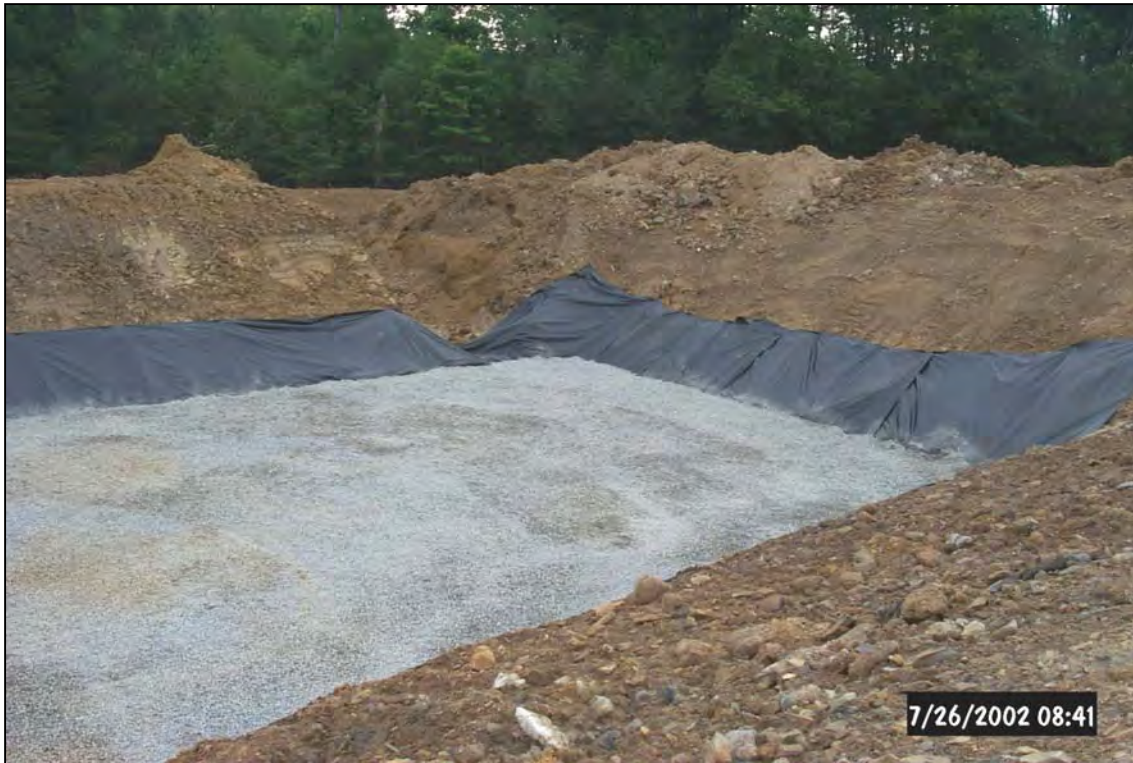
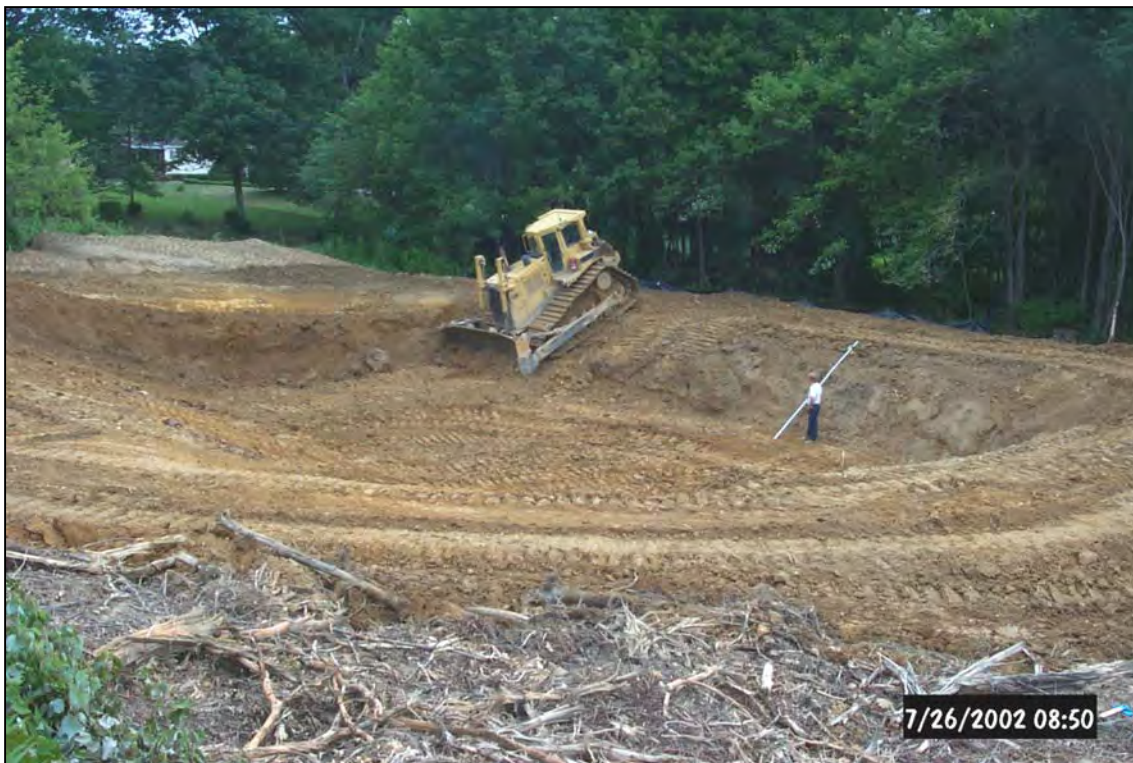
The lower tier of pipes were bedded in stone in Vertical Flow Pond 1 **(Above)**.
Construction of the basin for the Horizontal Flow Limestone Bed **(Below)**.

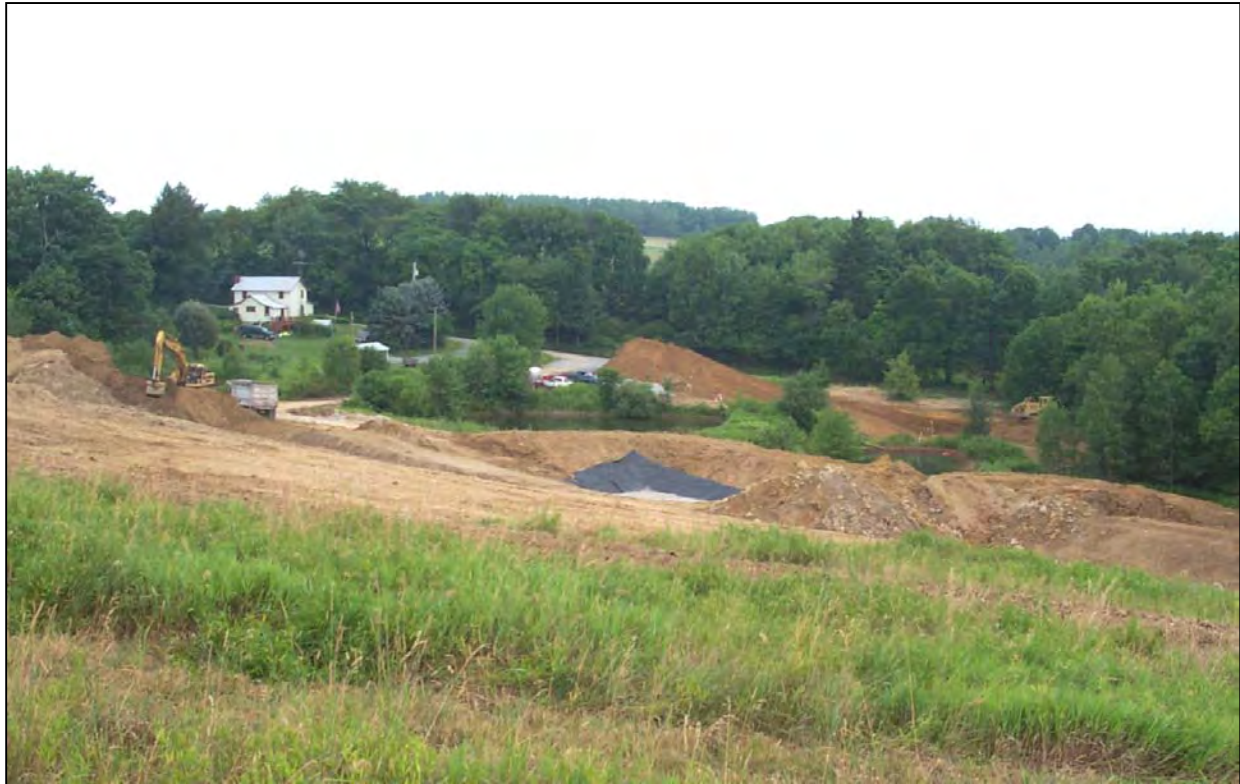
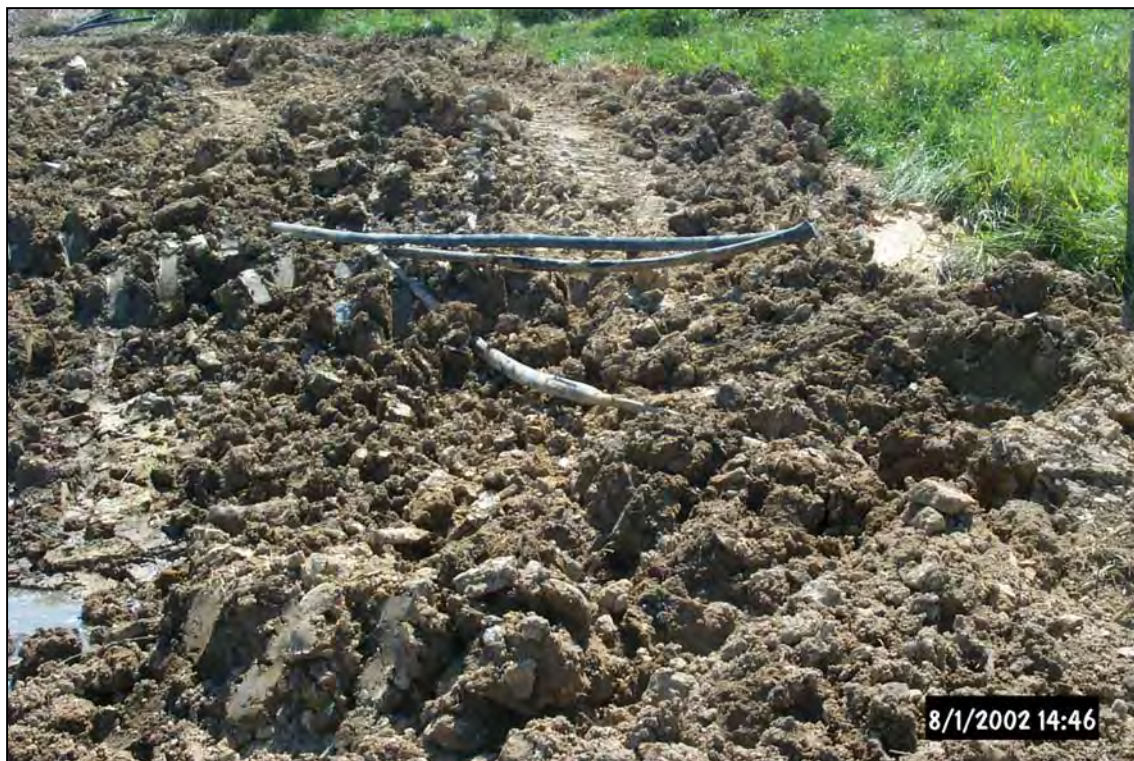
View of the De Sale Phase III passive system under construction (**Above**). To the left, an excavator is digging the collection ditch. In the center is Vertical Flow Pond 1. To the right is a dozer constructing the basin for the Horizontal Flow Limestone Bed. During construction several unknown buried pipes were discovered (**Below**).

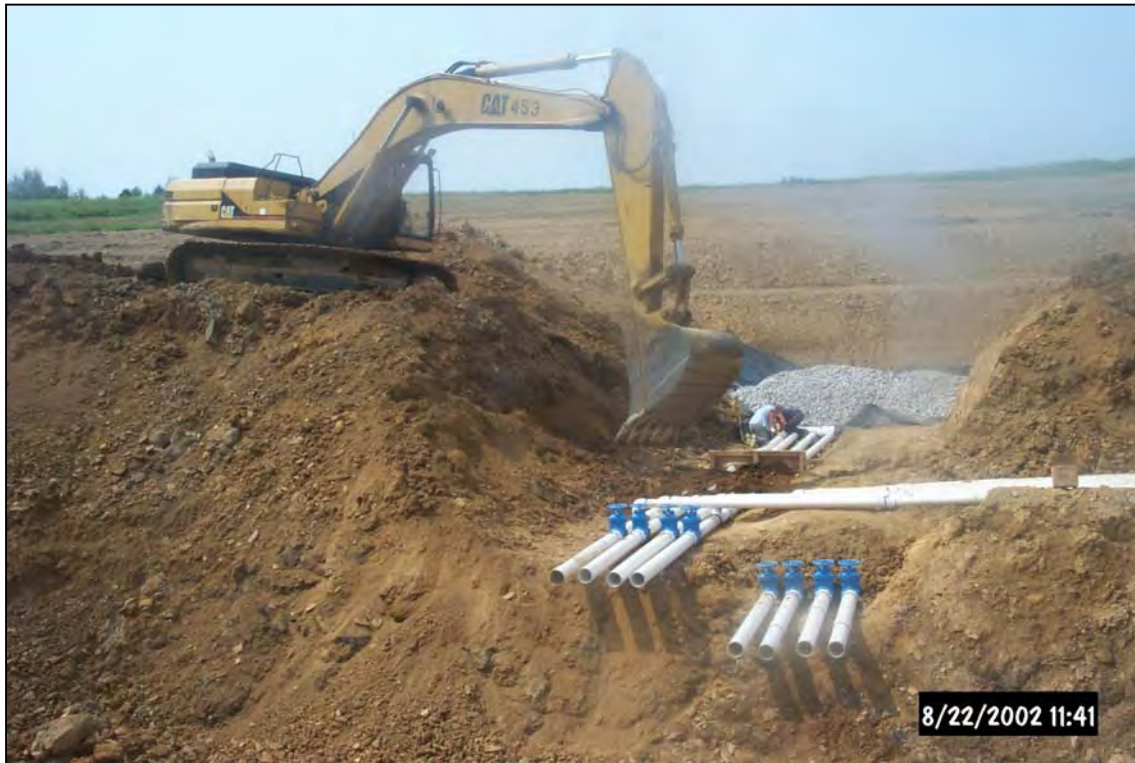
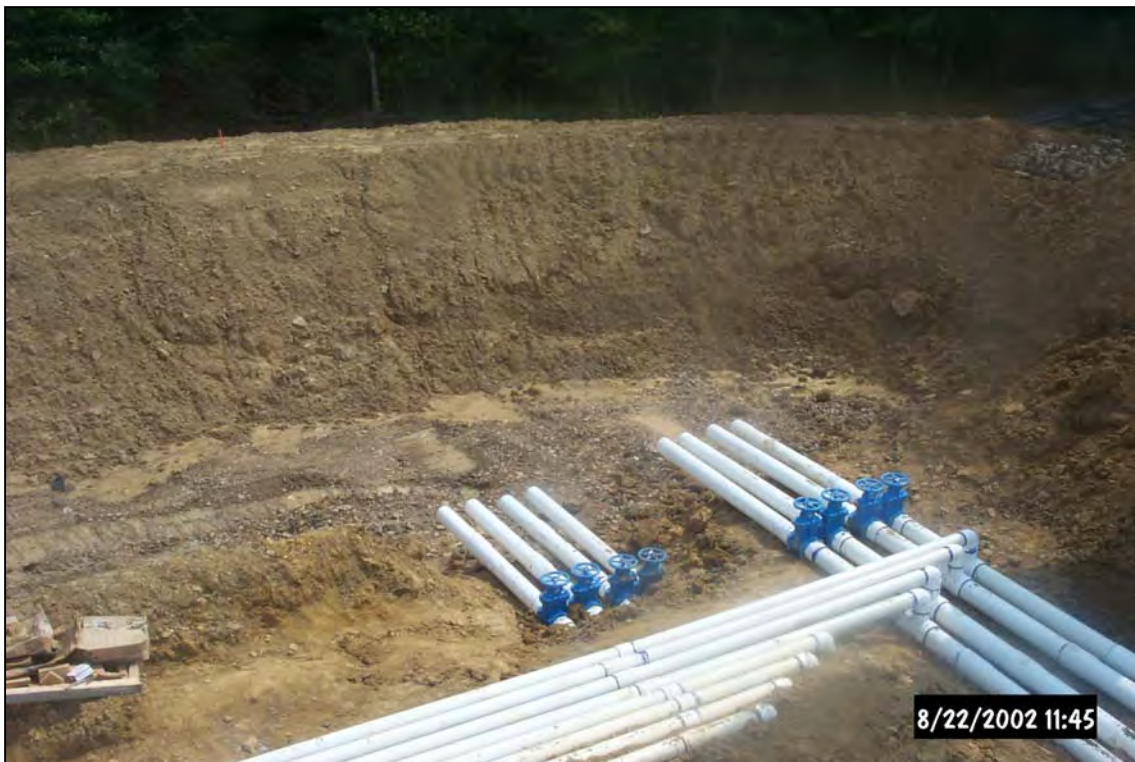
Installation of the Vertical Flow Pond 1 flush pipes.

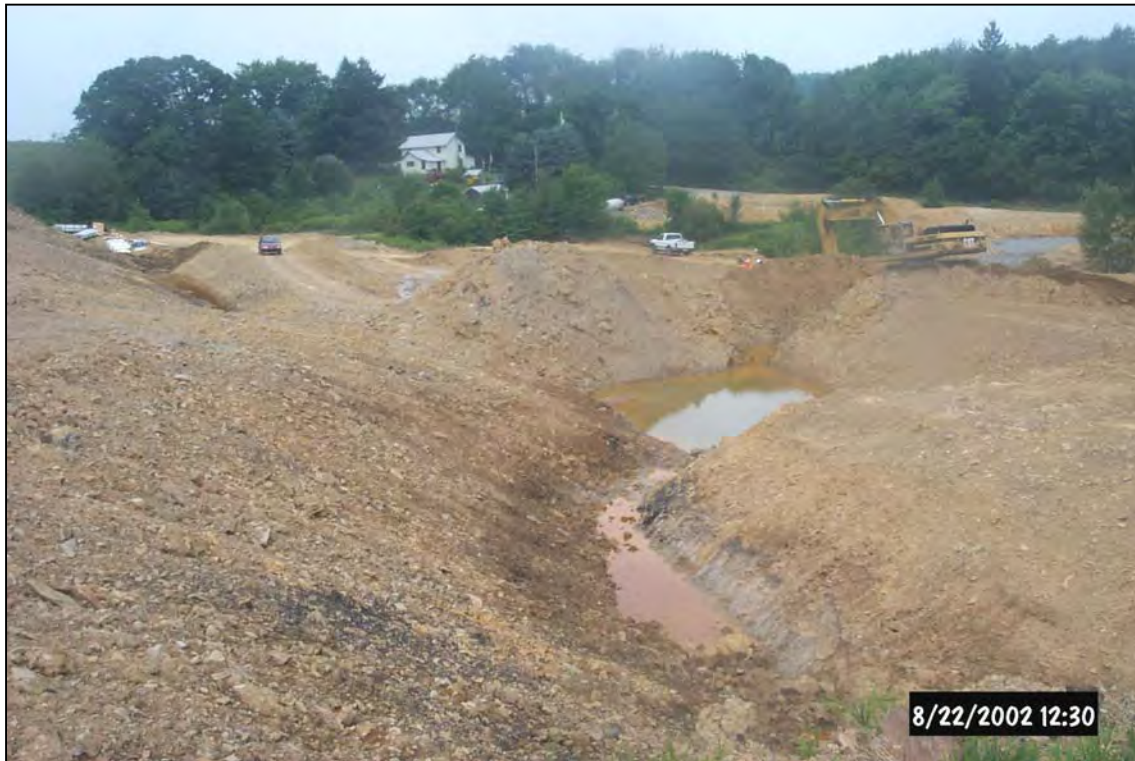
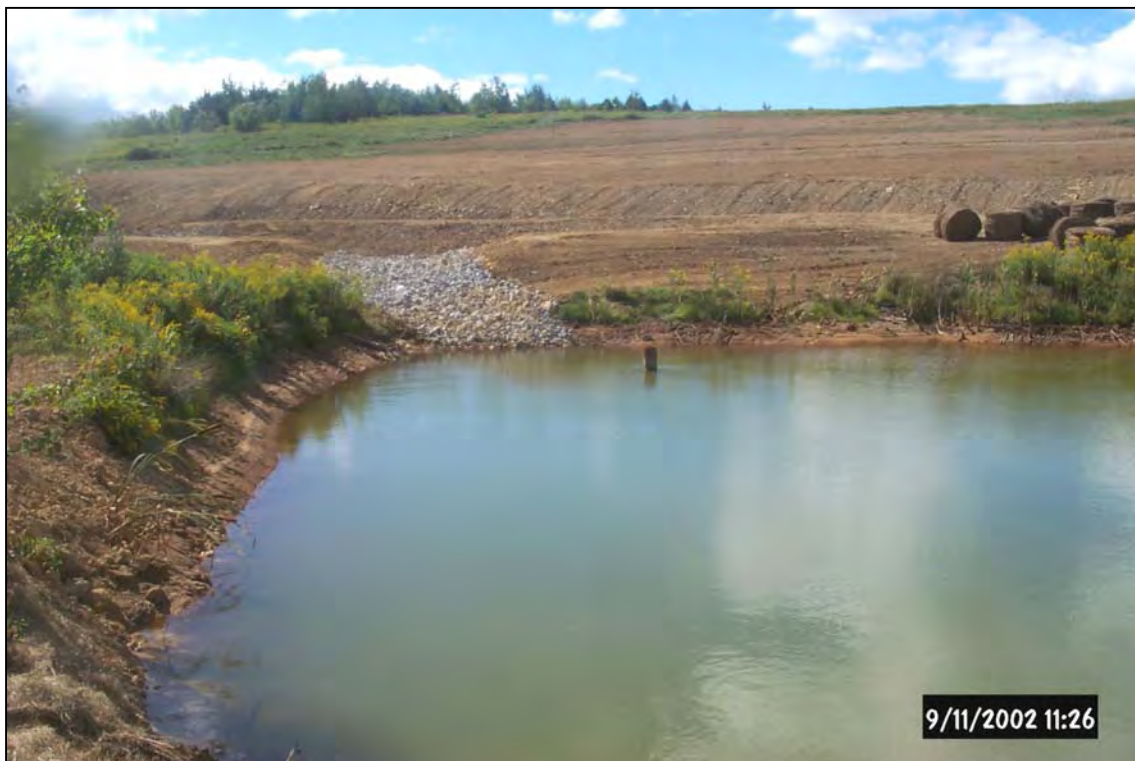
View of the forebay and a portion of the collection ditch during installation of the flushing pipes of Vertical Flow Pond 1 **(Above)**. The sludge drying beds on top of the hill were reclaimed and the land returned to approximate original contours **(Below)**.

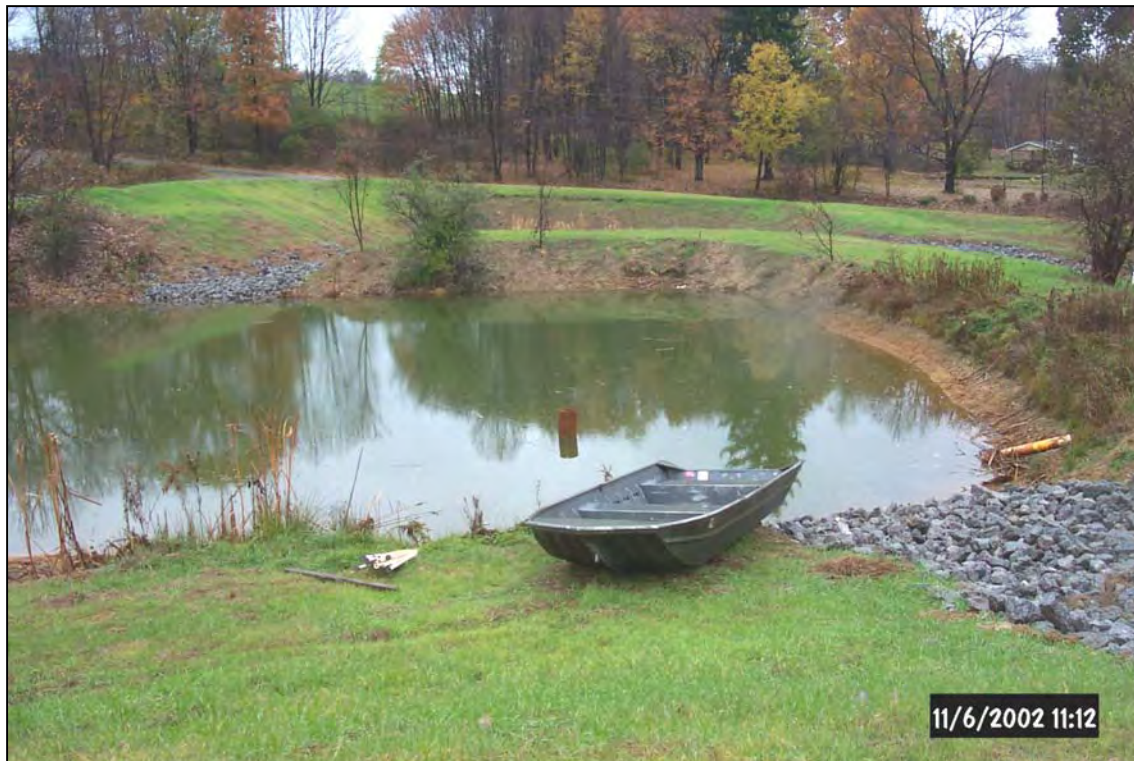
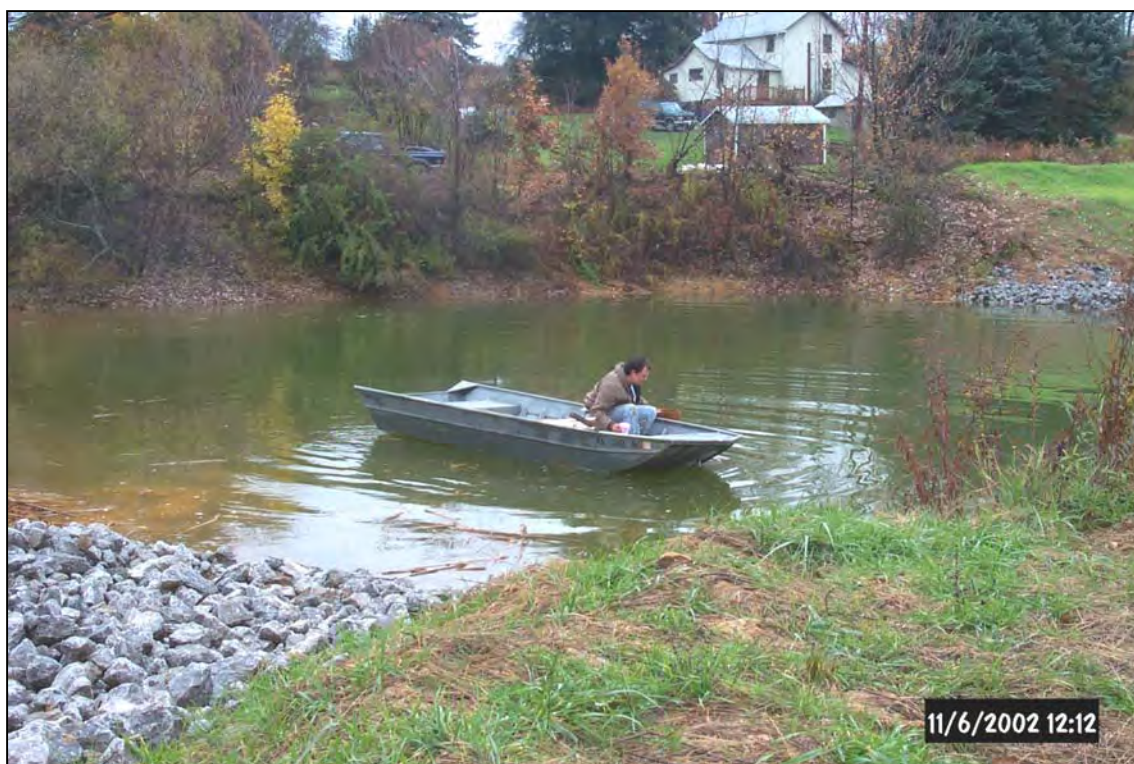
Once the construction was completed, water was not able to flow from the pre-existing Settling Pond 1 to Vertical Flow Pond 2 until the riser that had previously conveyed water to pre-existing Settling Pond 2 was plugged. This was accomplished by filling in the riser with cement which was mixed on land and then transported in a small boat loaned free of charge by Bob Beran, local resident and president of Beran Environmental Services, Inc.

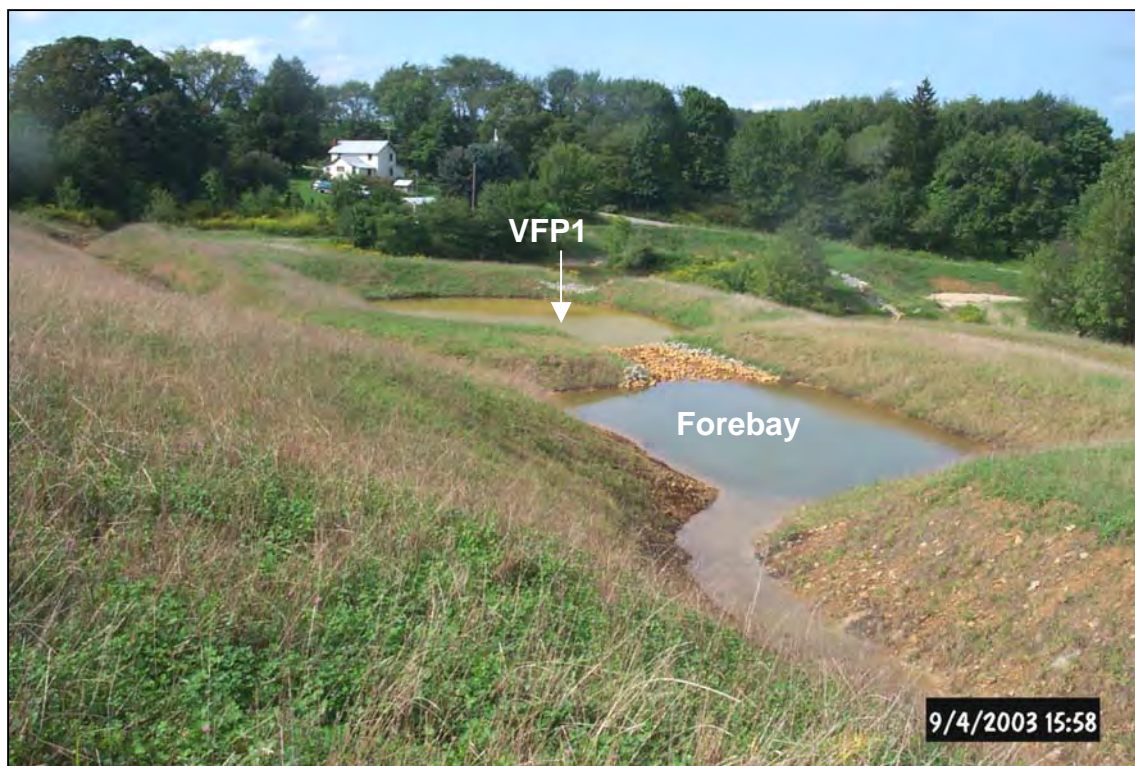
View of the completed De Sale Phase III passive treatment system, which incorporated three previously existing ponds in the design.

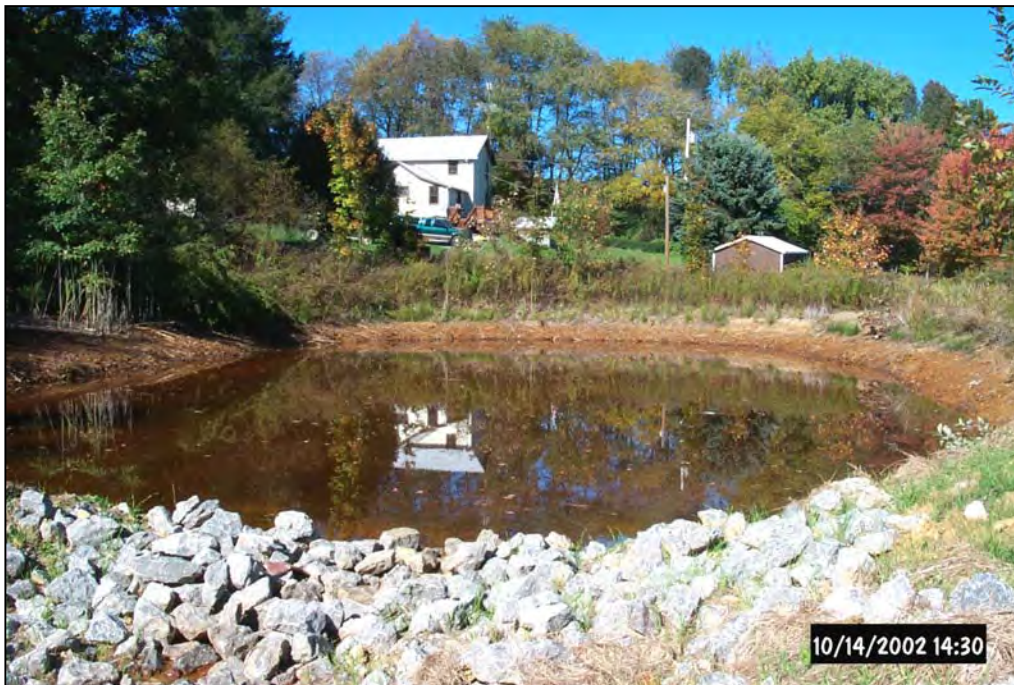
One of the pre-existing ponds located at the site was already collecting a portion of the degraded water from the site **(Above)**. A collection trench **(Below)** was installed to collect seeps **(Below)** at the toe of spoil as well as convey the water from the collection pond to the forebay.
