De Sale Restoration Area Phase III

Re: Final Report for ME# 351407; Project # NW10324
De Sale Restoration Area Phase III, Venango Twp., Butler Co., PA
630102/FR-trans

DE SALE RESTORATION AREA: PHASE III FINAL REPORT

**Seaton Creek Watershed, Slippery Rock Creek Headwaters
Venango Township, Butler County, PA**

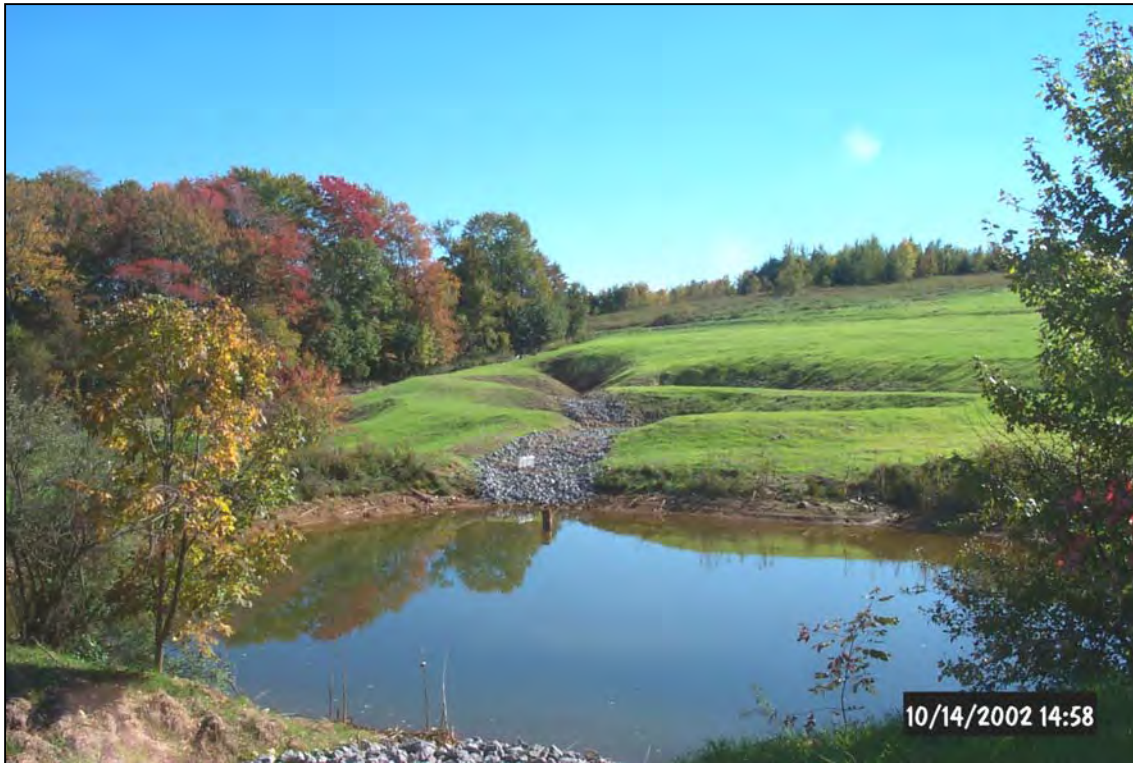
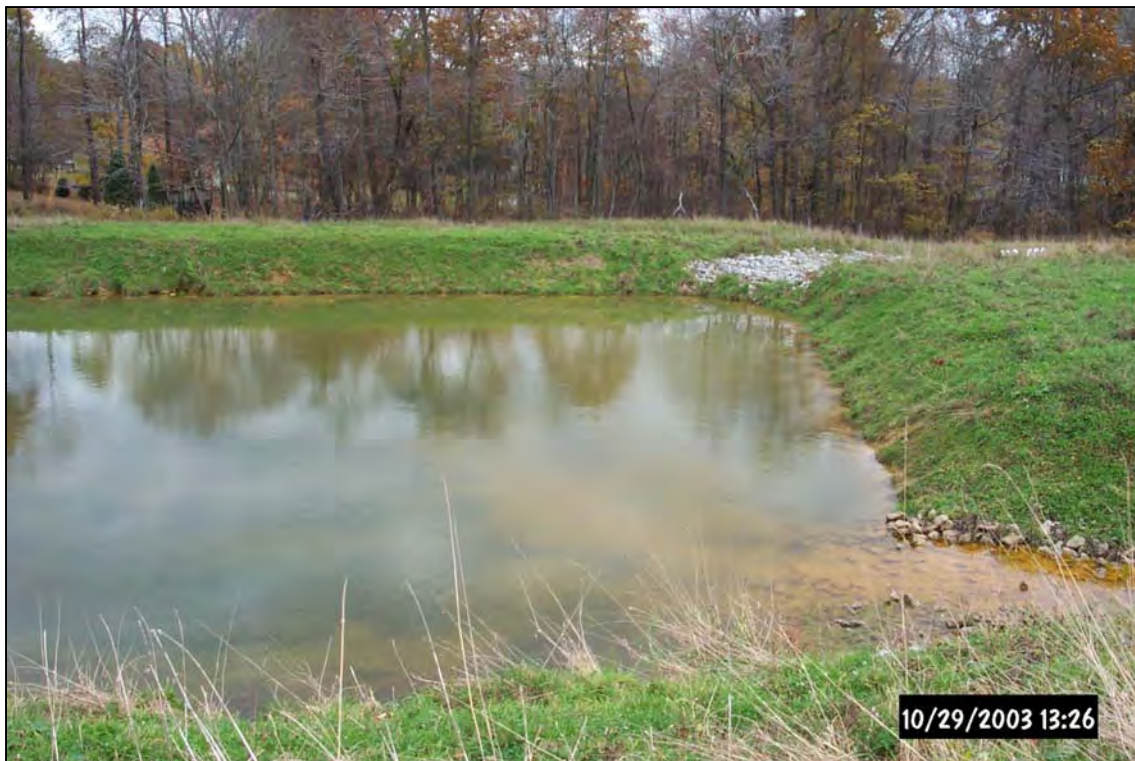
The effluent of Vertical Flow Pond 1 (VFP1) then enters the pre-existing Settling Pond 1 (SP1) for oxidation and precipitation of metals before entering Vertical Flow Pond 2 (VFP2) **(Below)**.

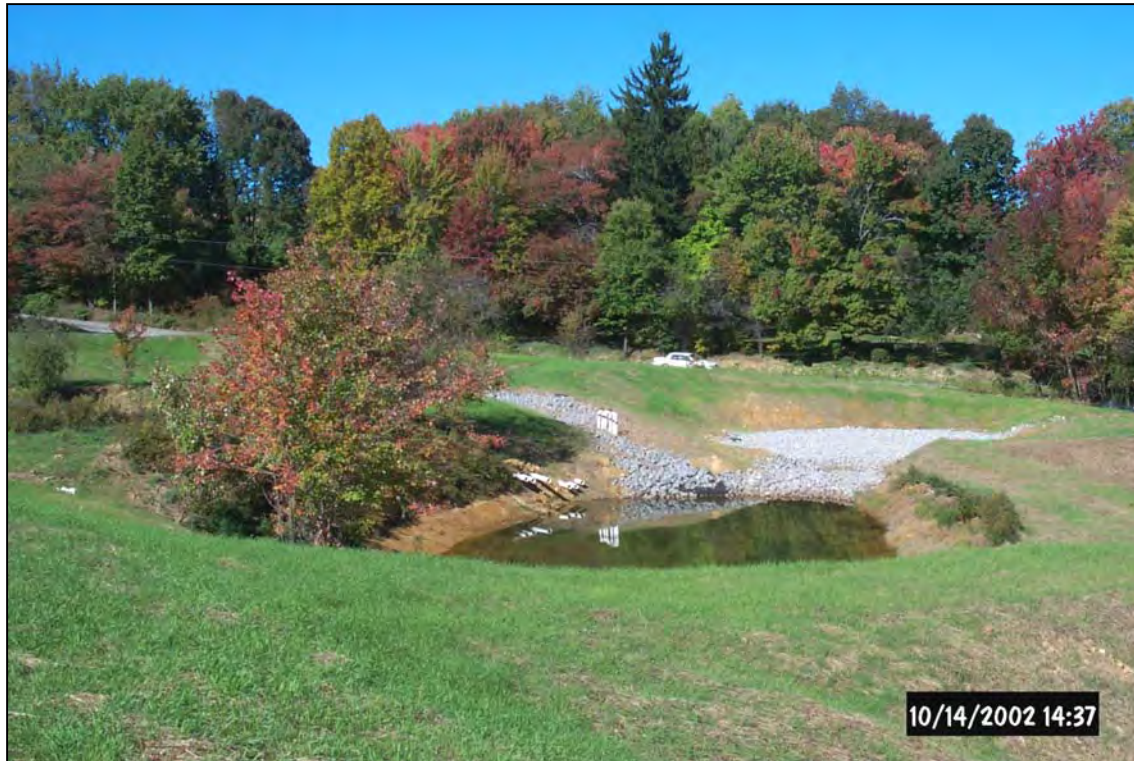
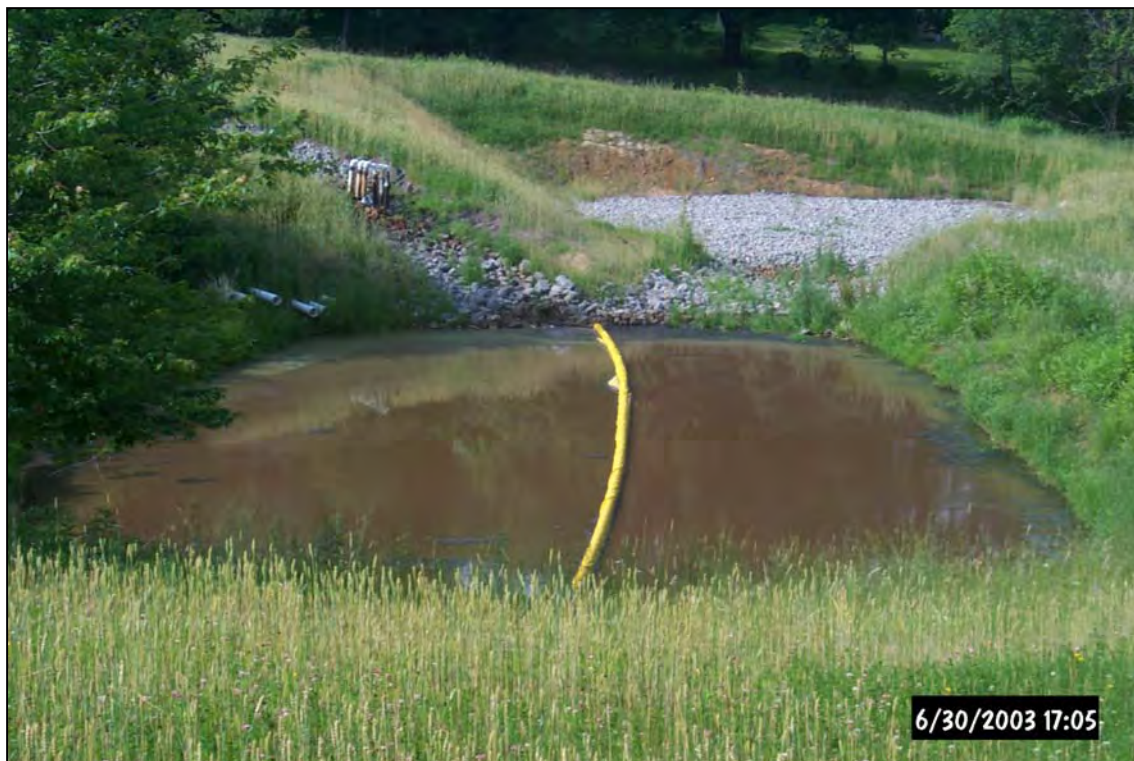
The effluent of Vertical Flow Pond 2 (VFP2) then enters pre-existing Settling Pond 2 (SP2) for additional oxidation and precipitation of metals before flowing into the Horizontal Flow Limestone Bed **(Above)**. To increase retention time within SP2 a directional baffle curtain was installed **(Below)**.

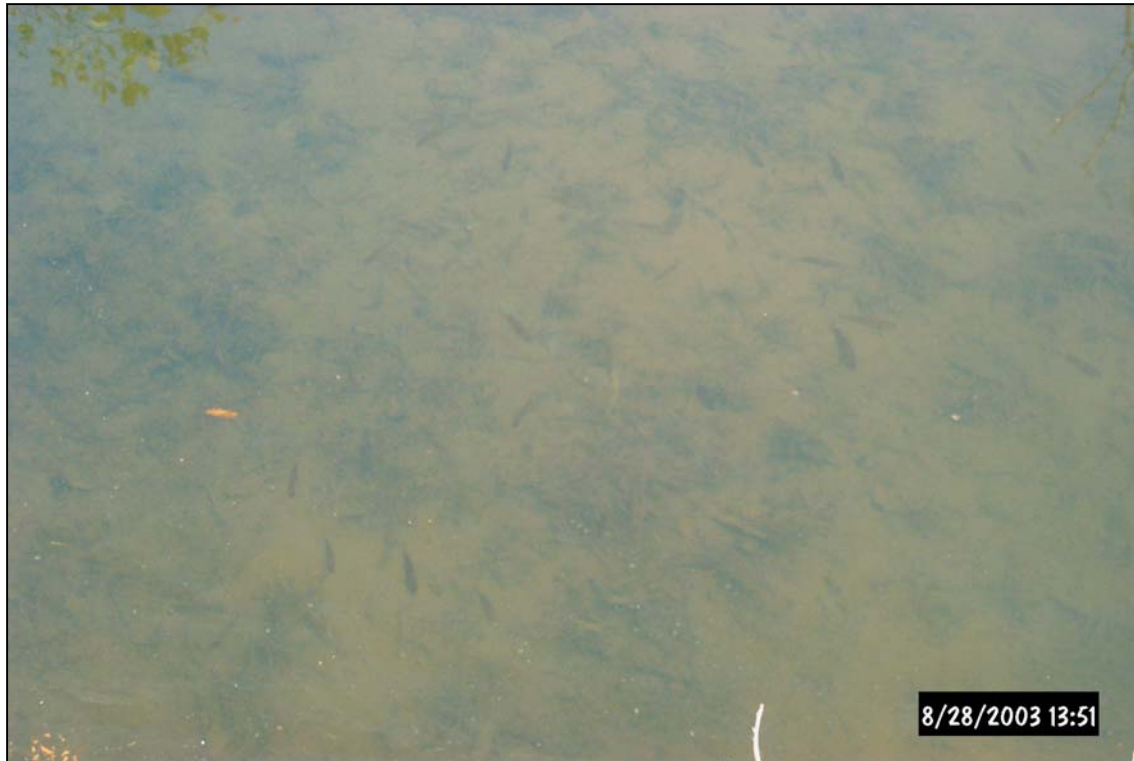
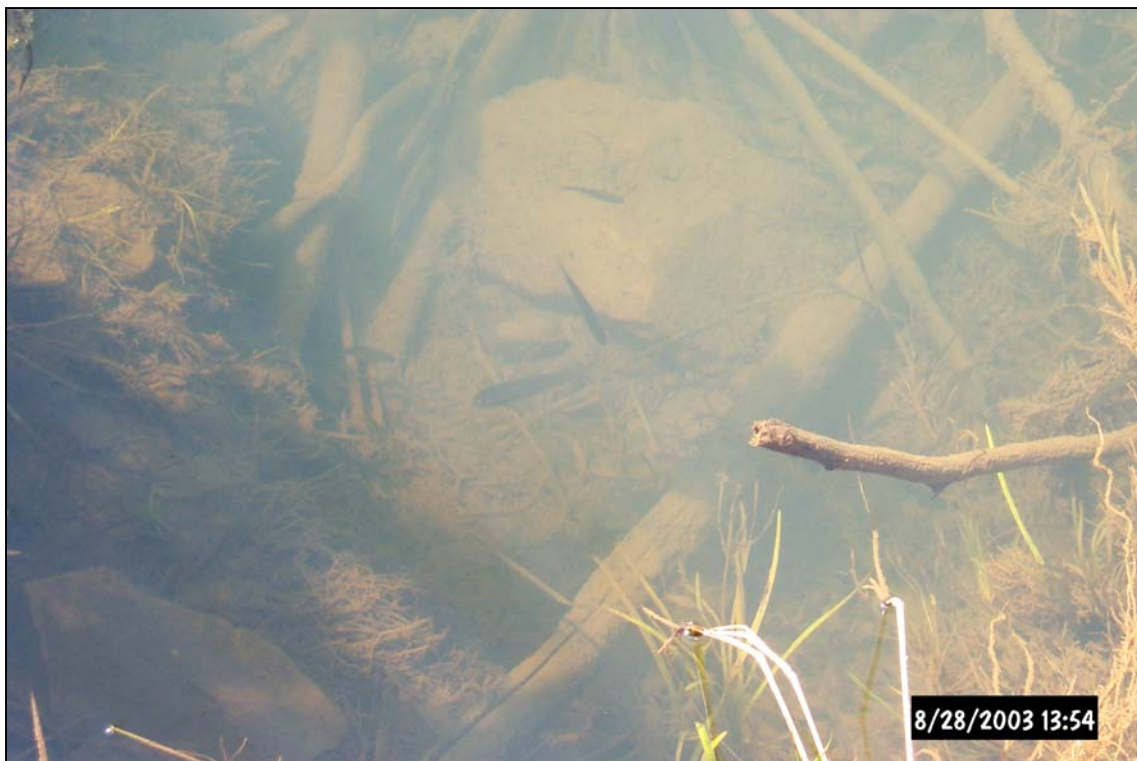
As a result of improved water quality in Seaton Creek due to land reclamation and the installation of passive treatment systems including De Sale Restoration Area Phases I, II, and III fish are now returning to the creek probably for the first time in a 100 years

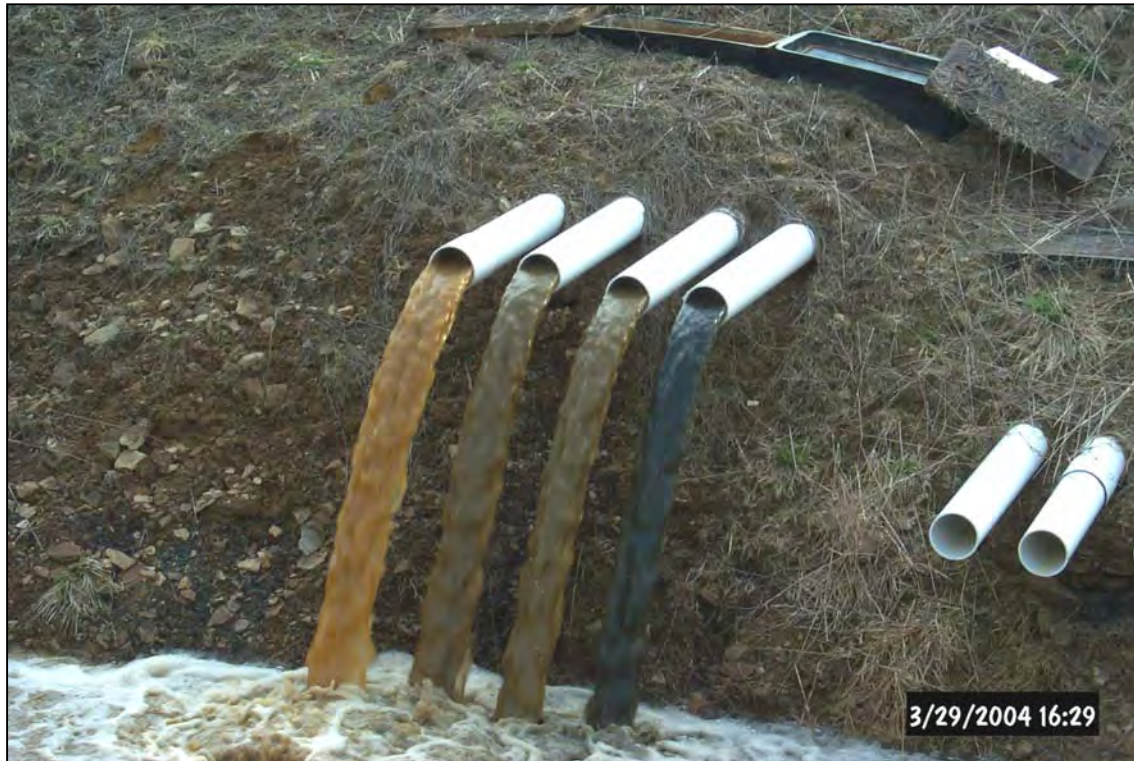
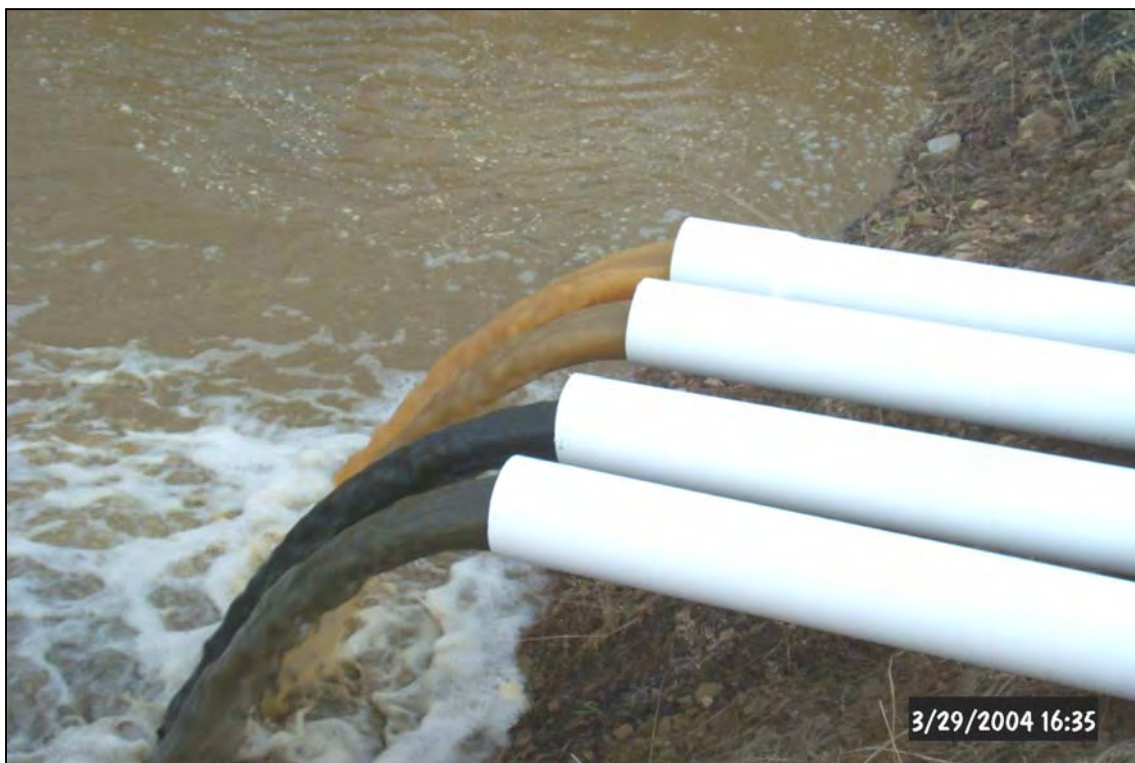
In order to maintain sufficient hydraulic conductivity through the treatment media the vertical flow ponds were flushed.

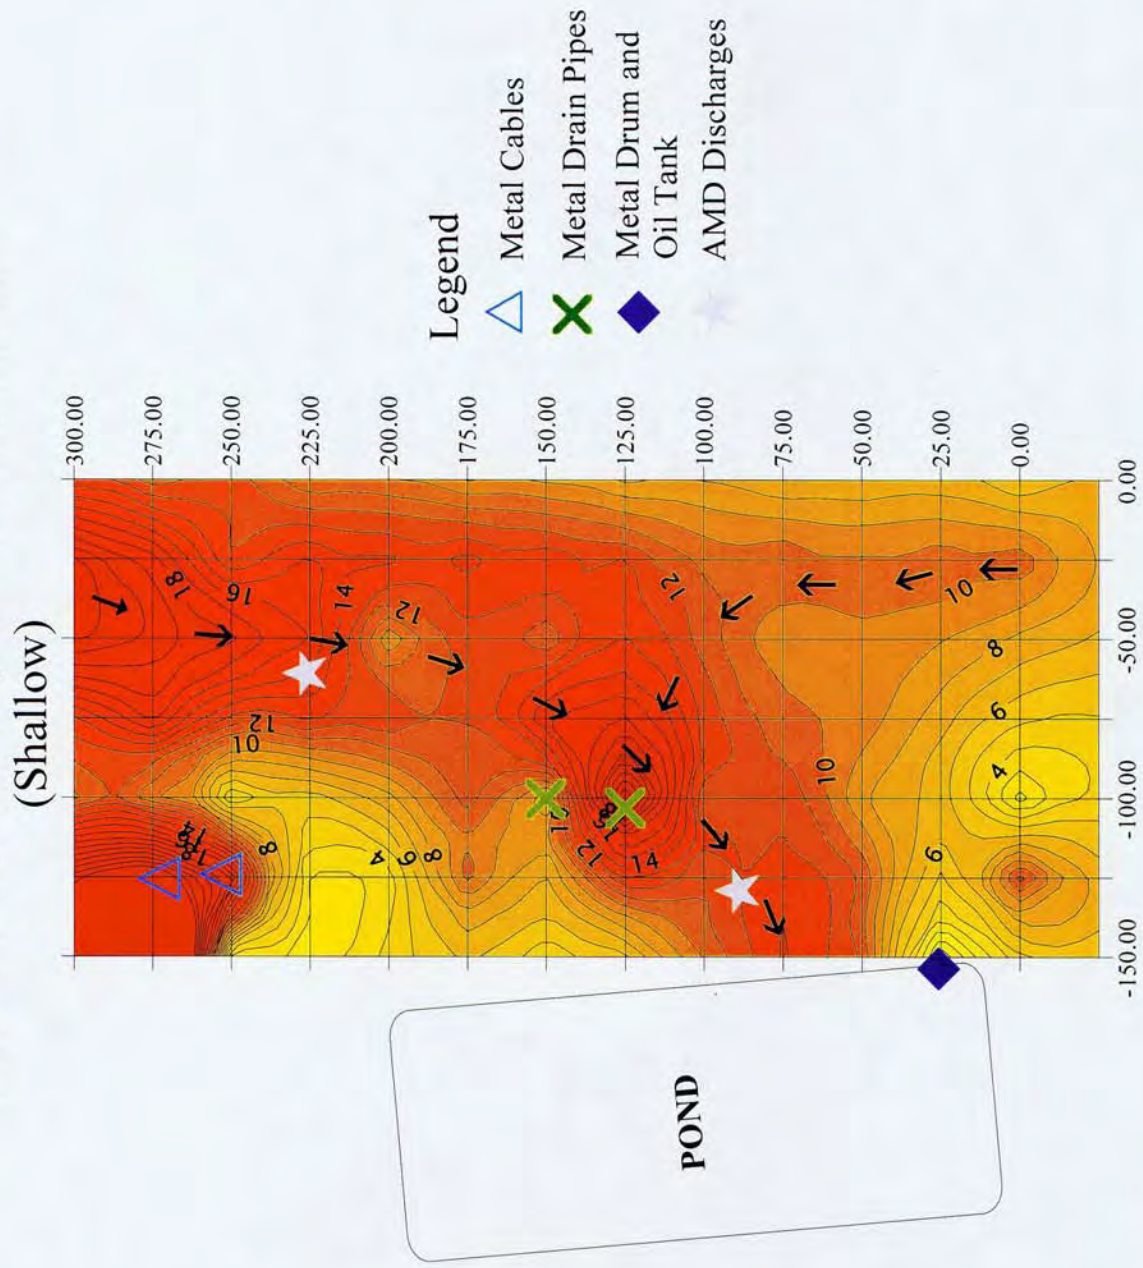
EM31 Conductivity for Desale Phase 3

Mapping was completed using a Geonics EM 31 electromagnetic terrain conductivity meter. Readings were recorded every 25 feet on lines 25 feet apart. Readings were also recorded in both the horizontal and vertical dipole modes. The plot that is marked shallow is most responsive to the near surface materials and is limited to a total depth of about 9'. The plot marked deep is responsive to deeper conditions and "ignores" the near-surface features. The interpretation is rather simple: the higher the number on the contour interval, the more saturated or more conductive the subsurface conditions. Since the earth is a poor conductor of electricity and AMD is an excellent electrolyte, the higher values are interpreted to be associated with subsurface AMD.

On the plot labeled "shallow", the approximate locations of the discharges and some of the other surface features are noted. Arrows are drawn to indicate the most likely flow path of the subsurface AMD. Any type of French drain installed to direct the AMD to your system would most likely intercept AMD if it were constructed at the location of the arrows. I am aware that there are constraints involving elevations, but the deeper the interceptor ditch can be dug, the better. As far as I am aware, the flagging was left in place.

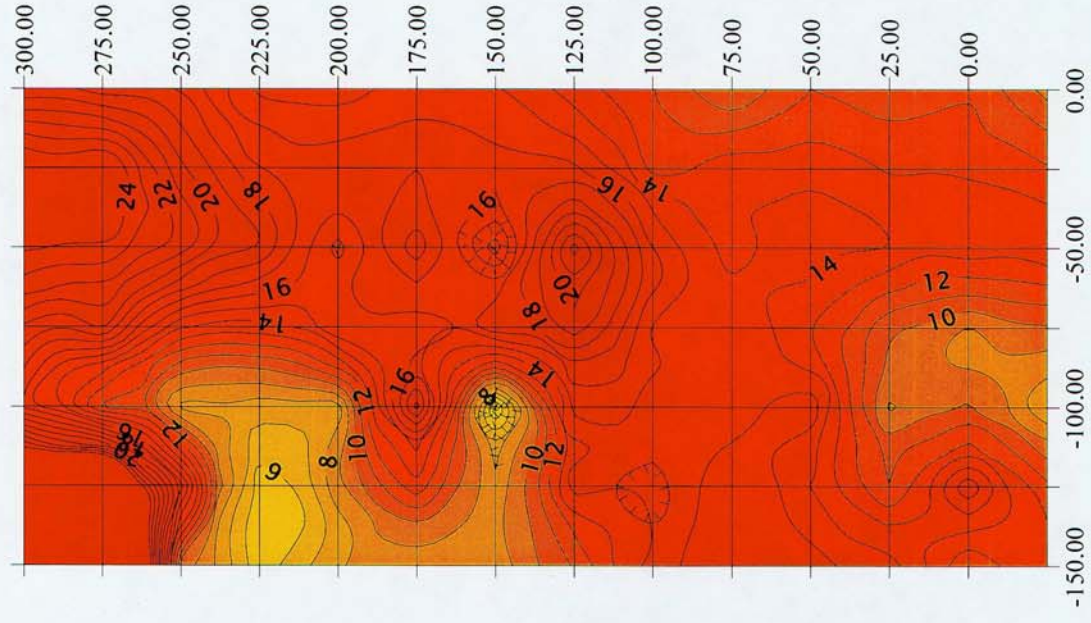
EM31 Conductivity for Desale Phase 3

(Deep)

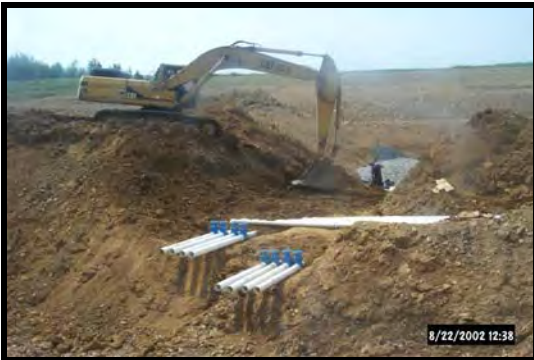
Construction of the **De Sale Phase III Passive Treatment System** was completed in September of 2002. The unique and innovative system which includes a forebay, two vertical flow ponds, 2 settling ponds, and a horizontal flow limestone bed, was designed by **BioMost, Inc.** and utilized several existing treatment ponds from the old active system that had been abandoned a number of years ago. **Amerikohl Mining, Inc.** constructed the system.

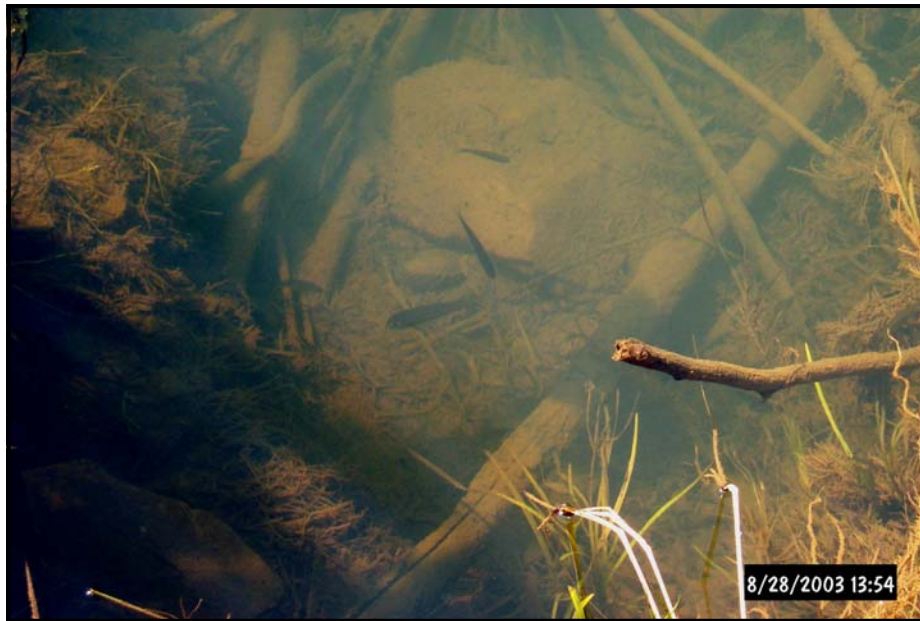
Look closely and you will see several fish in this picture (if your eyesight is good). What is the big deal? You are looking at a photo of fish swimming in Seaton Creek (at McJunkin Road), a tributary in the Slippery Rock Watershed which was formerly lifeless! The photographed site is located downstream of the DeSale treatment systems and upstream of Erico Bridge. Seeing different sizes of fish suggests they are reproducing!

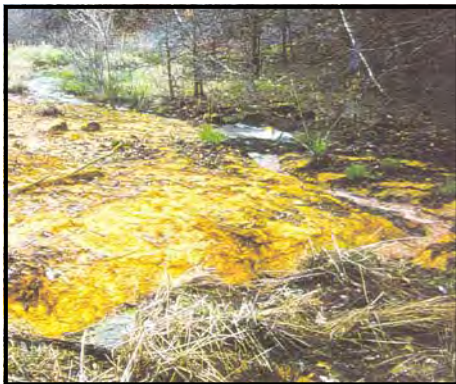
Before Construction

Construction: 2 anoxic limestone drains (350 & 1150 tons); settling ponds (11,000 SF); wetlands (17,500 SF)

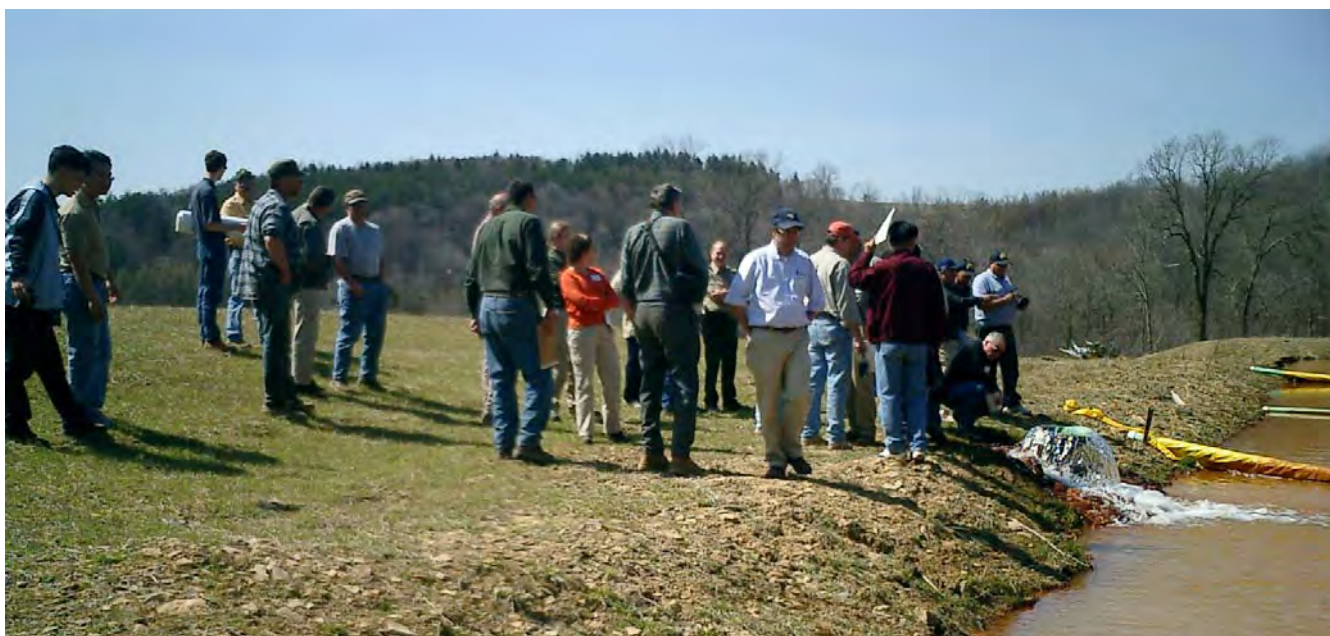
SRWC Symposium field tour of Erico Bridge, Venango Twp., Butler Co. What a beautiful day to be in the field!!! But, look at the flow!!! This is the highest flow, est. >1000 gpm, observed from the ALD (8,300 tons limestone).
