Erico Bridge Restoration Area

ERICO BRIDGE RESTORATION AREA FINAL REPORT

Seaton Creek Watershed, Slippery Rock Creek Headwaters
Venango Township, Butler County, PA

A Pennsylvania Growing Greener Watershed Restoration Project

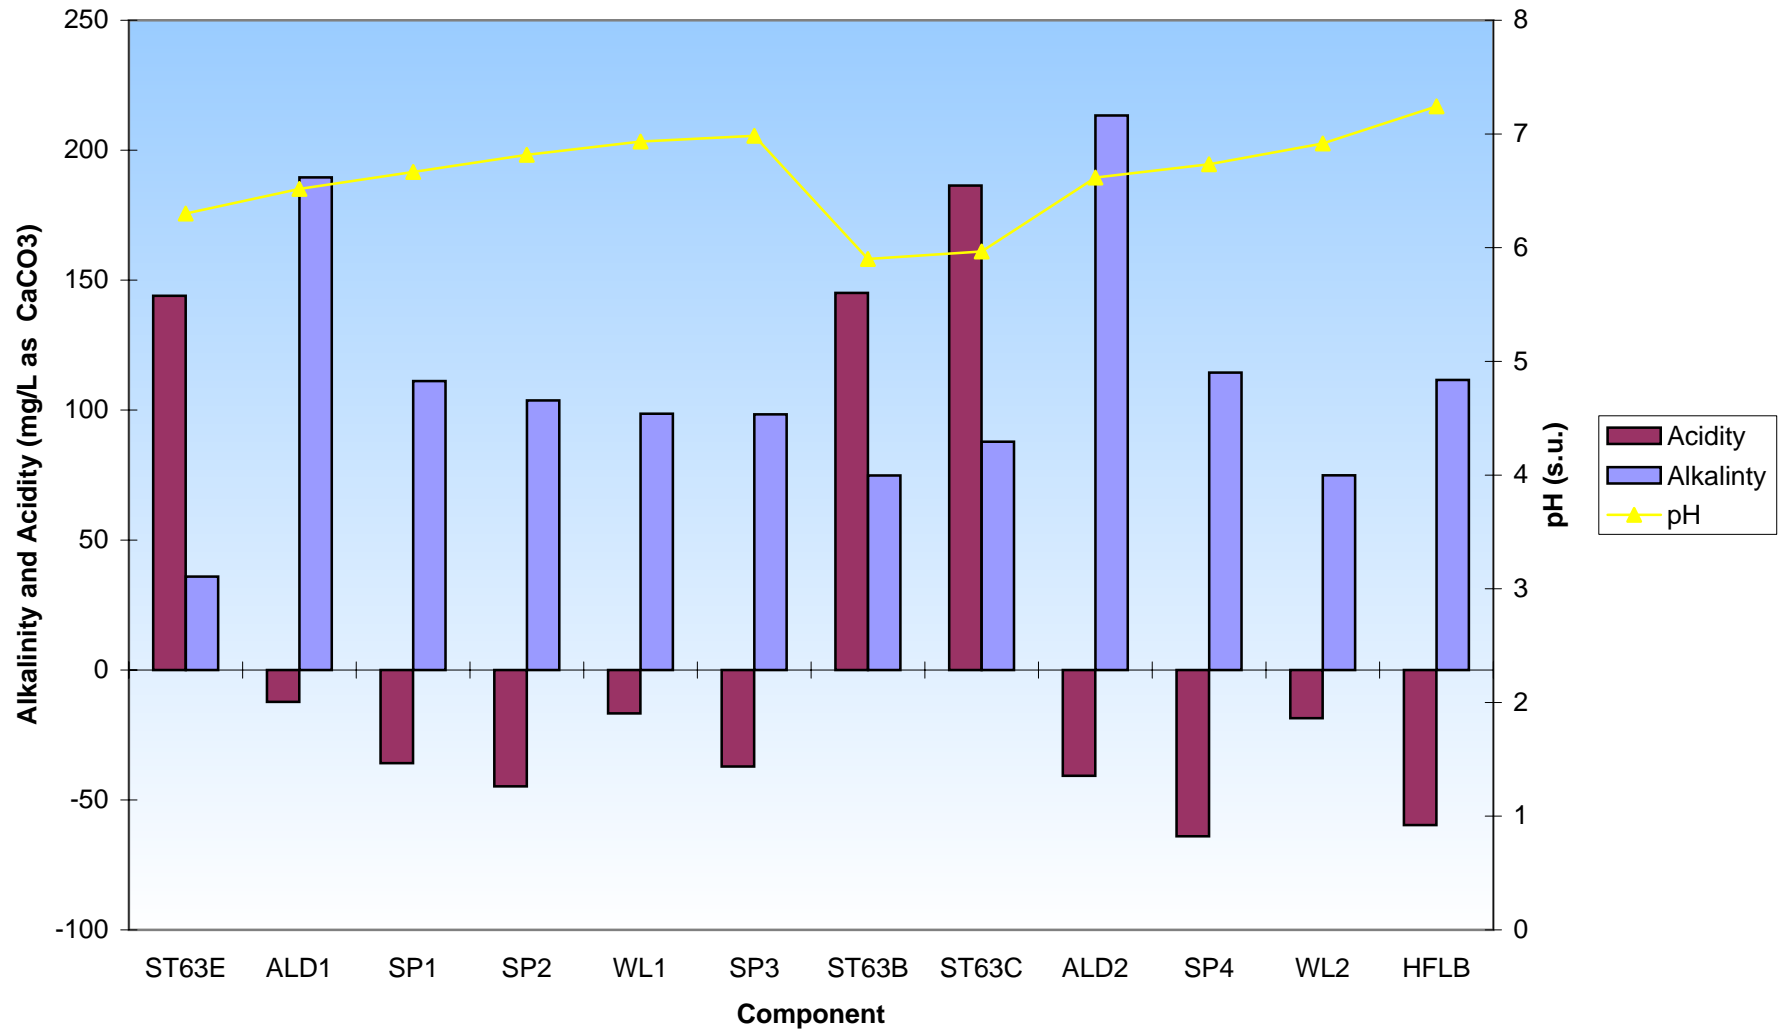
Figure 3

Comparison of pH, Alkalinity, and Acidity Through Main Passive Treatment Complex (Average Values)

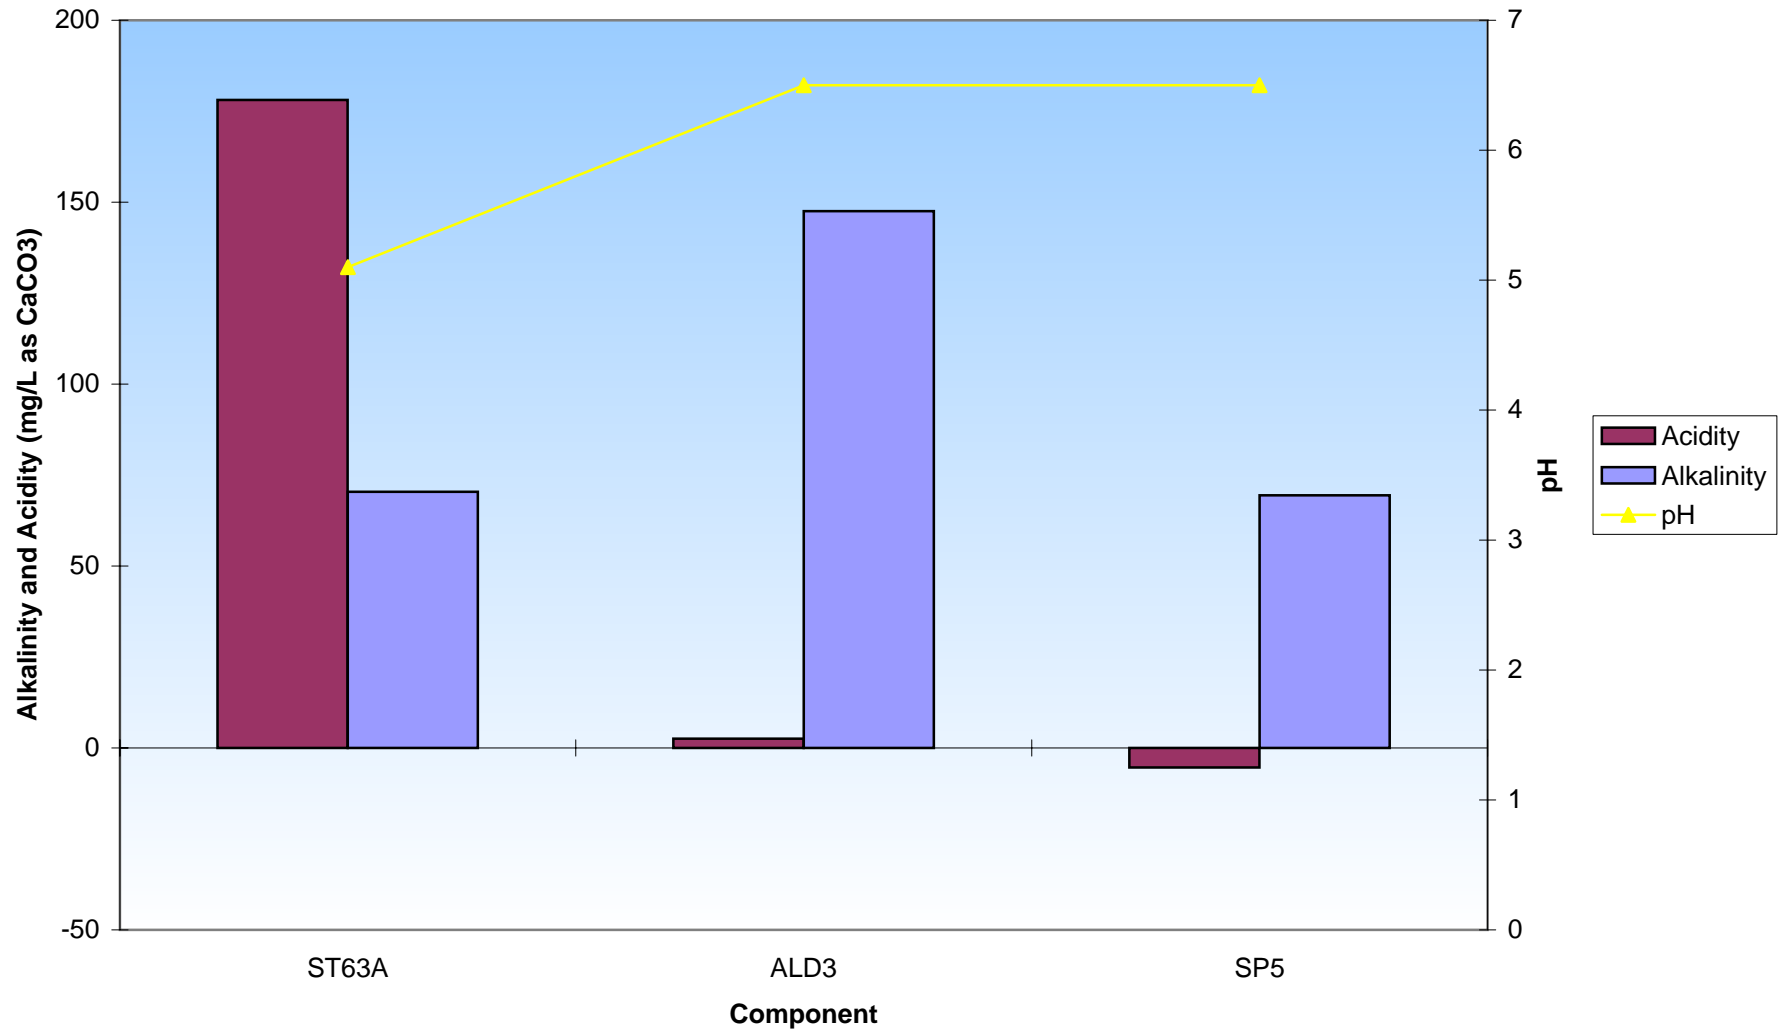
Figure 5

Comparison of pH, Alkalinity, and Acidity through the ALD3 Passive Treatment System (Average Values)

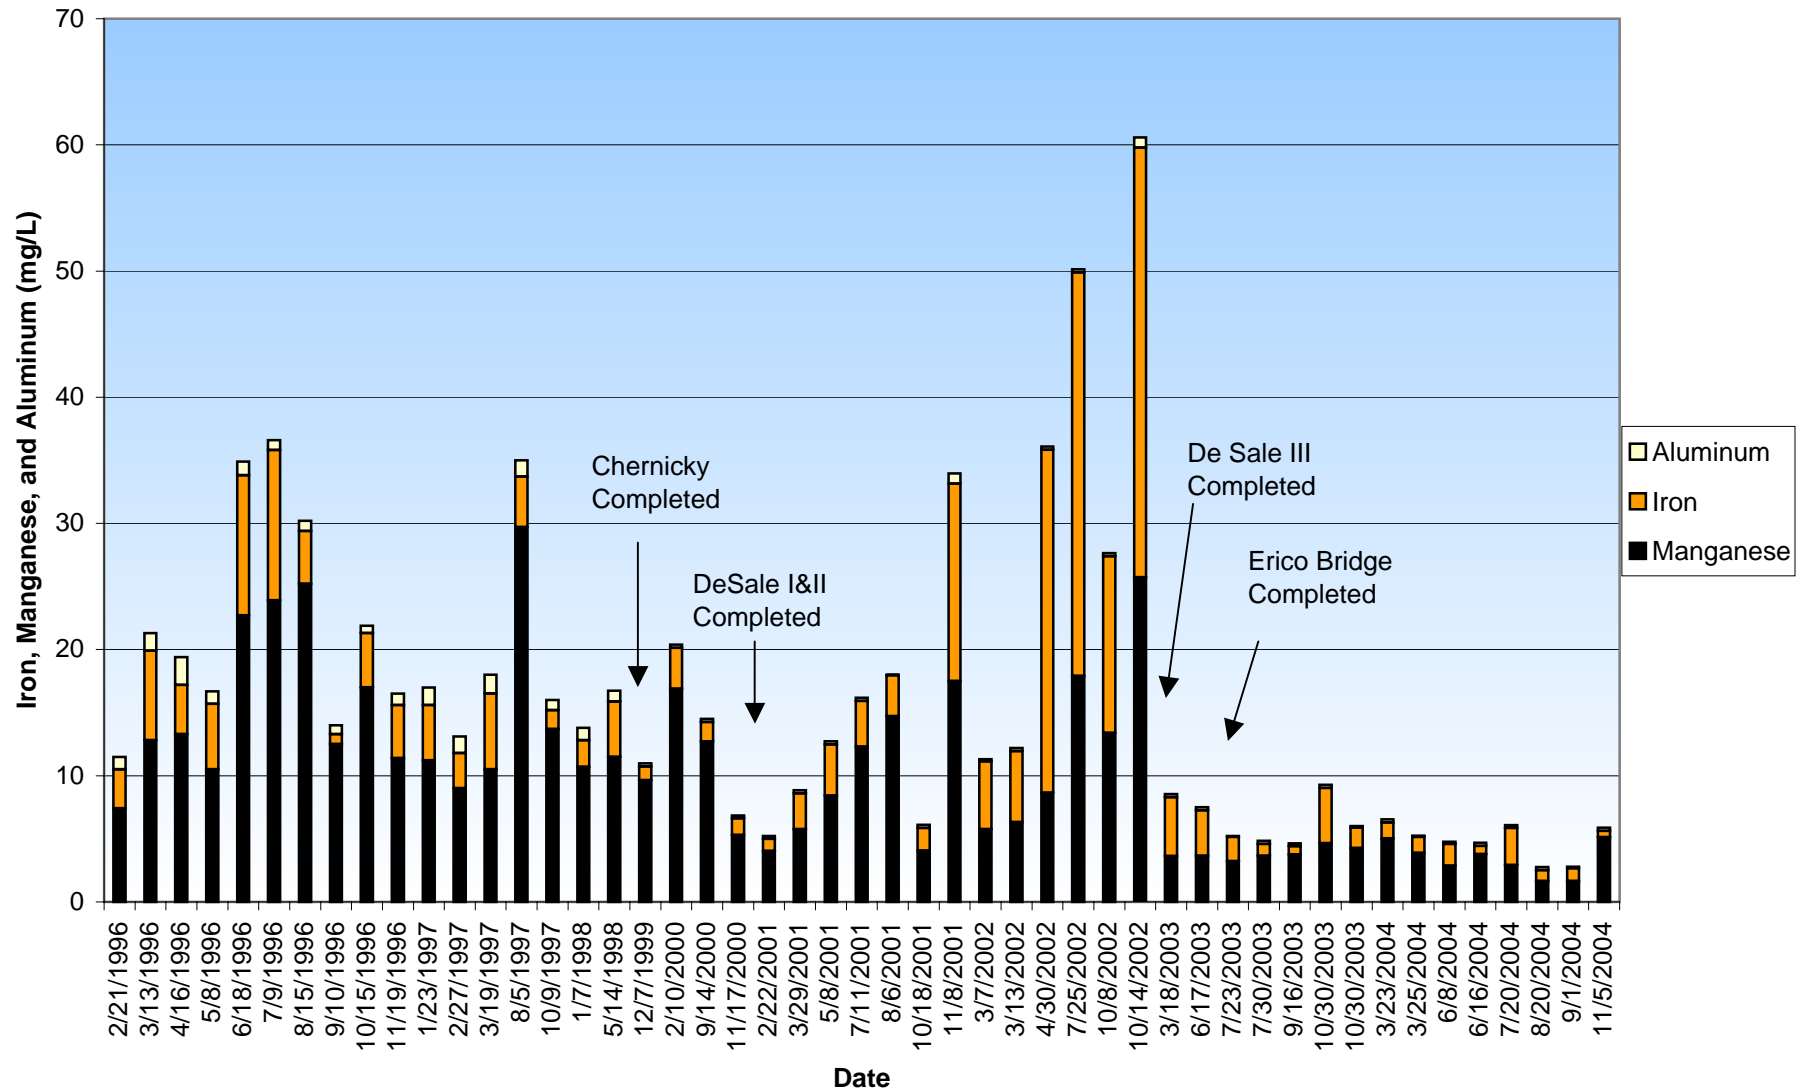
Figure 10

Comparison of Total Metal Concentrations at Seaton Creek Sampling Point 19.1 Over Time

Sampling point 19.1, located at the Erico Road bridge, is the immediate downstream monitoring location for the Erico Bridge Restoration Area. At this point, Seaton Creek has been substantially improved to a net alkaline stream with low metal concentrations. For those familiar with this sampling point a visible improvement can be seen as the water is much clearer and the streambed less red. Although an aquatic survey has not been conducted at this point since completion of the system, schools of fish have been spotted numerous times and spawning beds have been observed in the wetlands created after removal of the gob piles indicating that fish are at least trying to reproduce.

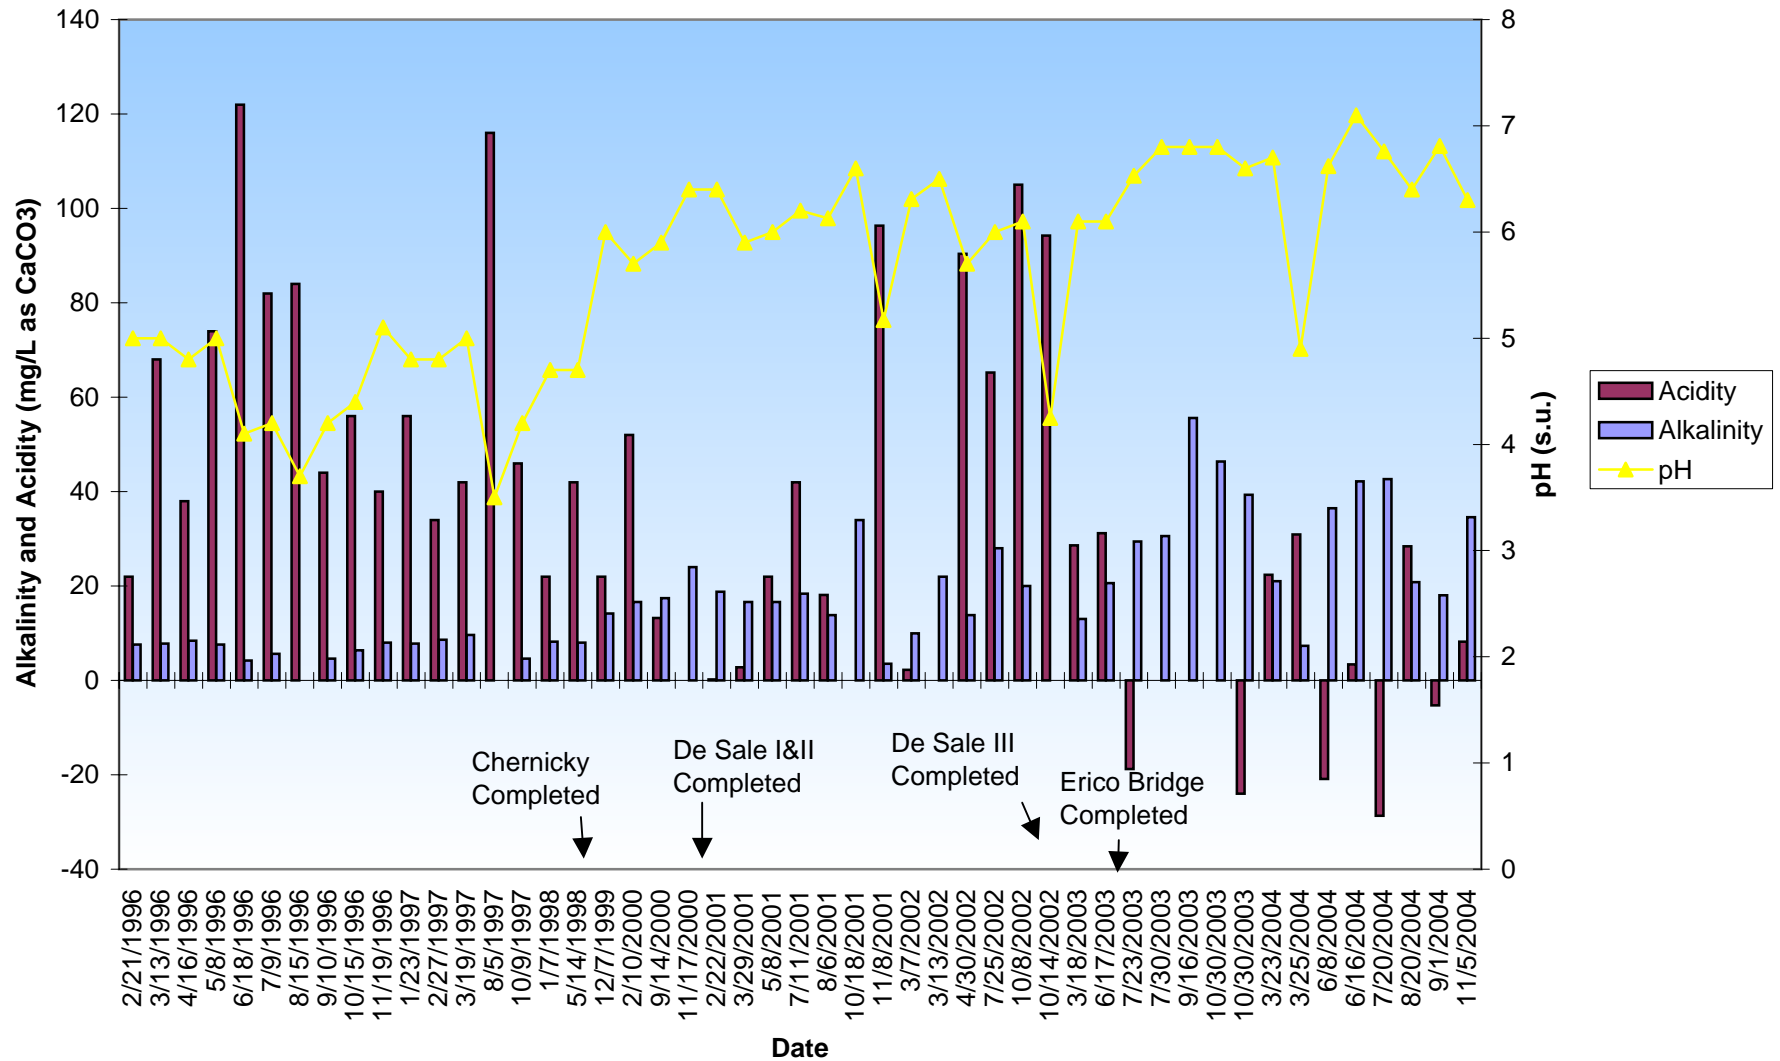
Figure 9

Comparison of pH, Alkalinity, and Acidity Over Time at Seaton Creek Sampling Point 19.1

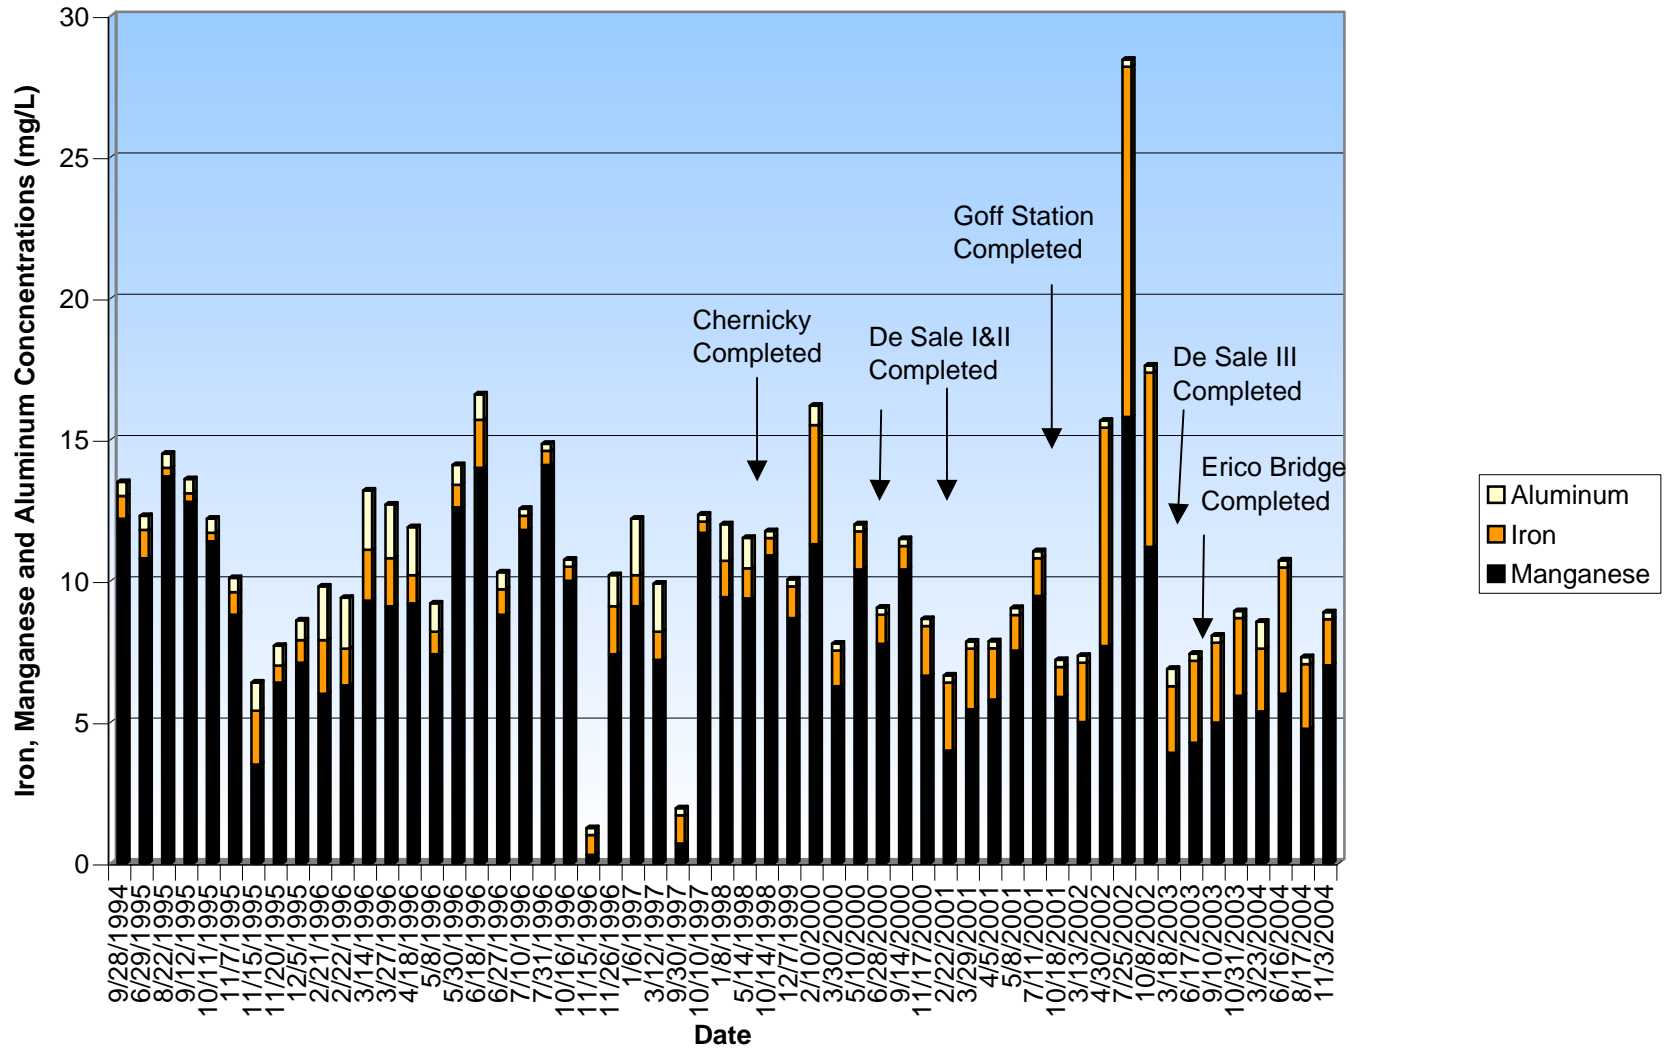
Figure 12

Comparison of Total Metals at Seaton Creek Sampling Point 68 Over Time

At sampling point 68, which is the final downstream point for Seaton Creek before the confluence with Slippery Rock Creek, improvements to water quality can also be observed as a result of the reclamation efforts. In addition to eliminating pollutants, the excess alkalinity in the treated discharges ameliorates impacts from other sources of abandoned mine drainage downstream of the sites. As depicted in the previous table at point 68, the pH of Seaton Creek has increased from a 5.7 to a 6.8. Alkalinity has also increased while acidity and metals have decreased. Depending on interpretation, the stream may also be slightly net acidic.

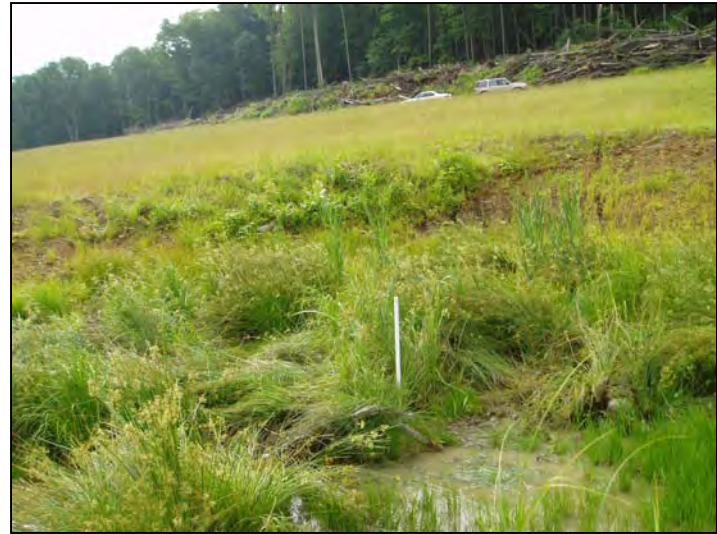
Photo 2: Observation point WL1 P1, facing east

A small layer (< 1 inch) of accumulated sand and iron precipitate was noted on the surface of the wetland substrate at this location. Areas of WL1 south of WL1 P1 were observed to have elevations above water level. Pits dug in these exposed areas revealed up to 4 inches of sediment accumulation.

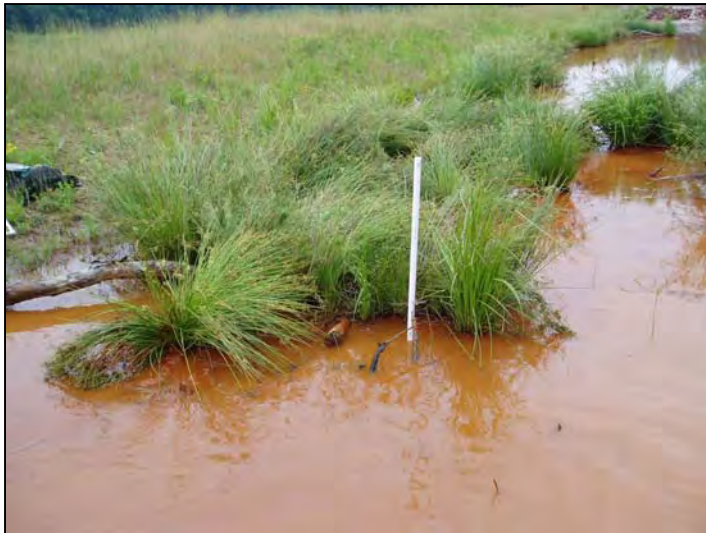
Photo 3: Observation point WL1 P2, facing northeast

A small layer of iron precipitate was noted on the surface of the wetland substrate at this location.
