# **Assessment of the Markle Passive Treatment System**

## **Technical report provided by Hedin Environmental through the Trout Unlimited Technical Assistance Program TUTAG-27**

**June 2007**

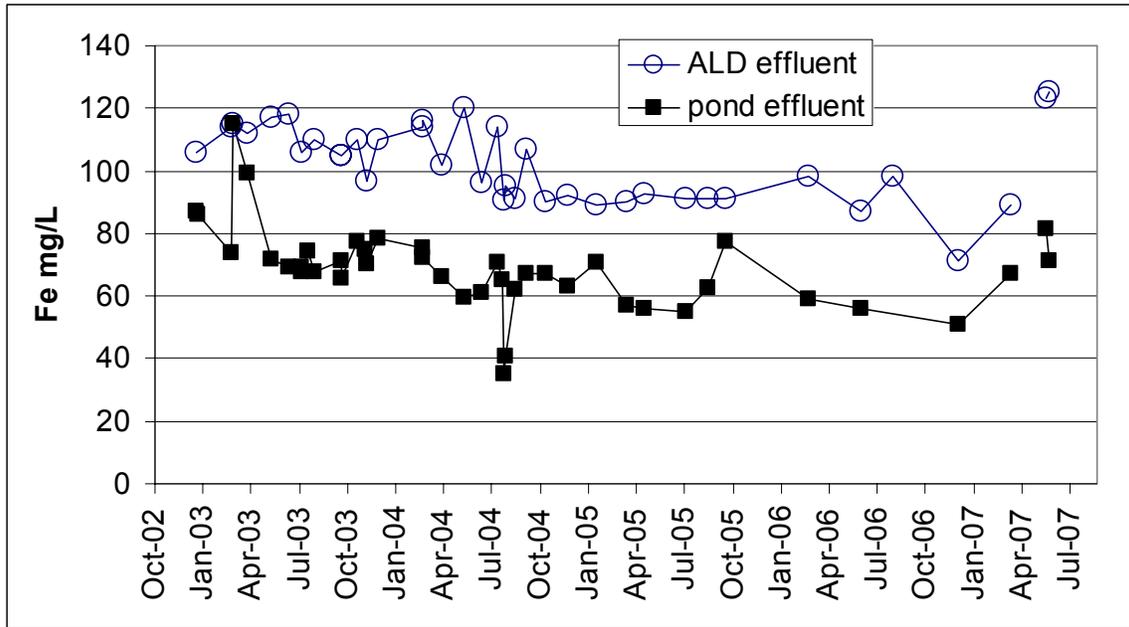
**Figure 1. Fe concentrations at the Markle Passive Treatment System. The decrease in effluent Fe concentrations in August 2004 is due to the TurbeJet experiment. All data collected by BAMR except June 2007 data which were collected by this project**

BAMR suspected that the rate of iron removal in the settling pond was limited by oxygen transfer into the water. To test this idea, the influent was aerated with a Turbo Jet for several days in August 2004. The effects of the aeration on the systems performance are shown in Table 5. The aeration lowered the effluent Fe concentration from ~66 mg/L to an average 38 mg/L. Fe removal was doubled. BAMR personnel report that these results were disappointing as complete removal of Fe was expected with the aeration.

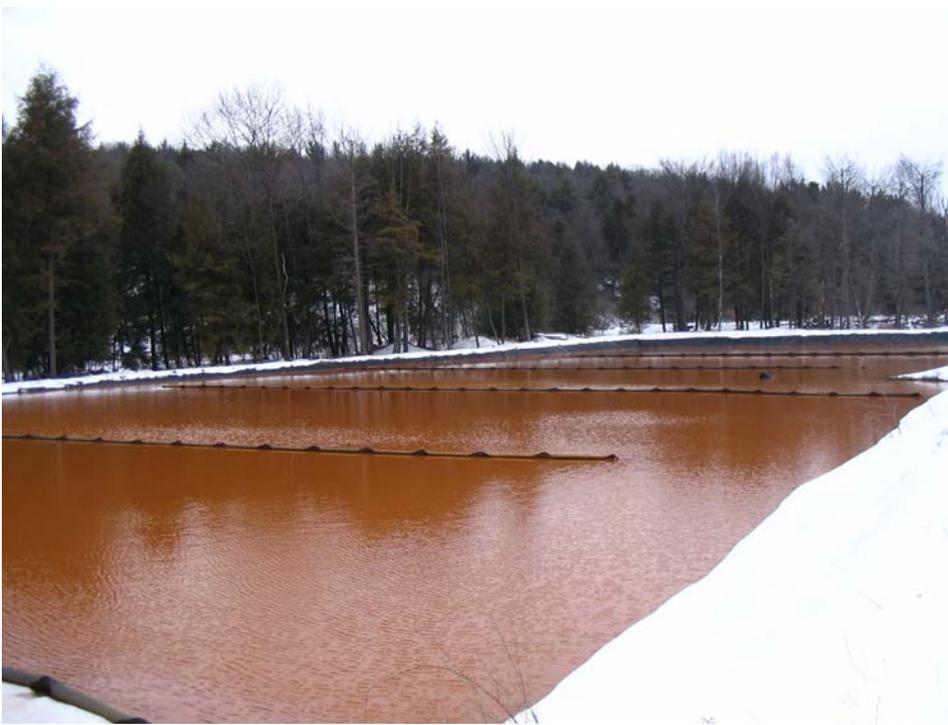
The system was inspected several times in 2007. Several problems were apparent. The intended discharge pipe was clogged with iron and debris, causing water to rise in the pond and discharge through the emergency spillway. Because of the location of the spillway, flow through it made about 15% of the settling pond non-functional. This was especially apparent in March when the site was inspected during cold weather. The pond between the ALD discharge and the emergency spillway was mainly open water (Photo A). The pond south of the spillway was frozen (Photo B).

**Photo A. The Markle system in March 2007. The photo is looking south from the NW end of the pond.**

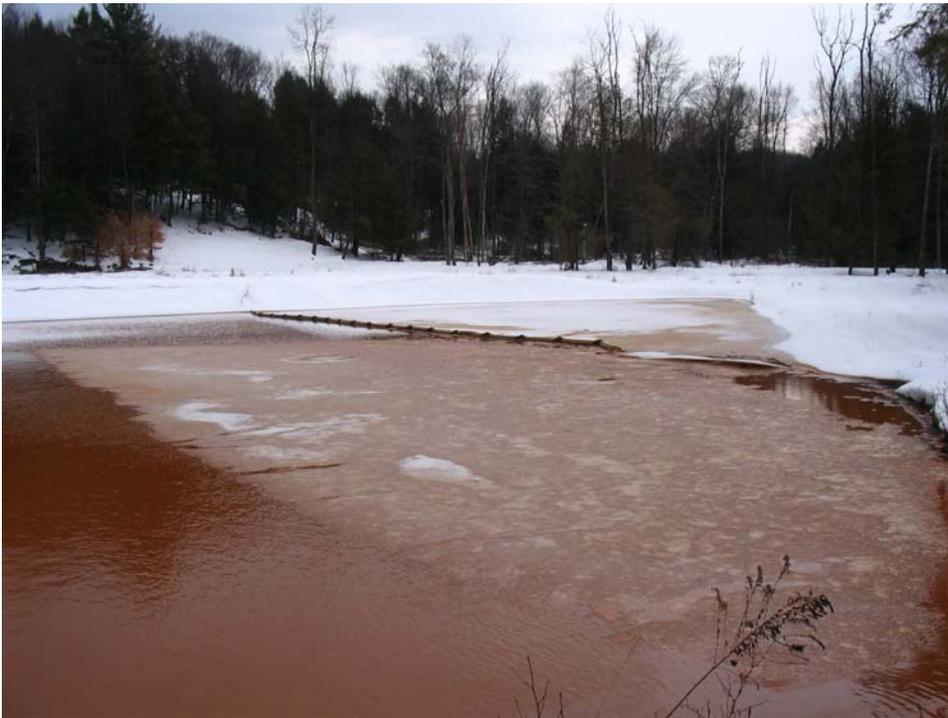
The raised water elevation in the pond (caused by the plugged effluent pipe) negatively impacted the purpose of the floating curtains. The curtains were installed to assure a serpentine flow path and provide maximum retention. The curtains are intended to be secured in a water-tight fashion to one side of the pond and extend toward the other side, stopping short of the opposite bank by 10-20 feet. The curtains may operate as intended when the effluent pipe is operational. However, when the pipe is clogged and water elevations in the pond are 6-9 inches higher, a gap develops between the curtain and the pond liner on the secured end (Photo C). The gaps allow water to leak by the curtain and bypass a substantial portion of the treatment system. In March and May 2007, all of the curtains were observed to be leaking in this manner. This problem, combined with the effluent through the emergency spillway provided a flow path that avoided 75% of the pond.

**Photo B. View from the emergency spillway to the south. The effluent pipe (located at the end of the pond) was plugged, making this portion of the pond ineffective (as indicated by the ice buildup).**

The pipe was unblocked during the first week of June and a discharge through the intended channel was reestablished.

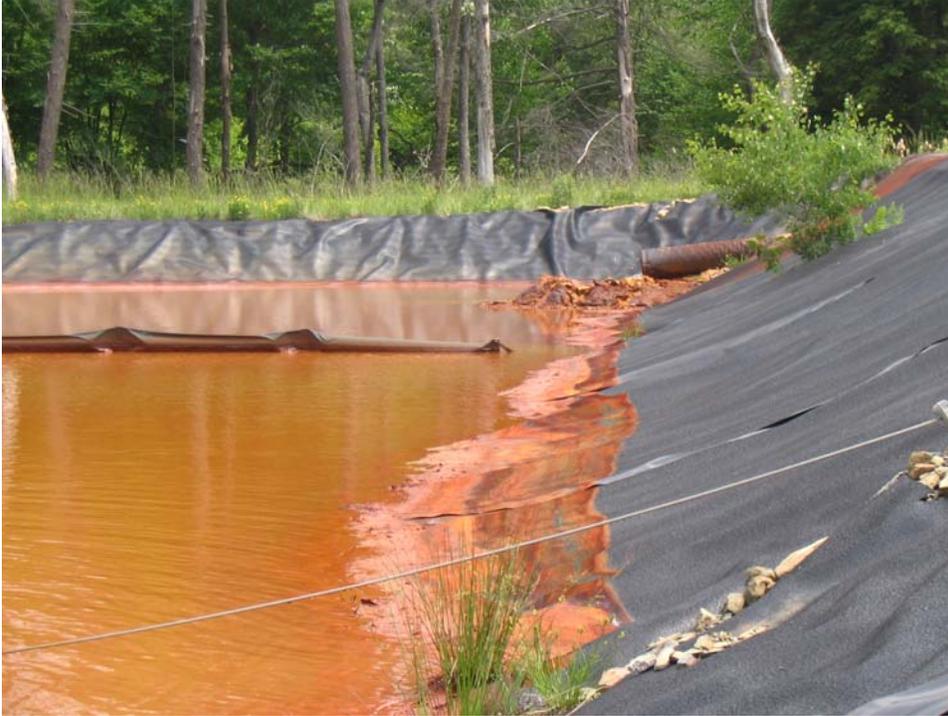
**Photo C. A gap between the curtain and pond liner that allows short-circuiting. The ALD discharge pipe is in the background.**

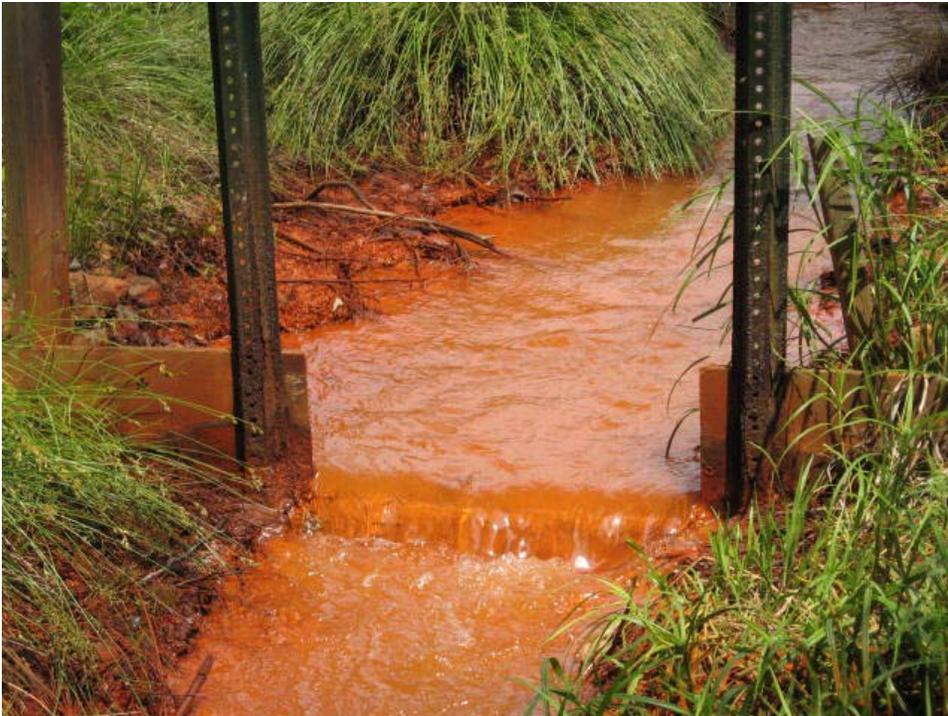
The second reason that the rectangular weir does not provide accurate flow measurements stems from the nature of its installation. The accurate measurement of flow with a weir requires a stilling area behind the weir. Water falls over the weir at a rate that can be predicted based on known constants (gravity, friction, etc.). If a stilling area does not exist, then the true velocity over the weir may be affected by other factors and flow estimates made using the weir charts will be inaccurate.

Photo D shows the weir. There is not a stilling area. Water flows down a sloped channel to the weir and discharges over the weir with more velocity than the calculations assume. The weir is underestimating flow rate.

**Photo D. The Markle weir. The absence of a stilling area makes measurements using standard weir charts inaccurate.**

In order to have confidence in the flow estimates, the head measurements for the existing 24" rectangular weir must be made to the nearest tenth of an inch. This is not a reasonable expectation, especially when the weir is usually found to be partially blocked by leaves, sticks, or iron sludge. The preferred situation is one where flow measurement errors of ½ inch do not substantially change the flow rate. Table 1 also shows the head measurements for a 90° triangular weir (V notch). The range in head is twice as large, making accurate measurement of flow rate much easier. Flow measurements at the site would be greatly improved with the installation of a V-notch weir.

The existing pond could be modified to incorporate the trough concept. At the same time, the pond could be split into two basins, divided by a weir that extends the full width of the pond. In order to provide a foot of drop between the influent trough and each basin, the water elevation in the pond would be raised by one foot. This requires raising the stream-side berm by one foot. The influent to the pond would be distributed the full width with a trough. The pond would be divided at its mid-point by a weir that extends fully across the pond. This weir would redistribute the flow across the full width of the pond and by dropping water 12 inches, provide more aeration. A collection trough could be installed at the end of the final basin that discharges water into the existing channel. The rectangular weir in the channel should be replaced with  $90^\circ$  V notch weir.

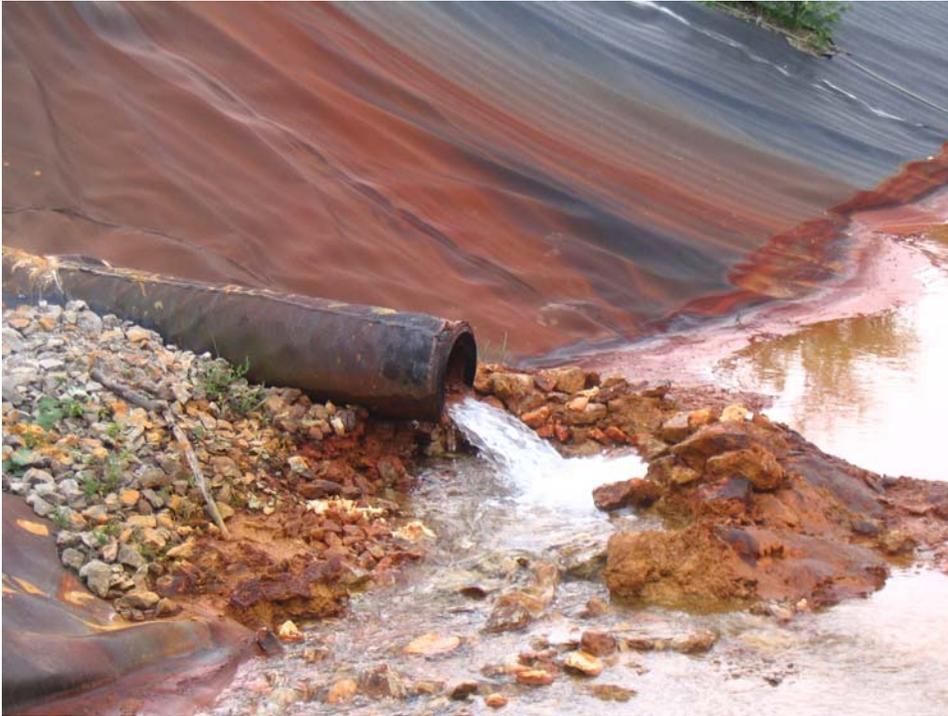
Table 2 shows flow rates measured in June 2007. A flow could not be measured on June 8 when all other flows were measured because a large stick was found to be blocking the weir and backing water in the channel. The stick was removed and the flow was measured on June 11 after conditions had equilibrated. Flows were measured at the ALD and underdrain discharges by making a timed collection of a known volume in a bucket (Photos E and F). The ALD discharge required the use of a 16 gallon tub. The timed-volume flows are accurate to within 10% or less.

**Photo E. The ALD discharge to the settling pond. Note the pool made in the aggregate to accommodate a flow measurements with a 16 gallon tub.**

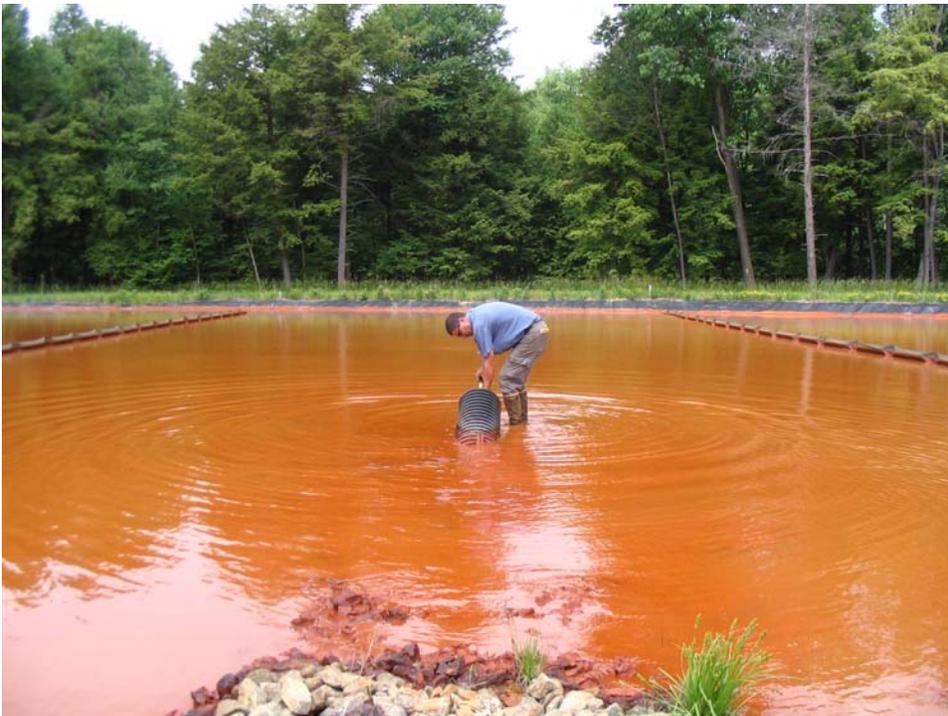
**Photo F. Measuring flow from the underdrain discharge.**

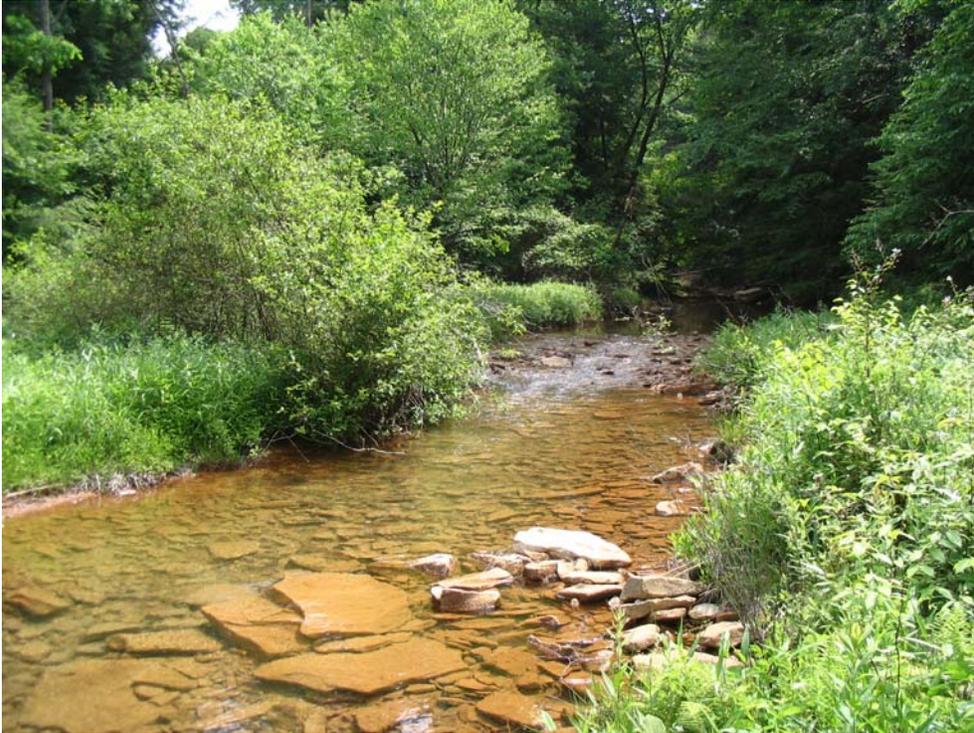
**Photo G. Little Mill above the Markle treatment system inflow.**

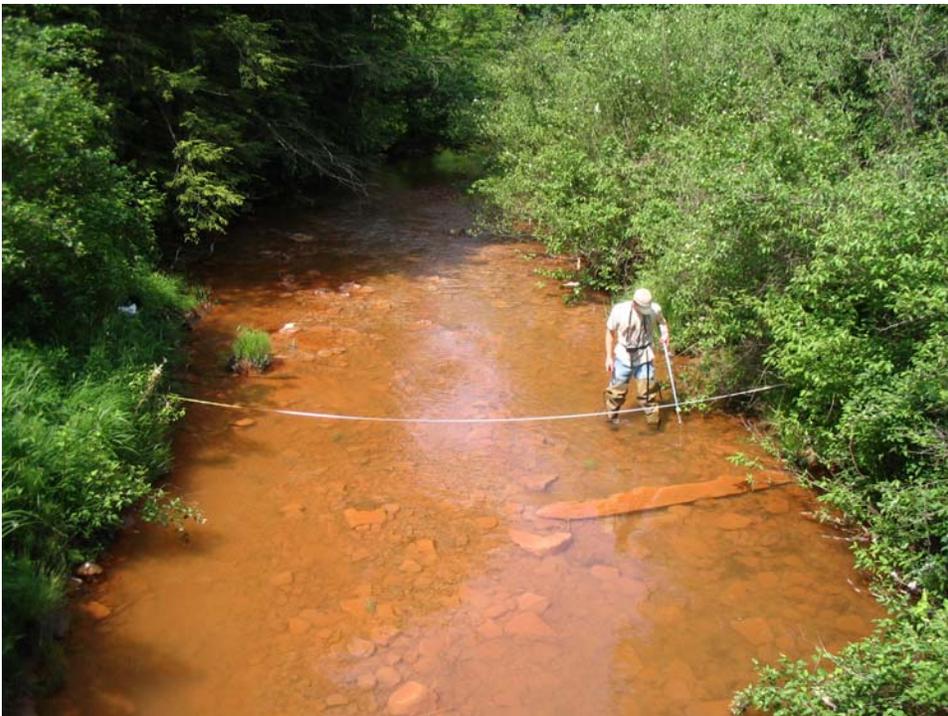
Stream impacts Two sets of samples were collected from Little Mill Creek by this study. Stream flow measurements were made on June 8 with a velocity meter. The primary impact on Little Mill is an increase in Fe. Concentrations downstream were 8-10 times higher than upstream. The stream was visibly more orange downstream (Photos G and H). The system inflow did not depress pH, which was about 6 on both days.

**Photo H. Little Mill below the treatment system inflow (view looking downstream from the bridge).**

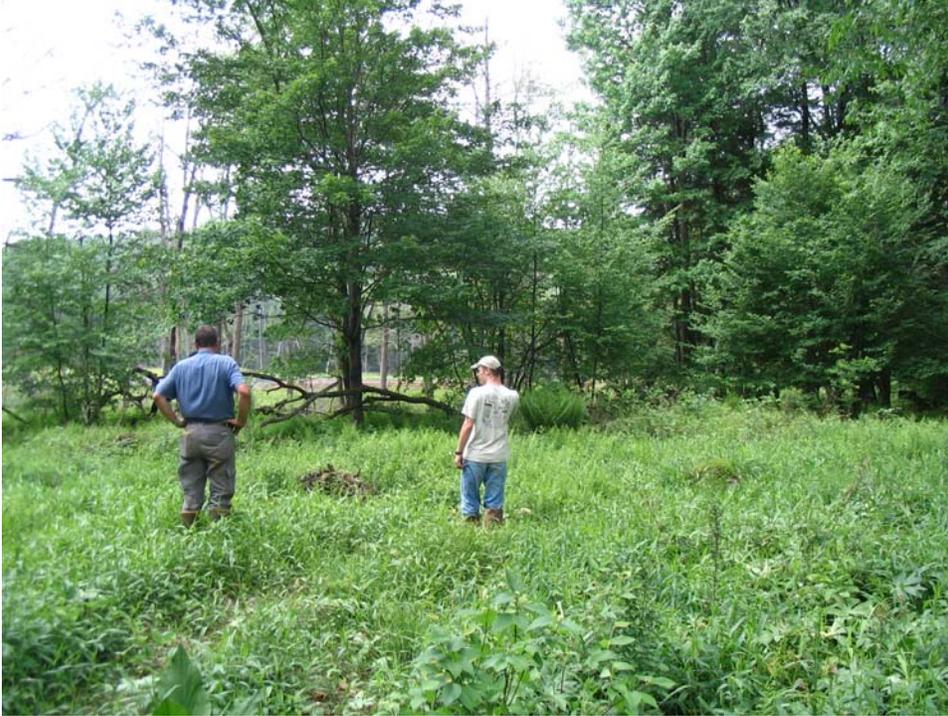
Reconnaissance of the site revealed an area to the north that could be used to construct an additional pond (Photo I). HE personnel met with the landowner on June 8, who expressed concerns about the system being expanded. To allay these concerns, an expansion plan was developed that stayed within the original project boundaries (as delineated on the as-built plans). A 15,000 ft<sup>2</sup> pond can be fit to the north of the existing pond, within the current project boundaries.

**Photo I. Area to the north that could be used for system expansion (the settling pond is visible in the background)**

If the project boundaries could be extended north to Little Mill Creek, a pond having 25,000 -30,000 ft<sup>2</sup> surface area could be constructed without producing unmanageable excess cuts.

The area to the north of the treatment system contains some wetlands that appear to contain clean water. Mitigation may be required.
