## BAMR AMD Project OMR Report

<b>Project #</b>	<b>BF 386-101.1</b> (Non-Primacy Bond Forfeiture)
<b>Project Name</b>	Pengrove Coal Coal - Hortert Site
<b>Municipality</b>	Eau Claire Borough
<b>County</b>	Butler County
<b>USGS Quad</b>	Eau Claire
<b>Site Lat./Long.</b>	41° 08' 12" N 79° 48' 27" W (NAD 83)
<b>Problem Area</b>	Site lies approx 1500' south (outside) of PA6591
<b>Feature Number(s)</b>	N/A
<b>Receiving Stream</b>	South Fork to Little Scrubgrass Creek (Sandy Creek Watershed)
<b>DEP Labs SIS Project ID</b>	BF 386-101.1
<b>SIS Monitoring Point ID Alias</b>	PC4-1, PC4-2, PC4-3, PC4-4, PC4-5, PC4-6, PC4-7
<b>Raw Water Quality (Design)</b>	Net Acidic Discharge
<b>pH</b>	<i>Note: The design was primarily based on the recommendations of a report prepared by the U. S. Department of interior's Bureau of Mines, Pittsburgh Research Center. A copy of this report is available in the project design file.</i>
<b>Iron (total)</b>	
<b>Aluminum</b>

**BAMR AMD Project OMR Report**  
**BF 386-101.1**

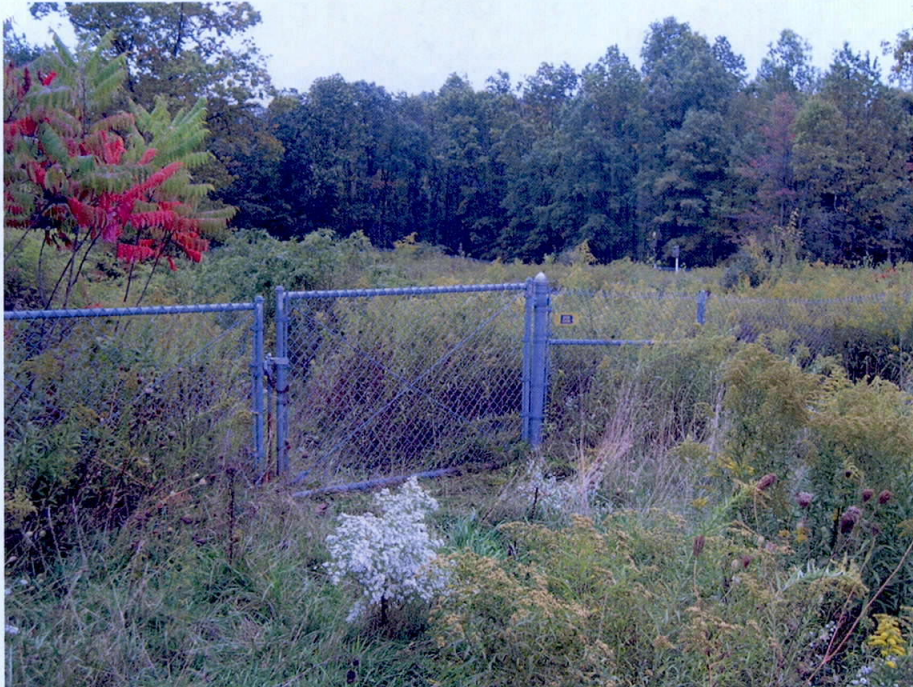
Access gate and fencing around treatment ponds.  
Date of Photo: 10-2-08.

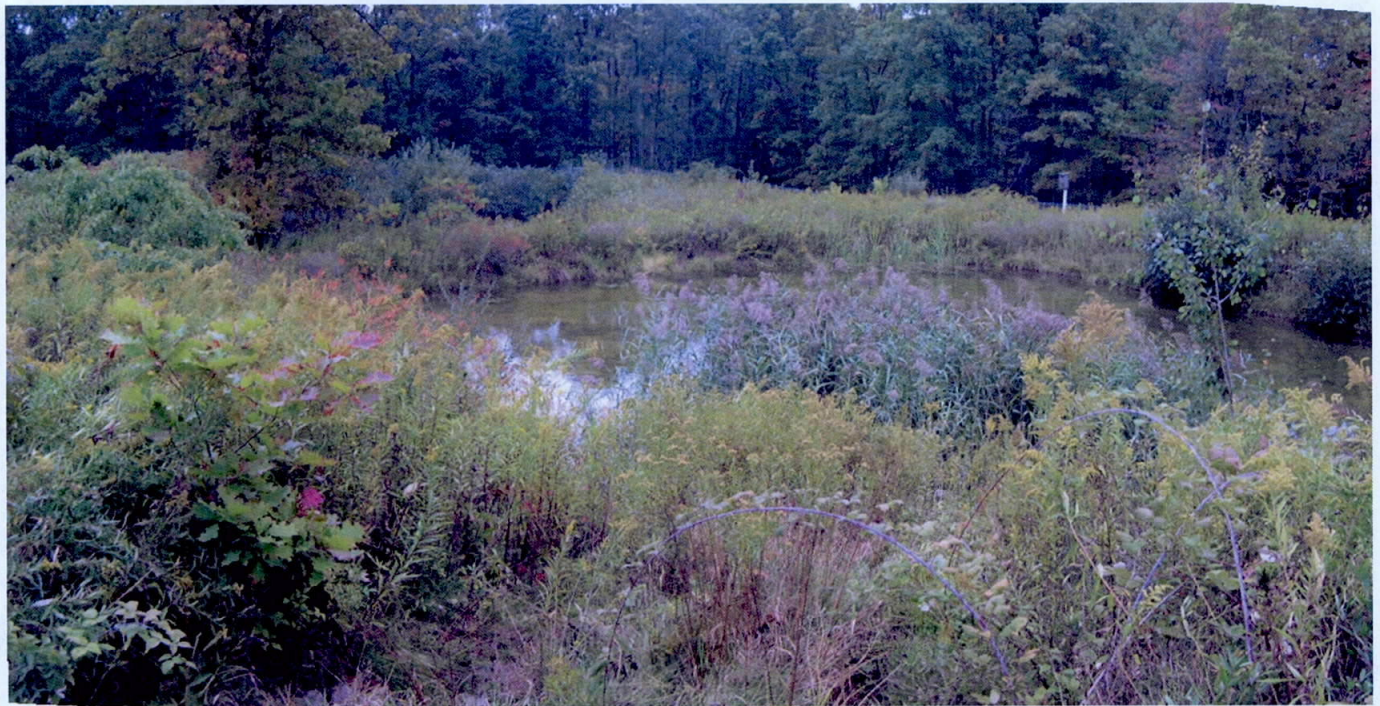
Area inside the fencing around the SAPS pond. Note the large amount of brush.  
Date of Photo: 10-2-08.

<b>Current Performance</b>	System continues to be treating water adequately, although there are maintenance items to be addressed.
<b>Were Project Goals met?</b>	Project goals to increase pH and Alkalinity, & decrease metals loading were met. Water quality exiting the site to South Fork has improved.
<b>RECOMMENDATIONS</b>	<p>Although the system appears to be working, the following maintenance items should be considered:</p> <ol style="list-style-type: none"> <li><b>1. Clear brush along Ditch "B" directing flow to system and revegetate with mixed grasses, where necessary.</b></li> <li><b>2. After clearing is performed, inspect ditch and repair/replace R-4 rock where required.</b></li> <li><b>3. Remove brush, sediment, and/or displaced R-4 rock from both inlet and outlet ends of 15" PVC pipe (directing flow to SAPS), clean-out clogged pipe and add R-4 rock as needed.</b></li> <li><b>4. Clear and grub brush located along the north side of both treatment ponds inside fenced in area, and clear and grub brush between ponds. Construct stone roadway/pathway for permanent future access and revegetate all other cleared areas with mixed grasses</b></li> <li><b>5. Clean out entire piping system of SAPS and Aerobic ponds.</b></li> <li><b>6. Property owner, Mr. Dennis Sloan has requested that the outlet portion of Ditch "A" be redirected. (possibly to the location reflected by the original plan). The owner's request should be given consideration.</b></li> </ol> <p><i>Note: Although all flumes have either been damaged, overgrown with brush, or displaced by sediment and/or rock, it is not recommended that they be replaced, as it likely that if replaced, they will again become in-operable in the future</i></p>

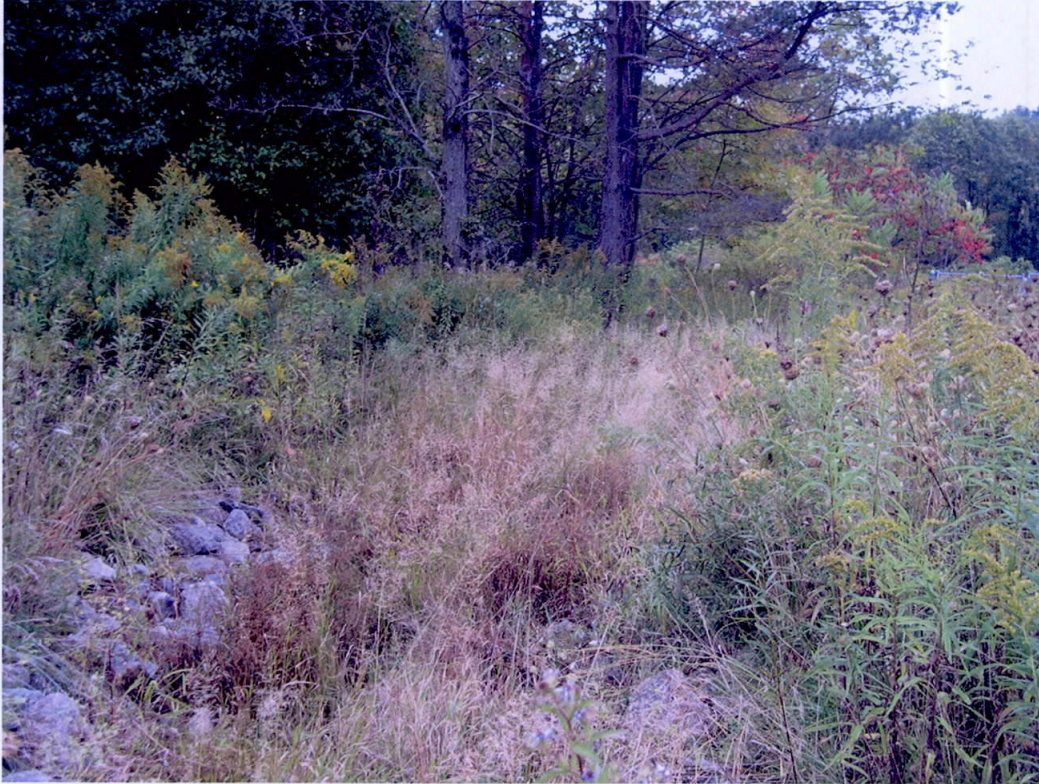
Rock lined ditch (looking down slope) directing flow to the SAPS pond. Note the amount of overgrown brush on ditch invert and side slopes.  
Date of Photo: 10-2-08.

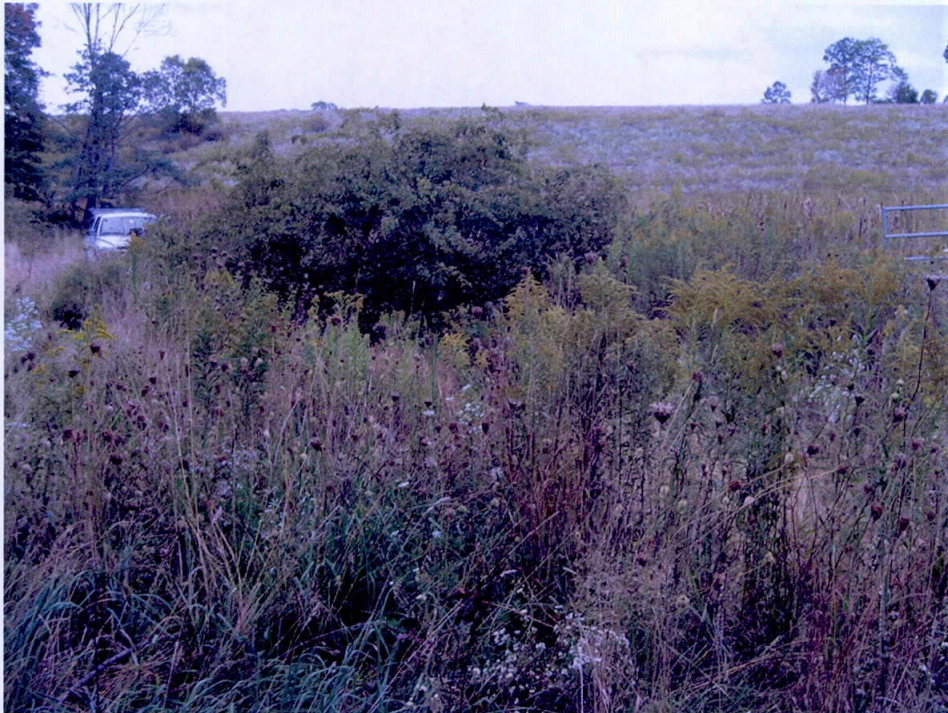
Rock lined ditch (looking up slope) directing flow to the SAPS pond.  
Rock lining not visible due to overgrown brush.  
Date of Photo: 10-2-08.

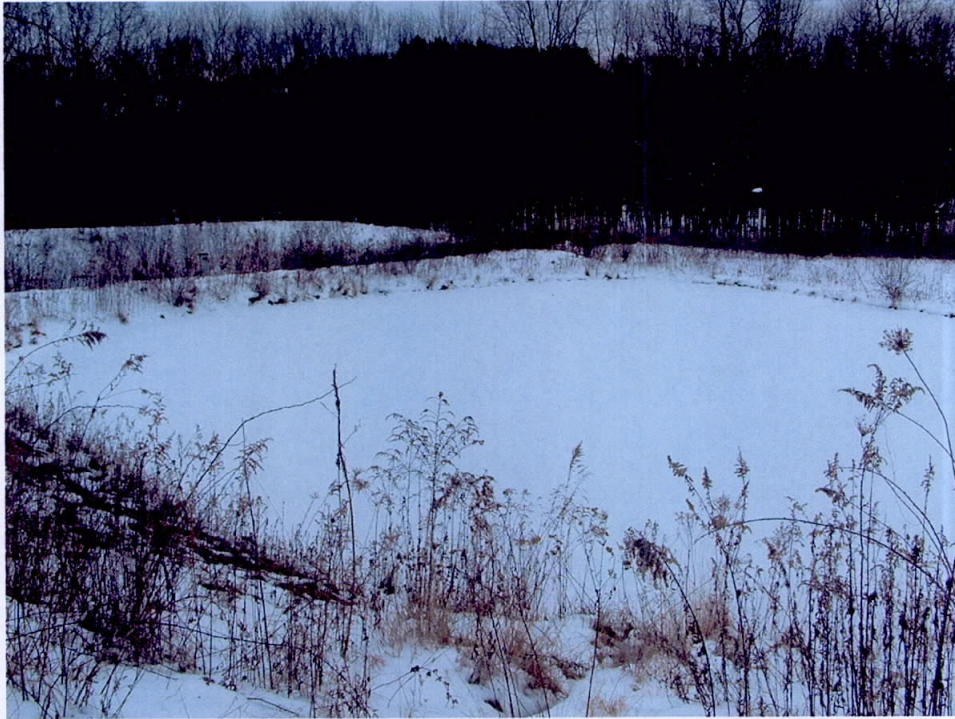
SAPS pond (looking in direction of inflow pipe directing flow to the SAPS pond).  
Date of Photo: 12-19-05.

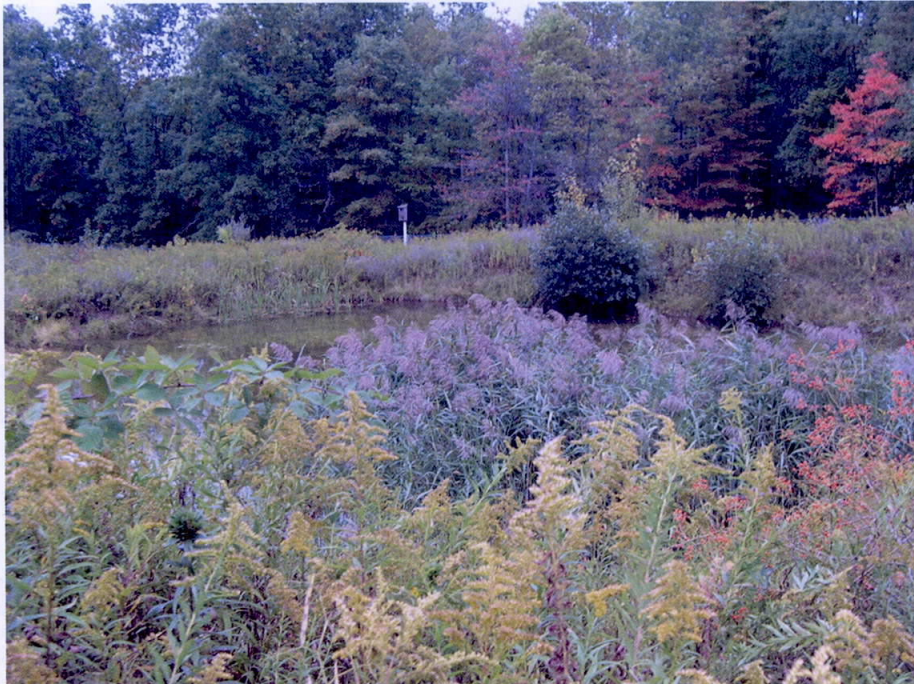
SAPS pond (looking in direction of inflow pipe directing flow to the SAPS pond).  
Date of Photo: 10-2-08.
