Richards Passive System Rehabilitation

A Blacklick Creek Watershed Association Project

Cherryhill Township, Indiana County, Pennsylvania

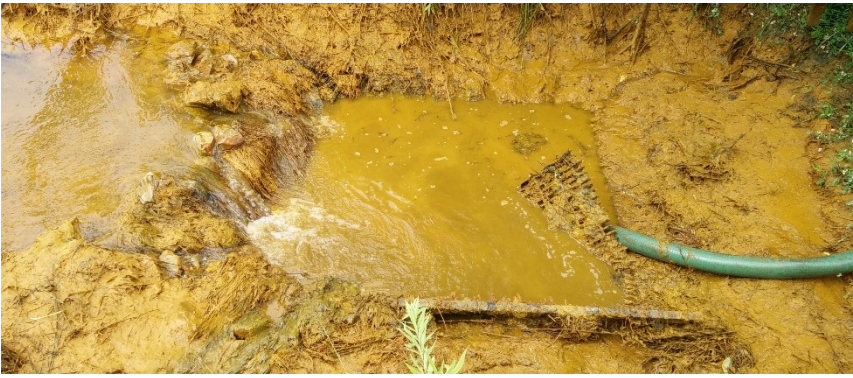
Before Rehabilitation: [ABOVE] The inlet system catch basin and piping often plugged causing raw water to bypass system (7/9/15); [RIGHT] Once raw water entered the vertical flow ponds, the treatment media was found to be plugged with iron and aluminum (5/23/17).

Project Description: The Richards Passive System was initially constructed in 1999 (Phase 1: VFR1→settling pond) and expanded between 2001 and 2003 (Phase 2: VFR2A & VFR2B→wetland). Various issues complicated system operation over the years. Defining the amount of drainage to be treated has been particularly problematic due to a lack of consistent and comprehensive flow measurement. Untreated drainage often bypassed the treatment system due to plugging issues with the collection/distribution system. Prior to the current efforts, it was determined that the three vertical flow reactors (VFRs) were plugged to the point of being unable to provide effective treatment. To eliminate inlet plugging issues, an innovative three-way flow splitting weir box was plumbed directly into the mine drain that will allow for accurate flow measurements and proportional distribution of flow. VFR1 was enlarged and reconfigured as a Jennings-type vertical flow pond (JVFP1), VFR2A and VFR2B were combined into a single, larger Jennings-type vertical flow pond (JVFP2), and the Phase 2 sludge holding basin was enlarged and reconfigured into a third Jennings-type vertical flow pond (JVFP3). JVFP1 discharges to the settling pond where an earthen directional baffle and a primary spillway pipe were added. JVFP2 and JVFP3 discharge to the wetland where PVC Z-Pile directional baffles were added and the basin was reconfigured to improve retention time. A seep encountered during Phase 2 and previously piped to the stream untreated was captured in a new French drain and piped to the wetland to mix with the alkaline effluent of JVFP2 and JVFP3. An artesian flowing corehole encountered in the wetland during Phase 2 construction continues to discharge to the final 1/3 of the wetland.

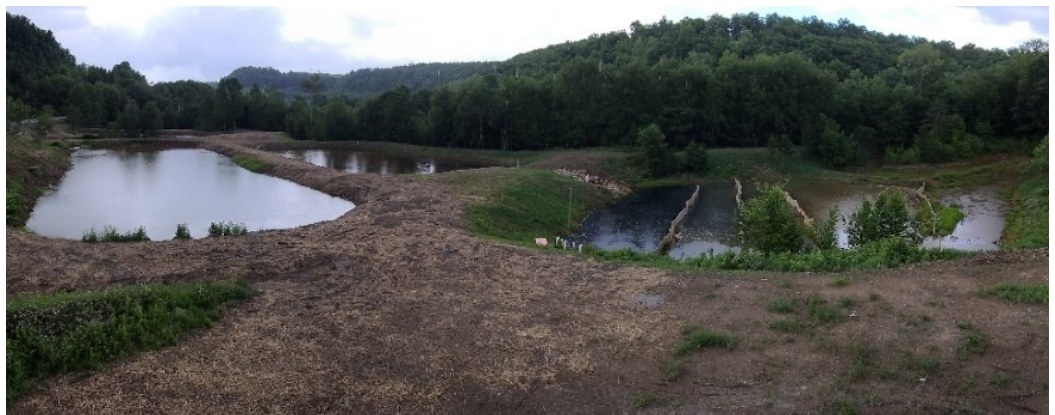
After Rehabilitation: Richards System with VFP2 (left), VFP3 (back middle) and Wetland with directional z-pile baffles (right) (7/8/21).

The rehabilitated system has a hydraulic capacity of 1,000 gpm and is designed to treat up to 747 gpm (max flow) with an average flow of 117 gpm. Pollutant load design capacity is 1,005 lb/day acidity, 148-296 lb/day or iron, and ~128 lb/day aluminum.
