The Solar Passive Mine Water Treatment System: Current Effectiveness and Long-term Operation and Maintenance Expectations

Prepared for Independence Conservancy by Hedin Environmental

October 26, 2007

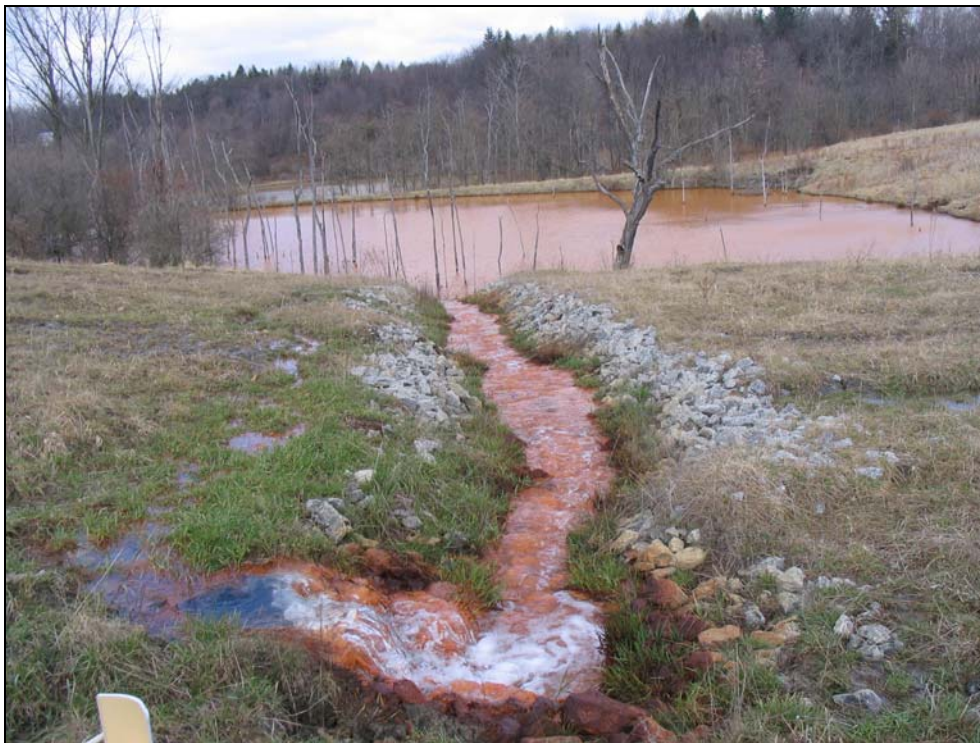
Photo A. The discharge from the ALCD and its flow down the ditch into Pond 1.

Water flows from the ALCD down a ditch to the 1st settling pond. A flume was installed in the ditch to facilitate accurate flow rates. The first settling pond has a surface area of 42,688 ft² (1.0 acre). This surface area is about twice the acreage shown on the original turnpike map. There are several dead trees present in the pond. Apparently the water level in the pond was raised during the turnpike construction. This may have occurred when an aggregate spillway was installed at the pond effluent.
