SLIPPERY ROCK WATERSHED COALITION

FINAL REPORT: WATERSHED PROJECT

STREAM RESTORATION THROUGH COAL MINE DRAINAGE ABATEMENT
Cherry, Marion, Venango, Washington Townships, Butler County, PA

December 1999

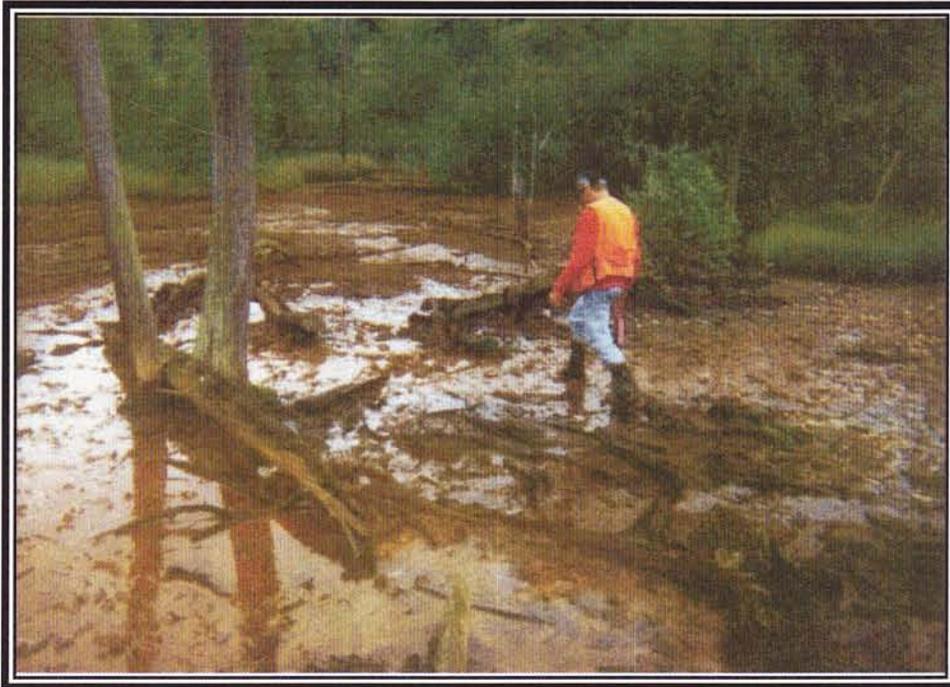
(SR101-A 8/12/96)

“Dead area” - topographic survey by CDS (Looking south)

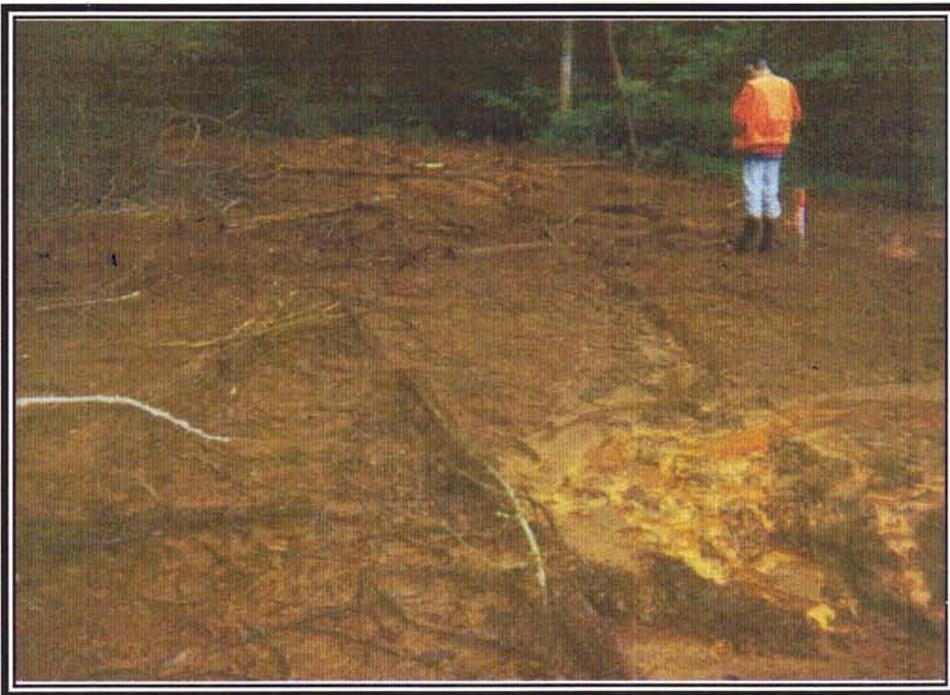
(SR101-A 8/12/96)

“Dead area” - topographic survey (Looking north)

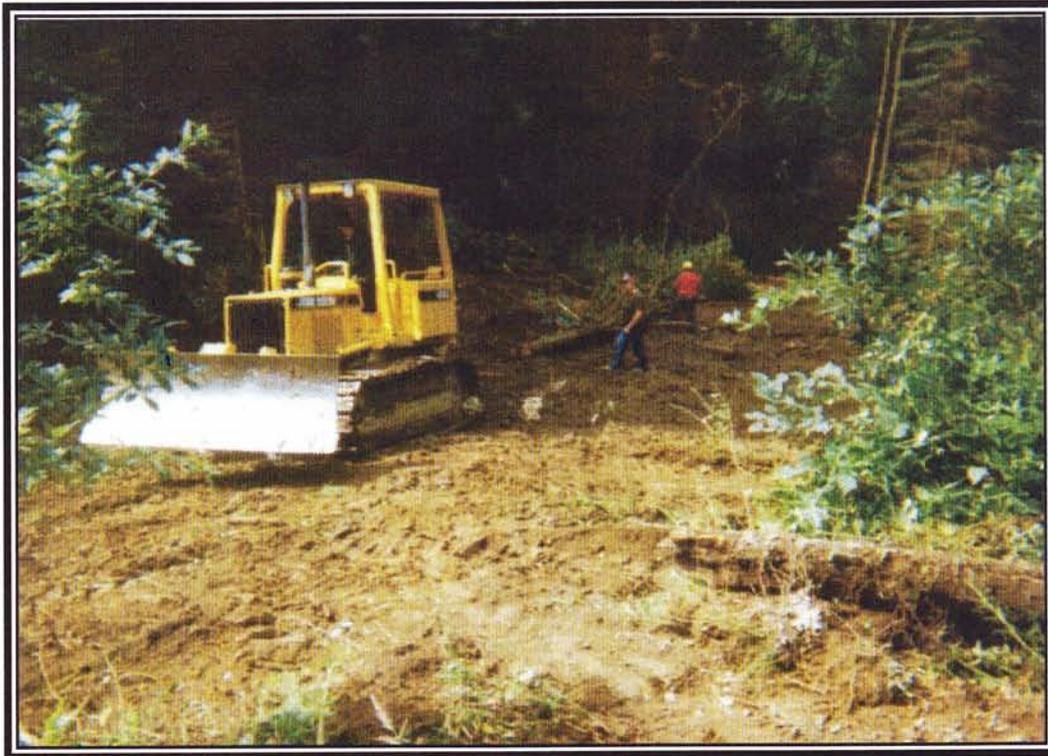
(SR101-A 8/14/96)

PA Department of Environmental Protection, BAMR contribute to the effort by clearing and constructing access and staging area.

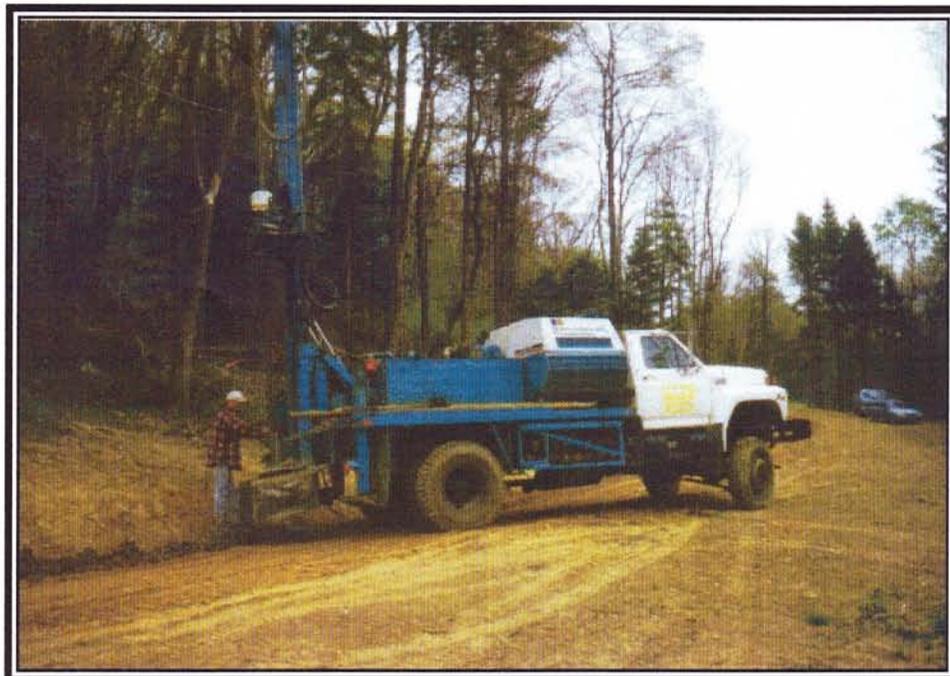
(SR101-A 5/28/97)

Monitoring Well 1 - drilling by McKay&Gould for Amerikohl Mining

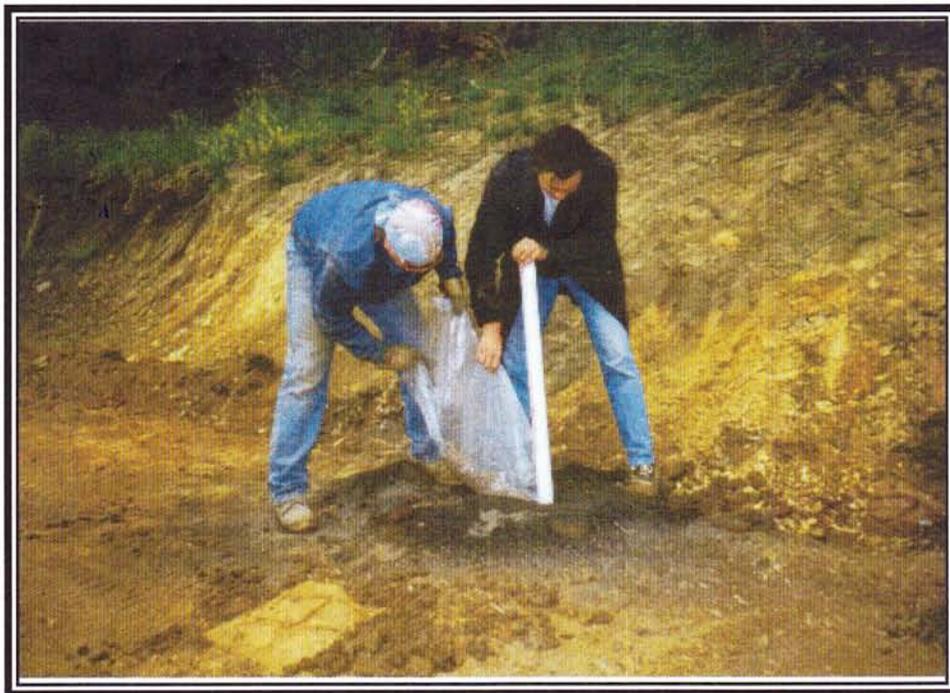
(SR101-A 5/28/97)

Monitoring Well 1 - installation Amerikohl Mining & Tim Danehy (BMI)

Upon excavation of the pit for the ALD, the water level was lowered an additional foot in Monitoring Well 1; however, the water levels in Monitoring Wells 2 and 3 exhibited a recovery of 2 to 2 ½ feet in comparison with the previous measurement. MW1, 2, and 3 are about 55, 50, and 15 feet, respectively, from the ALD excavation area. An explanation for the greatest fluctuation in the furthest well may be to MW2 and 3 being completed at an elevation about 6 feet below MW1. The moderate recovery noted in MW2 and 3 is probably due to the influence of water associated with the sandstone intercepted by these wells. (During drilling, the disturbed nature of the material encountered in MW2 and 3 made the determination of the target depth difficult. Pilot holes were not drilled.)

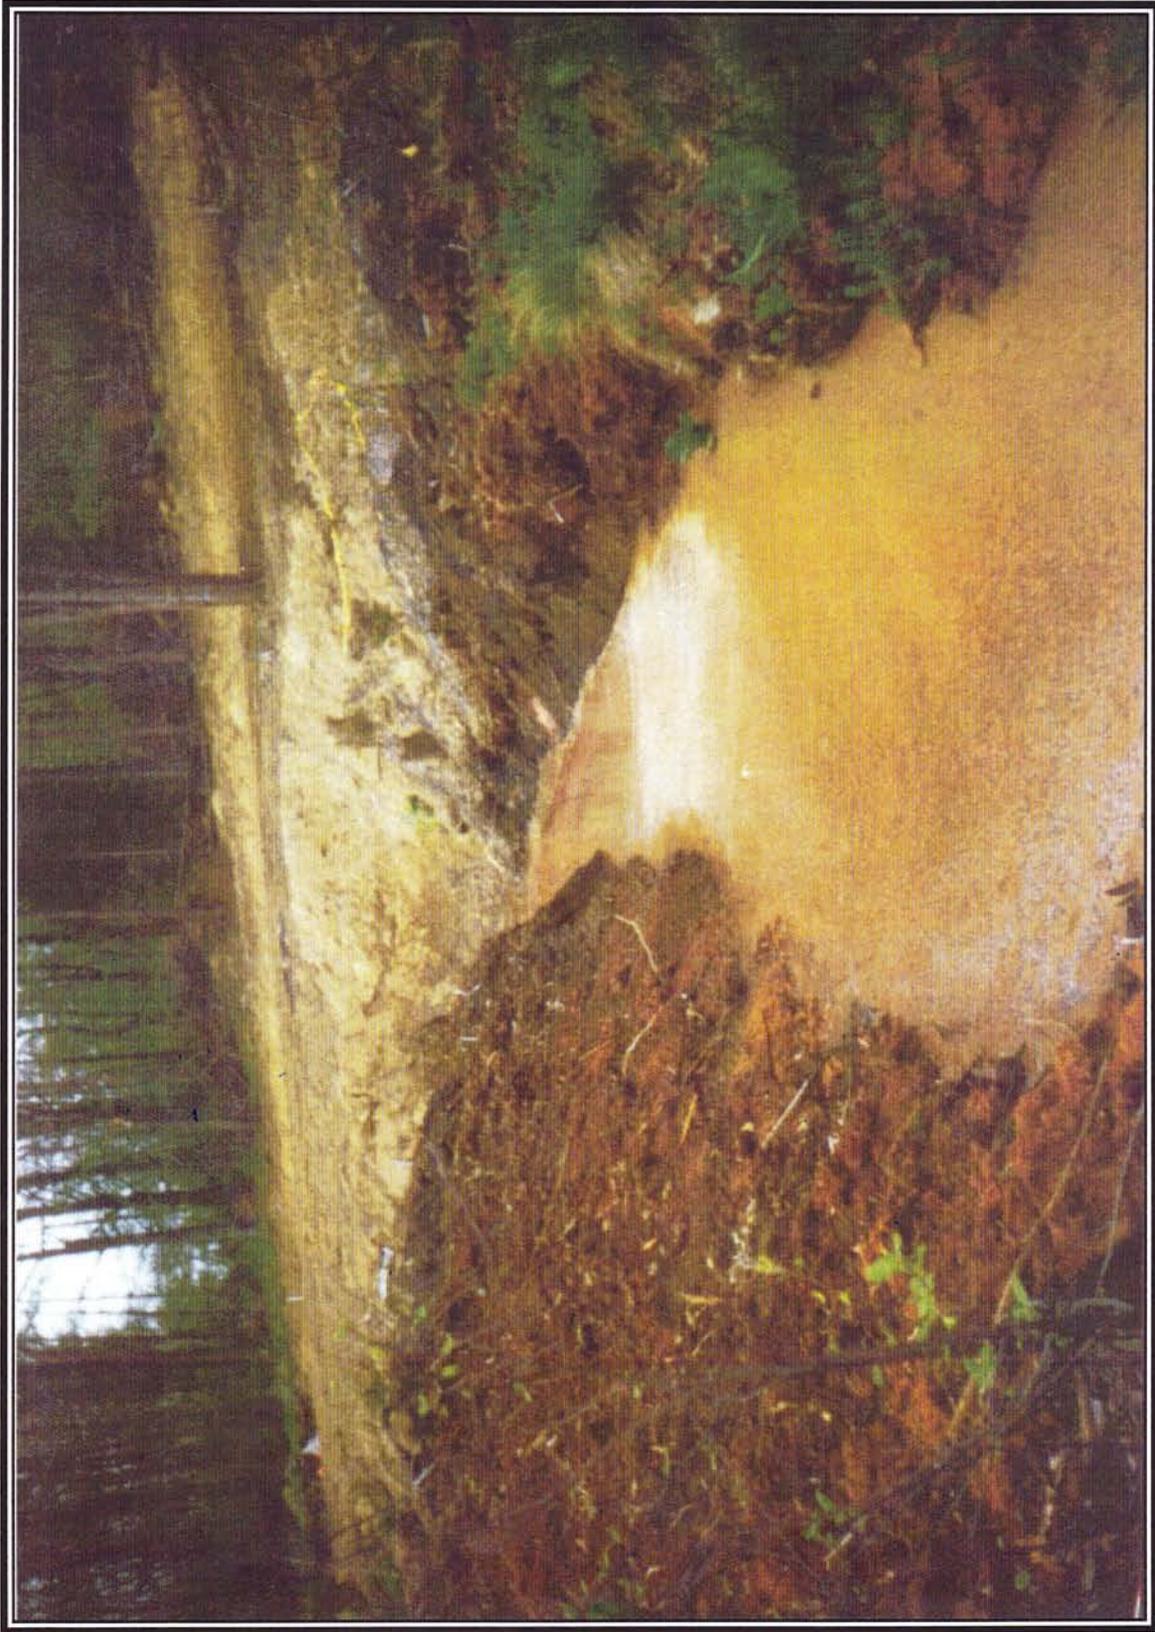
(SR101-A 5/28/97)

Temporary drainage ditch installed (8/15/96) to dewater construction area near future collection system.

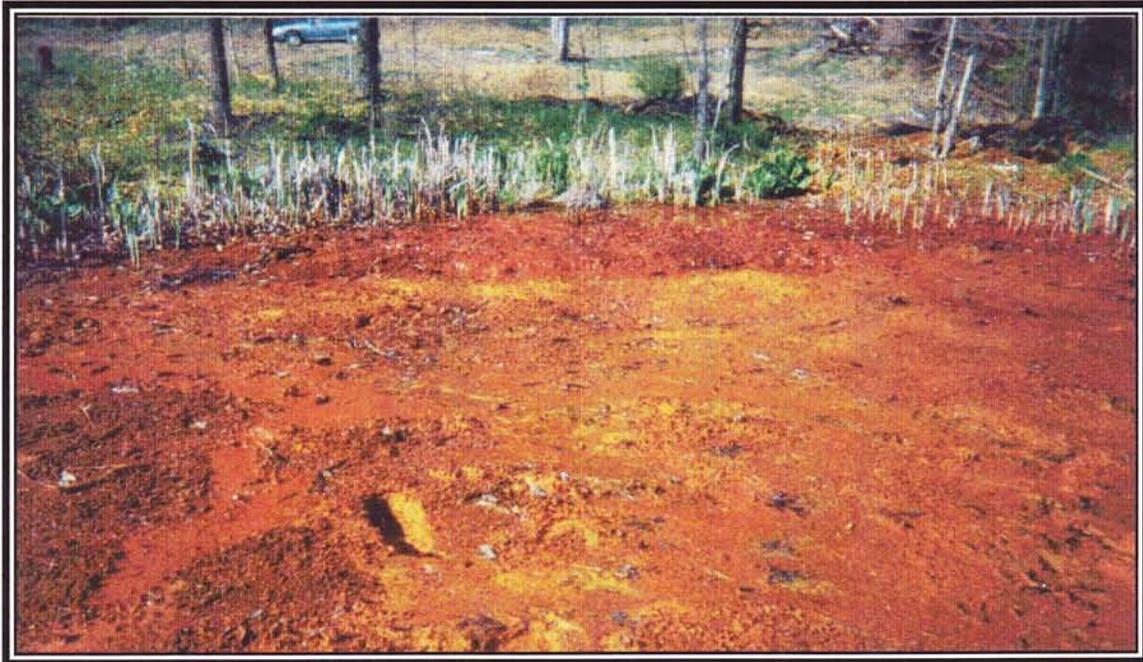
(SR101-A 5/5/98)

“Dead area” characterized by accumulation of red-orange iron precipitates (note footprint in center foreground). (Looking north)

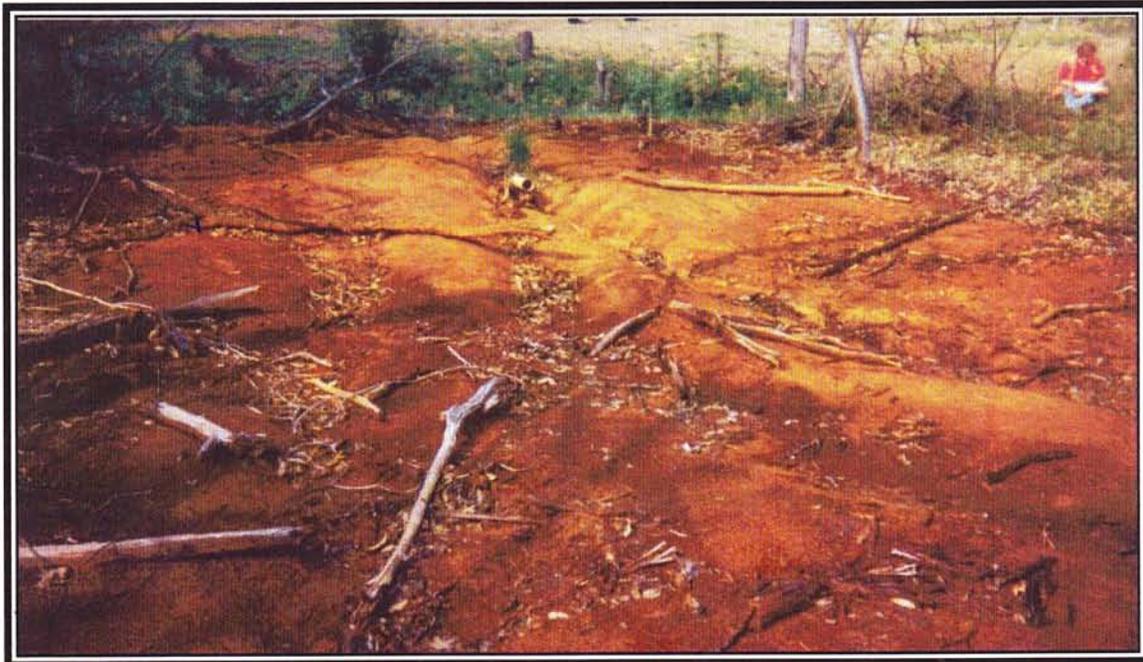
(SR101-A 5/5/98)

“Dead area” - dewatered prior to construction. (Note dry pipe.) (Looking north)

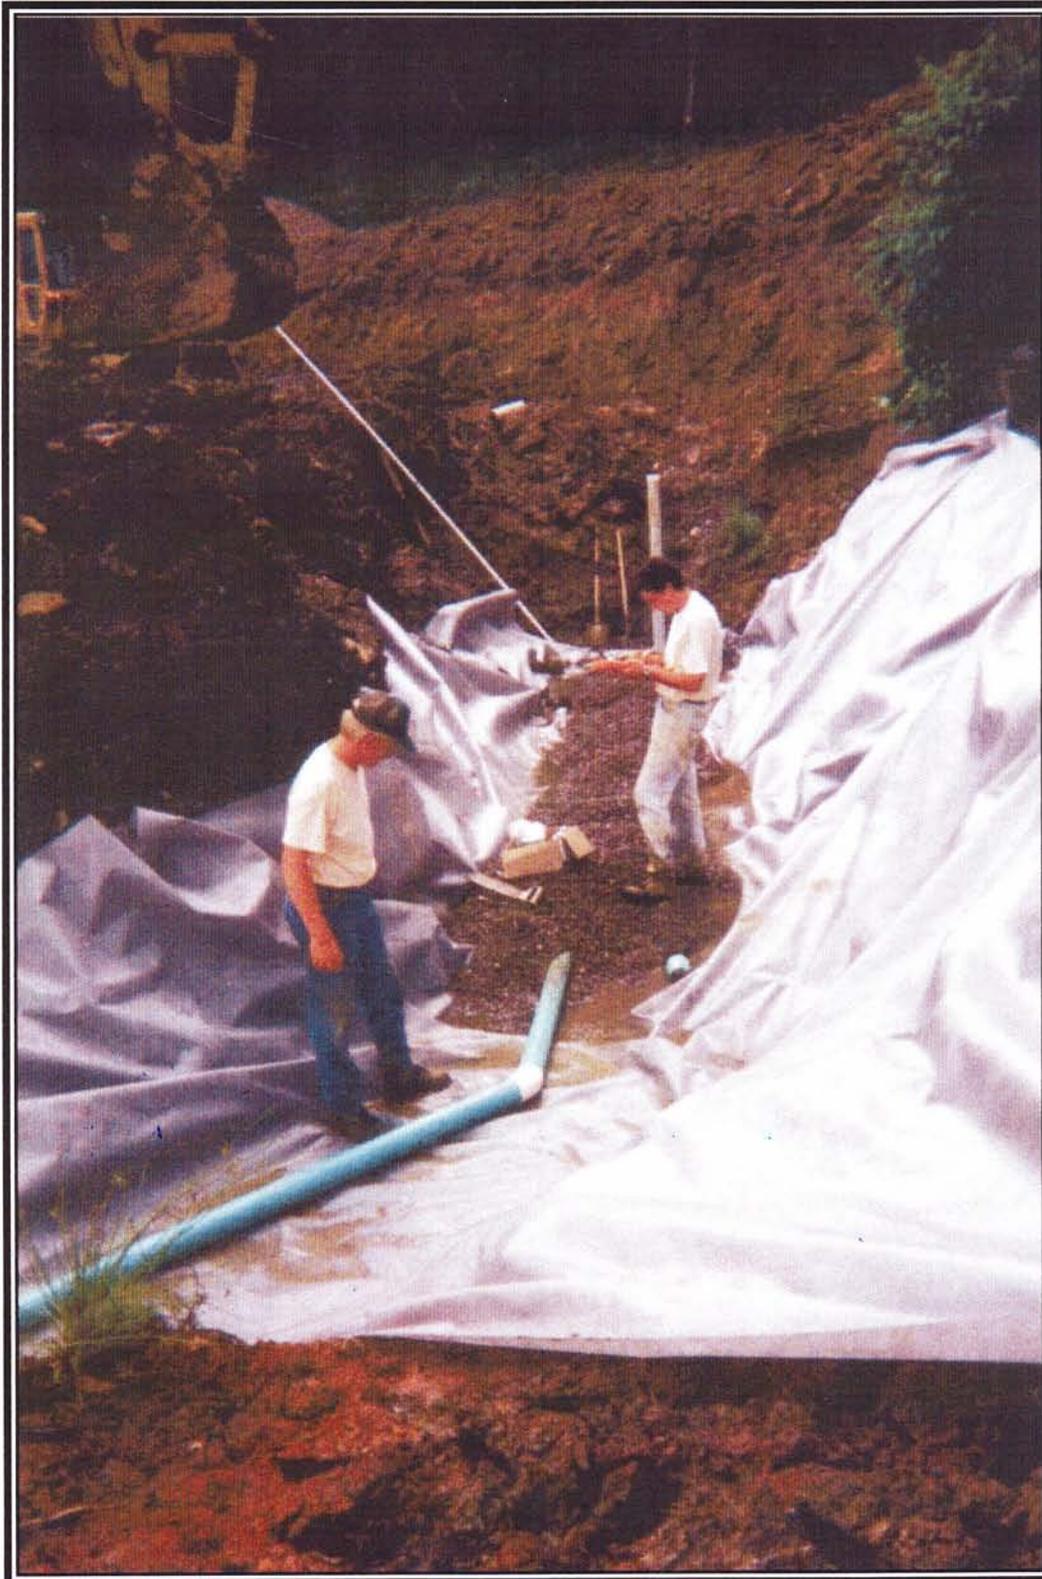
(SR101-A 6/17/98)

Anoxic Collection System: Jesteadt Excavating & BioMost (Looking north)

As previously noted, preliminary exploration with a backhoe revealed that the contaminated water flowed from friable, black, carbonaceous shale located beneath gray clay that was 1-3 feet below the ground surface in the seepage area. An interception ditch was excavated through the clay and into the shale. A collection system consisting of perforated, 4-inch, SDR35 PVC pipe, bedded in PennDOT 2B river gravel, wrapped in geotextile fabric, was placed in the interceptor ditch and buried. (See photo log, p. 7 & 8.) Additional gravel was placed around the drainage system in the eastern end of the ditch where a majority of the water was encountered. During construction, the collection system discharged to a drainage ditch dug perpendicular to the slope on the east side of the site. With completion of the treatment facilities, the collection system was redirected into the ALD. The temporary discharge channel was sealed with native clay material to assure that the preferred flow path for the degraded drainage was into the collection system and into the ALD. (See As-Builts.)

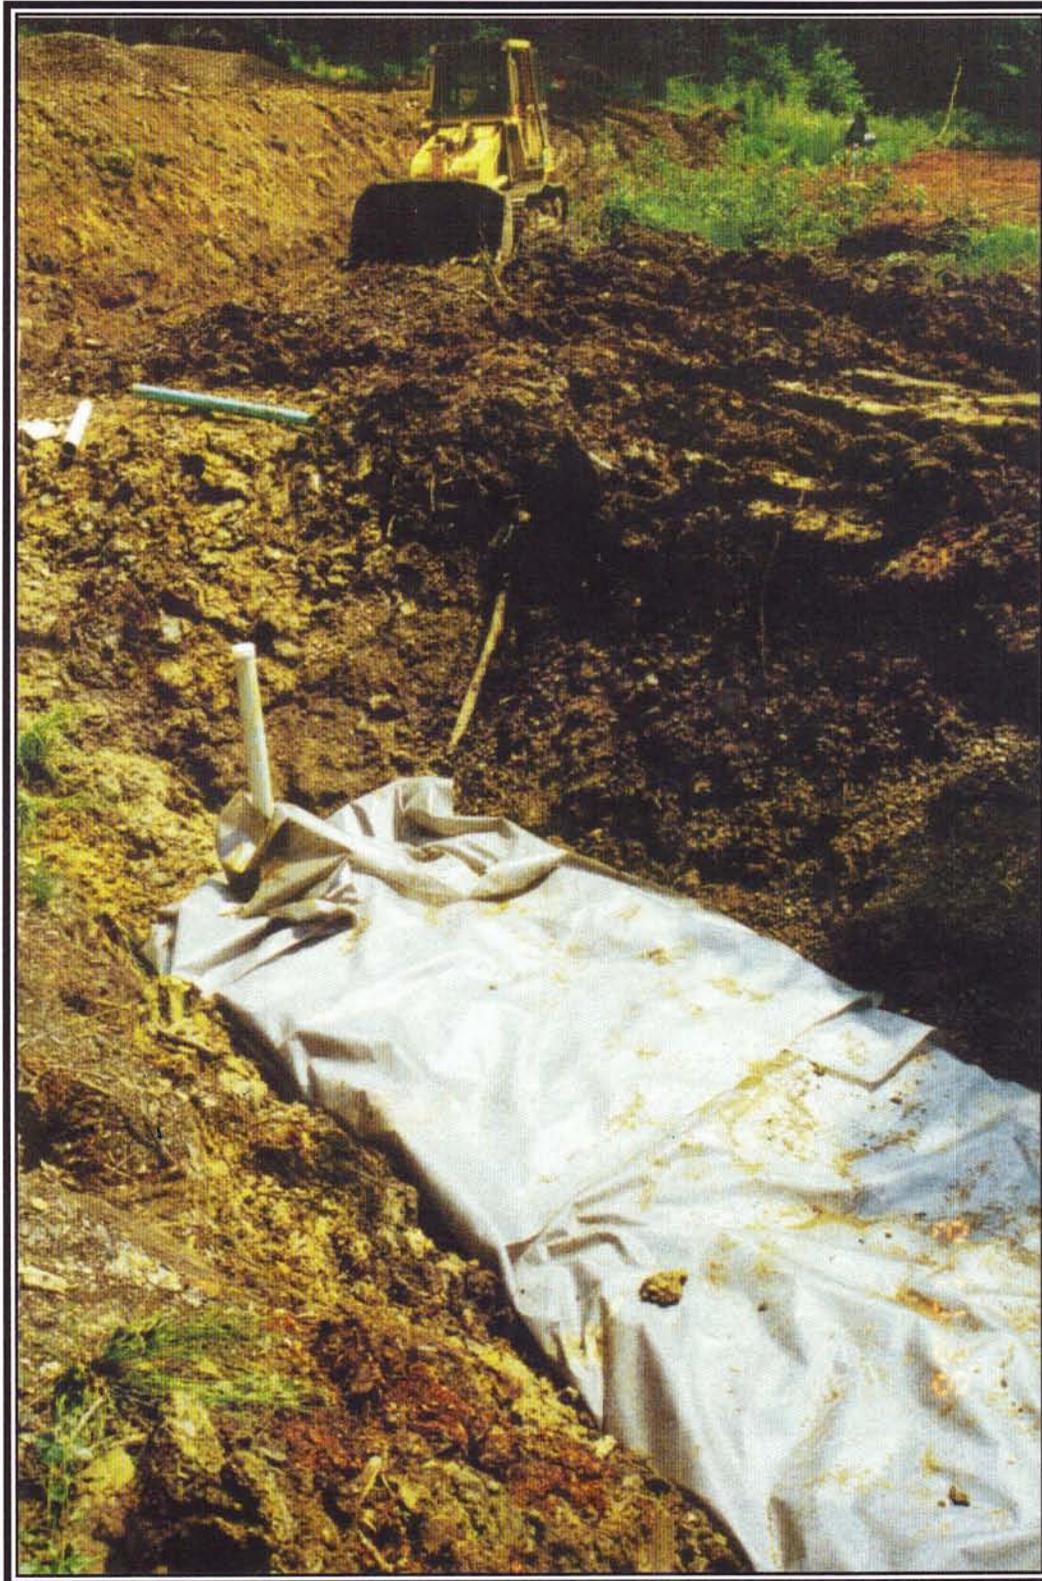
(SR101-A 6/17/98)

Anoxic Collection System "wrapped" in geotextile (Looking NE)

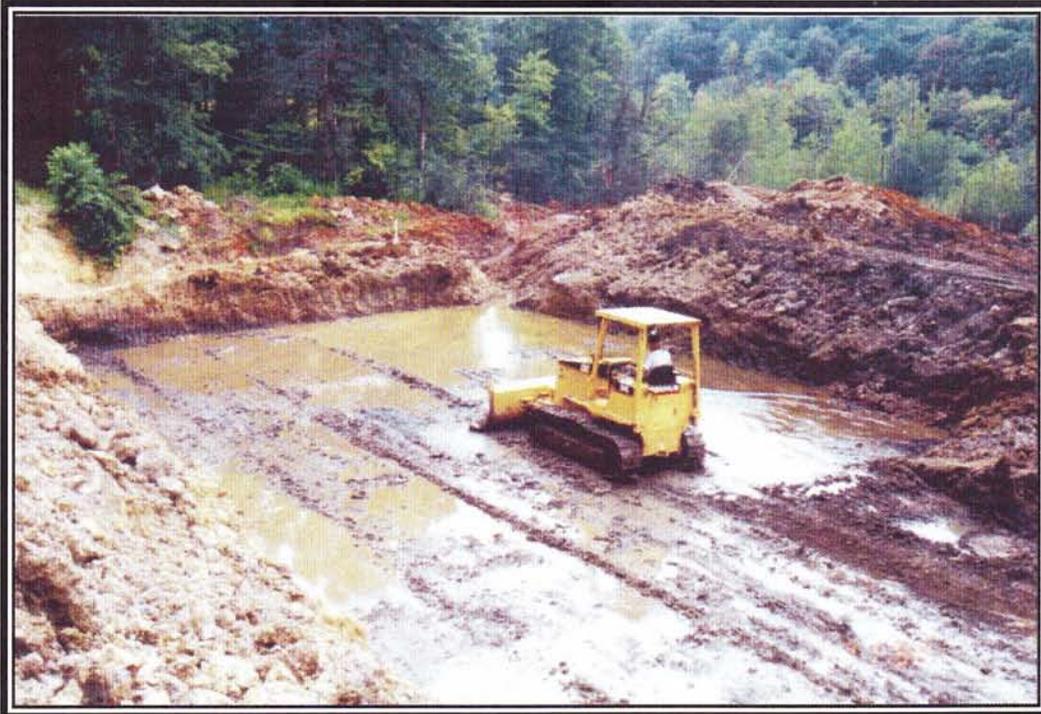
(SR101-A 7/27/98)

ALD construction by Jesteadt Excavating (Looking southeast)

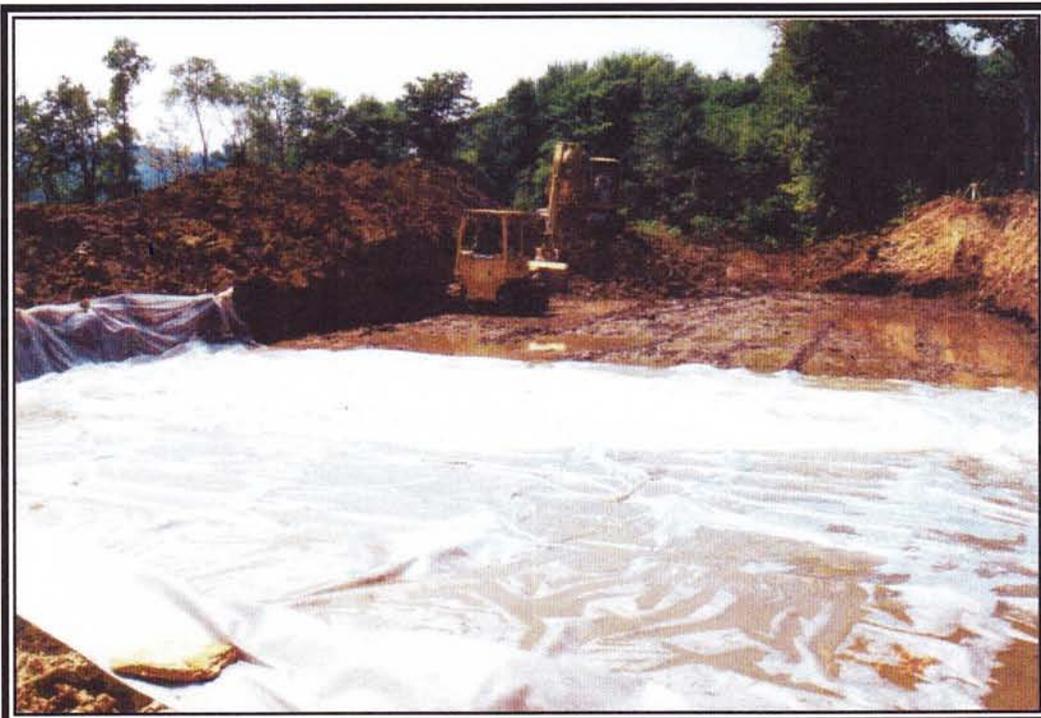
(SR101-A 7/27/98)

ALD construction: placement of 6-mil plastic liner by BMI (Looking SW)

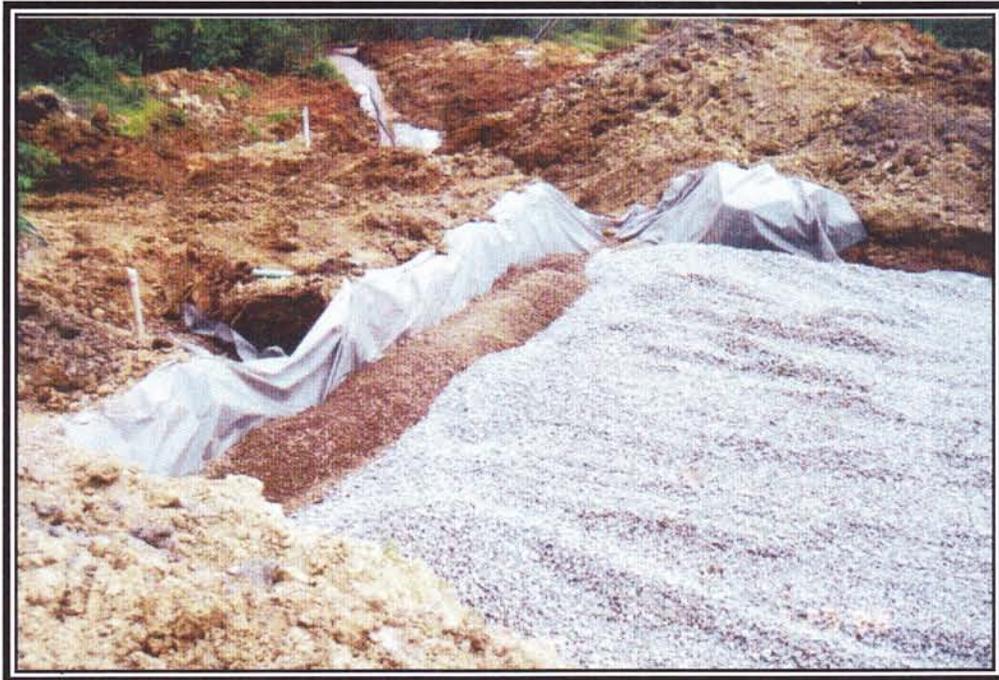
(SR101-A 7/29/98)

ALD inlet manifold bedded in river gravel prior to receiving mine drainage (Looking SE)

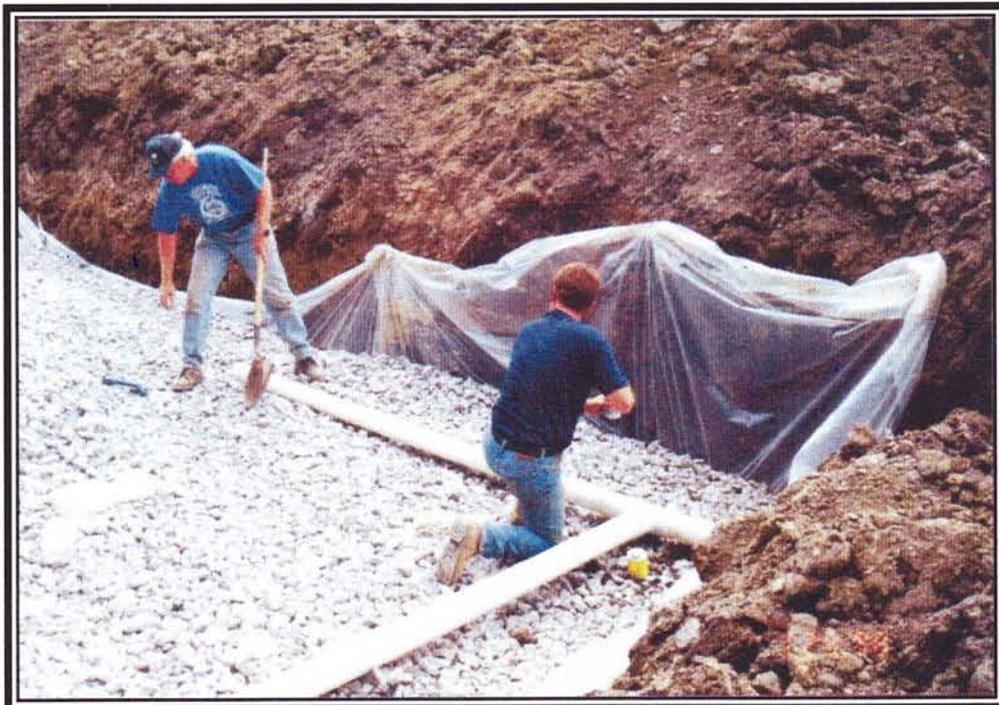
(SR101-A 7/29/98)

ALD outlet manifold; Jerry Jesteadt & Dave Macurak, Jesteadt Excavating (Looking SE)

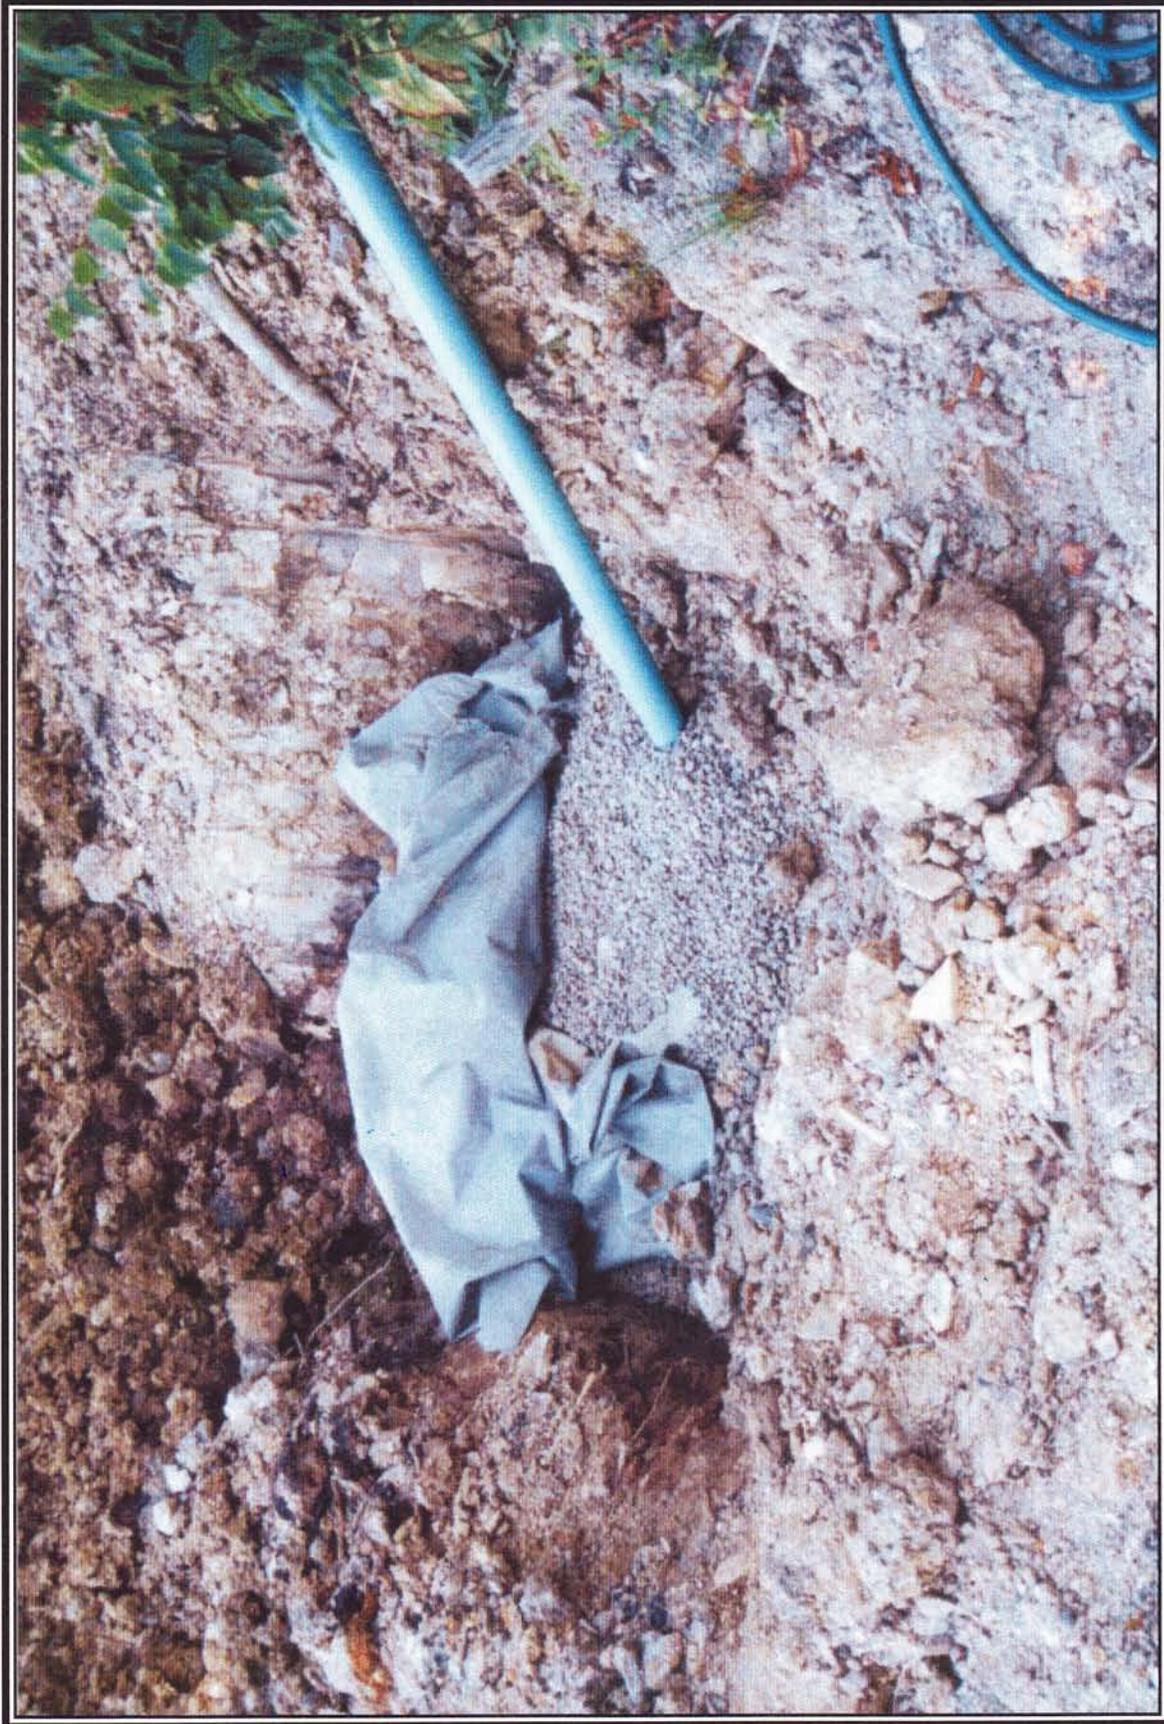
(SR101-A 8/3/98)

Raw Water Sampling Port: 1/2" PE tubing placed near bottom of anoxic collection system (note 4" SDR 35 casing on right) (Looking north)

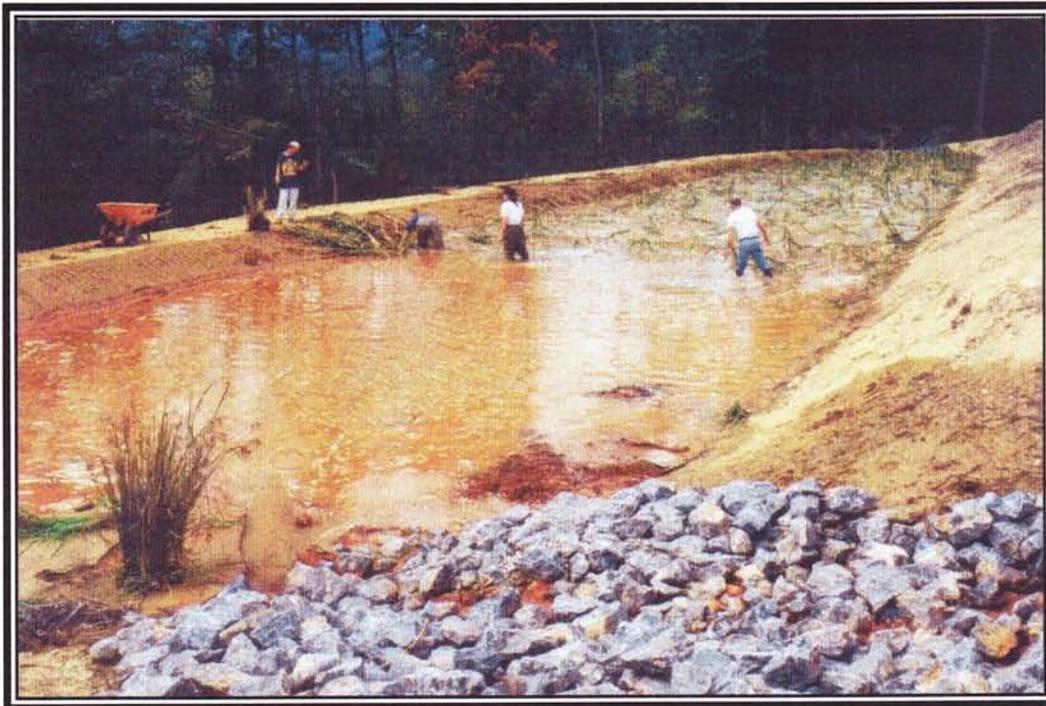
(SR101-A 8/21/98)

Volunteers plant Wetland #2 with cattails harvested nearby.

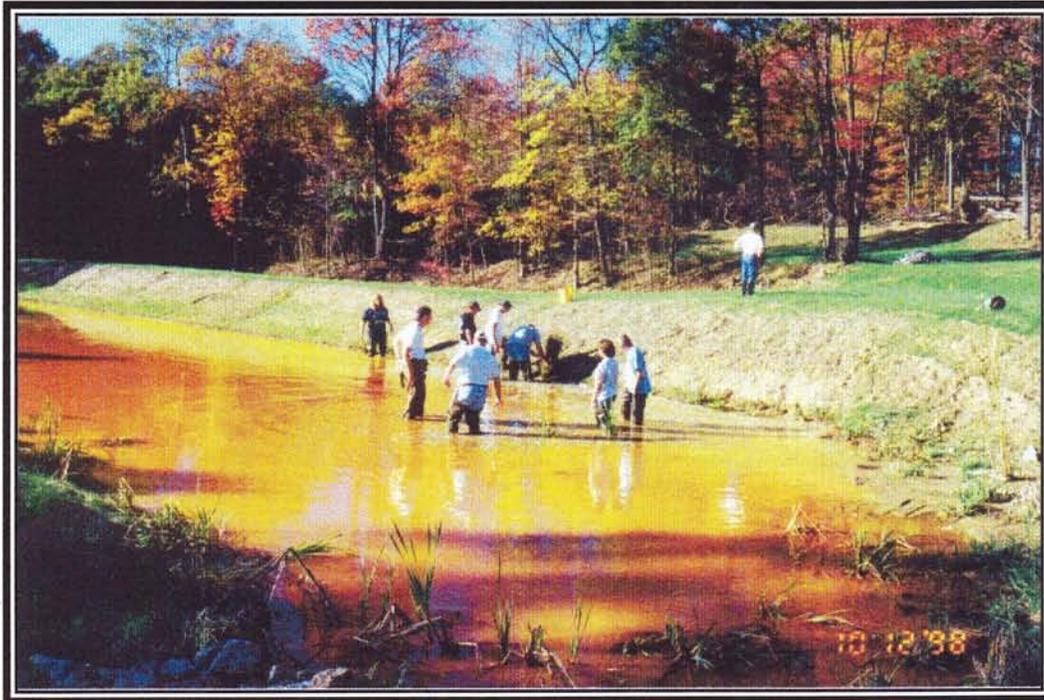
(SR101-A 10/12/98)

Slippery Rock University volunteers plant Wetland #1 with cattails harvested nearby (Dr. Jerry Chmielewski, Aquatic Plants class)
