SLIPPERY ROCK WATERSHED COALITION

SR96

### SR96: FINAL REPORT

Slippery Rock Creek Headwaters  
Washington Twp., Butler County, PA

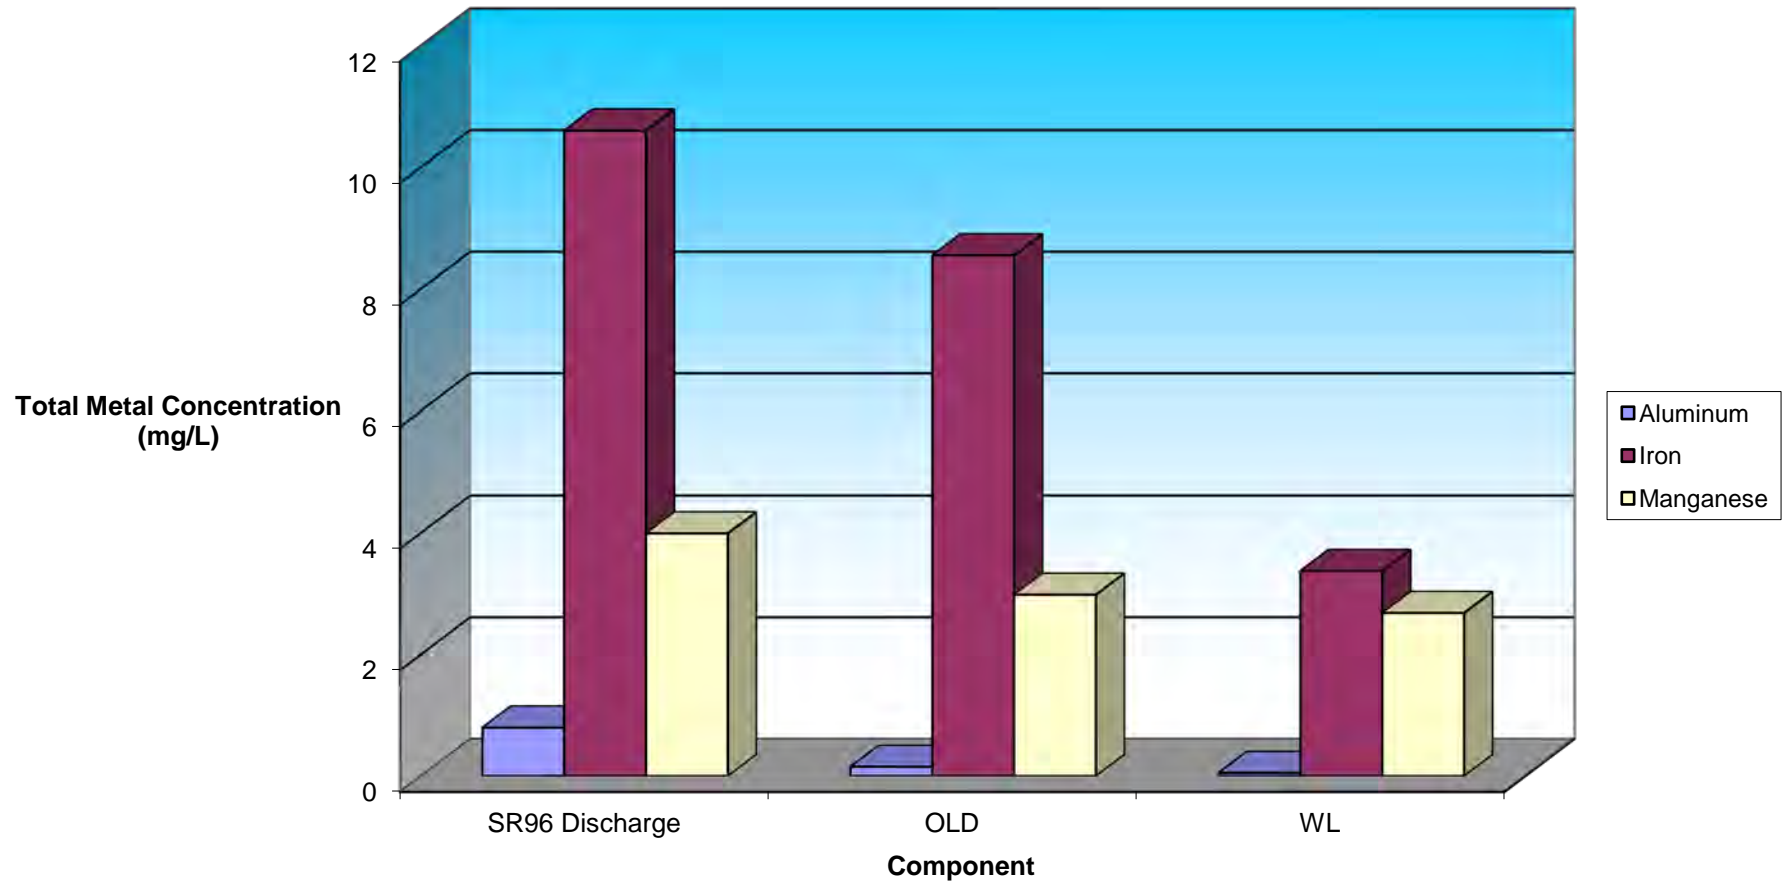
### Comparison of Iron, Aluminum, and Manganese Total Metal Concentrations Throughout the SR96 Passive Treatment System

Additional iron and manganese are expected to be removed prior to discharging to “Hilliards Branch” as the system effluent flows through additional wetlands prior to entering the receiving stream.

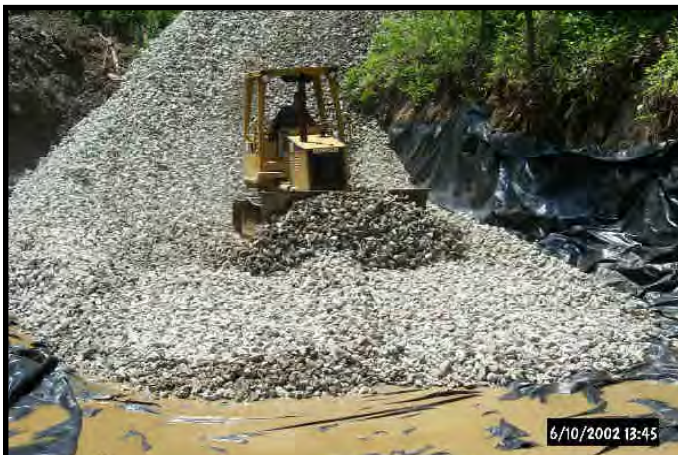
### Construction Begins at SR96

Construction of the 700 ton limestone drain recently began at the SR 96 site. On May 30th and 31st, OSM intern **Steve Short** (a biology student at Grove City College) staked 100 hay bales at the site for E&S Control. June 10th brought the actual construction of the drain. **Jerry and Jason Jesteadt** of **Jesteadt Excavating**, **Steve Short**, and SRI intern **Chris Treter** placed liners, spread limestone, and assembled the piping system. Thanks to Jerry and Jason Jesteadt for helping to build this system!!!!

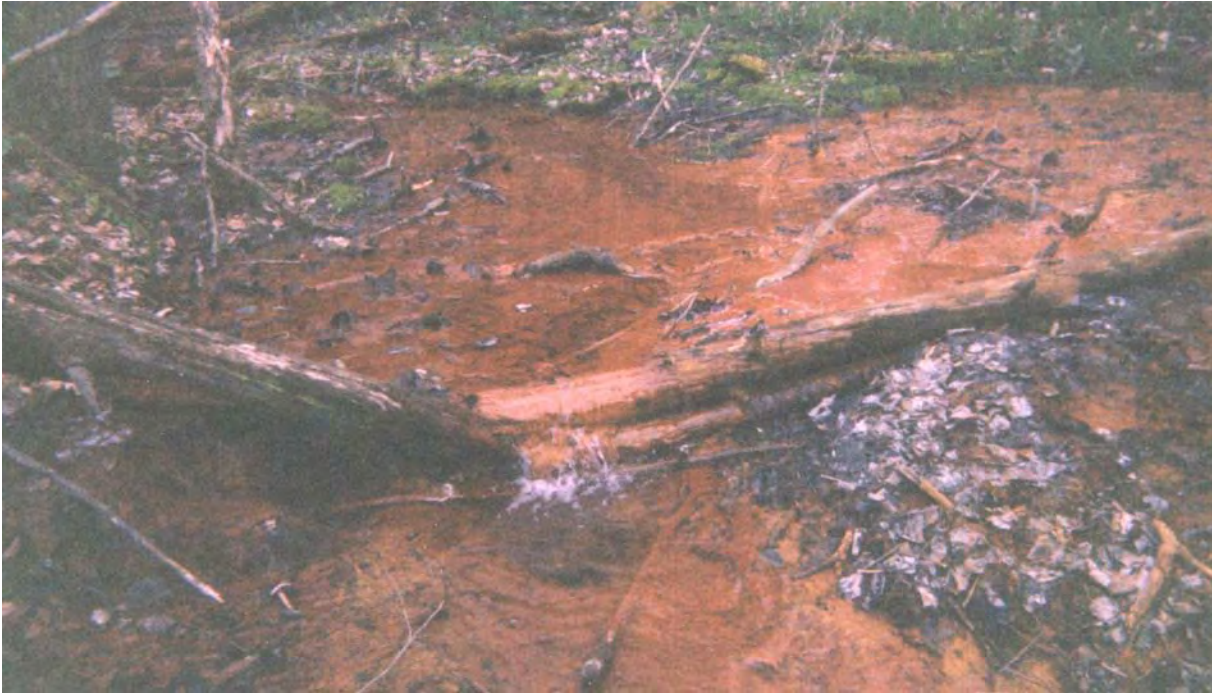
The acidic metal-laden SR96 discharge near its source.

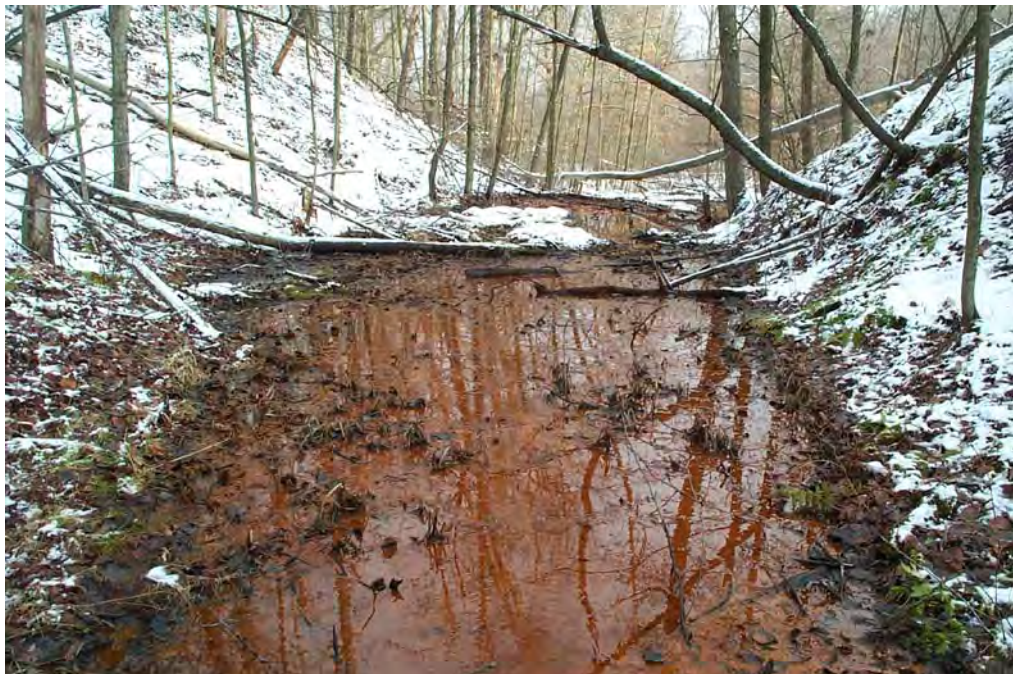
The SR96 discharge flowing through the spoil breach.

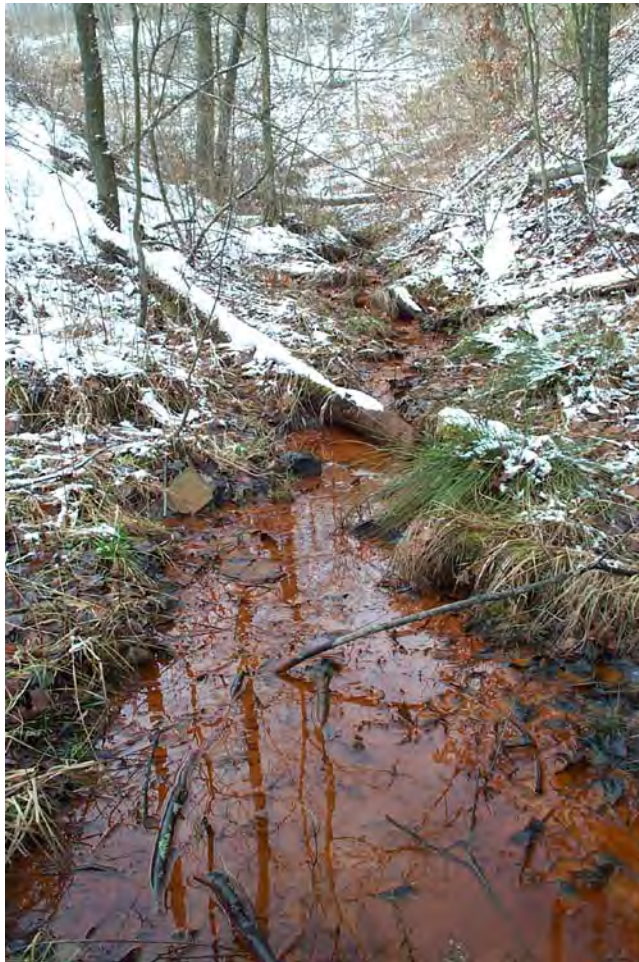
**Left:** The SR96 discharge flowing through the spoil breach. Note the limited construction area and steep spoil piles.

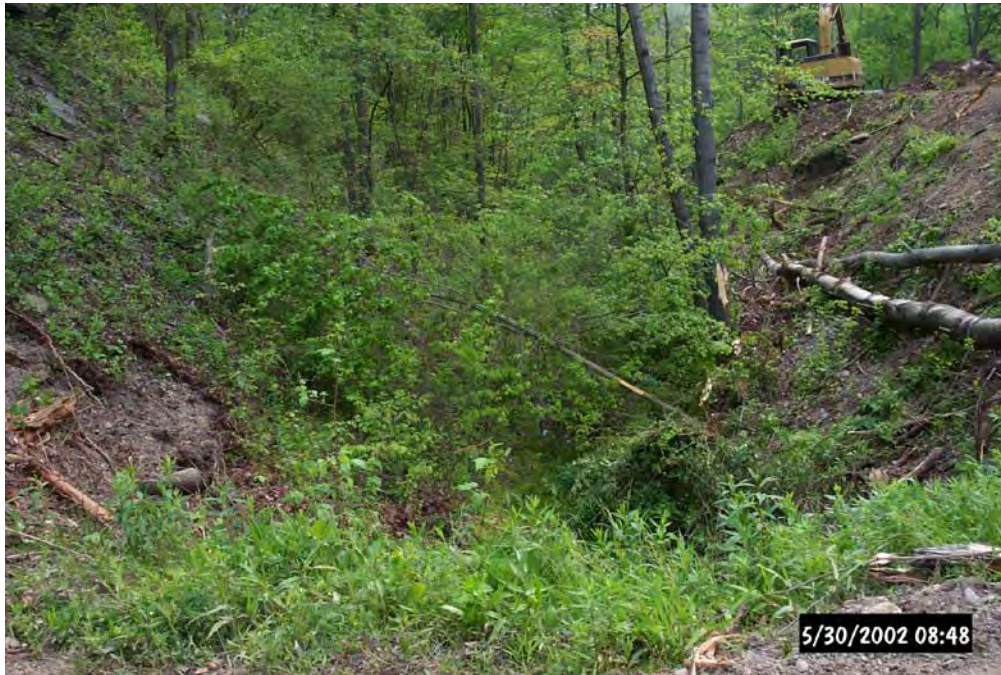
View of the vegetated spoil breach and source of the abandoned mine discharge during site preparation for the construction of the Oxyc Limestone Drain passive treatment system.

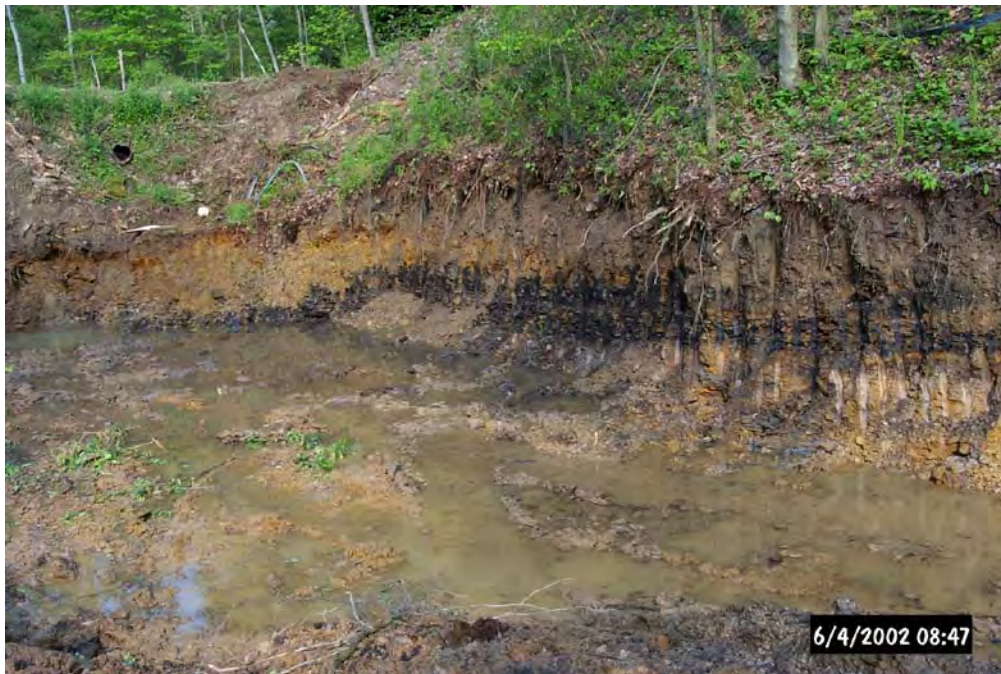
A portion of the Oxyc Limestone Drain during excavation. Note the coal seam along the bank.

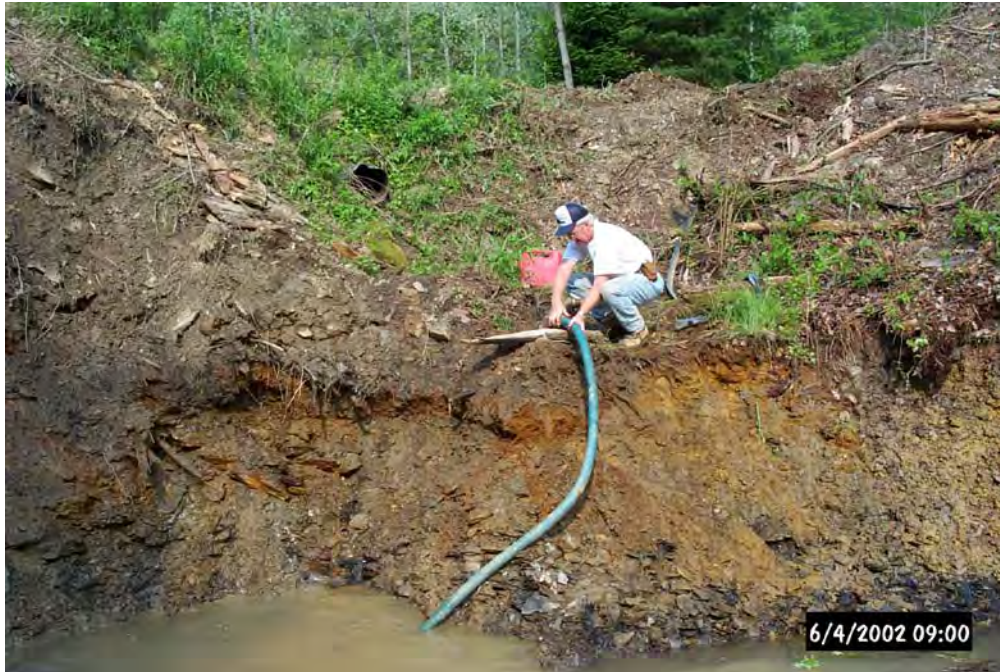
Jerry Jesteadt, owner of Jesteadt Excavating, pumping out water that has collected within the sump for the Oxic Limestone Drain.

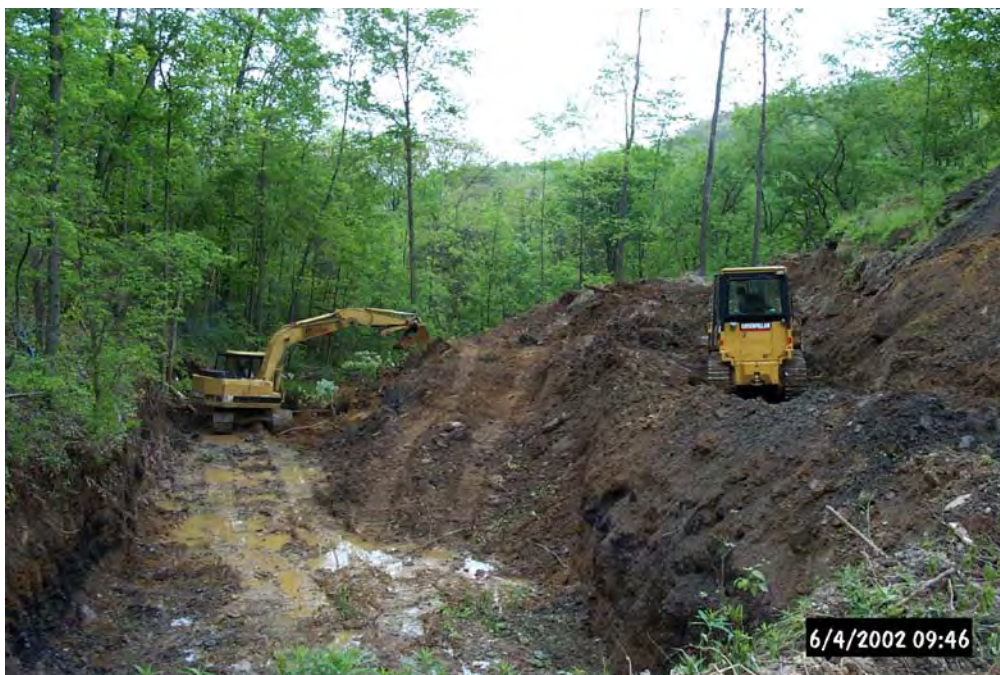
Jesteadt Excavating removing a portion of the spoil in order to construct the diversion channel around the Oxic Limestone Drain.

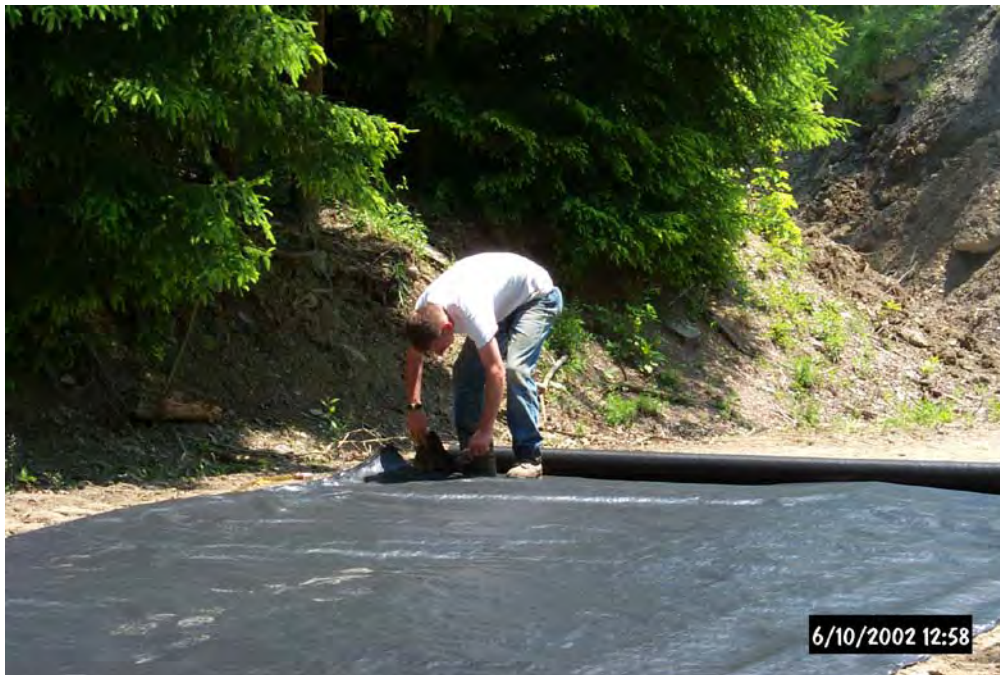
Jason Jesteadt installing the geotextile fabric before the limestone is placed.

Geotextile is to decrease sediment from filtering into the drain. Approximately a 1/2-foot of AASHTO #57, 90% CaCO<sub>3</sub>, limestone aggregate was then placed on top of the Geotextile as bedding stone for the underdrain system. Approximately 3½ feet of AASHTO #1, 90% CaCO<sub>3</sub>, limestone aggregate was then placed on top of the underdrain system. Flushing events of very limited duration are planned. The system would be completely drained only during major maintenance.

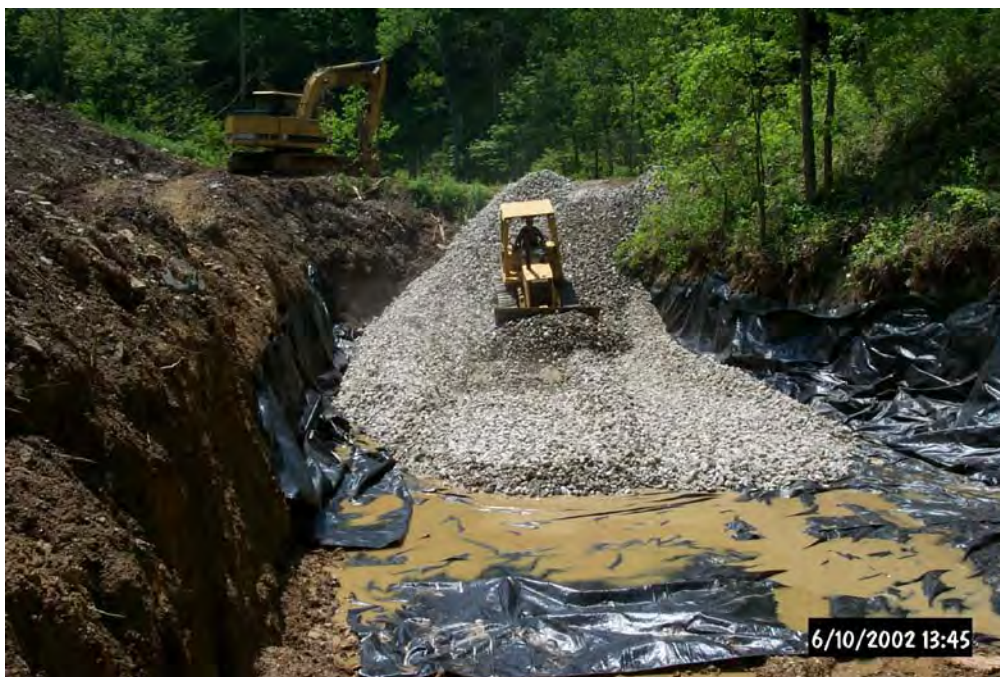
Placement of the AASHTO #1 90%  $\text{CaCO}_3$  limestone in the Oxidic Limestone Drain by Jesteadt Excavating.

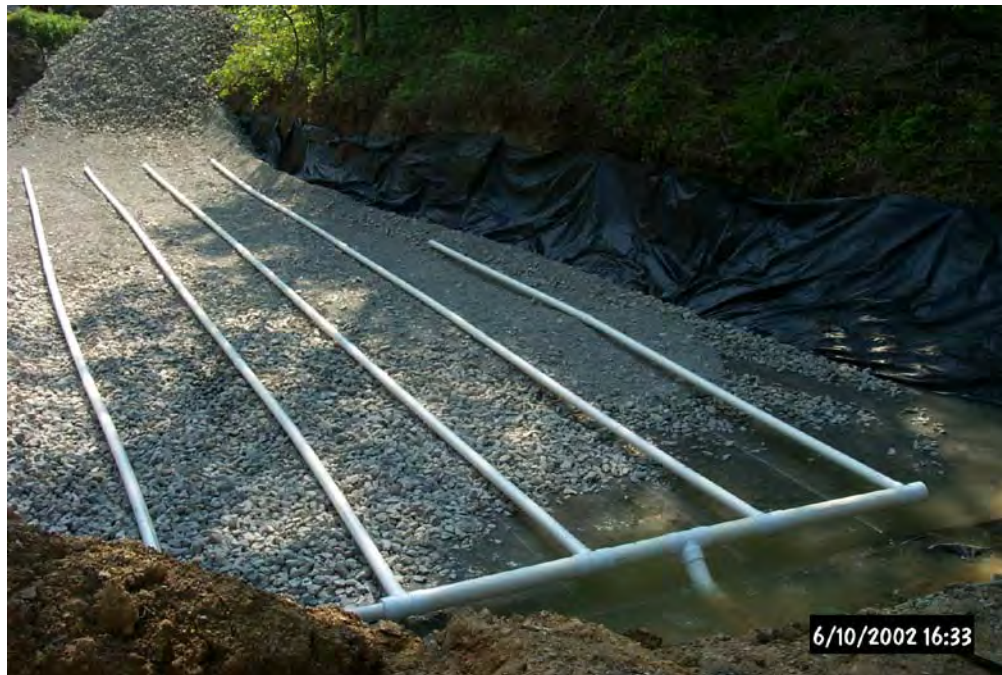
The underdrain flushing system for the Oxidic Limestone Drain.

The underdrain was constructed of 4-inch, Schedule 40, PVC pipe. Perforated laterals were placed on 4.5-foot centers and connected to a solid header with a sanitary-type tee. Perforations were hand-drilled with two, 0.5-inch perforations approximately 30° from the top of the pipe. The perforation spacing was equal to the lateral spacing (4.5 feet). The header pipe extends from the treatment media through the breastwork to a 4-inch, slide-type gate valve. Prior to the gate valve, a “Y” was installed about midway through the breastwork to create a riser for the primary outlet.

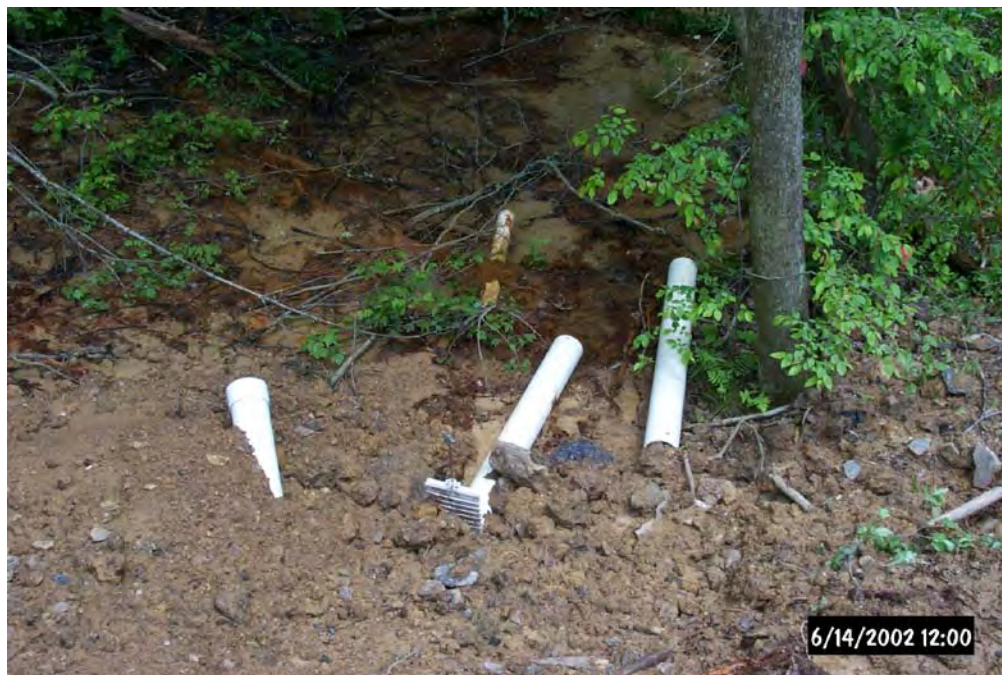
The outlet pipe from the Oxidic Limestone drain, which will discharge into the wetland is located on the left while the flush valve and flush pipe is located in the center.

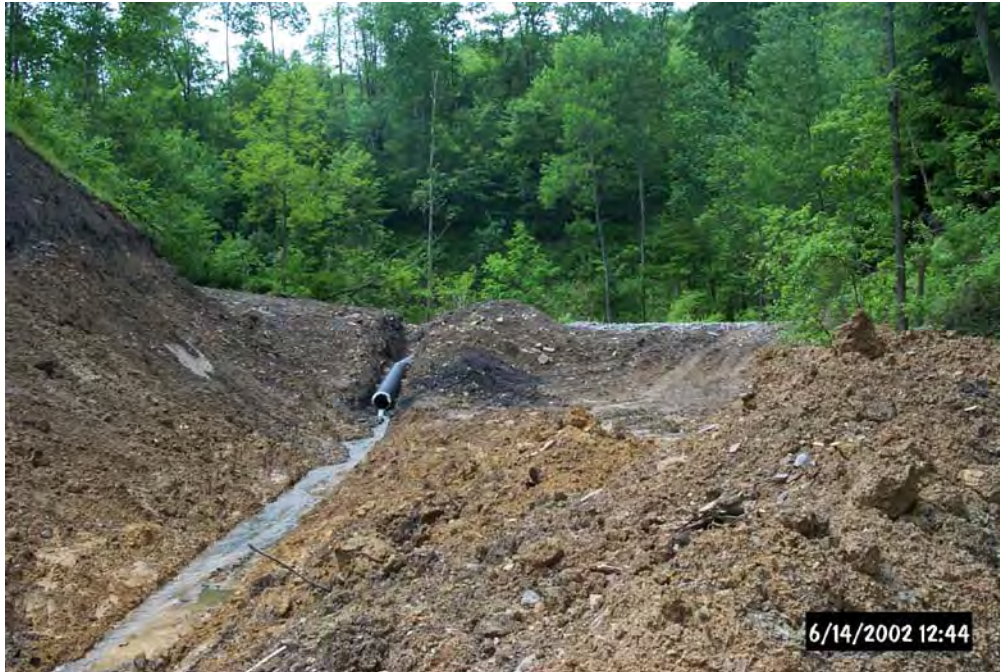
The drainage channel on the left is utilized to divert the flow from the pit impoundment around the buried Oxidic Limestone Drain (Center).

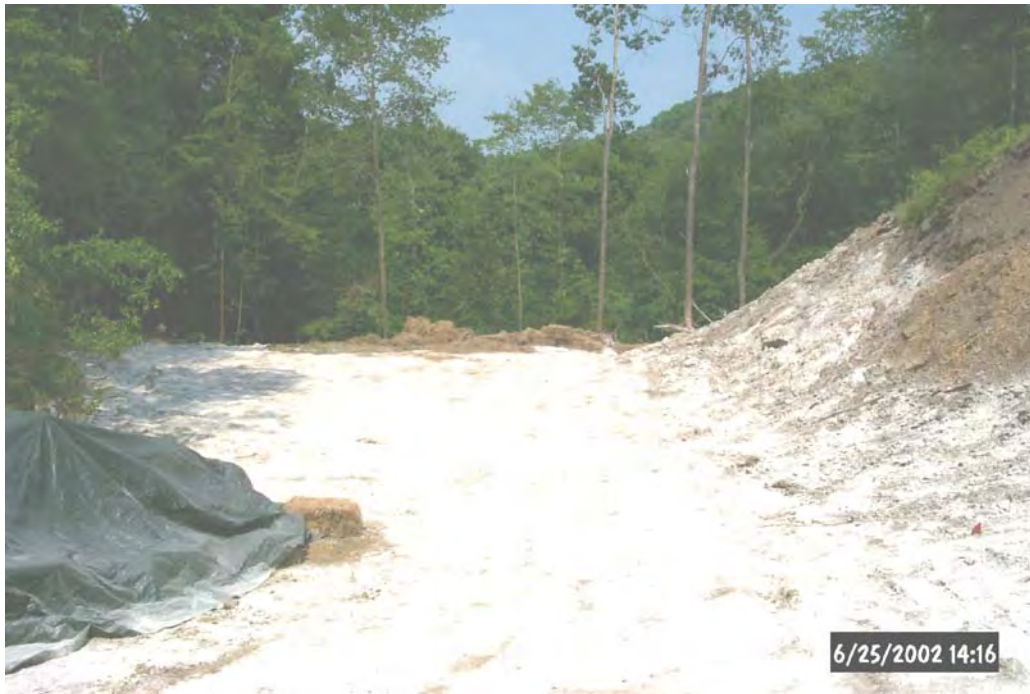
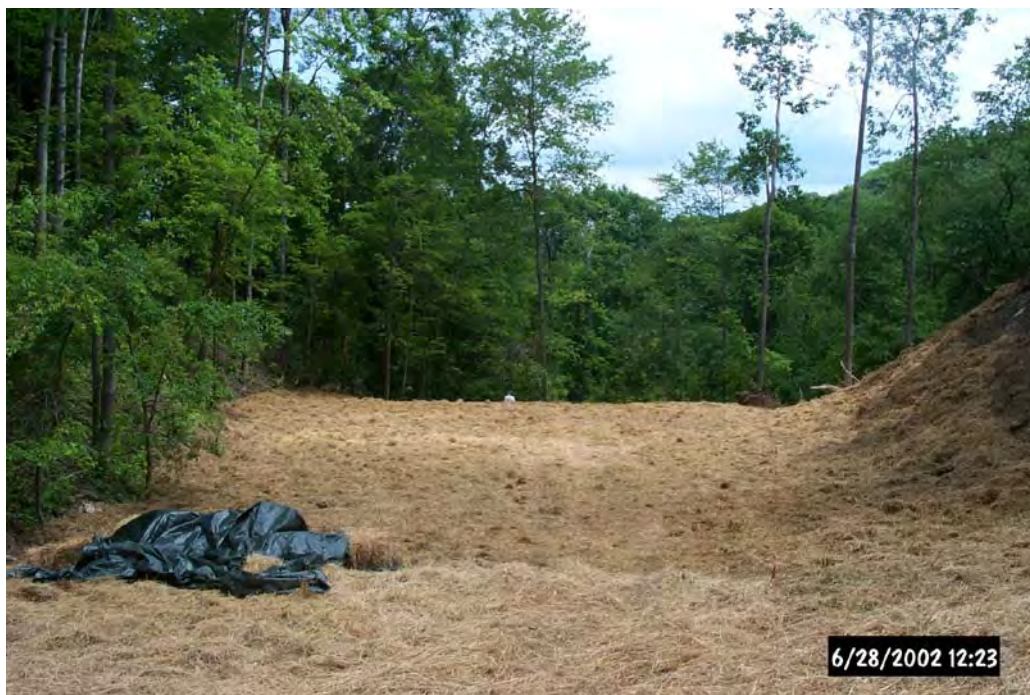
Following construction, agricultural lime was placed (above) before seeding and mulching (below) of the site.

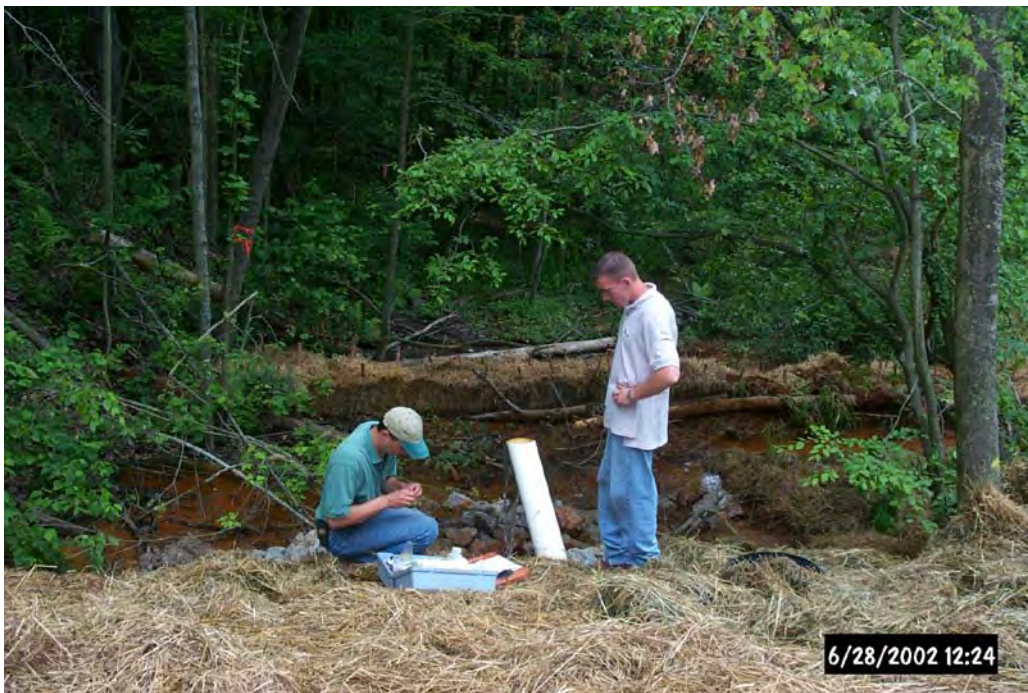
Tim Danehy and intern Steve Short, Stream Restoration Incorporated OSM intern, checking the alkalinity of the effluent of the Oxidic Limestone Drain.

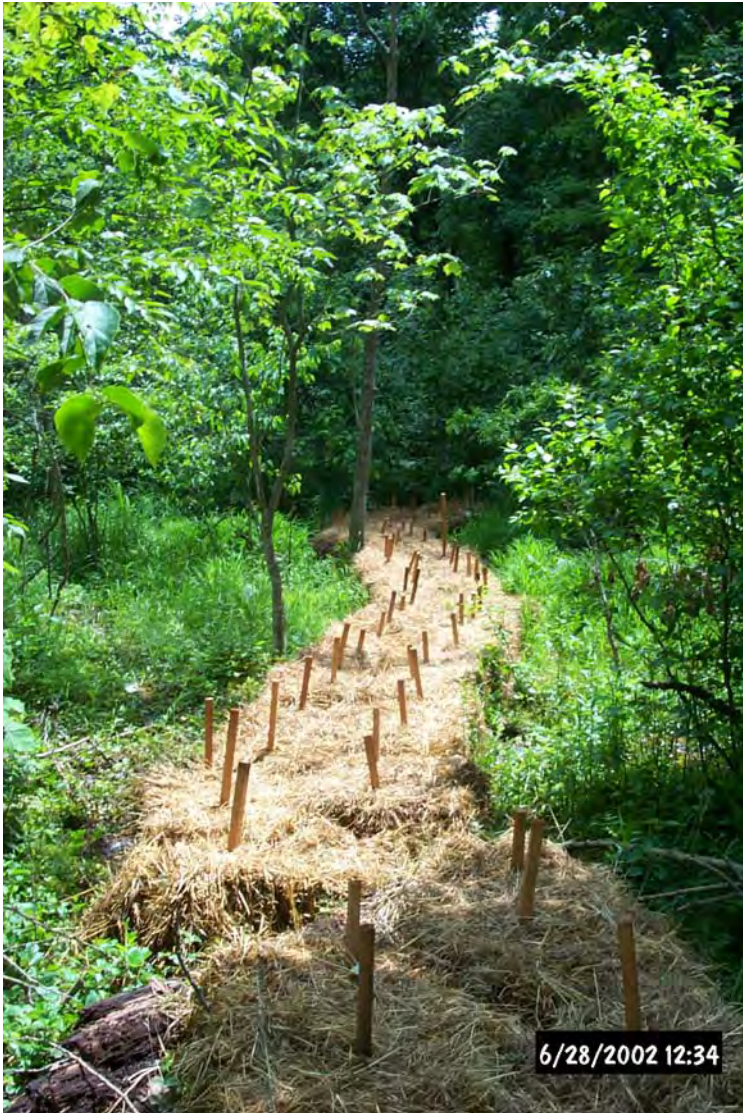
Double layered staked hay bales were installed by interns, Chris Treter and Steven Short. The hay bales are being used as flow diversion barriers to fully utilize the existing wetland.

Instead of excavating the existing natural wetland and constructing a new wetland, double-row hay bales were installed as directional flow barriers to substantially increase retention time and surface area contact to maximize treatment potential. From the wetland, the water enters the Hilliards Branch of Slippery Rock Creek.
