# **Use of Biosolids in the Passive Treatment of Abandoned Mine Drainage at the Jennings Environmental Education Center**

# FINAL REPORT

Jennings Environmental Education Center  
Pennsylvania Department of Conservation and Natural Resources  
Bureau of State Parks  
Brady Twp. Butler County, Pennsylvania

August 1999

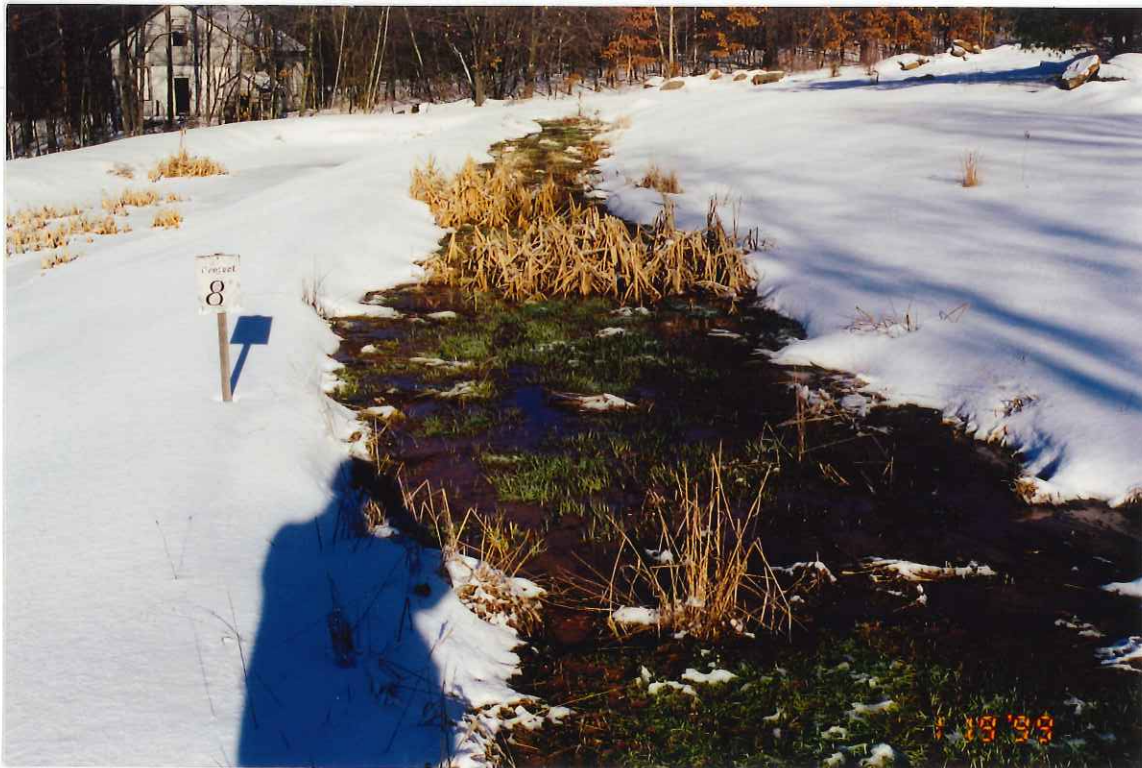
Photo 2. Channel wetland constructed using composted biosolids and quarry fines as a fabricated substrate continues to grow during winter months at the Jennings Environmental Education Center, Brady Township, Butler County, PA. (1/19/1999)

The results of this project have been shared with the general and scientific communities on a regional, national and international basis through the development of a poster and paper presented at the American Society for Surface Mining and Reclamation 1999 conference in Scottsdale, AZ (abstract published in conference proceedings p. 715) and the National Association of Abandoned Mine Lands Programs 1999 conference in Champion, PA, respectively and reporting related activities in the Slippery Rock Watershed Coalition's monthly newsletter, "The Catalyst". (See attached paper, photo. 2, and newsletter.)

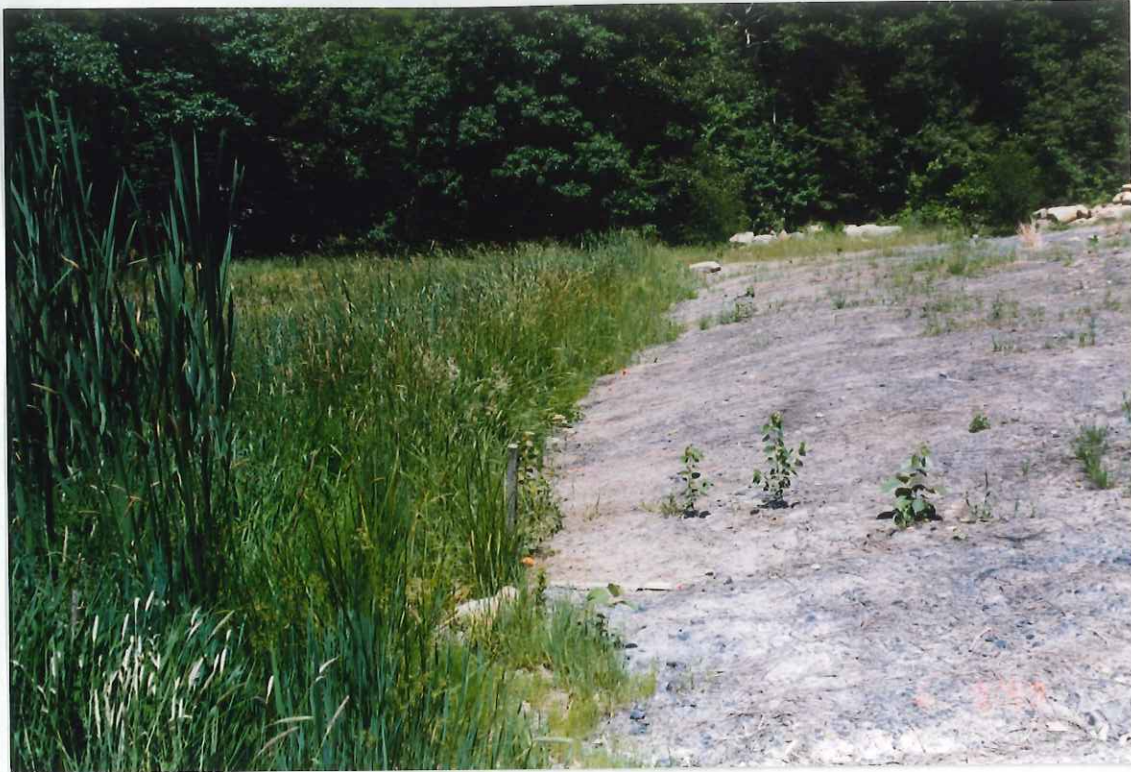
Photo 3. Channel wetland constructed using composted biosolids and quarry fines as a fabricated substrate sustains a dense and diverse vegetative cover(left) at the Jennings Environmental Education Center, Brady Township, Butler County, PA. (6/9/1999)

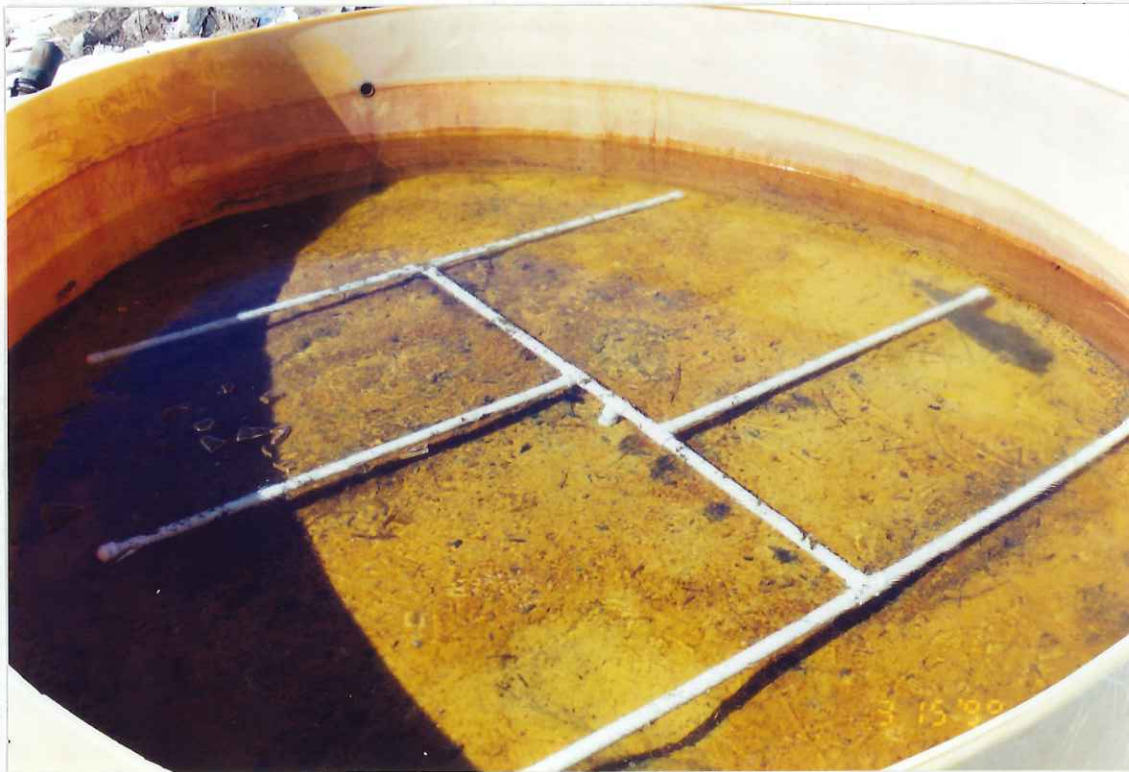
Photo 4. Pilot scale vertical flow tank constructed using composted biosolids and #9 limestone. Overdrain lattice work distributes acid mine drainage received by feeder pipe at center. Jennings Environmental Education Center, Brady Township, Butler County, PA. (3/15/1999)

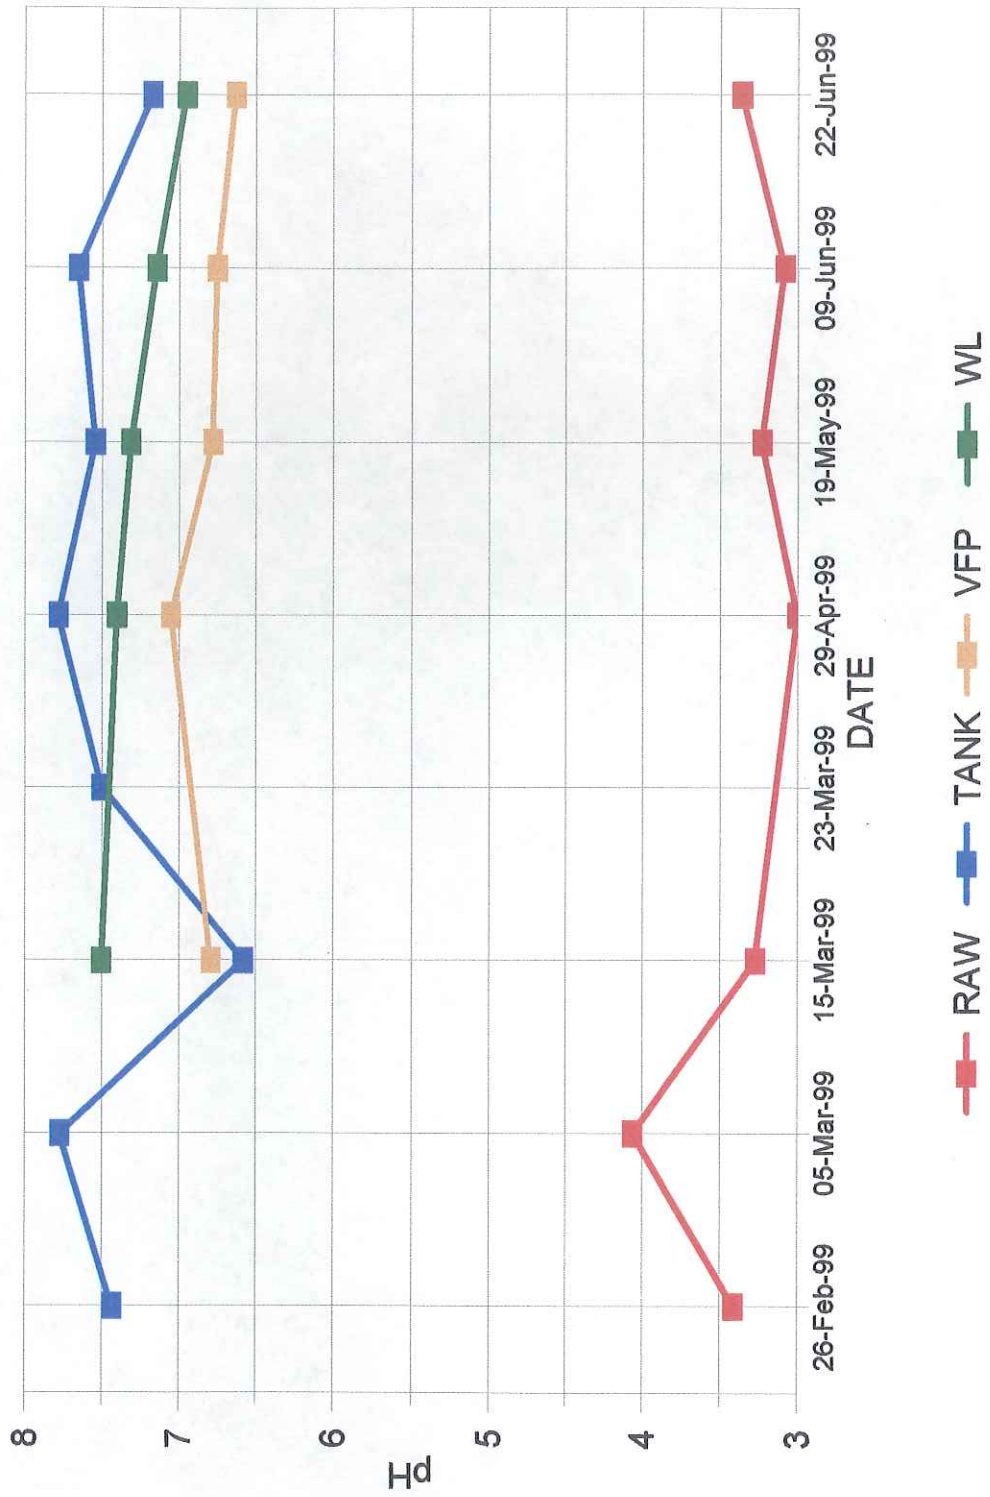
Figure 3

# pH (laboratory)

Due to the small surface area of the channel wetland(1900SF) only a very small improvement in water quality relating to standard mining parameters was expected. The pH was consistently higher at the effluent of the channel compared to the influent. This is assumed to be caused by the release of carbon dioxide and subsequent reduction in carbonic acid concentrations in the water. (See Figure 3.)

The aluminum-bearing discharge at Jennings requires that a circumneutral pH be maintained in order to effectively facilitate the sustained precipitation of aluminum hydroxide. This was achieved by the biosolids tank throughout the project. The tank actually produced higher pH values than the full-scale vertical flow pond on all but one occasion. (See Figure 3.)

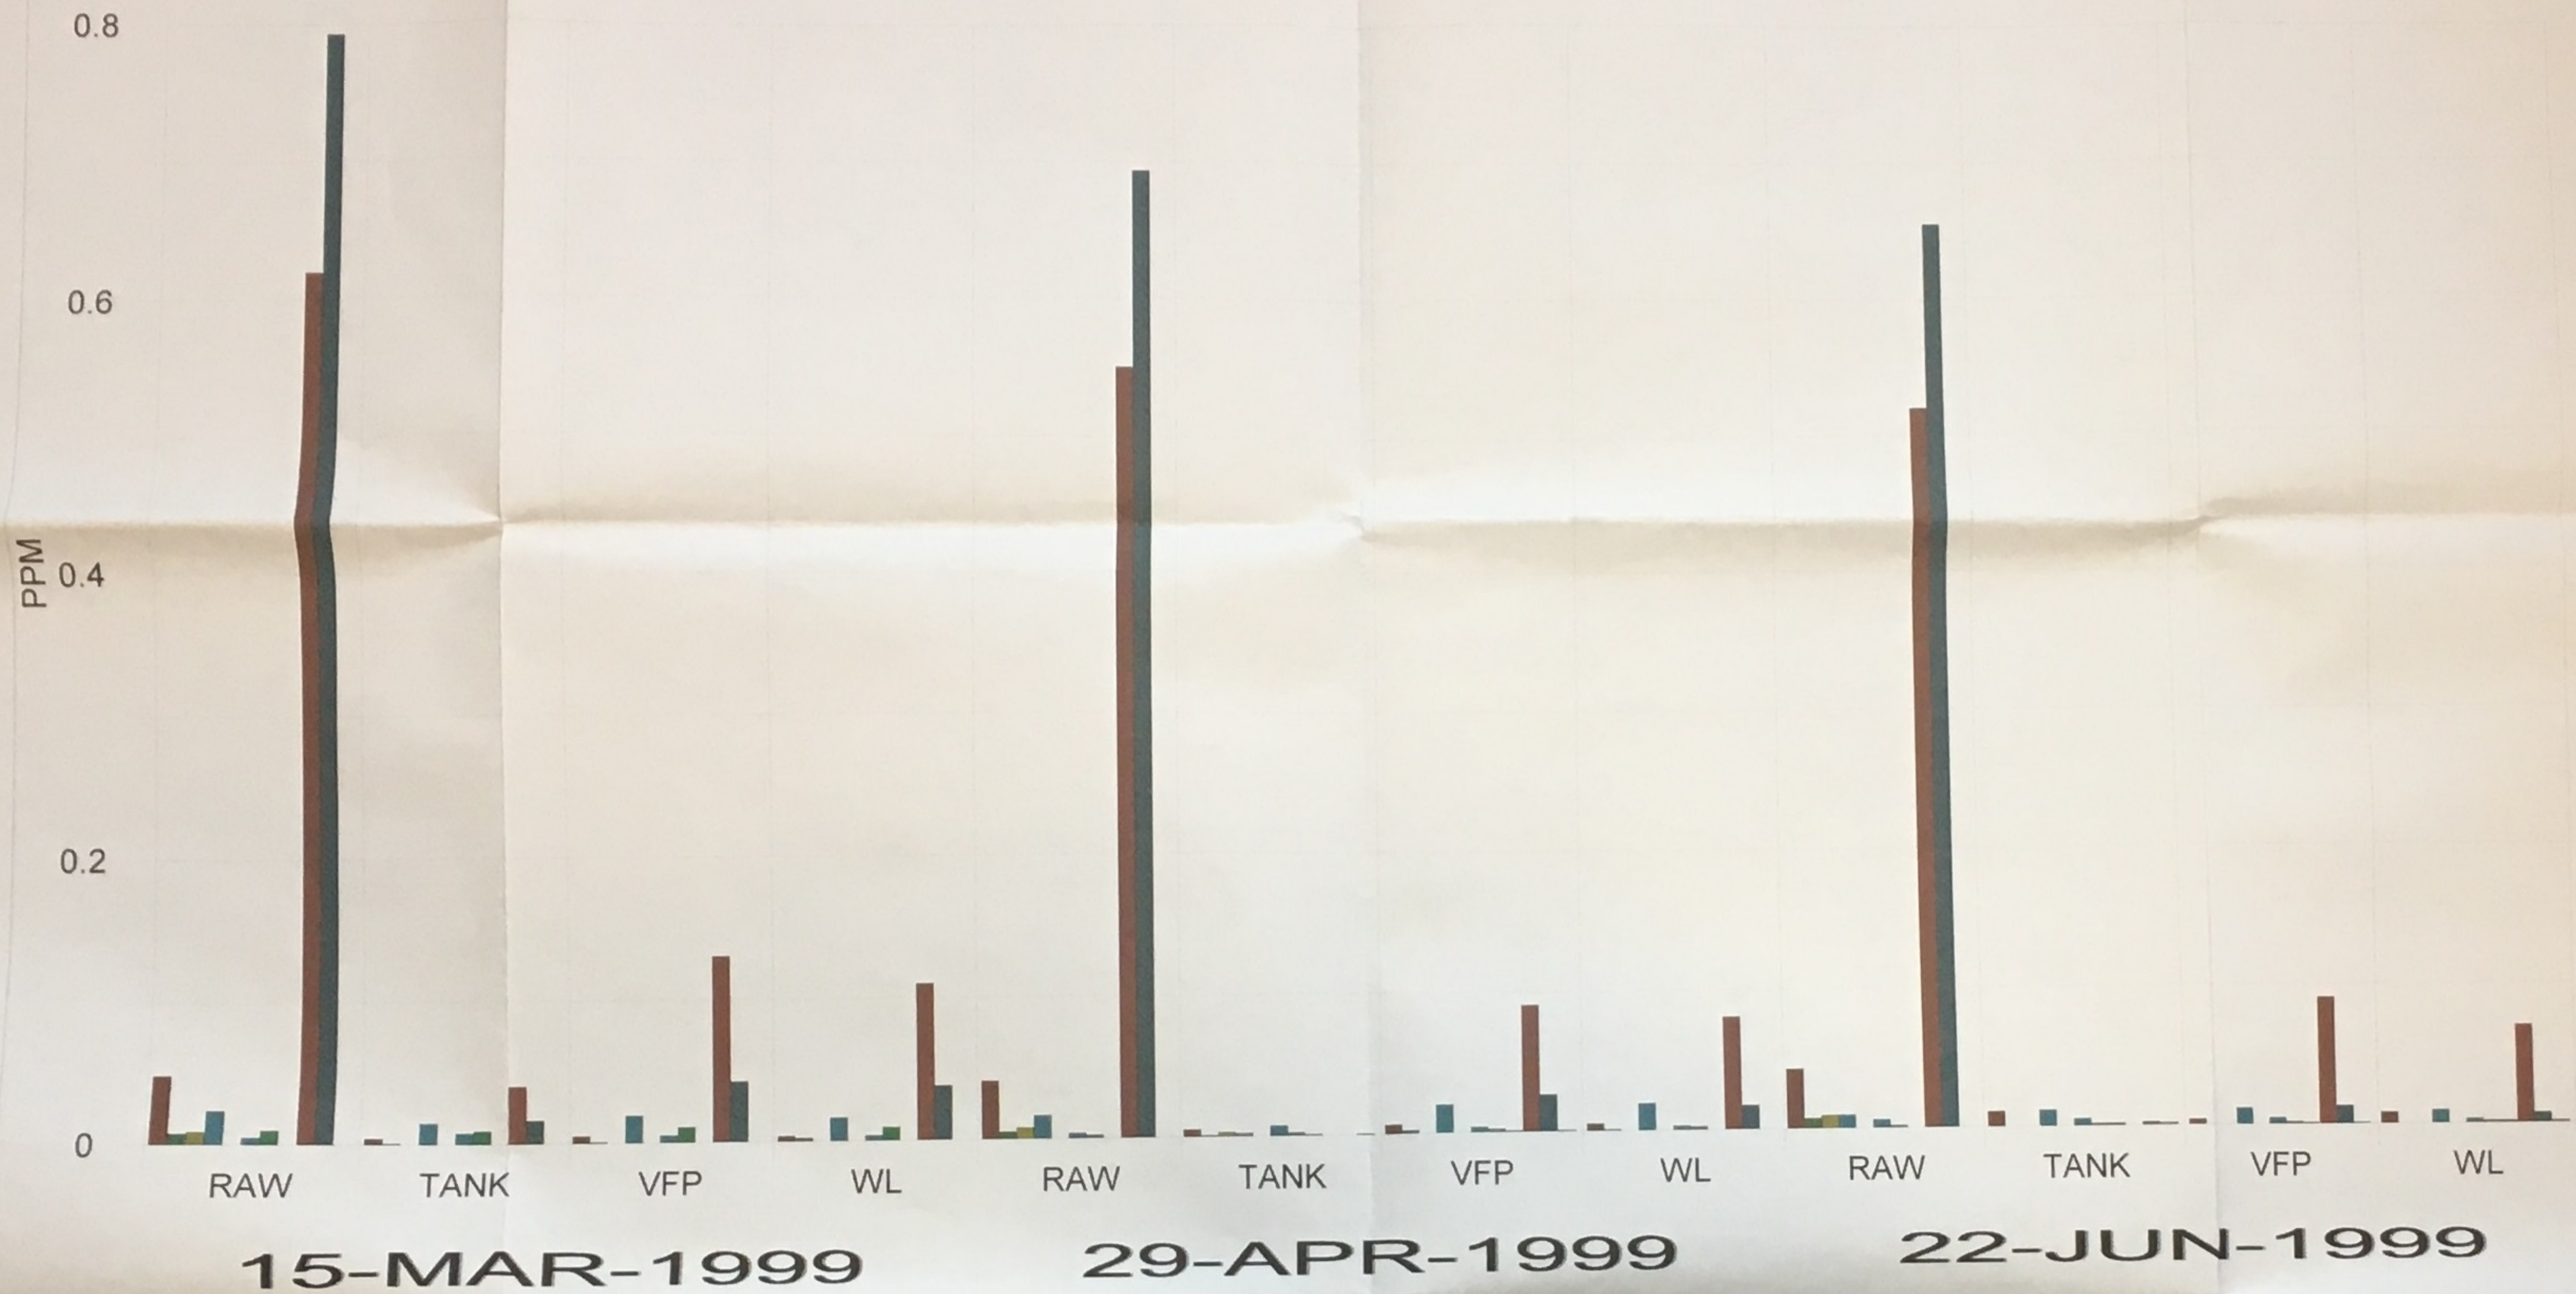
FIGURE 1

# METAL CONCENTRATIONS

(with Ni & Zn)

A suite of metals associated with the use of biosolids was monitored during this project. These metals include: As, Cd, Cr, Ca, Cu, Hg, Mo, Ni, Pb, Se, & Zn. These samples were filtered in the field using a 0.45 micron filter and fixed with nitric acid. Overall there was a slight decrease in all concentrations for these metals, with two exceptions, cadmium and lead. On one out of three occasions, the cadmium concentration increased from 0.001 ppm influent to 0.002 ppm effluent. The highest cadmium concentration observed, 0.002 ppm, is 2.5X below the EPA drinking water standard. Two of the three samples showed an increase in lead of 0.001 ppm and 0.005 ppm. The maximum concentration measured at the effluent of the wetland was 0.0019 ppm Pb which is 8X below the EPA drinking water standard. Due to the very small variations in concentrations observed during this project and the small sample set reviewed, it is difficult to determine if these two observed increases are caused by dissolution from the biosolids or minor analytical errors. (See Figures 1 & 2.)

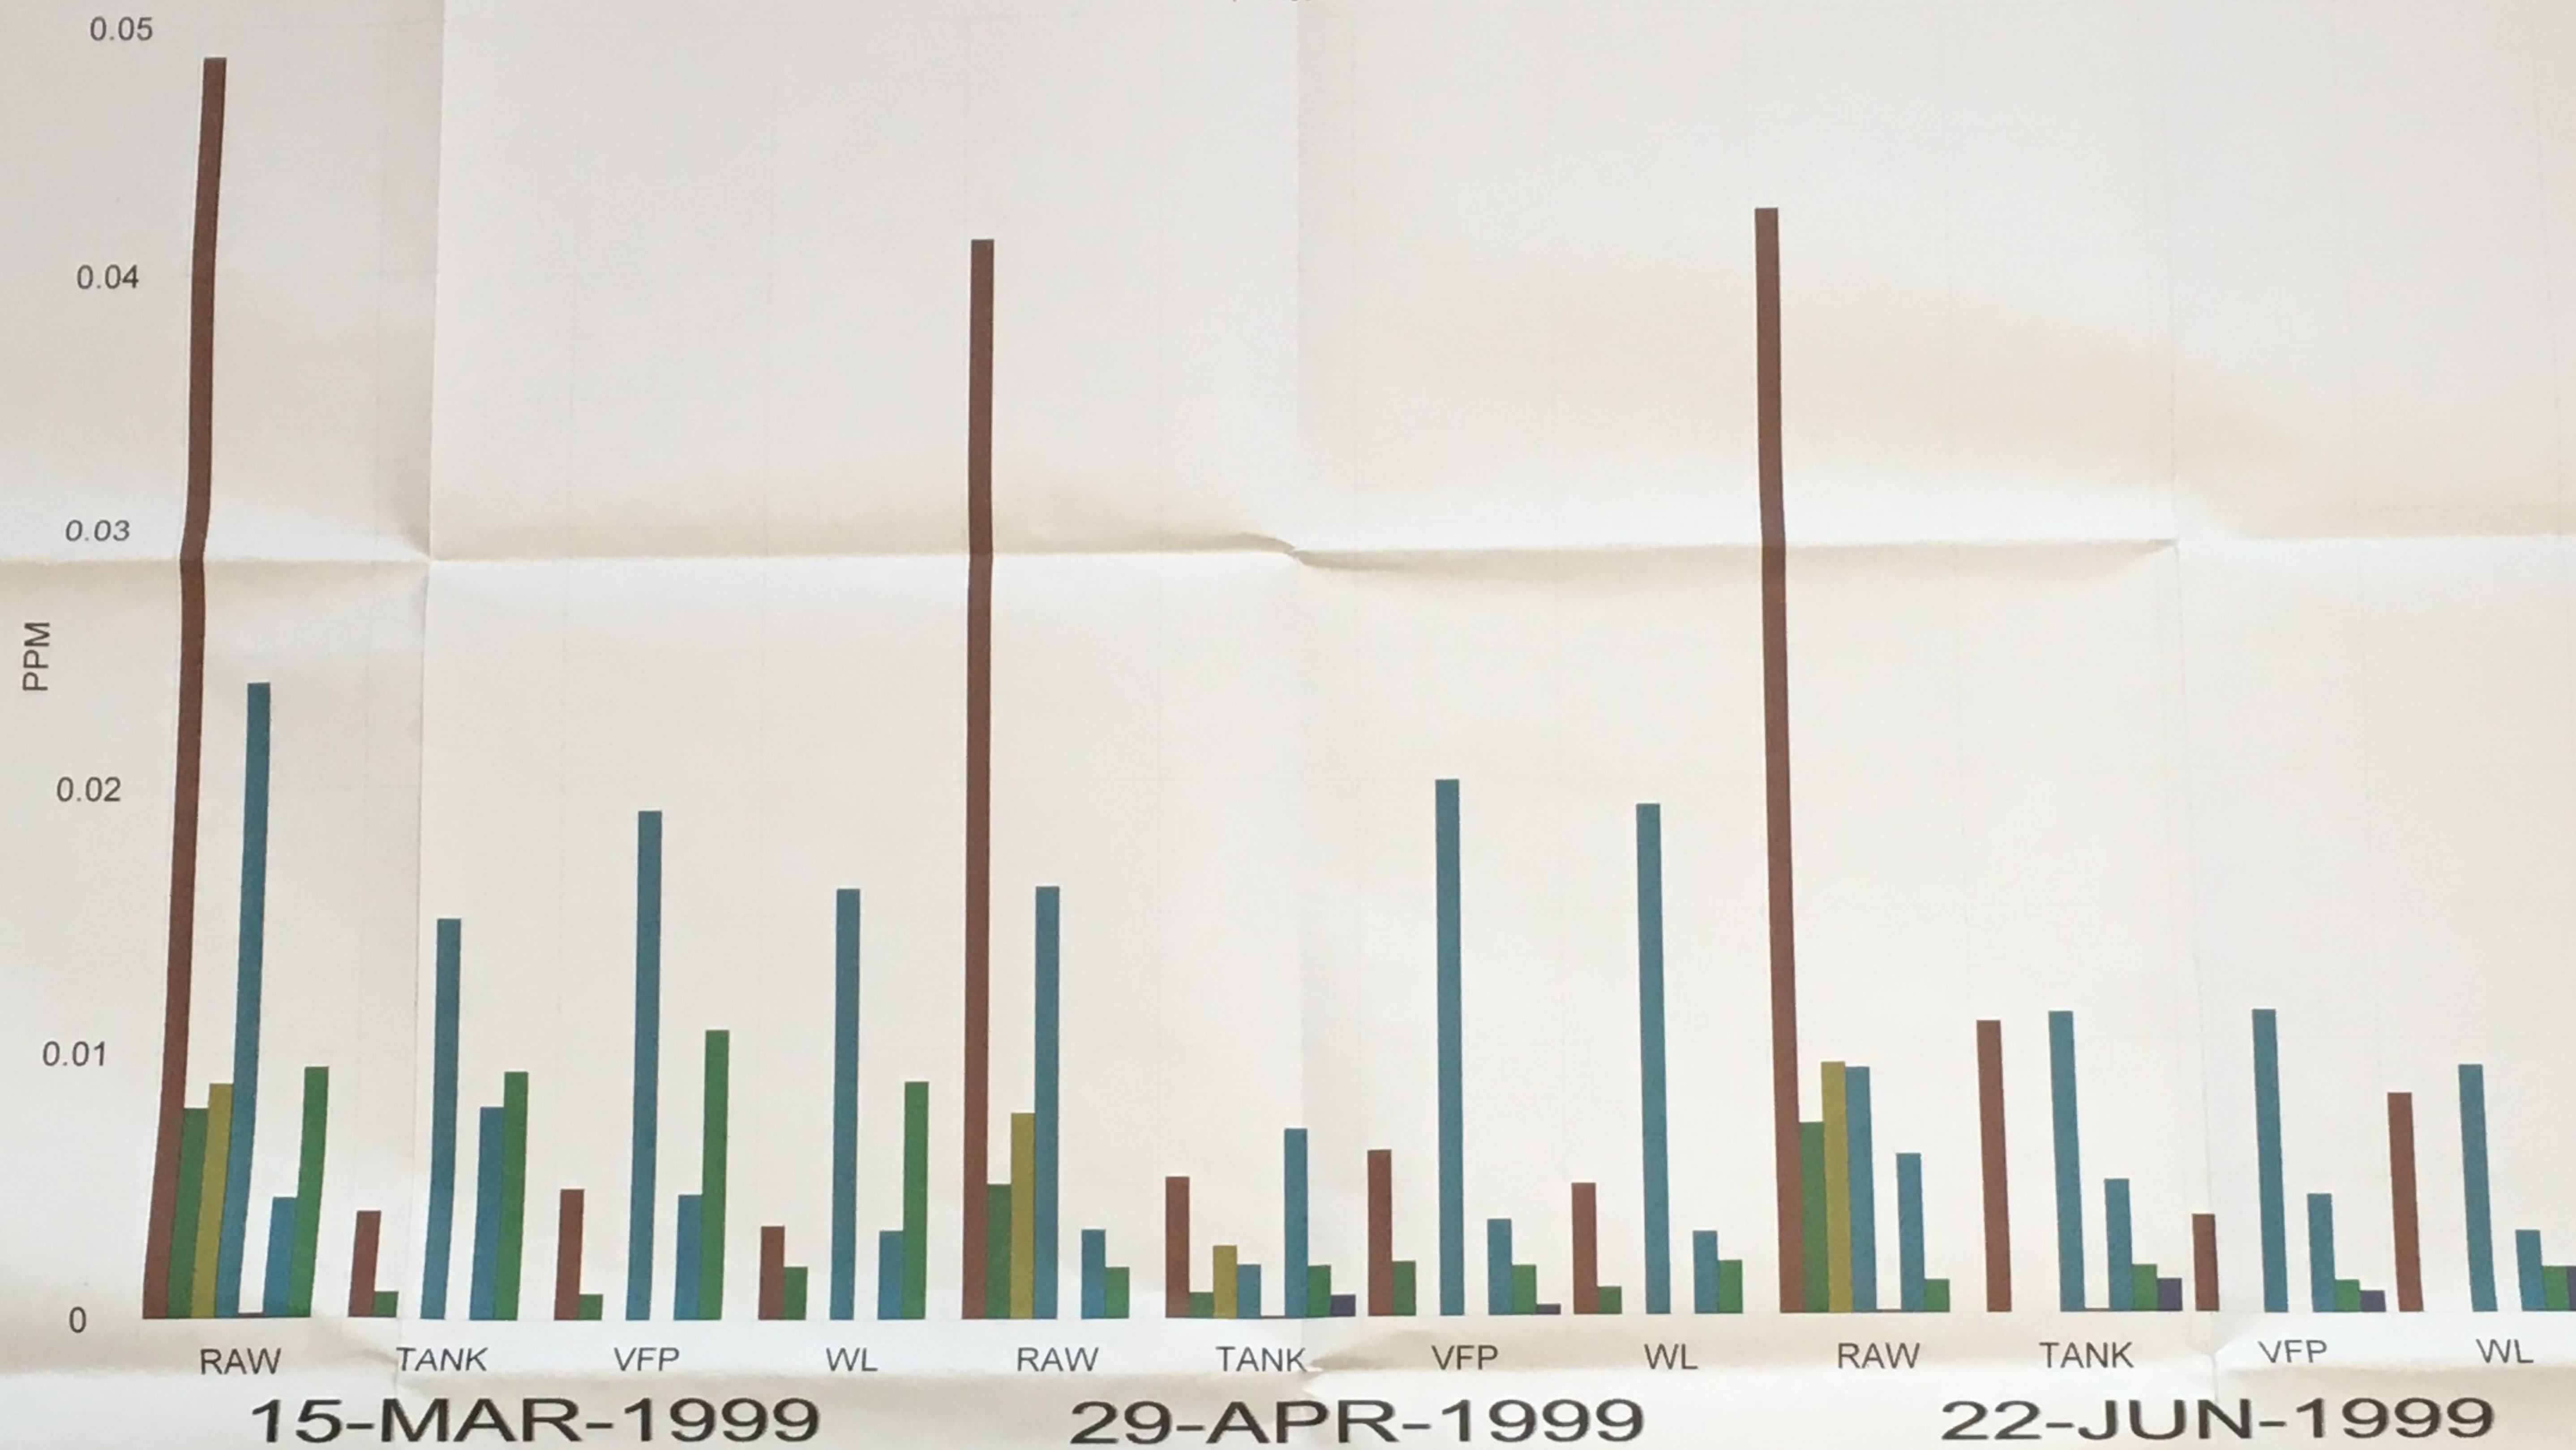
FIGURE 2

# METAL CONCENTRATIONS

(without Ni & Zn)
