Treatment of the Jamison Mine Borehole Discharge, Phase II Final Report

**Prepared for Kiskiminetas Watershed Association by Hedin Environmental
March 18, 2015**

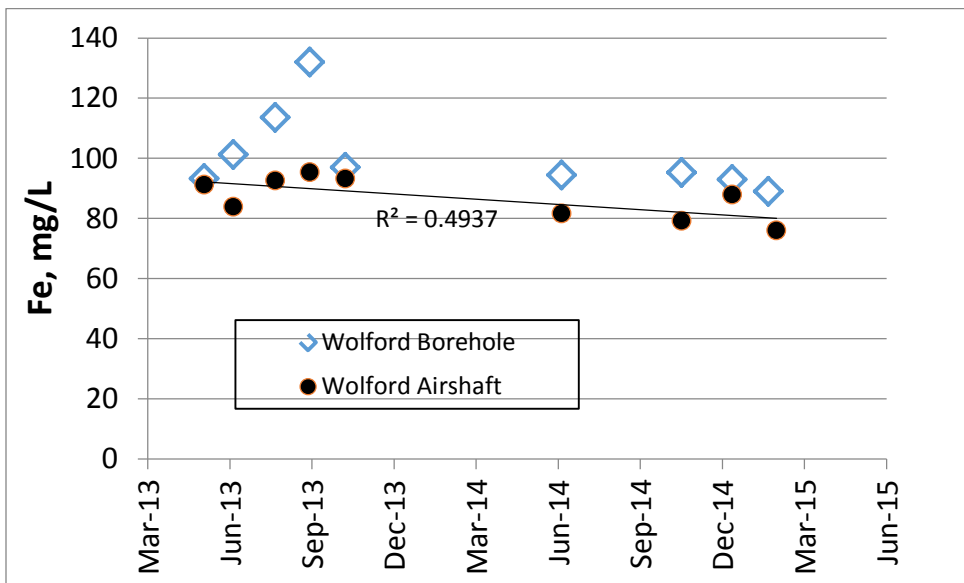
Figure 2. Fe concentrations at the Wolford Borehole and Jamison Air Shaft while both were flowing between 2013 and 2015. The downward trend for airshaft is statistically significant at the 0.05 level. The trend for the borehole is not significant.

The chemistry of the air shaft improved over the two year period at a statistically significant rate. (Figures 1 and 2). The chemistry of the borehole showed no such improvement. The rate of improvement over the monitoring period is -29 mg/L acidity per year and -7 mg/L Fe per year. It is not known if this improvement will continue. Based on observations at other sites, it is likely that the improvement will level off at a point determined by a new geochemical equilibrium in the deep mine.

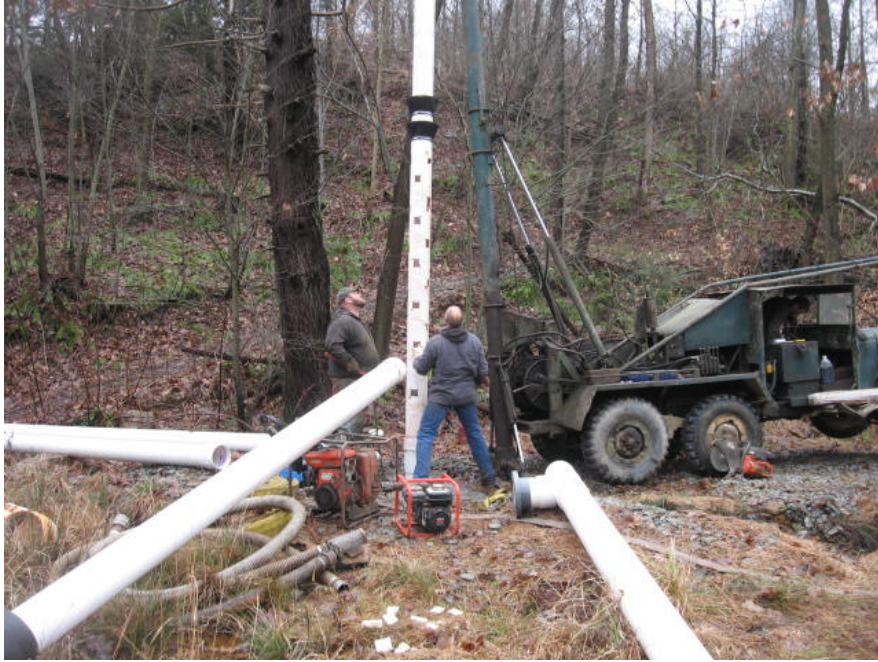
Photo 1. Perforated pipe and shale traps being lowered into the borehole

Specifics of Borehole Rehabilitation Work started on January 16 2012 and was completed on the 17th. S&T Services installed 110' of 8" Schedule 40 PVC pipe with two sets of rubber shale traps with a rag trap sandwiched in between. Photos 1, 2 and 3 show the pipe installation. This triple stack of traps were installed just above the roof of the mine into solid rock at about 78 feet. The annulus between the 8" pipe and well bore was then cement grouted from the top shale trap at about 78' from top of the hole to the surface. Before the annulus was grouted off and the pipe was set into the mine, a 3 inch water pump was used to pump the flow of water from within the pipe to prevent flow of water on outside of pipe. By stopping the flow of water during cementing operations the grout could be introduced down the annulus down to the top of rag packer by tremie tube. A tremie tube is in this instance a 1 inch steel pipe in 20 ft lengths that would be assembled together one by one as these were lowered into the annulus until setting upon the top packer. The tremie tube would be attached to the concrete pump to pump cement grout slurry down the tube all the while the tremie tube is delivering the grout at the bottom forcing water to the surface by displacement. As the cement grout was being introduced into the annulus the tremie tube was being raised in 20 ft increments and a section removed. The cement grout slurry displaced the water in the annulus forcing the water up the annulus and out of the well. After cement grout flowed to the surface all tremie tubes were removed. The 3 inch pump kept pace with flow of water inside the mine to prevent pressure of water from pushing the cement grout slurry. The extreme high density of the grout forced the cement to the bottom of packer. The water pump was filled with gasoline and allowed to pump water into the night to allow the concrete slurry to harden. On the following day it was found that all water was

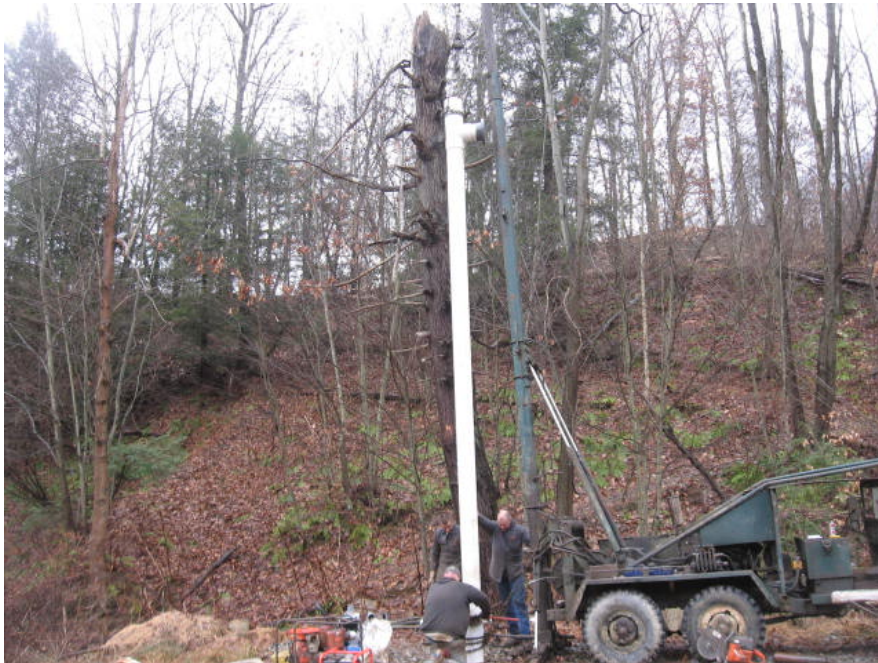
Photo 2. Solid pipe being lowered into the borehole

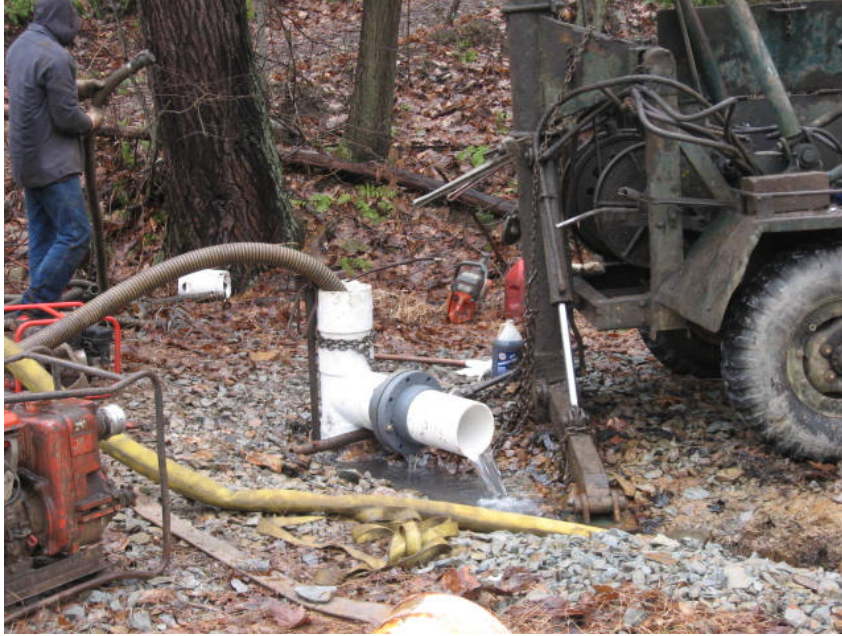
Photo 3. Finished pipework with grout injection

flowing inside the 8 inch pipe. No leaks were observed on outside of the new 8" well casing. It was decided to allow a couple of weeks for cement to cure before adding and closing the butterfly valve.

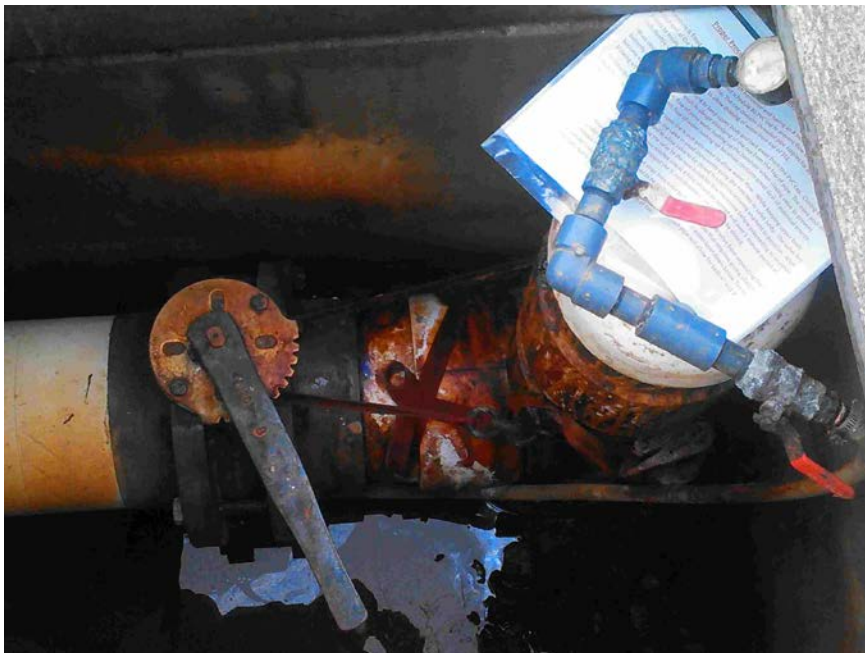
Photo 4: Wolford Borehole Improvements.

The top of the pipe was designed to allow the control of the discharge. An 8" tee was installed with one end on horizontal and the other end in vertical position. An 8" threaded plug was glued to the vertical end. An 8" butterfly valve was installed on the horizontal end. Photo 4 shows the borehole improvements.

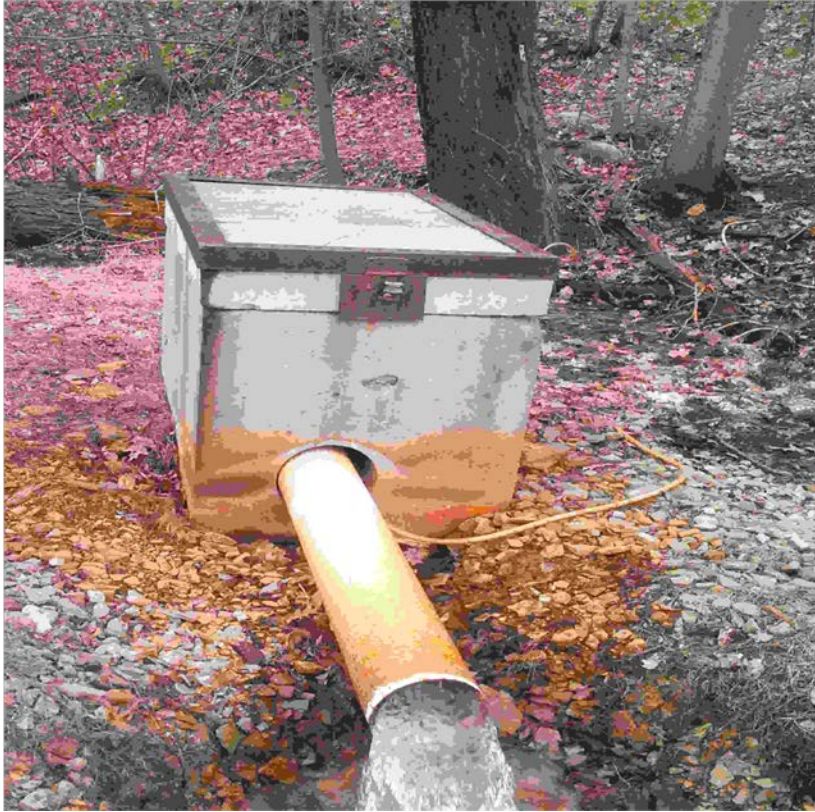
Photo 5: Concrete Vault Protection of Wolford Borehole Improvements.

A concrete vault was set around the borehole location in March 2012 to protect the new plumbing from freezing and vandalism. Santella Excavating (Derry, PA) installed the vault and made modifications to the plumbing. This vault was fitted with locking removable lid for full access to the inside of the vault. Photo 5 shows the vault. Plumbing was added to the top of the Tee that allowed connection of both ¾ inch tygon plastic tubing with ¾ inch throttle gate valve and a pressure gauge to monitor amount of pressure on the wellhead when valve was closed. Tygon tubing is clear plastic flexible tubing that allows fluid levels to be observed from the outside.

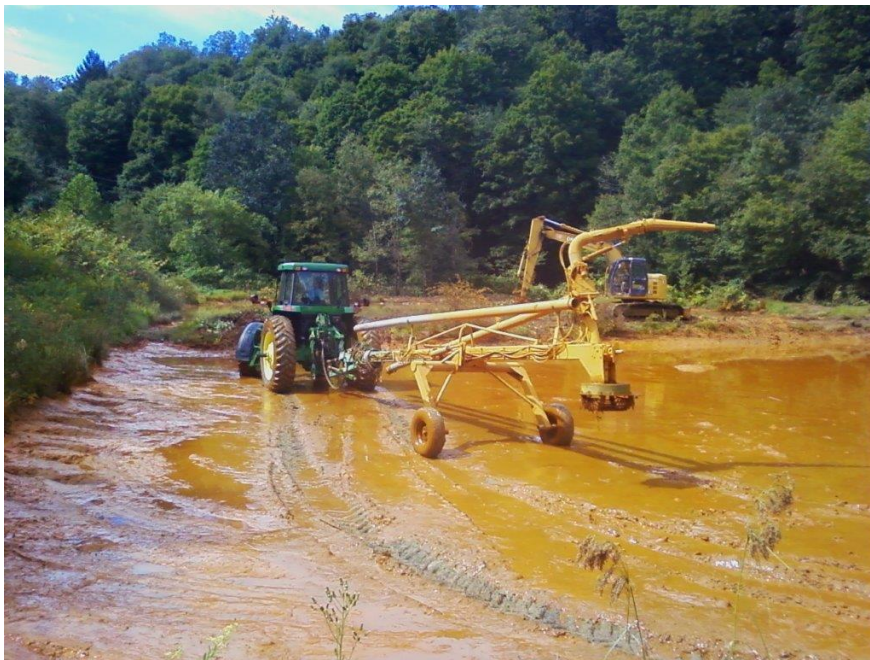
Photo 6. Sludge pumping equipment used for the Wolford project. The pond has been drained down and much of the sludge already removed. The photo shows the pump being moved.

The dewatering basin pond was constructed on a hillside overlooking the treatment system using an excavator and bulldozer. The basin was installed by Santella Excavating in June 2012. In September 2012 Santella Excavating returned to the site and pumped sludge from the treatment ponds to the basin. A Houle manure pump powered by a John Deere tractor was used to stir and pump iron oxide from the ponds. Once the iron was mobilized the tractor pump transferred sludge via 6 inch water hose to a 4 inch diesel powered water pump for boosting the sludge to the dewatering basin. An excavator was used to excavate sumps into bottom of ponds for placement of the pumps and to also stir up the sludge and push it towards the pump intake. The sludge removal was completed in one week. Photos 6 – 8 show the sludge removal operation.

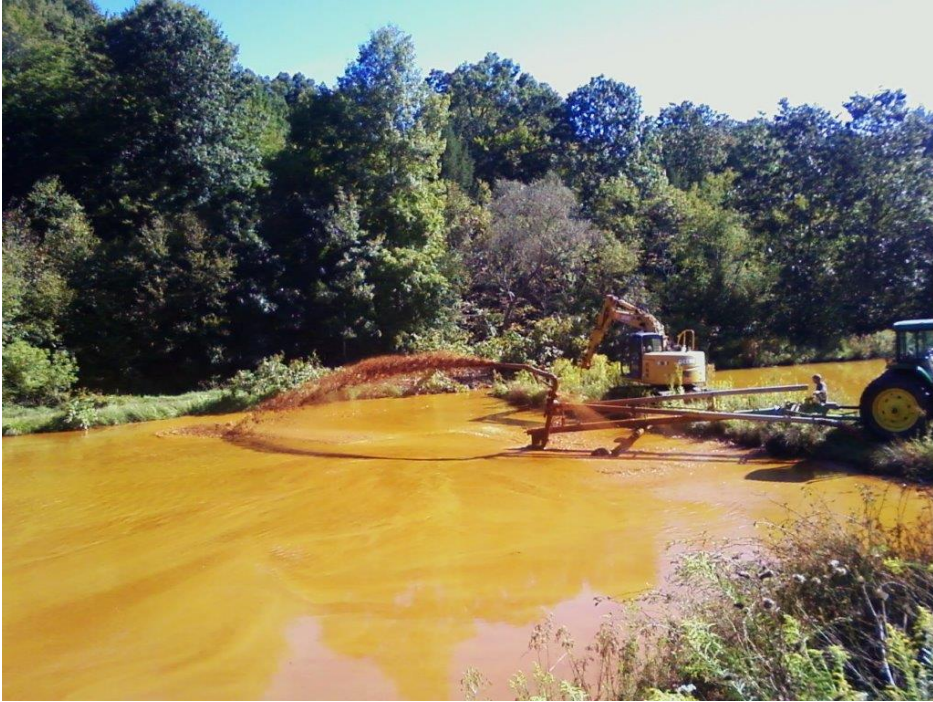
Photo 7. Sludge pump in operation at Wolford. The pump both mixes (spraying) and pumps. The photo shows mixing operation.

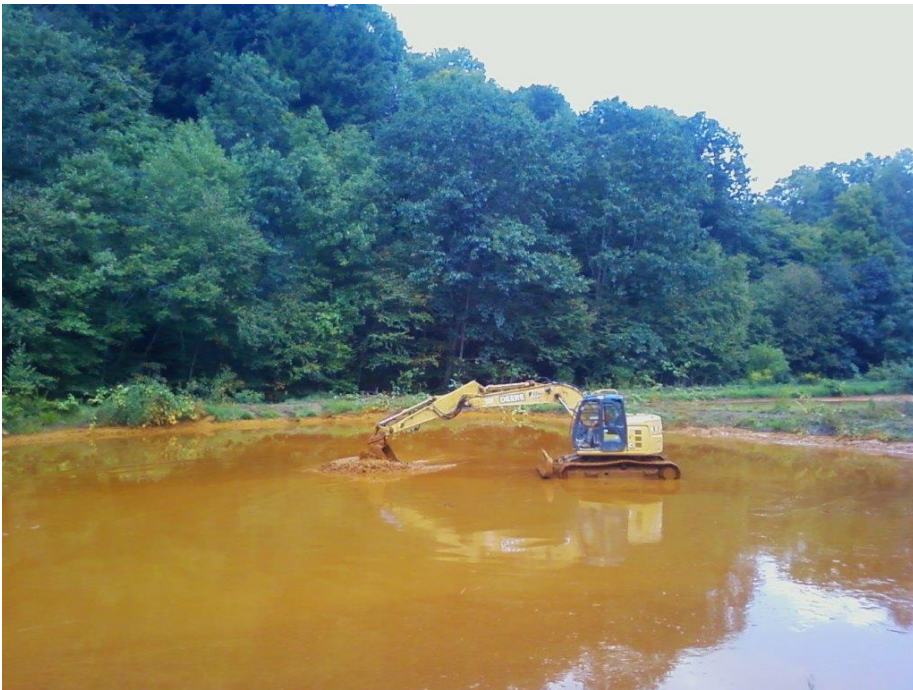
Photo 8. Sludge was pushed toward the pumping station using an excavator.

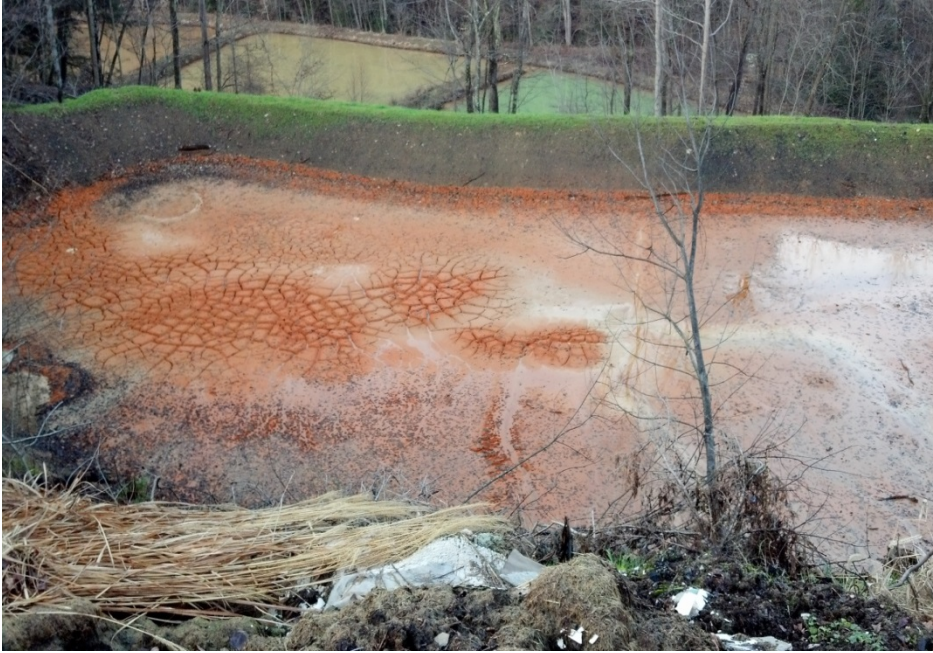
Photo 9. The sludge basin in December 2012. The sludge dewatered naturally in place (note the cracking) and then was stacked in small piles to promote drying.

Once all the material had been pumped to the dewatering basin, the sludge was allowed to settle and dewater for several months. Photo 9 shows the basin with dewatering sludge in December 2012. After three months the sludge had dewater sufficiently to allow it to be stacked by an excavator into small piles, which promoted further dewatering and drying. The stacking also created room in the basin to allow trucks access when the iron was removed. In September 2013
