Dents Run 3895 Passive Treatment System
SRI O&M TAG Project #32 Request #1
OSM PTS ID: PA-276

Requesting Organization: Bennett's Branch Watershed Association
Receiving Stream: Porcupine Run
Watershed: Bennett Branch Sinnemahoning Creek
Municipality/County: Bennezette Twp., Elk Co.
Latitude/Longitude: 41° 20' 24.72" N / 78° 20' 18.984" W

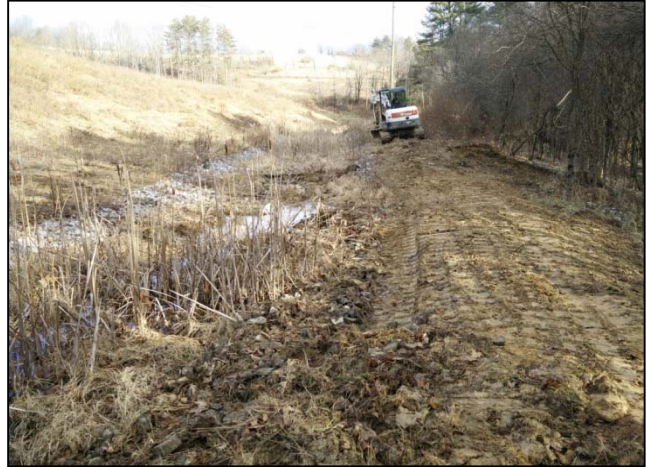
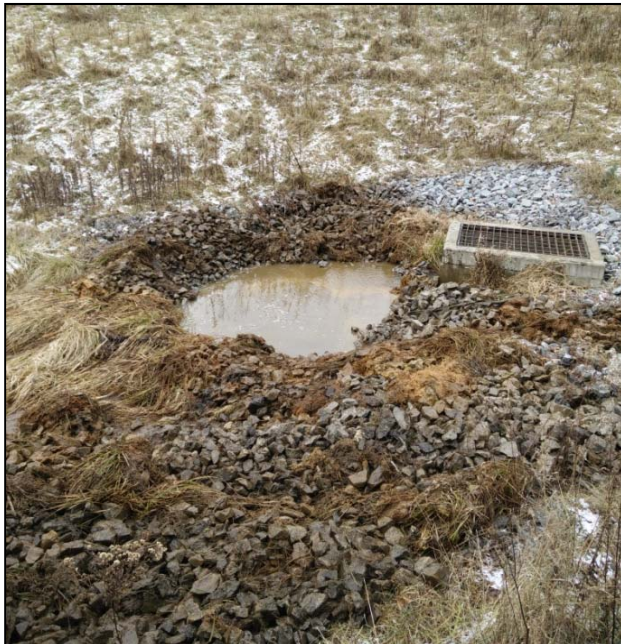
At Dents Run 3895, the elevation of the SP1 settling pond outlet pipe had shifted (Top Left) which prevented water from flowing into the Phase 2 portion of the passive system. This caused the water level to increase in the pond and then flow out through the emergency overflow riser (Top Right) bypassing the rest of the system. The SP1 outlet pipe was shortened and a downward facing elbow added (Middle Left) to restore proper flow. The low spot in the OPC3 berm was repaired by adding dirt to build up the berm (Middle Right) in order to prevent overtopping. Vegetation, metal sludge, and other debris that had accumulated in the OPC3 inlet spillway, (Bottom Left) were removed and the channel deepened to prevent water from backing up into SP1.
