MIDDLE LOYALHANNA CREEK WATERSHED

SECTION 2

Section 2 – Middle Loyalhanna Creek Watershed

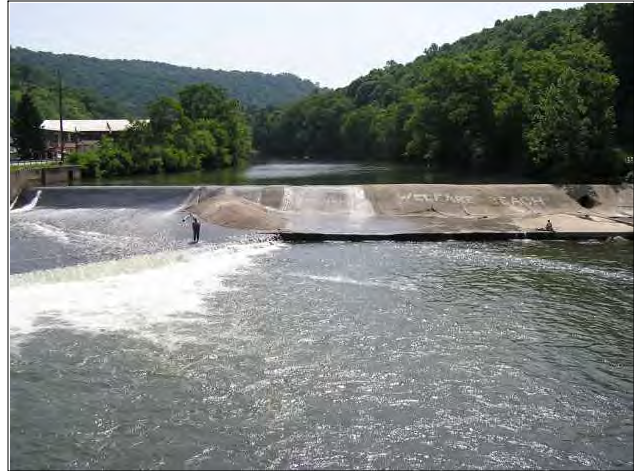
Looking upstream from the Kingston Dam at the junction of Route 217 and Route 30.

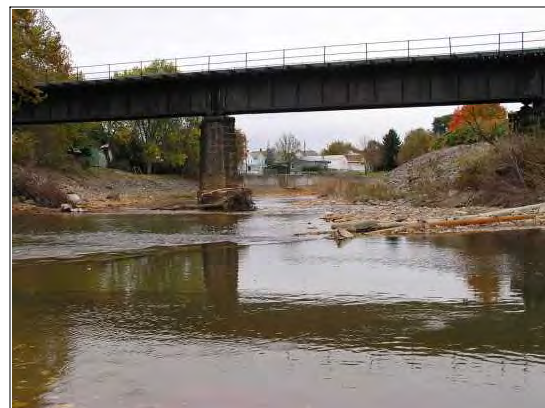
Five hundred feet downstream of the Loyalhanna Creek confluence with Monastery Run, two discharges each contribute 130-150 gpm into the Loyalhanna Creek. The first is a borehole drilled into the middle of the stream. The borehole, referred to as the Adelphoi Borehole, was drilled in order to relieve basement flooding in nearby homes in the 1950s or 1960s. As of late fall 2004, the borehole was plugged with gravel, cobble, and various debris from flooding. As a result of the borehole and other discharges, iron staining is visible along the Loyalhanna Creek streambanks and substrate. The second discharge, known as the Adelphoi Pipe, flows from the bank directly above the borehole. Both discharges are located directly behind the Adelphoi Village school complex. Flowing from a large storm drain, one more discharge enters the stream 500 feet from the two Adelphoi discharge locations. Its source is the Latrobe Mine and Coke Works in Lloydsville. Because it flows

Looking downstream at Latrobe from the location of the Adelphoi Borehole and Adelphoi Pipe discharges

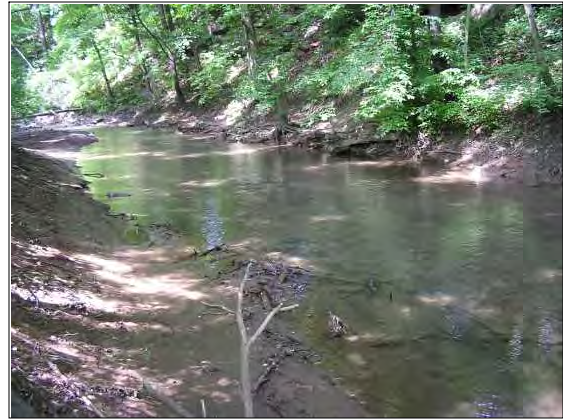
*Looking upstream at Ninemile Run
from its mouth*

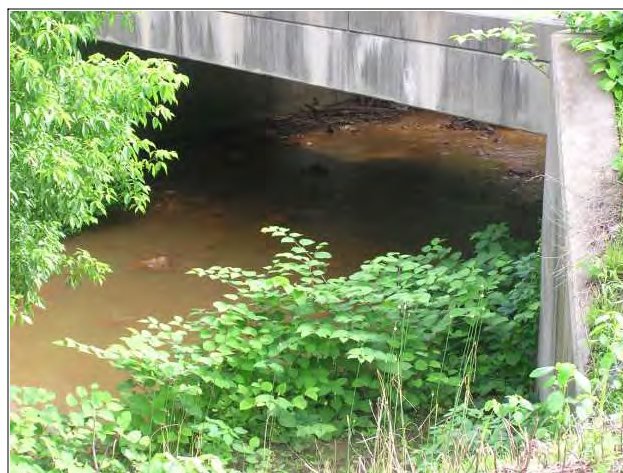
*Monastery Run as it passes underneath Route 981
North in Latrobe*

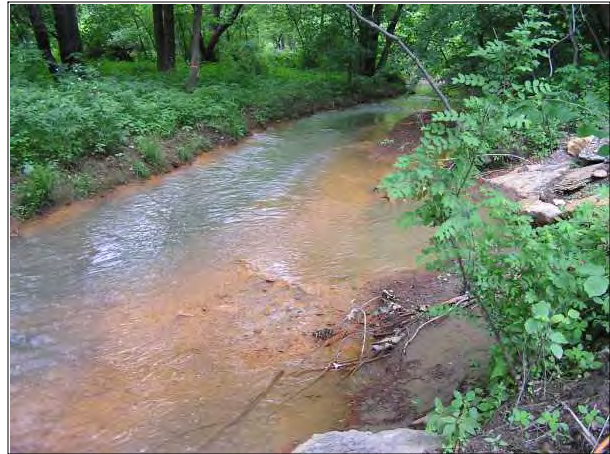
Saxman Run looking upstream from the Lattanzio Road Bridge at the Latrobe sewage treatment plant

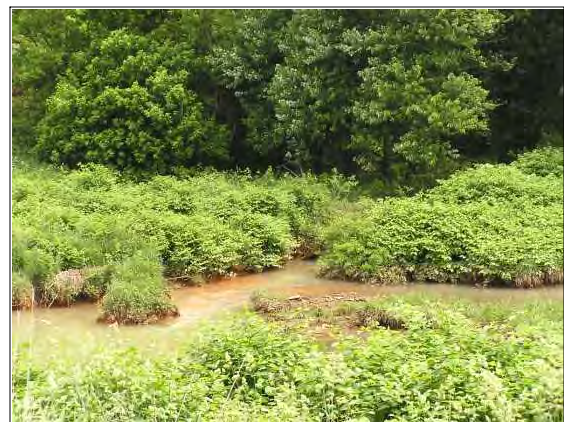
The mouth of Saxman Run as it enters the main stem of the Loyalhanna Creek

stem of Saxman Run remains orange in color. The stream substrate is dominated by iron oxide sediment.

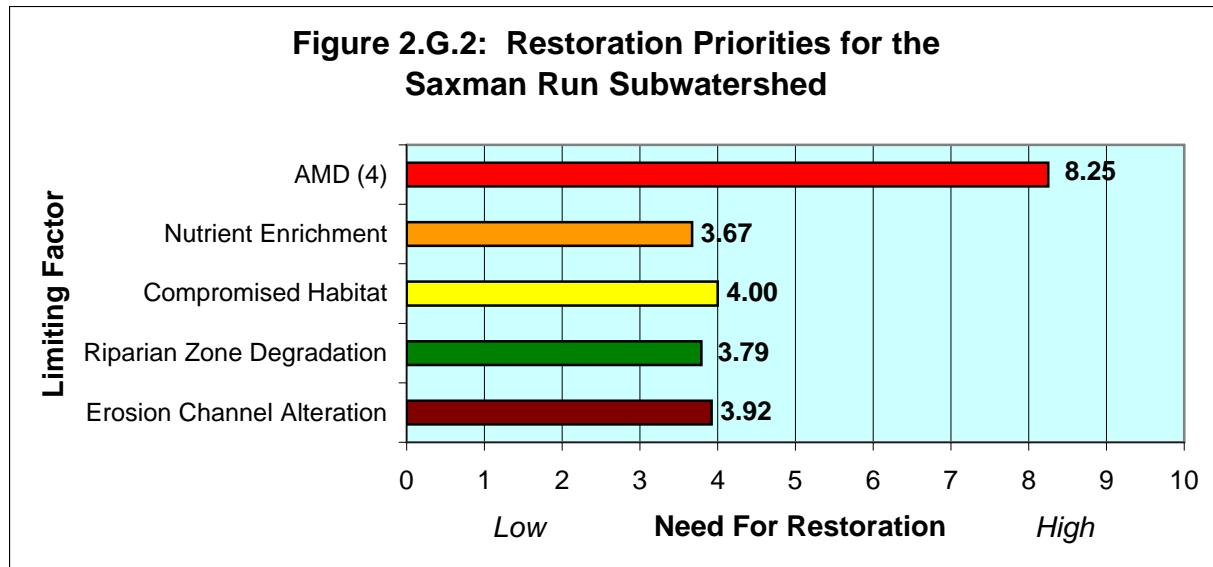
Figure 2.G.2 exhibits overall restoration priorities for the entire Saxman Run Subwatershed. As indicated, the limiting factor that received the highest restoration priority rating was AMD. Three sources of AMD exist within the subwatershed. As much as 90% of the Saxman Run main stem is impacted by AMD. In addition to high priority ratings in the AMD category, other limiting factors also rated high, most specifically, compromised habitat. This is most likely a result of iron and aluminum sediment precipitating to the stream bottom. Nutrient enrichment also rated high. This reflects tributaries where suspected sewage impacts were located during the visual assessment. In addition, algae are present within the substrates of all Saxman Run tributaries.

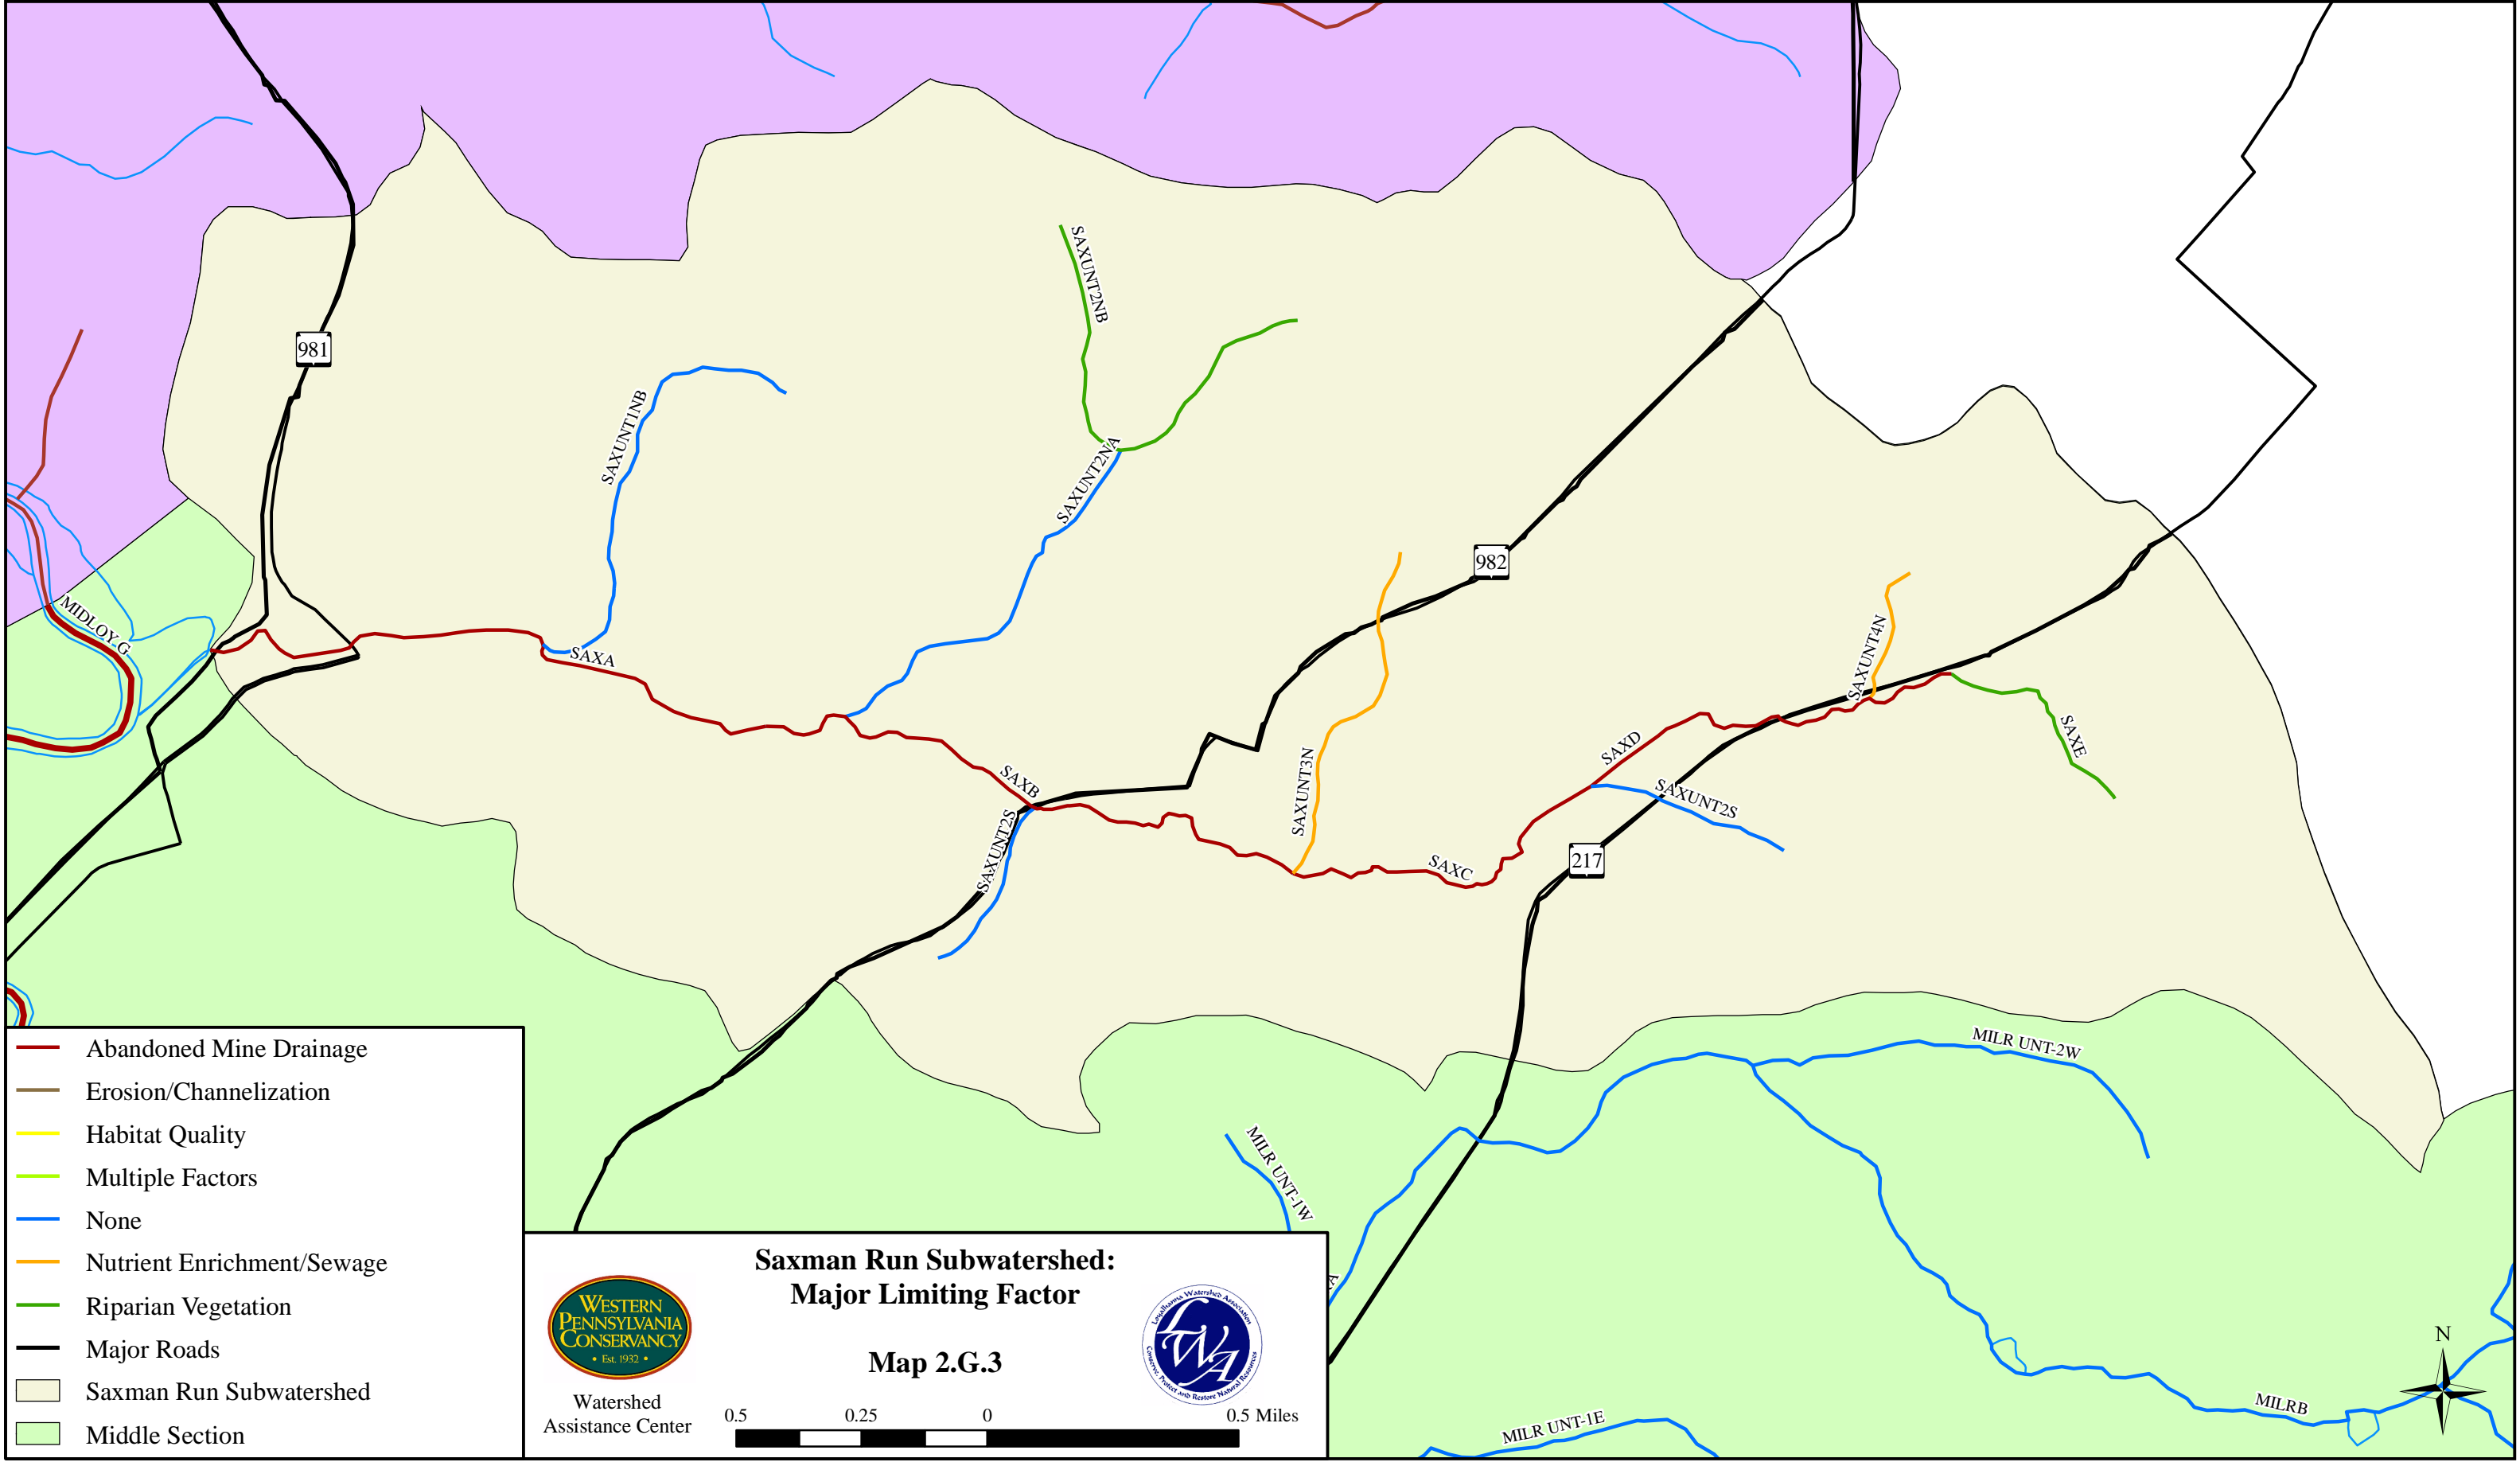
Eight stream sections received scores indicating notable impacts. The limiting factors identified were erosion and channel alteration, compromised fish and macroinvertebrate habitat, riparian vegetation degradation, nutrient loading, and AMD. Please refer to Table 2.G.2 and Map 2.G.3 for impact description and segment location.

Table 2.G.2: Impacted Stream Segments and Restoration Suggestions for the Saxman Run Subwatershed				
LIMITING FACTOR: Riparian Vegetation Degradation				
Stream Segment Name	Description of Impact	Remediation Strategy	Possible Funding Sources	Priority Rating and Cost
SAXB <i>Main stem segment that flows through a residential area in Snyderstown.</i>	Homes, mowed lawns, and road surround the streambank. Very little vegetation is present and there are very few trees that provide canopy cover.	1. Educate landowners. 2. Work with landowners and the City of Latrobe to remediate the streambank. Possible Partners: DEP, City of Latrobe	Local, State	Low – Medium
SAXE <i>The headwaters of the main stem that flows through a residential area in West Derry.</i>	Homes, mowed lawns, road, and trash surround the streambank. Tires, road signs, aluminum siding, etc. are strewn beside the stream. No trees are present to provide shade to the stream.	1. Educate landowners. 2. Clean up area surrounding the stream. 3. Work with township and landowners to remediate streambank. Possible Partners: WCD, DEP, Derry Township	Local, State	Medium (due to headwater location)
