Slippery Rock Passive Treatment Rehab & Maintenance

A Slippery Rock Watershed Coalition Project

Final Report

Appendix 1
Photographs

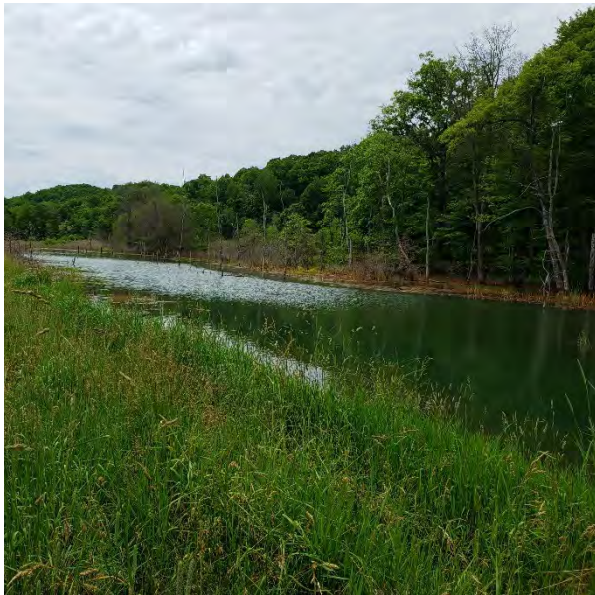
Top Photo: Wetland 2, the final treatment component, prior to the rehabilitation project. (2020)

Bottom Left: Wetland 1 receives drainage from both the Ferris West (VK) and Ferris East (JP) treatment systems. (2020)

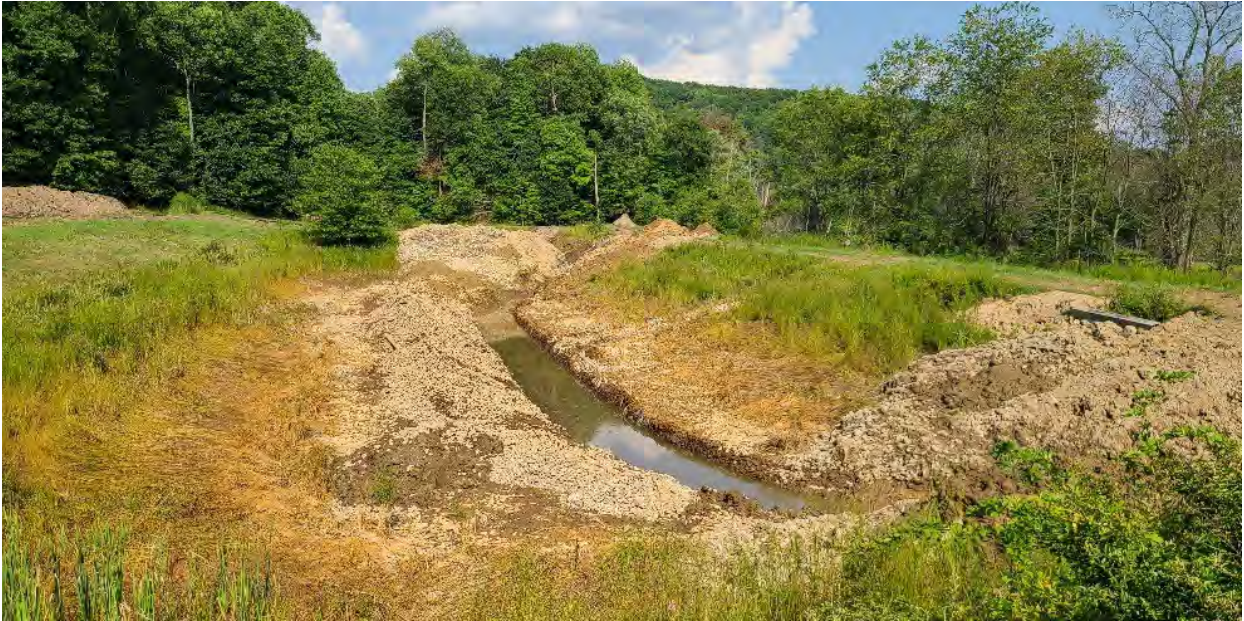
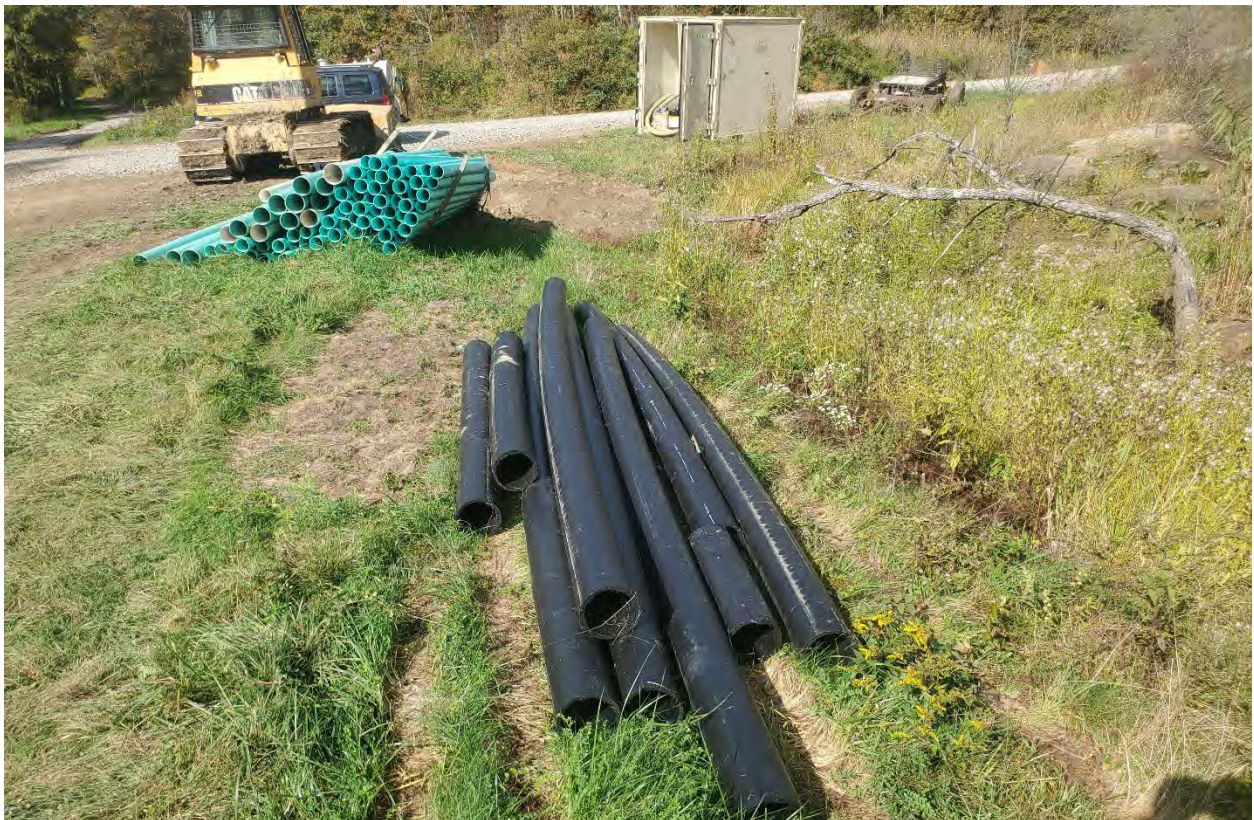
Top Photo: Limestone in VK2 (JVFP West) was drained, cleaned, and re-used as under drain stone. (2021)

Bottom Photo: Due to pandemic-related supply chain issues, six-inch SCH40 PVC pipe, typically used for outlet piping was not available and HDPE piping was used to allow construction to progress. (2021)

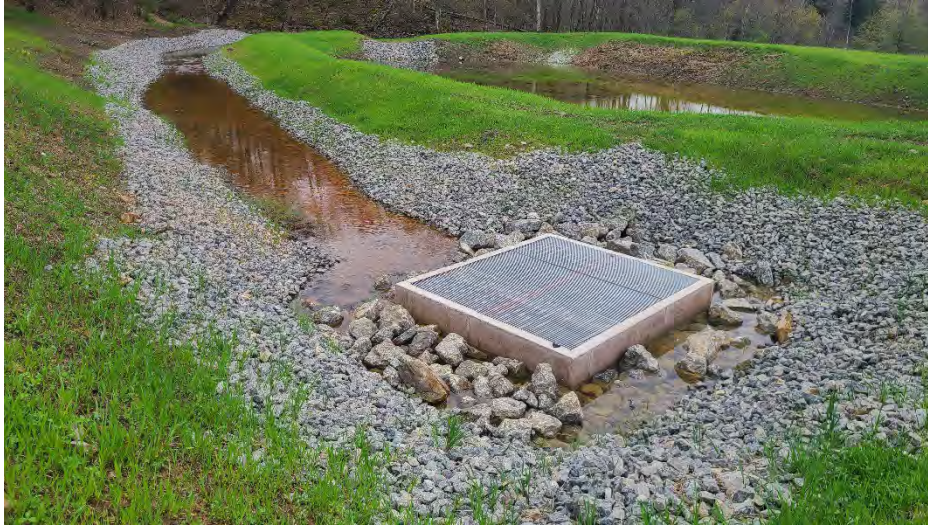
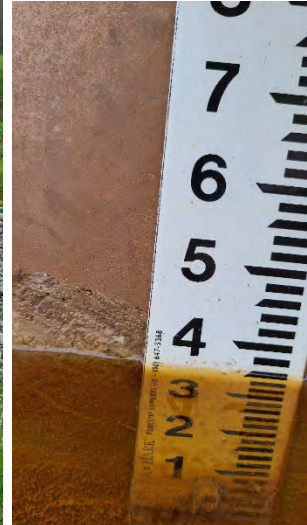
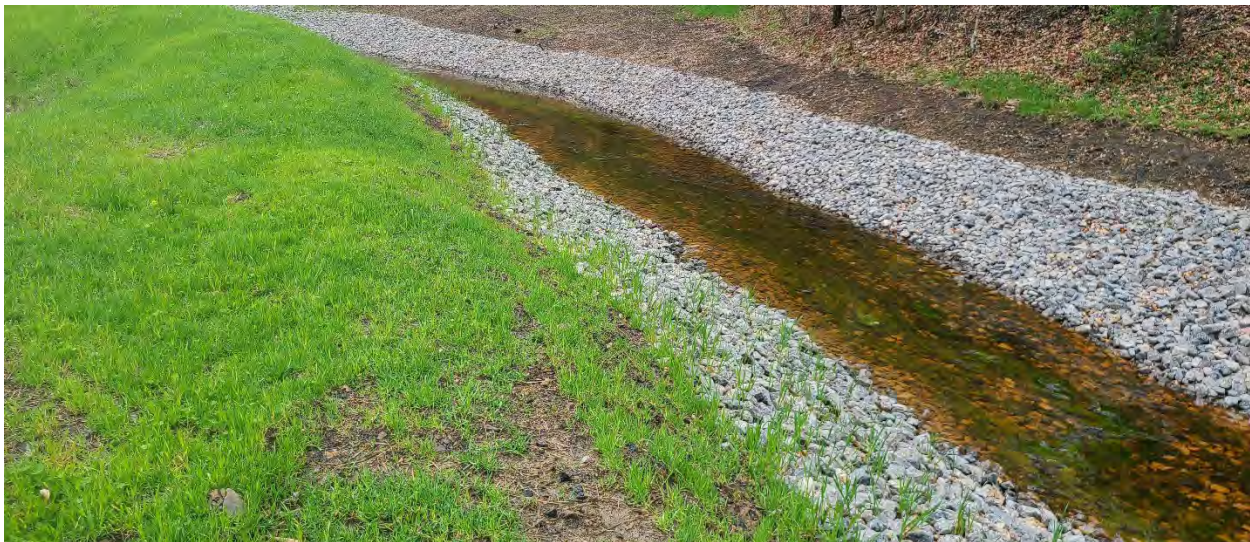
Top Left: Terraced iron formation (TIF), also known as oxidation precipitation channel (OPC), installed at the inlet Ferris West treatment system that treats the SR85/86 discharges. (2022)

Top Right: Staff gauge inside of the TIF flow splitter box used to measure the depth of flow over the three 90-degree V-notch weirs. (2022)

Bottom: Inlet of the TIF as the mine drainage enters the treatment system. (2022)

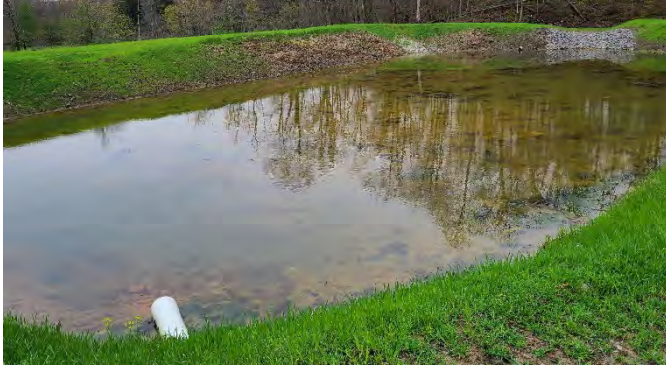
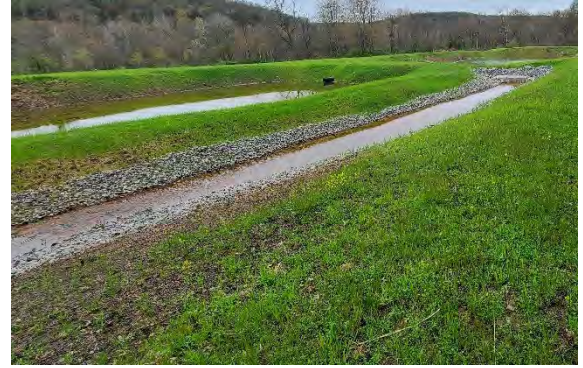
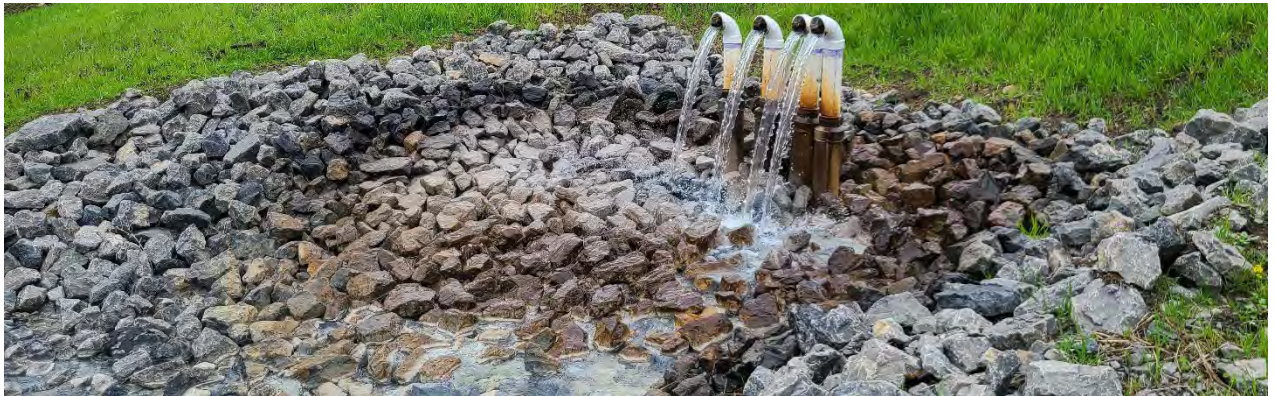
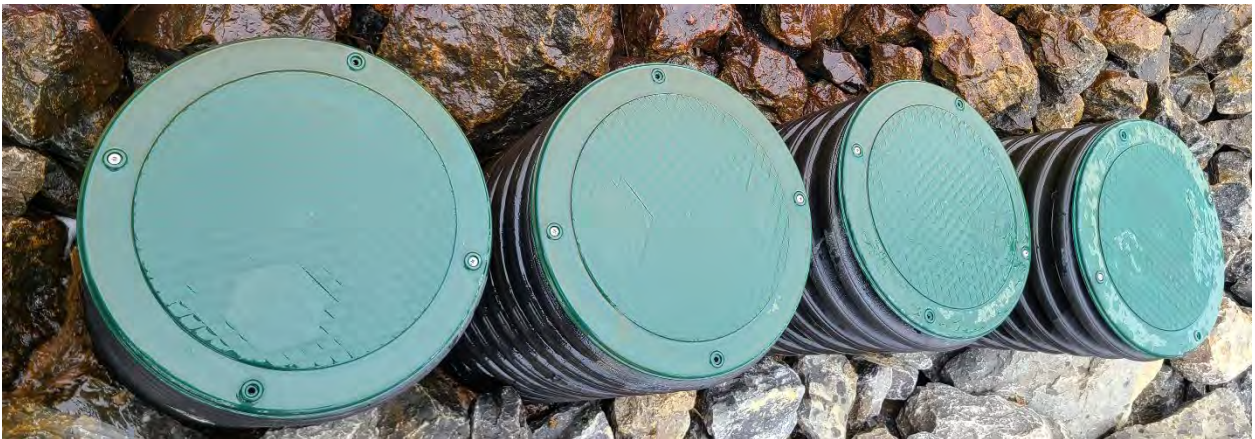
Top Left: The VK1 vertical flow pond was reconfigured into a Jennings-type vertical flow pond now referred to as JVFP East. (2022)

Top Right: The TIF provides initial treatment while conveying AMD to the flow splitter box that directs 33% of the flow to JVFP East and 67% of the flow to JVFP West.

Middle: Flow from JVFP East exits all four adjustable outlet risers and as it enters a rock-lined spillway to Wetland 1. Each of the two reconfigured JVFPs have a four-cell underdrain system. (2022)

Bottom: Each cell of the underdrain in each JVFP has an individual drain valve housed in a valve box (12" N12 pipe with Polylok lid) that can be used to dewater the JVFP and during maintenance work. (2022)

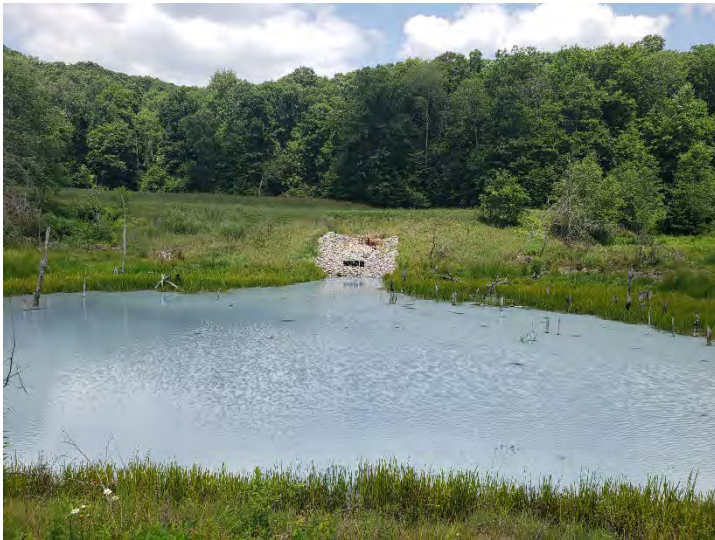
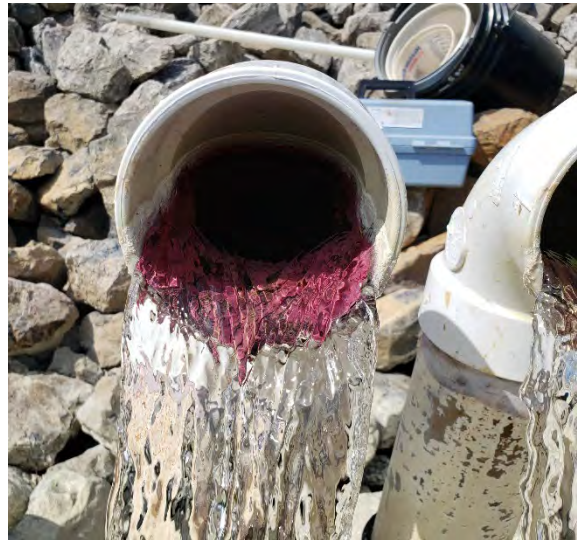
Top Left: Water exits JVFP East and enters Wetland 1 after two years of operation. (2023)

Top Right: Pink/purple coating inside the JVFP outlet pipes are photosynthetic purple sulfur reducing microorganisms. (2023)

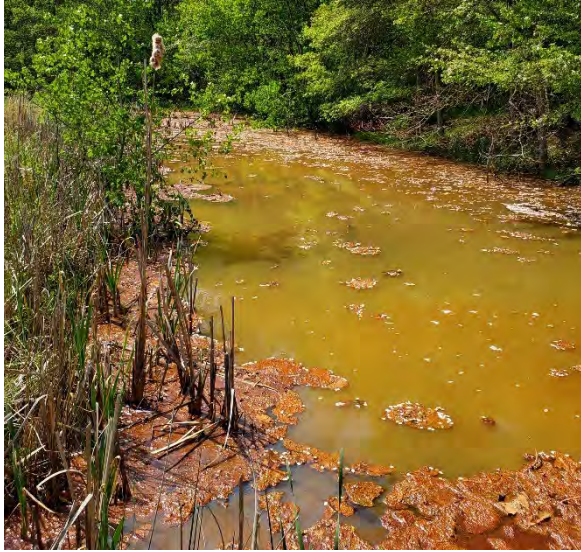
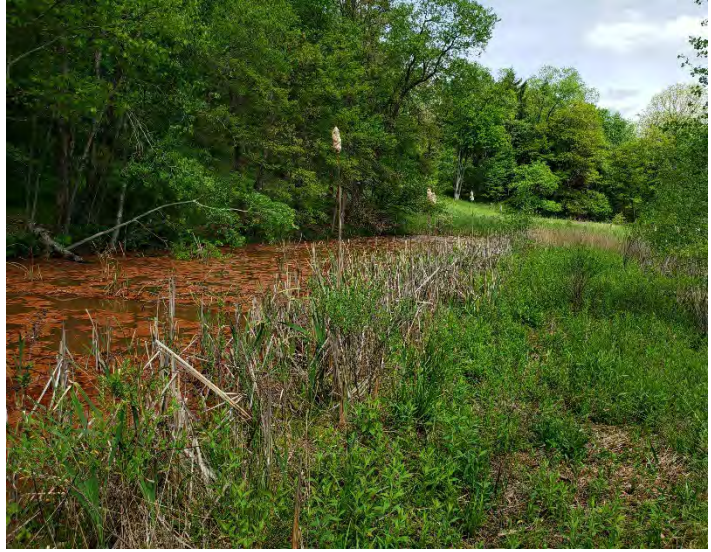
Top Left: Pre-rehabilitation photo of the settling pond at SR101A containing a yellow-orange color due to precipitated iron in the settling pond. (2020)

Top Right: Photo of the settling pond on the other side. Clumps of iron sludge with algae can be seen floating across the surface of the settling pond. (2020)

Bottom: Close-up of clumps of iron solids and biofilms at the surface of the settling pond. (2020)

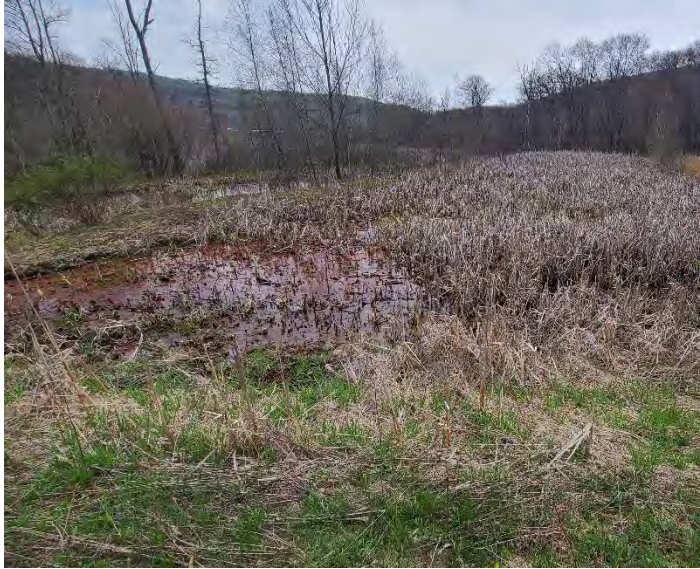
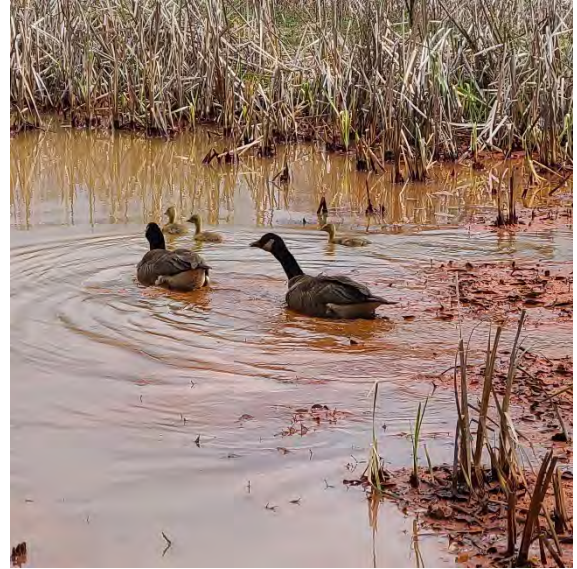
Top Left: SR101A wetland with vegetation and sludge in it prior to rehabilitation. (2021)

Top Right: Wildlife utilizing the constructed wetlands, despite the buildup of sludge. (2021)

Bottom: Due to the high water levels caused by accumulated iron precipitates, the embankment of Wetland 2 was saturated causing a five-ton excavator to sink at the beginning of rehabilitation efforts. (2021)

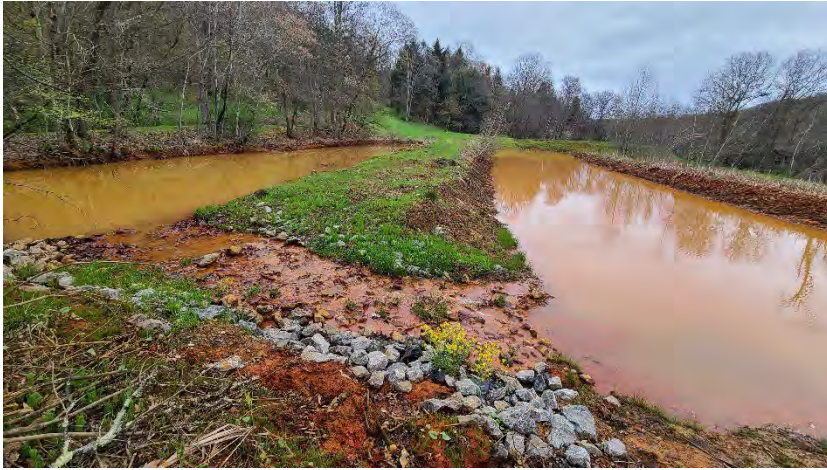
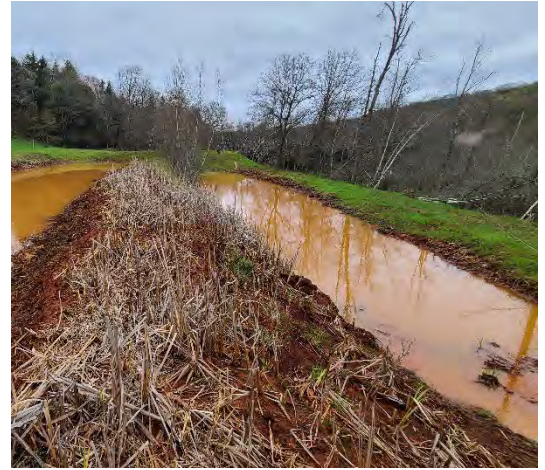
Top Left: Photo of settling pond (left) and wetland 1 (right) in SR101A after sludge/debris removal. (2023)

Top Right: Photo of wetland 1 (left) and wetland 2 (right) in SR101A after sludge/debris removal. (2023)

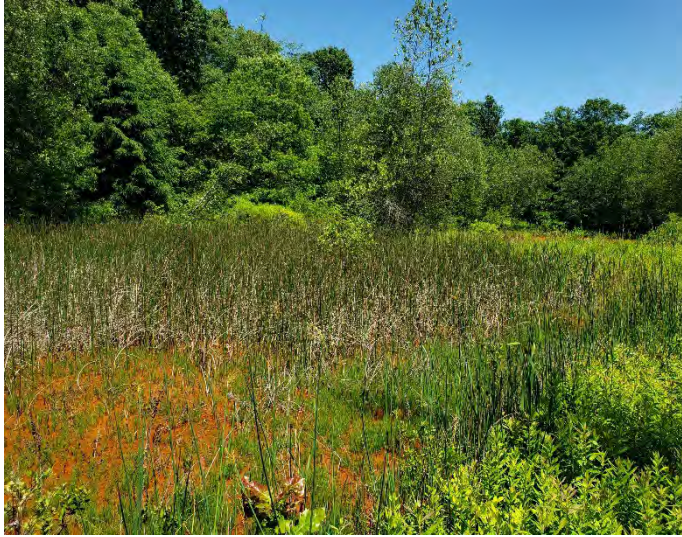
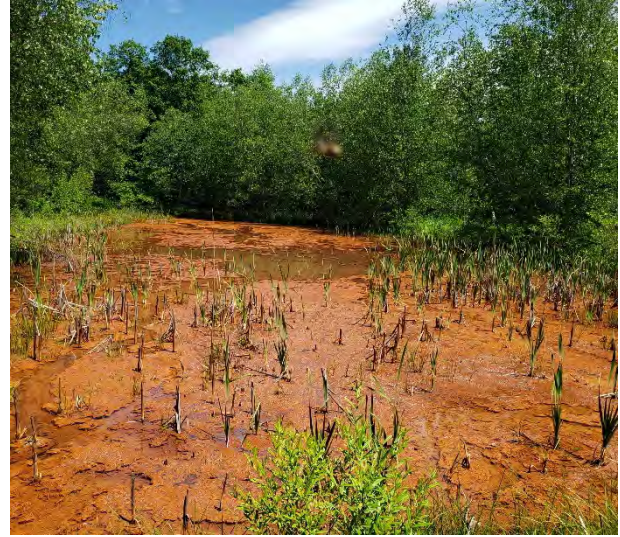
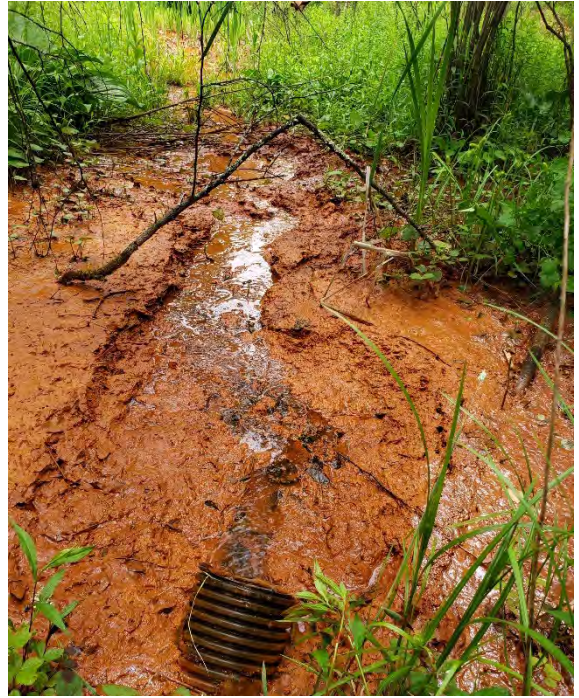
Top Pictures: Pre-rehab pictures of wetlands in SR114D system filled with iron sludge. (2020)

Bottom Left: First of the three wetlands in SR114D, named Wetland D2, with iron sludge build-up. (2020)

Bottom Right: Iron sludge build-up surrounding the ALD B outlet pipe prior to rehabilitation. (2020)

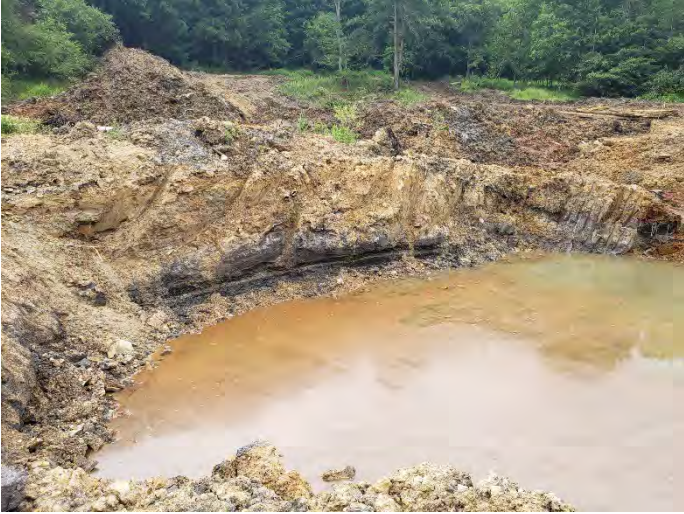
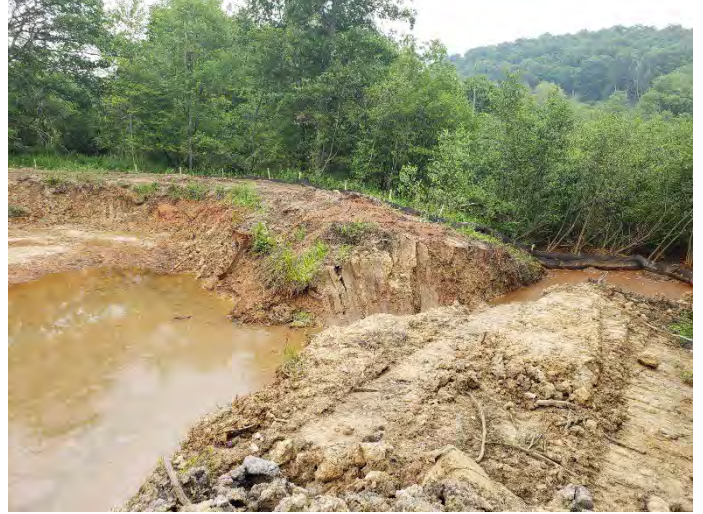
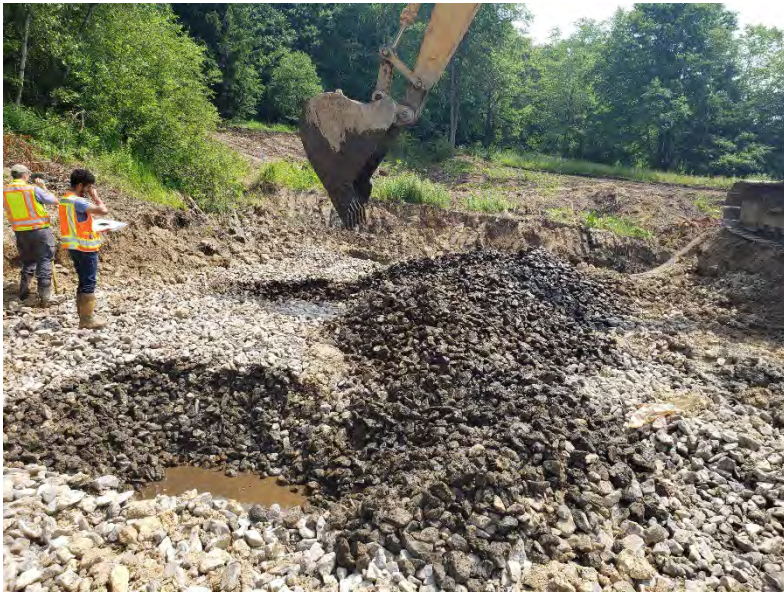
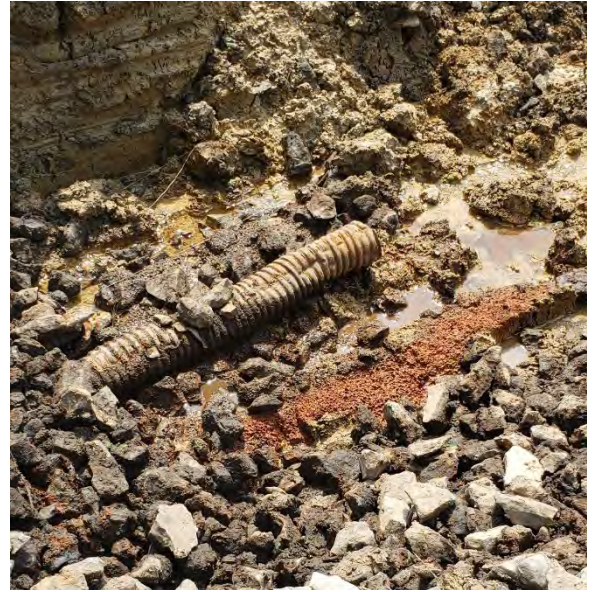
Top Photos: Reconstruction and expansion of SR114 Pond B. (2023)

Bottom Left: Surveys completed by BioMost, Inc. during reconstruction and expansion of the anoxic limestone drain (ALD B). (2023)

Bottom Right: Old and degraded piping removed from the anoxic limestone drain ALD B. (2023)

Pond B: Pond B receives flow from the SR114 B ALD. Pond B was cleaned out and then significantly expanded (60%) in size from 6,605 square feet to 10,513 square feet in area and deepened by about a foot during the rehabilitation project. A windowed baffle curtain was installed and spans the width of the pond. Post-construction water monitoring has indicated that Pond B is now intercepting a significant source of AMD that was previously not present and not part of the original design. The cause of this increased flow is currently uncertain, but may be related to changes in flow to the SR114D ALD. This is discussed further in the ALD section below as well as in the system performance section.

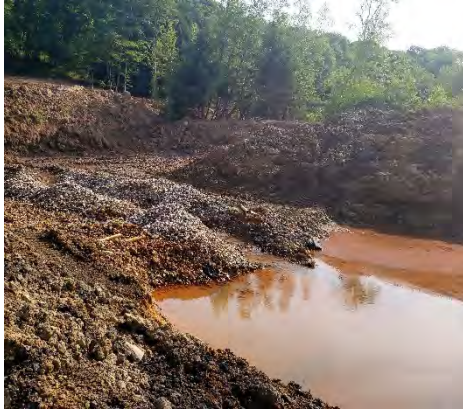
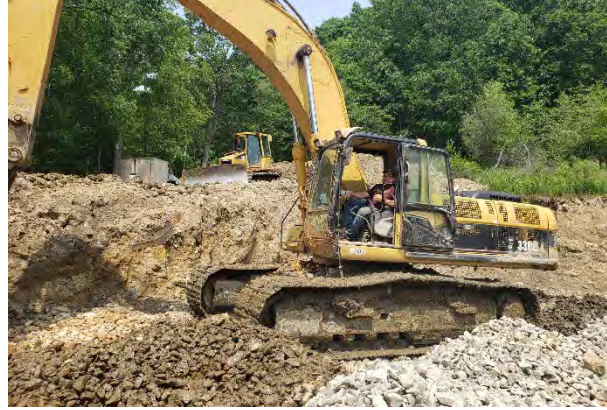
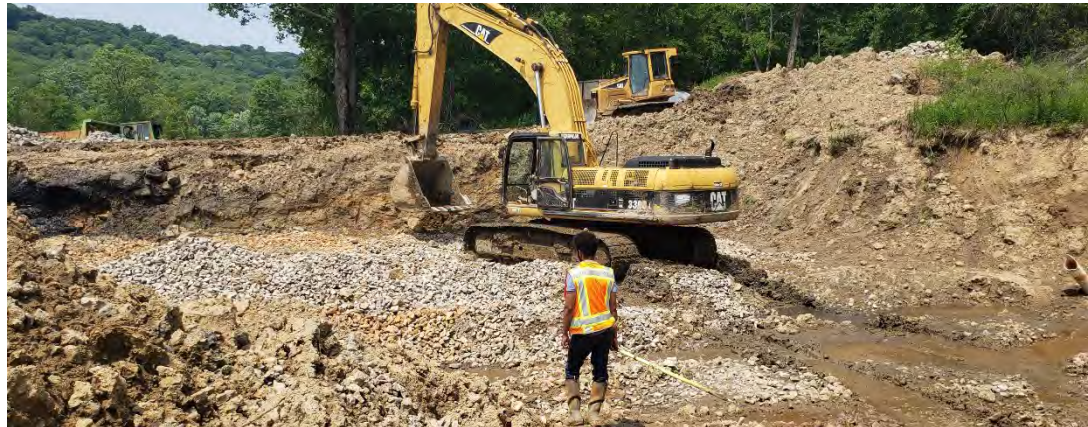
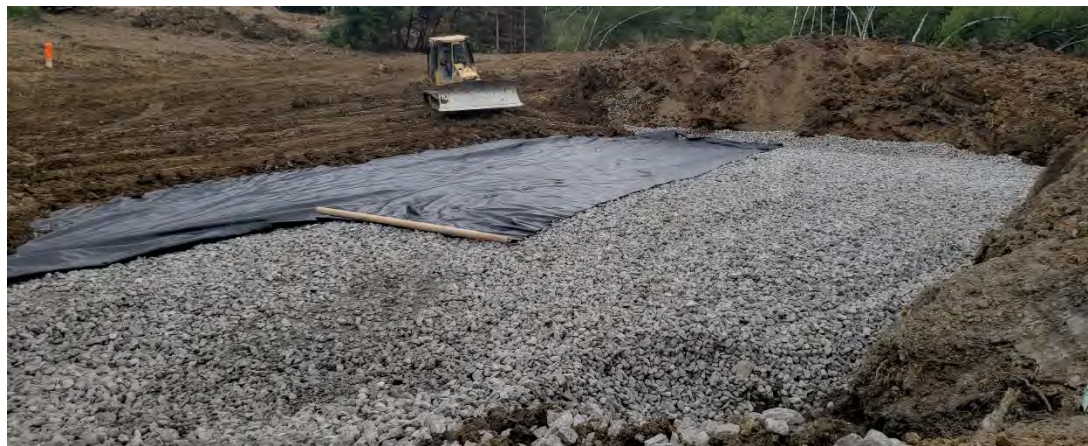
During a post-construction inspection in August 2023, ALD D was found to have little water flowing out of the effluent pipe. This prompted concern and additional inspections. BioMost indicated that the likely cause was that the well(s) which were the conduits of the AMD into the ALD had become plugged, collapsed, or compromised in some manner. Over the following few months, BioMost took various actions to attempt to restore flow including using a power snake and hiring a small drill rig to "open up" the hole and clean out the well. The flow rate has since increased at the ALD but is still not back to typical "historical" values. Increased flow at Pond B may indicate that a portion of the water has since found a new discharge point. This is further discussed in the performance section.

Top Photos: ALD D was excavated by Spur Excavation, LLC to evaluate the quantity of remaining limestone. (2023)

Middle: As Spur Excavation, LLC works to uncover ALD D, BioMost, Inc. conducts survey work to determine the quantity remaining limestone. (2023)

Bottom: Prior to covering the ALD D with earth fill, geotextile was placed to separate the high-calcium carbonate limestone from the overlying soil material. (2023)

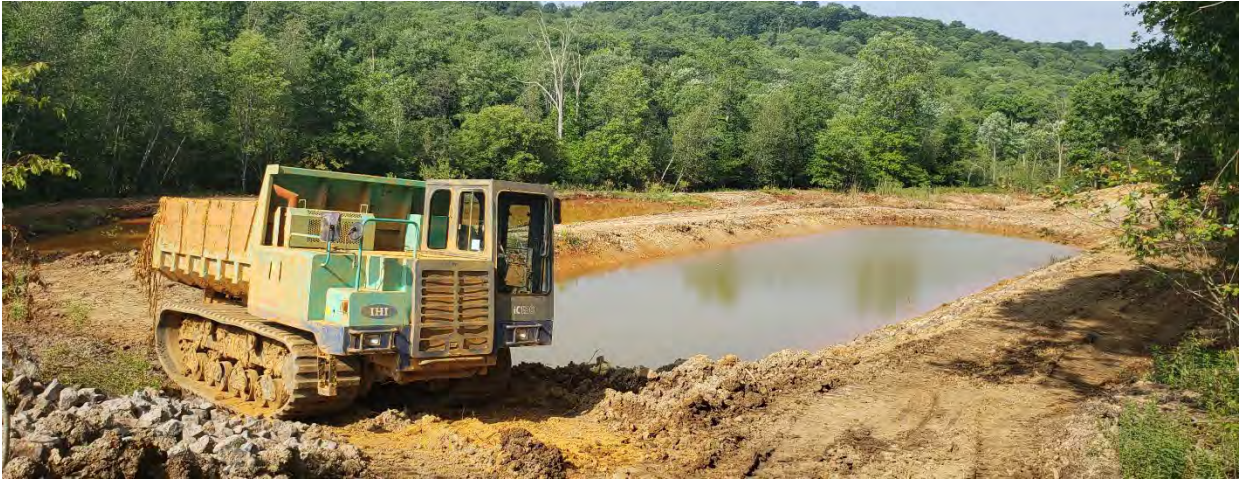
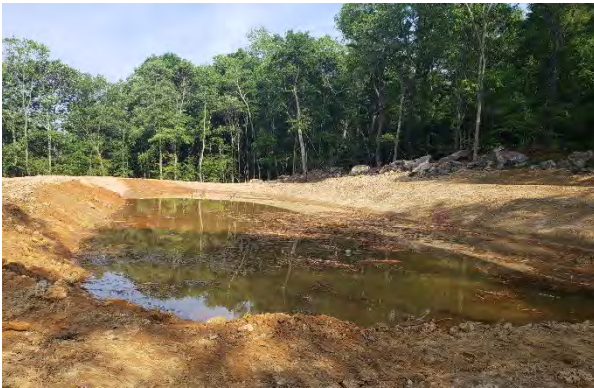
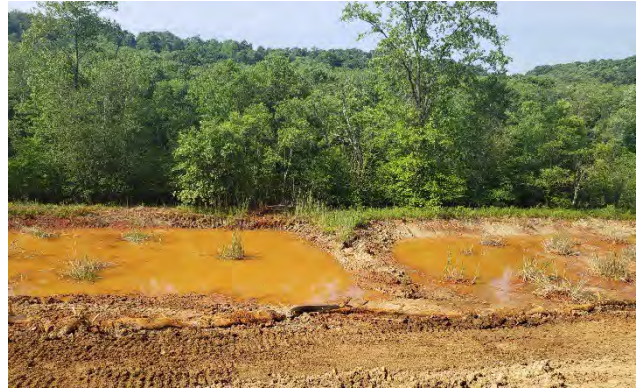
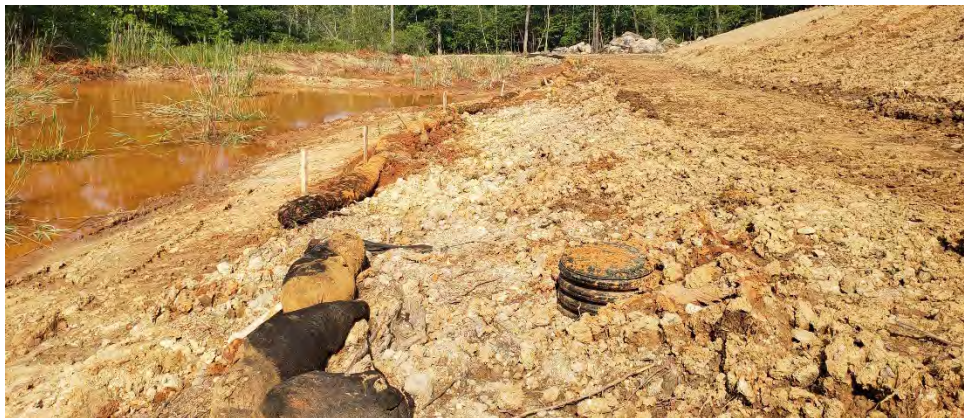
Top: Due to the soft soil conditions and deep sludge, specialty equipment such as the track truck pictured was used to transport sludge and debris from Pond D1 (right) and Wetlands D2 to D4 (left) to the dewatering basin. (2023)

Middle Left: Dewatering basin constructed to hold sludge and debris from ponds and wetlands. (2023)

Bottom: The drainpipe from the dewatering basin (right) enters Wetland D4 (left) via the valve located in the valve box (foreground). (2023)

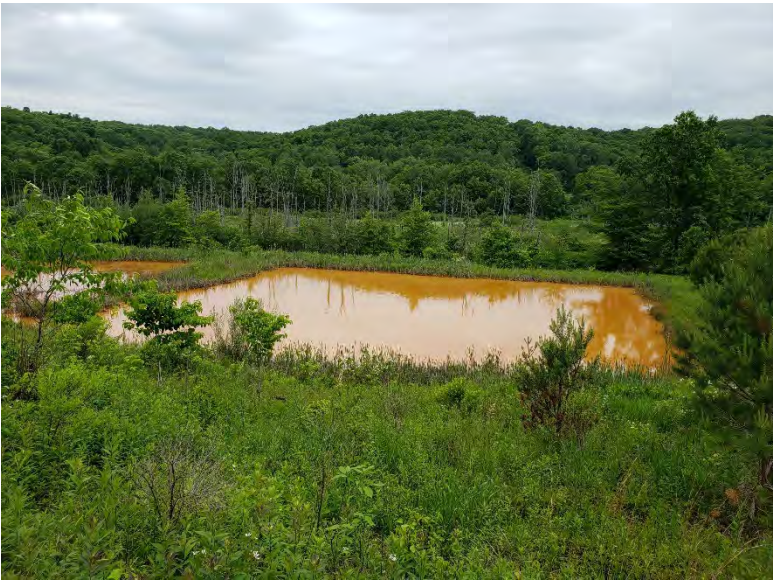
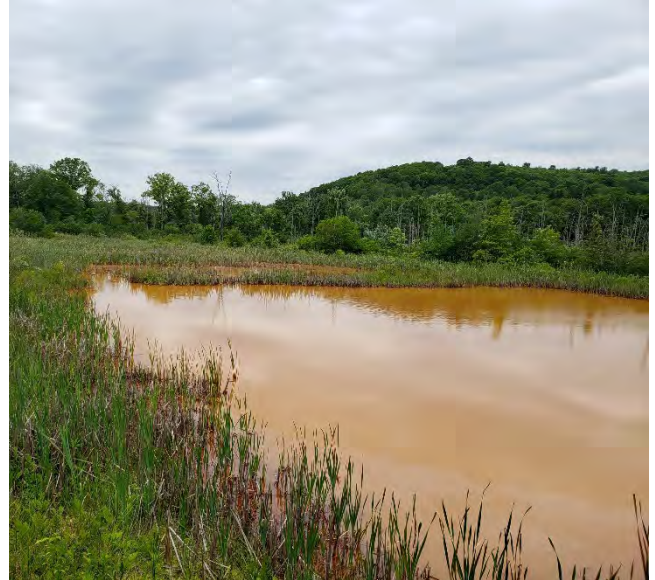
Top Left: Photo of settling pond at SR81 passive treatment system prior to rehabilitation. (2020)

Top Right: The settling pond (foreground) followed by constructed wetlands (background). (2023)

Bottom: Close-up photo of thick iron-laden water in the settling ponds. Red-orange sludge is built-up around the vegetation. (2020)

Settling Pond (SP) & Wetland (WL) Complex: What remained of the original settling pond and wetland were reconfigured, with the new settling pond making up 13,400 square feet of the eastern most section and the new constructed wetland making up 4,200 square feet of the western tip. The settling pond contains 2 windowed baffle curtains, both connected to the sides of the pond by stainless steel cables and each consisting of a foam float at the top, a stainless-steel bar guard, a turbidity curtain spanning the depth of the pond, a chain weight at the bottom of the curtain, and 2-foot-wide custom cut windows at the top of the curtain. Leading to

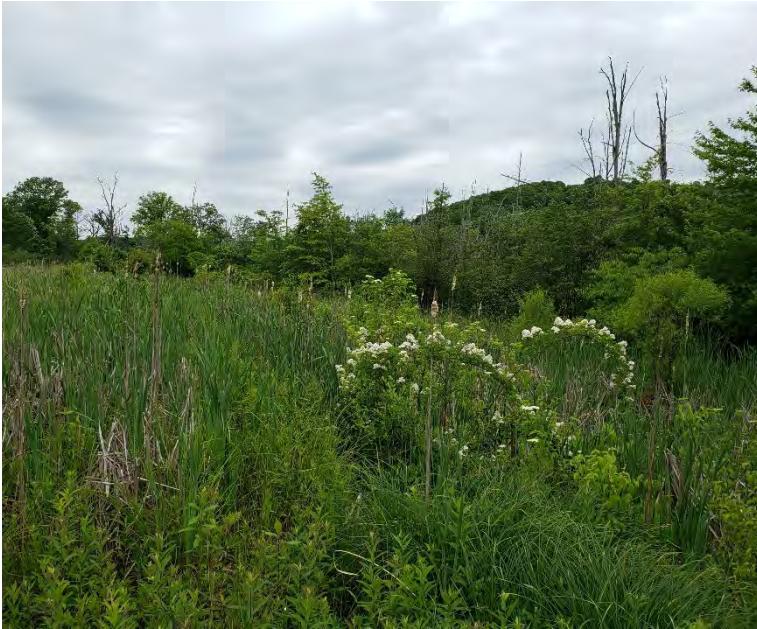
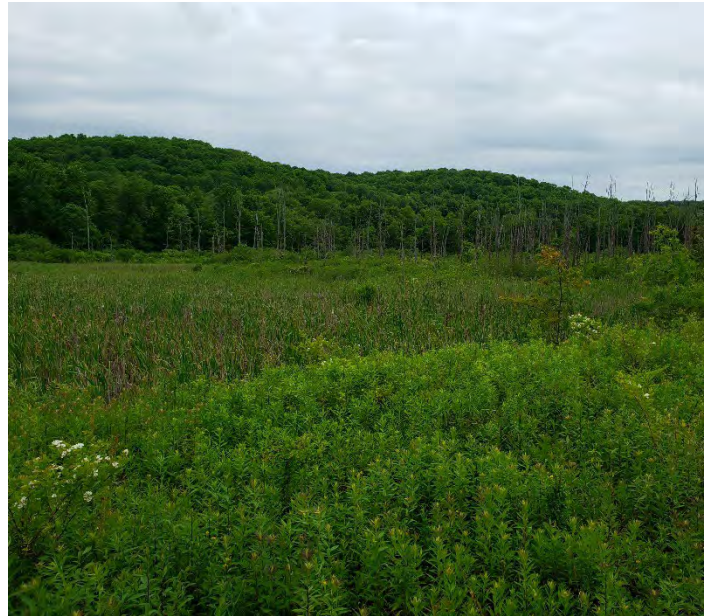
Top Left: Vegetation overgrowth SR81 wetlands prior to rehabilitation. (2020)

Top Right: Natural wetlands situated to the north of the constructed wetland and settling pond. (2020)

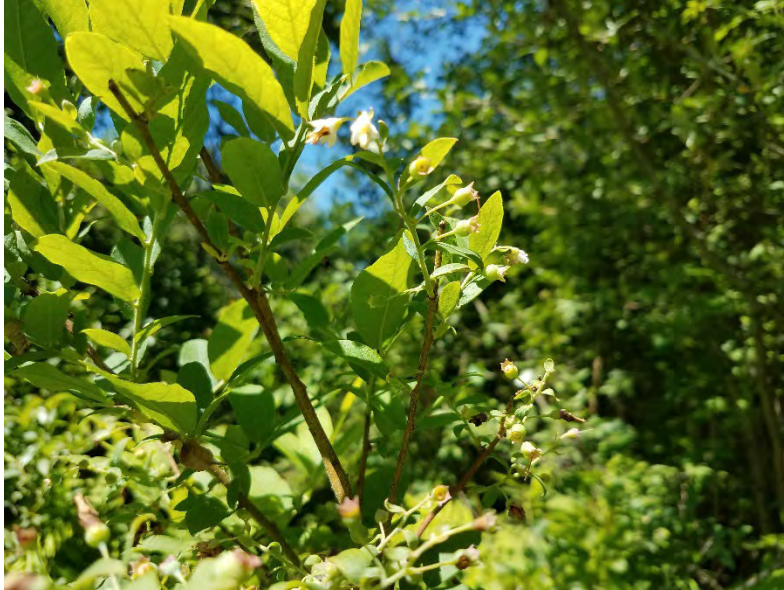
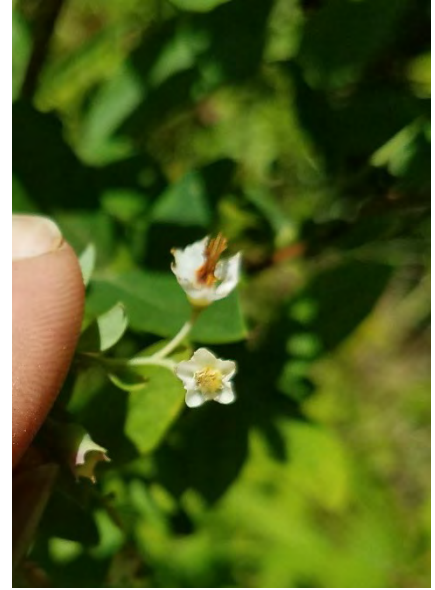
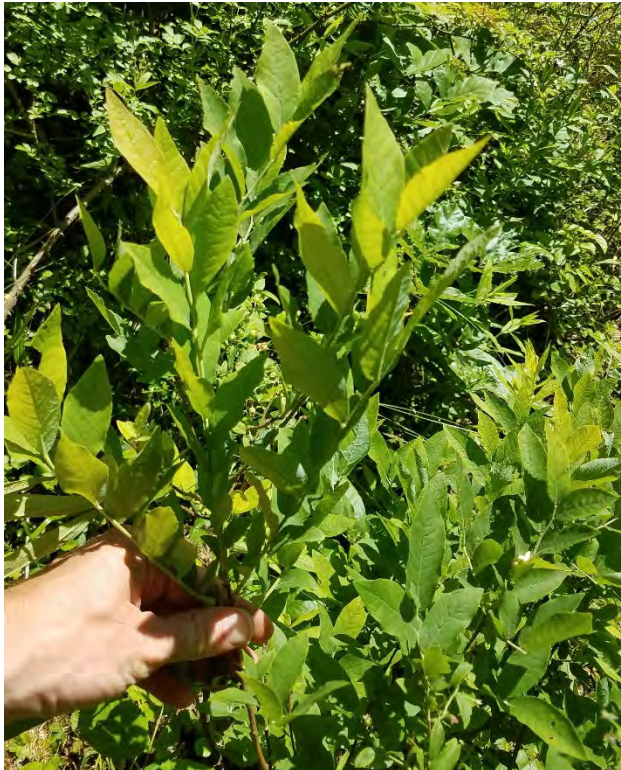
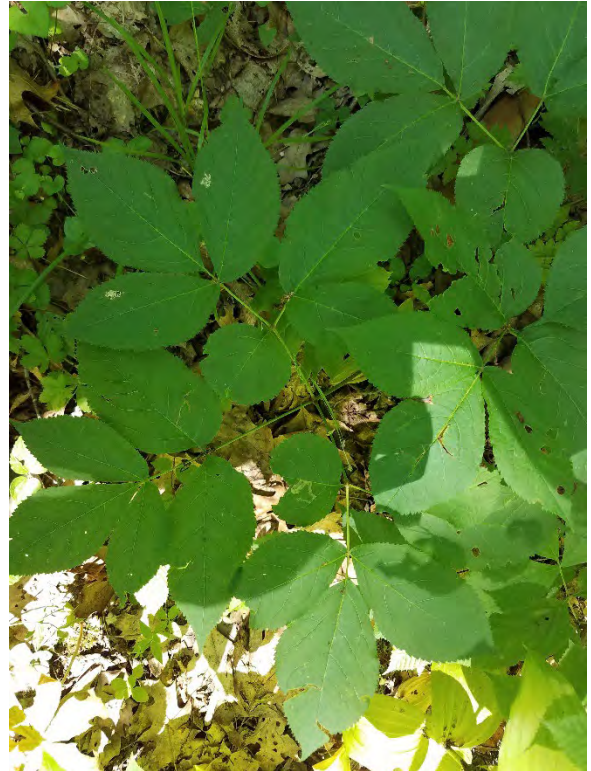
All Above Photos: A wetland delineation was completed to obtain a restoration waiver to facilitate flow distribution efforts placed in the natural wetland to reduce channelization and increase retention time and treatment effectiveness. (2022)

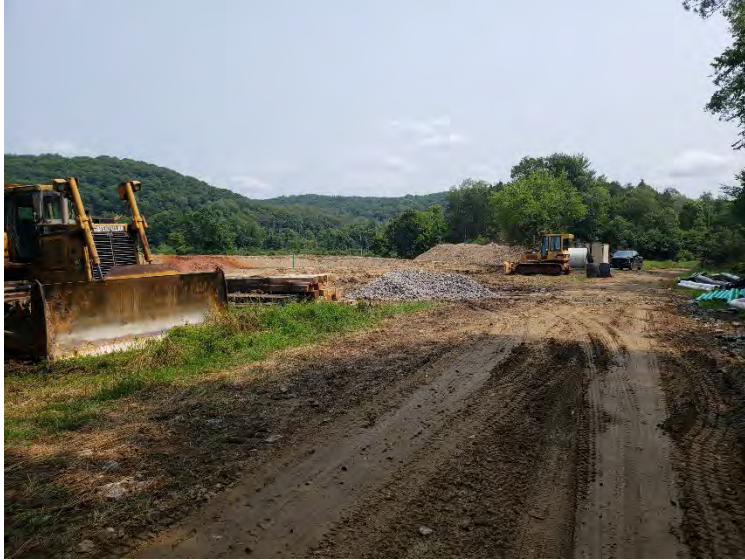
Top Left: Construction of the dewatering basin to hold sludge and debris removed from the SR81 settling pond and wetland. (2023)

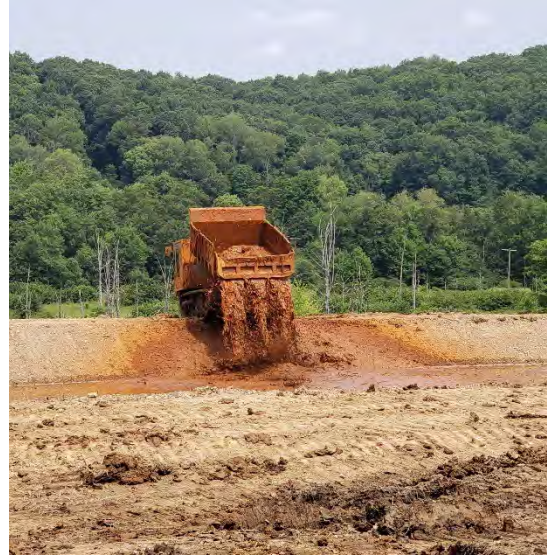
Top Right: Spur Excavation, LLC placing sludge and vegetation from the SR81 settling pond to the dewatering basin. (2023)

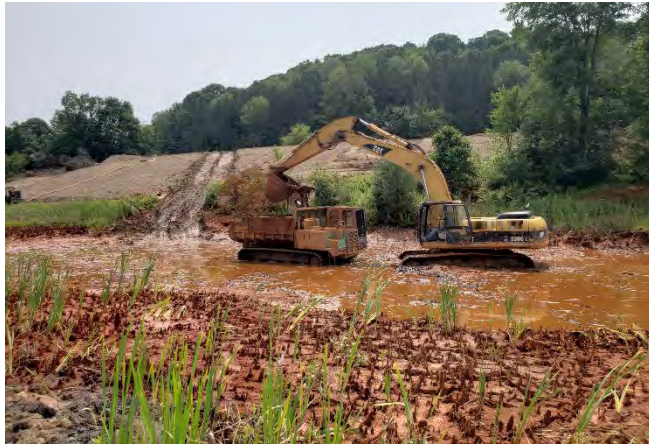
Bottom Left: Spur Excavation removing the sludge and vegetation from the bottom of the settling pond and placing it in the track truck to be hauled up gradient to the dewatering basin. (2023)

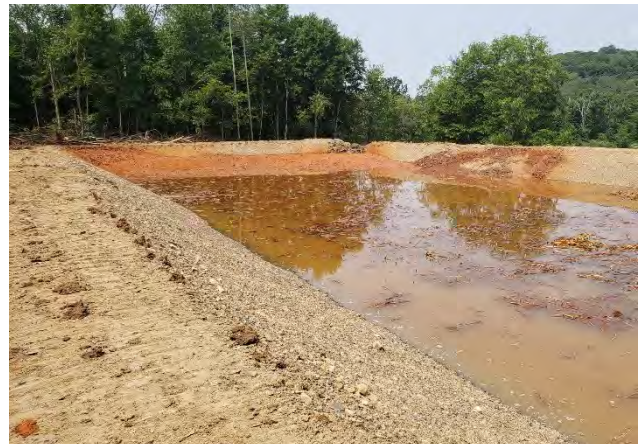
Bottom Right: Dewatering basin holding sludge and debris from the settling pond and wetlands. (2023)

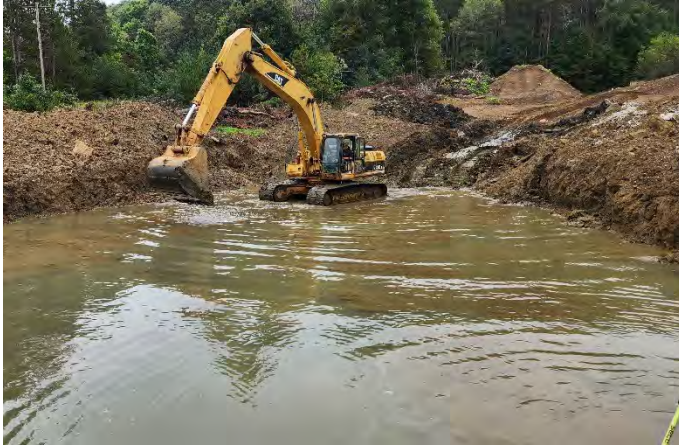
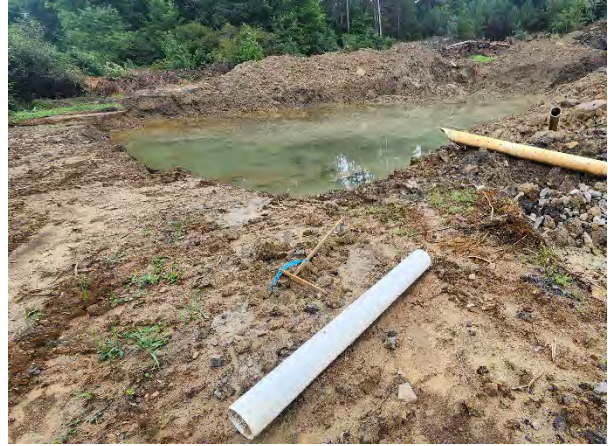
Top Photos: Spur Excavation, LLC uncovered the ALD (now ALD1) to assess the condition and quantity of remaining limestone. (2023)

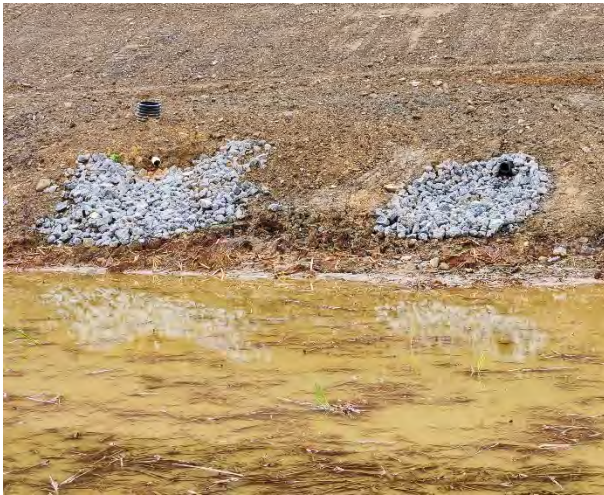
Bottom Left: The outlet of the dewatering pipe (left) and overflow pipe (right) from the dewatering basin enter the settling pond. (2023)

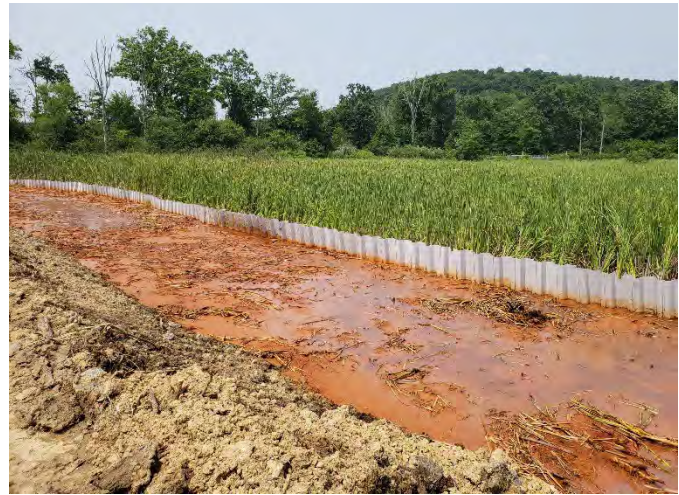
Bottom Right: A Z-pile moat used to distribute flow from the constructed wetland to the natural wetland in an effort to increase retention time and treatment efficacy in the natural wetland. (2023)

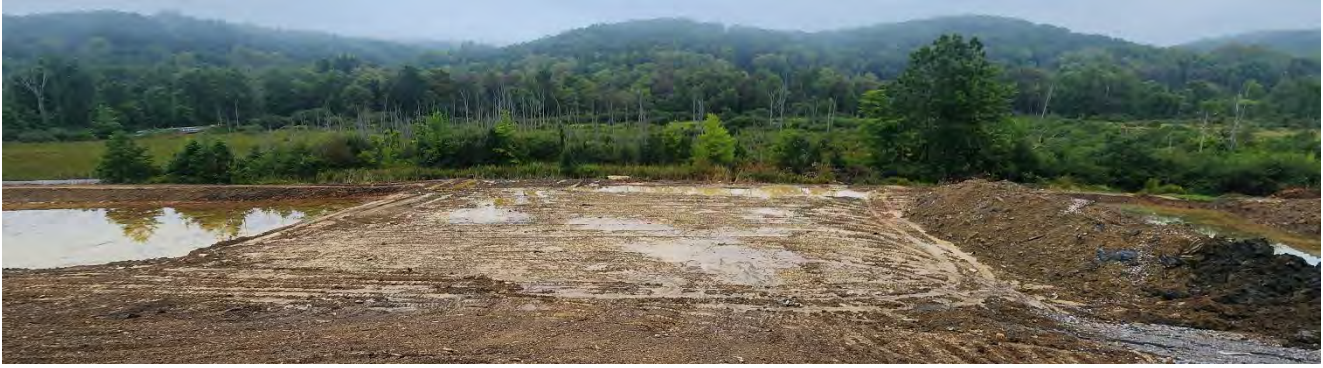
Top Photo: Cleaned settling pond (left), ALD 2 after placement of cover material (center), and ALD 1 prior to installation of new limestone (right). (2023)

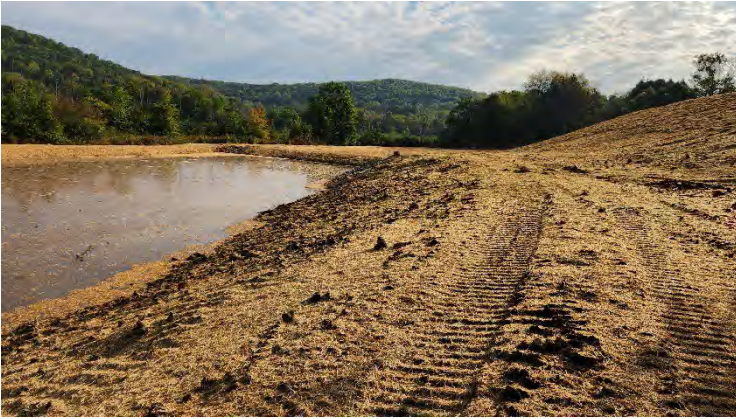
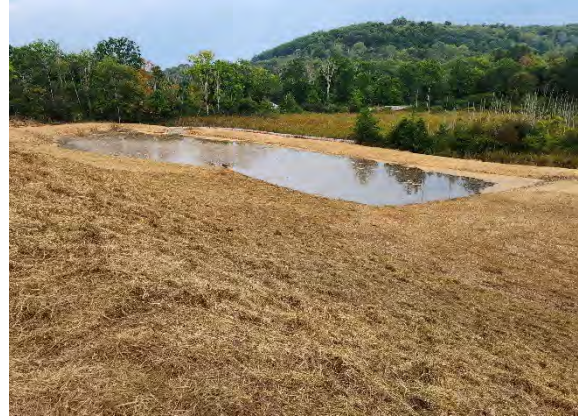
Bottom Photos: Settling Pond after the site was graded, seeded, and mulched. (2023)
