Slippery Rock Passive Treatment Rehab & Maintenance

A Slippery Rock Watershed Coalition Project

Final Report

Appendix 1
Photographs

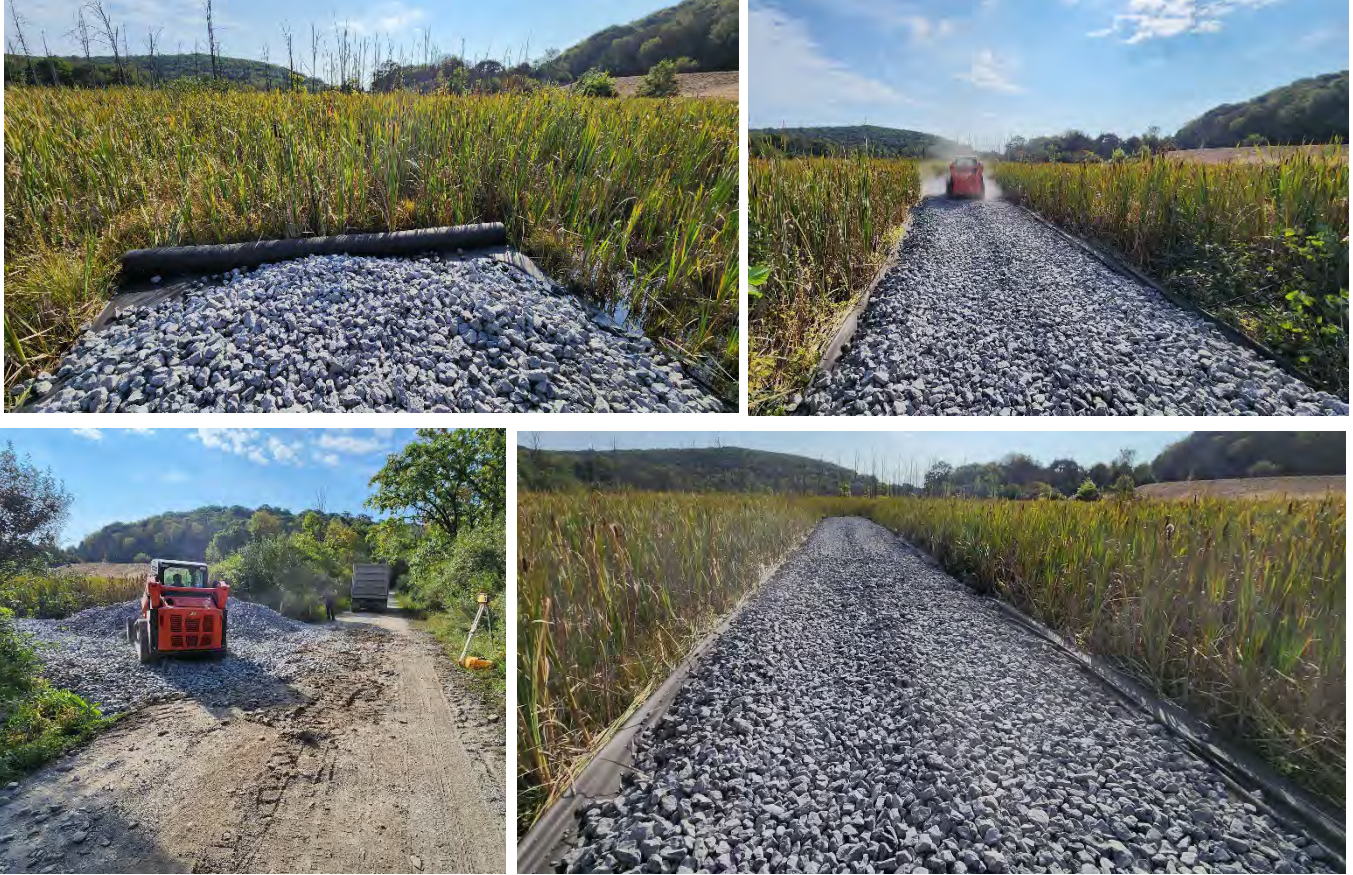
Top Photos: Construction of the rock distribution berm in the natural wetland which receives flow from the SR81 passive system. (2023)
