Laurel Run #1 Passive Treatment System
SRI O&M TAG Project #29 Request #2
OSM PTS ID: PA-191

Requesting Organization: Blacklick Creek Watershed Association
Requesting Organization Representative: Dennis Remy
Municipality/County: Rayne Township, Indiana County
Dates of work performed: 5/20/2019

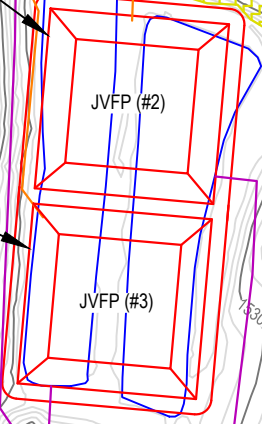
RECONFIGURE EXISTING TREATMENT COMPONENTS
 TO A JVFP CAPABLE OF TREATING 100 GPM
 2000 TONS HI-CAL LIMESTONE
 470 CY MUSHROOM COMPOST
 930 CY WOODCHIPS

SPLIT FLOW INTO 3 PARALLEL JVFPs
 DESIGN FLOW OF 300 GPM
 (REUSE EXISTING FLOW SPLITTER &
 REPLACE / IMPROVE PIPING)

CLEAN OUT SLUDGE
 AND ORGANICS FROM
 EXISTING WETLAND AND
 DISPOSE OF ON-SITE
