SHEET 1 OF 2 - PLAN VIEW

**AS-BUILT (WORKING DRAWING)
 PASSIVE TREATMENT SYSTEM
 DE SALE RESTORATION AREA
 PHASE II**

Venango Township
 Butler County, PA

Slippery Rock Watershed Coalition
 in cooperation with
 Stream Restoration Incorporated

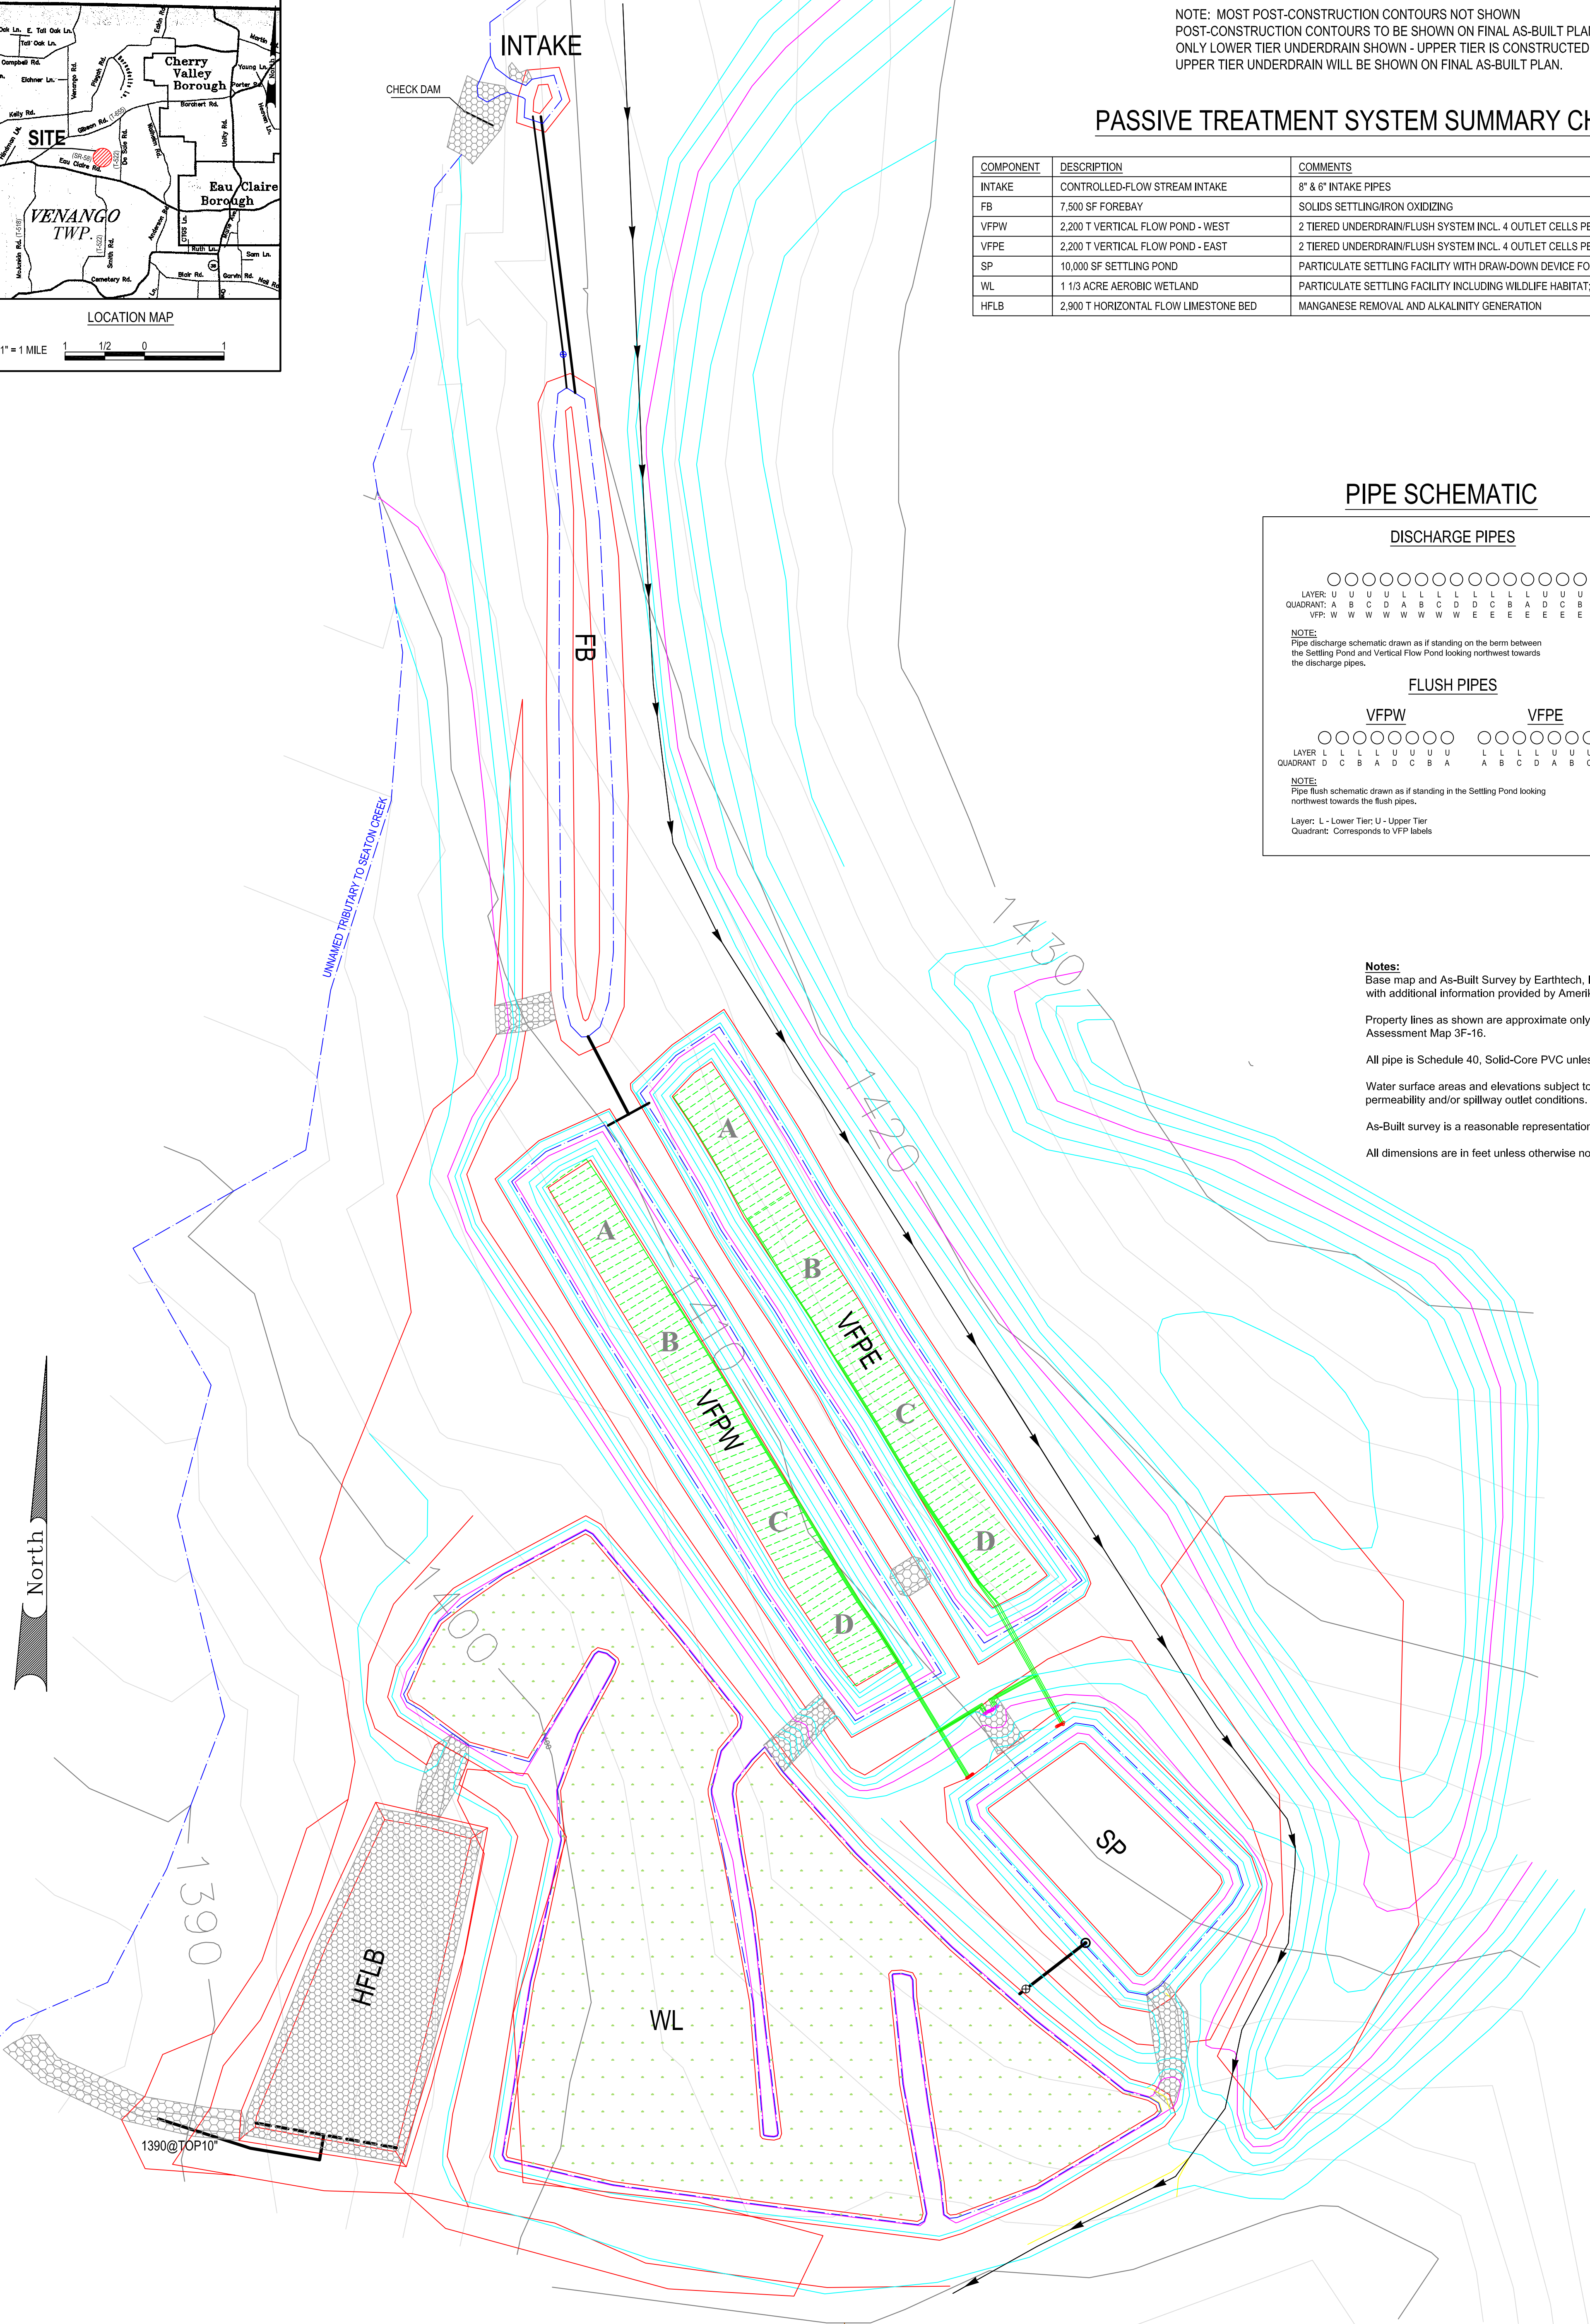
NOTE: MOST POST-CONSTRUCTION CONTOURS NOT SHOWN
 POST-CONSTRUCTION CONTOURS TO BE SHOWN ON FINAL AS-BUILT PLAN
 ONLY LOWER TIER UNDERDRAIN SHOWN - UPPER TIER IS CONSTRUCTED IN SIMILAR MANNER WITH 30' LATERALS
 UPPER TIER UNDERDRAIN WILL BE SHOWN ON FINAL AS-BUILT PLAN.

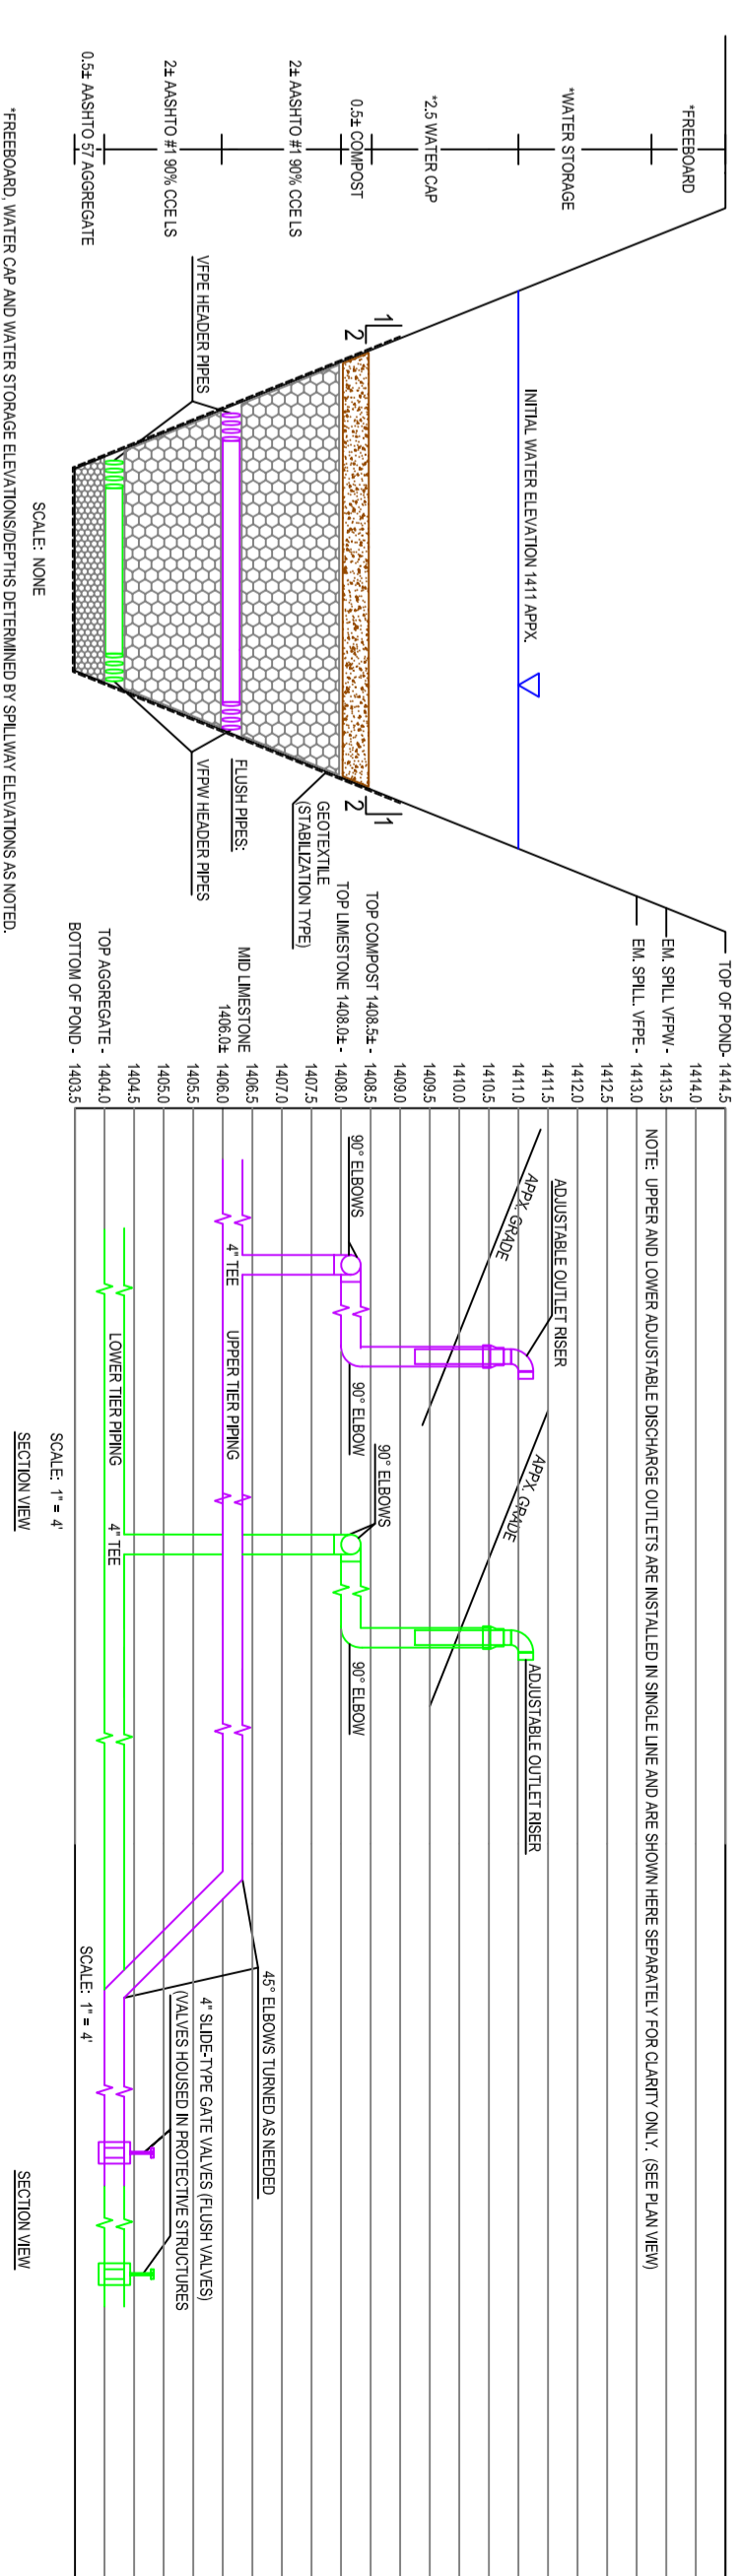
VERTICAL FLOW POND SECTION

OUTLET RISER SECTION

FLUSH SYSTEM SECTION
