Operation, Maintenance, and Replacement Plan

October 2013

DEVELOPED BY:
MOUNTAIN WATERSHED ASSOCIATION
P.O. BOX 408
MELCROFT, PA 15462

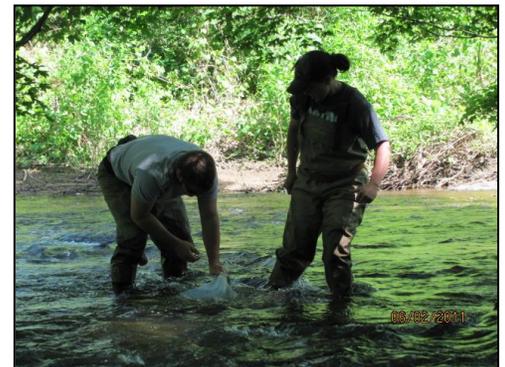
Macroinvertebrate sampling using a Surber sampler at IC5 just below the Sagamore Bridge

Biological samples were collected on Indian Creek at sample sites above and below the treatment system discharge (IC-4 & IC-5) in 2011 and 2012 following the protocol identified in Appendix A. Based upon the Biotic Index IC4 and IC5 primarily rank as clean streams. A complete species list and Biotic Index scores are identified in the appendix sections E & F.

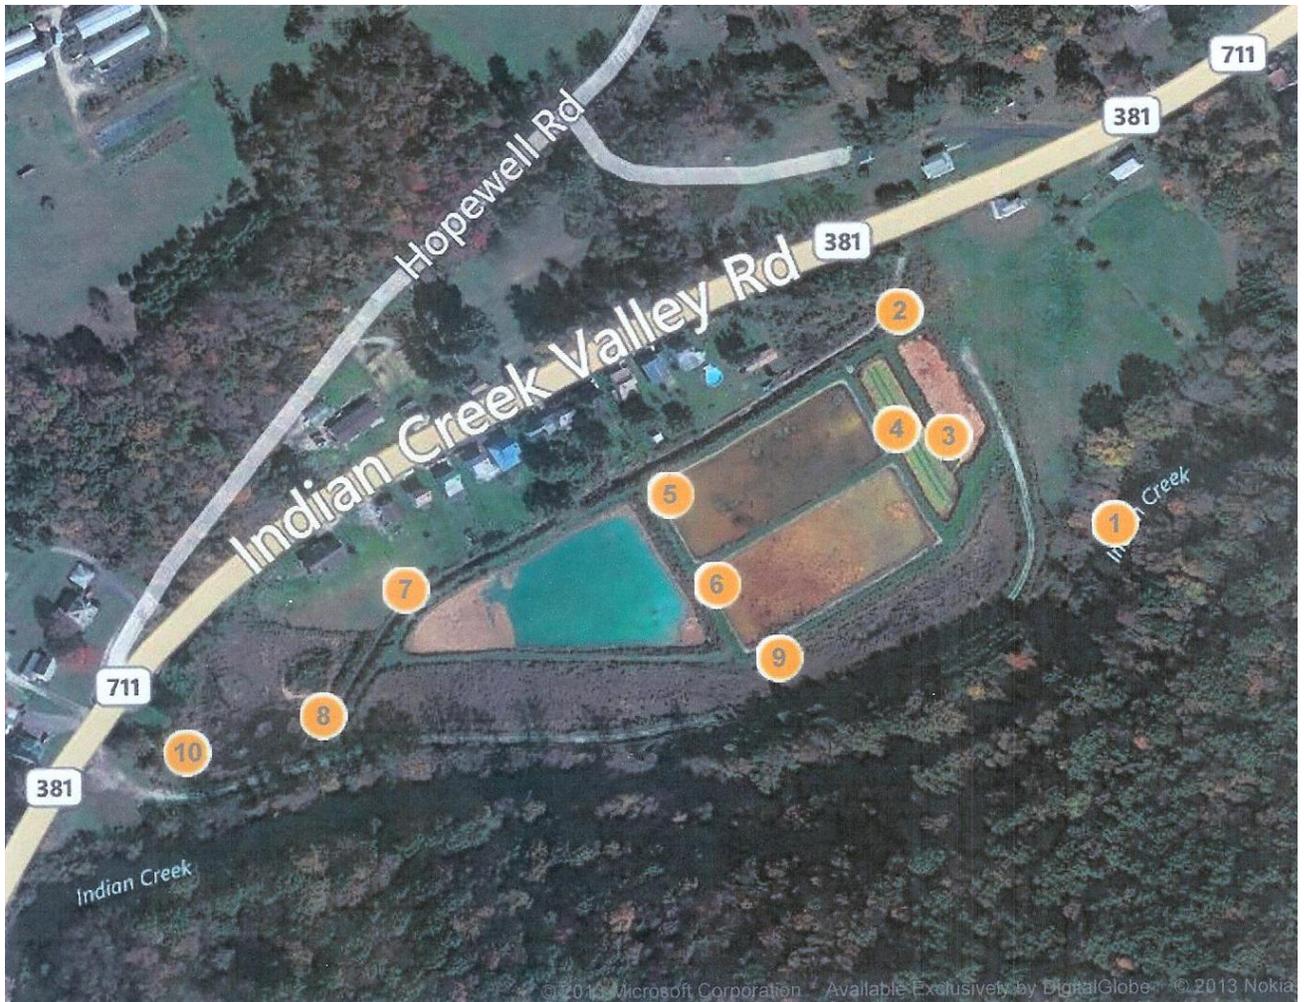
KALP TREATMENT SYSTEM

1. **IC 4** – *Indian Creek above treatment system*
2. **KALPDBRAW** – *Raw sample from directional boreholes before any treatment occurs*
3. **VFW1** – *the effluent to vertical up-flow pond before it enters the first settling basin*
4. **SB1** - *Outlet pipe from settling basin #1*
5. **VFW2** - *Outlet pipe from vertical flow wetland #2*
6. **VFW3** - *Outlet pipe from vertical flow wetland #3*
7. **SB 2** – *Effluent pipe from Settling Basin #2*
8. **COMBOUT** – *Combined effluent of system and bypass*
9. **MITWET2** – *Mitigation wetland 2 near vertical flow ponds*
10. **MITWET1** – *Mitigation wetland 1 lower end of site*
11. **IC-5** – *Indian Creek at Sagamore Bridge*
12. **IC 6** – *Indian Creek at Resh Park before confluence with Back Creek*

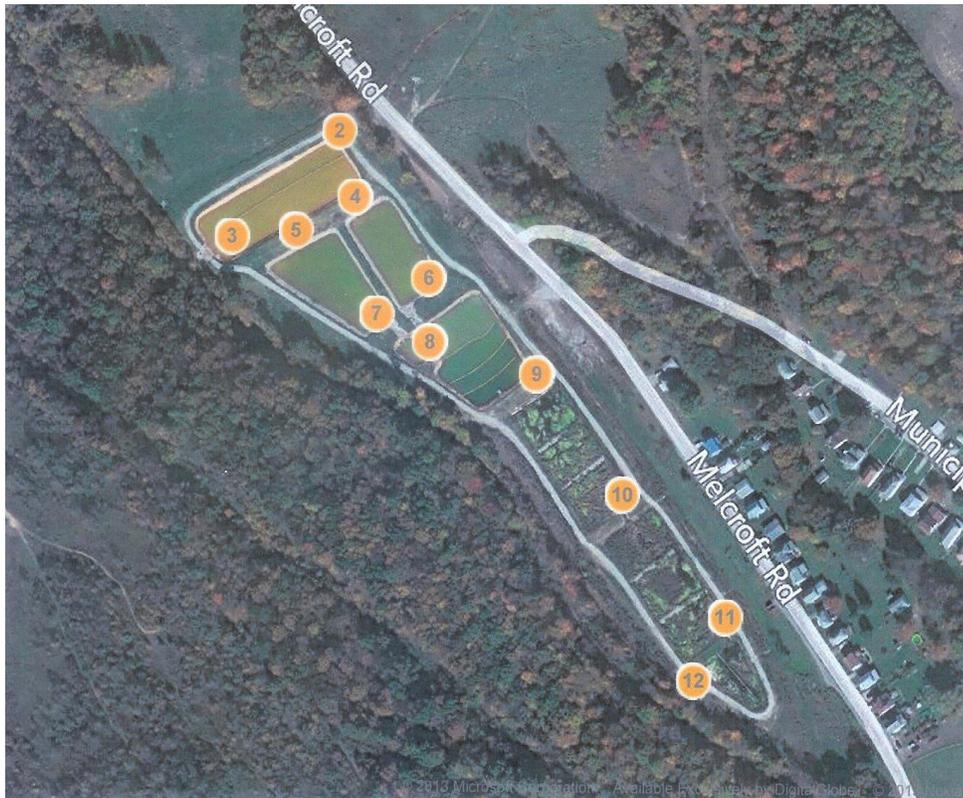
MELCROFT TREATMENT SYSTEM

1. **ChampUS** – *Champion Creek approximately 150 yards above treatment system*
2. **3PONDINL** – *System influent from directional boreholes at dock*
3. **NEWKALP** – *System influent on far side of the collection pond*

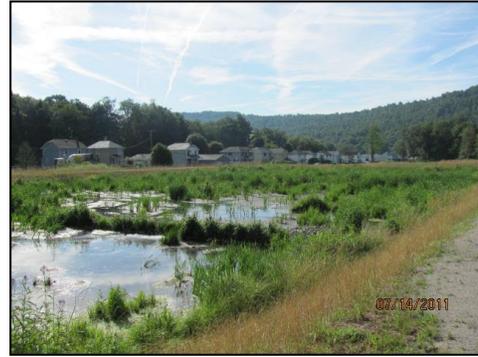
The aerobic wetland section of the Melcroft Treatment System

The mine drainage enters the Melcroft treatment system at the collection pond and is then slowly transported to one of the two vertical flow ponds. From there the water goes into the settling pond. After the settling pond the discharge is further treated as it passes through two aerobic wetlands before going through its final treatment phase in the manganese removal bed. It is then discharged into Champion Creek. This project is unique in that an informational trail around the treatment ponds and restored railroad trestle provide ready access for both monitoring and for the public to see how the system functions.

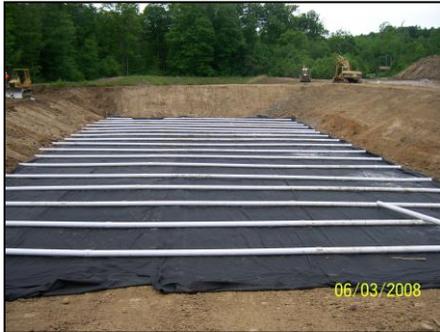
The underlying piping in the first phase of treatment in the system

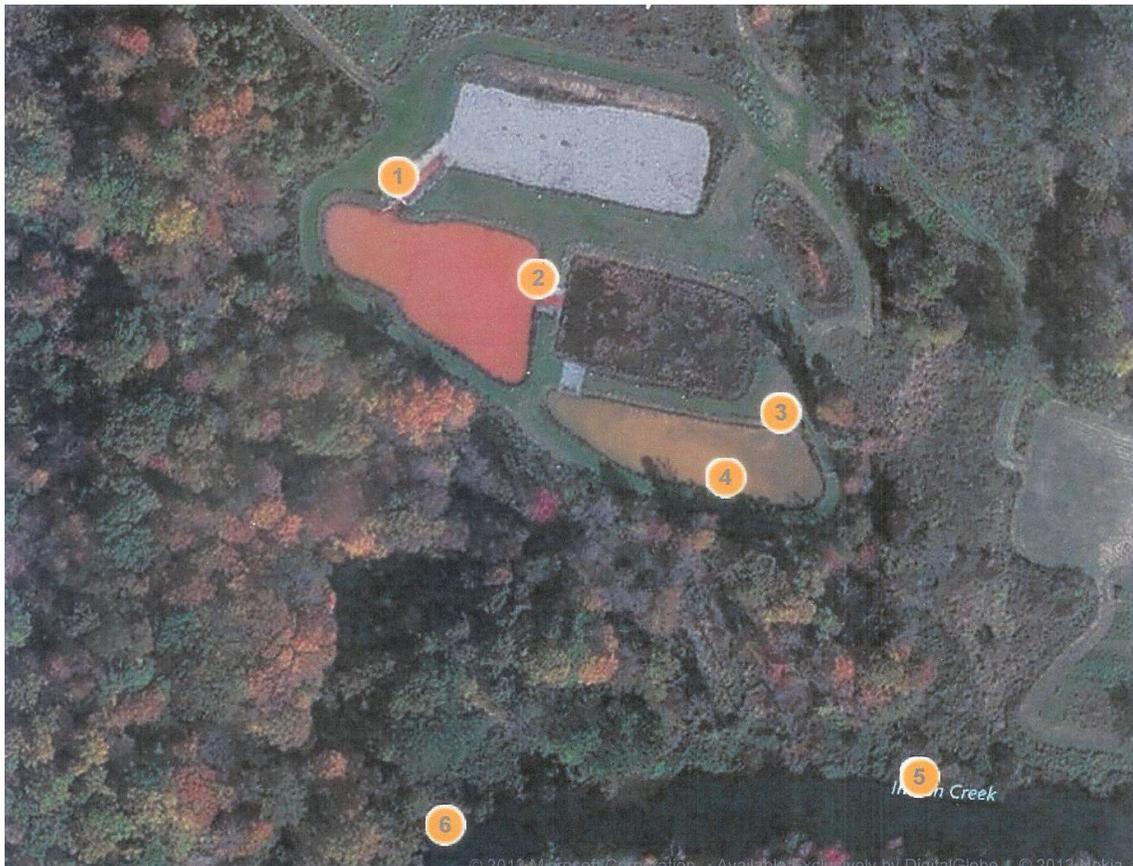
GALLENINE TREATMENT SYSTEM

1. **GALUP** - *Effluent of first pond at the H flume*
2. **GALSED** - *Rock apron below sediment pond*
3. **GALDOWN** - *Pipe outlet from vertical down-flow pond*
4. **GALOUT** - *System effluent pipe at bottom of access steps*
5. **IC 7** - *Indian Creek upstream of Treatment system*
6. **IC 8** - *Indian Creek below Treatment System and before confluence with Polar Run*

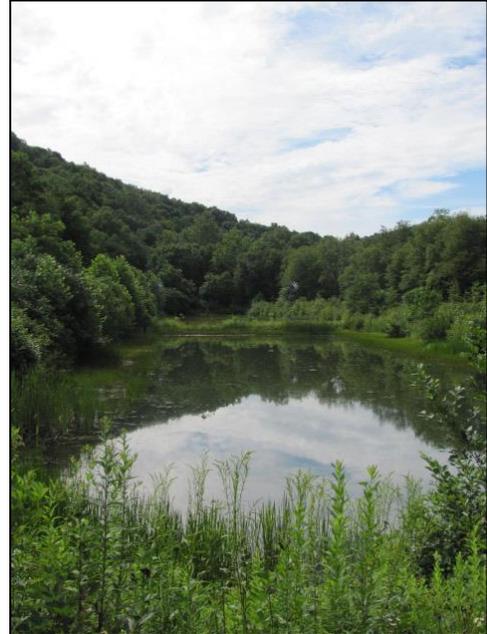
The Max B. Nobel Abandoned Mine Drainage Treatment System also known as the Sagamore Treatment System

The system was built between September 1999 and March 2001. It contained two catch basins located north and south of the ponds. The discharges were unique because one was alkaline while the other was acidic. The two discharges were both piped into the first pond where the discharges treated each other with additional help from windmill aerators, which were installed to increase oxygen levels. This helps to remove the iron and acid from the water. The mine water leaves the first basin, with a pH of 6.2 to 6.8, and enters the second basin where the iron is given additional time to settle out before the system discharges into Indian Creek. Water is discharged with a pH of 6.5 to 6.9.

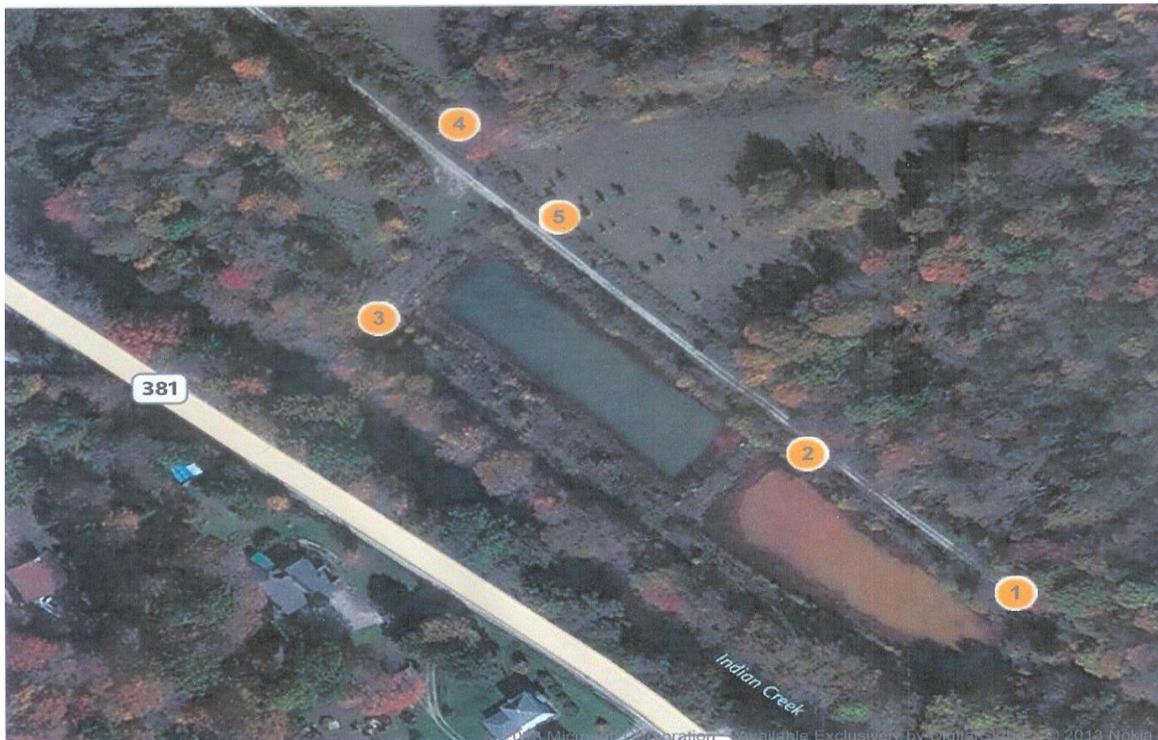
SAGAMORE TREATMENT SYSTEM

1. **SAGLARGE** - Large raw discharge entering the first pond
2. **SAGSMALL** – Small raw discharge entering the first pond near its effluent
3. **SAGOUT** – Final effluent from the treatment system
4. **SAGALD** – Anoxic limestone drain sample collected before it unites with the ditch discharge and flows under the Indian Creek Valley Trail
5. **SAGDITCH** - Ditch discharge along the Indian Creek Valley Trail

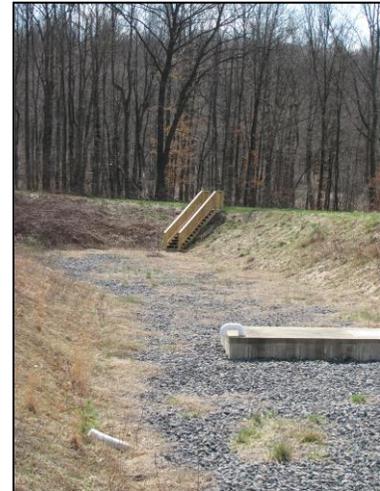
Upper portion of the Permapress Treatment system

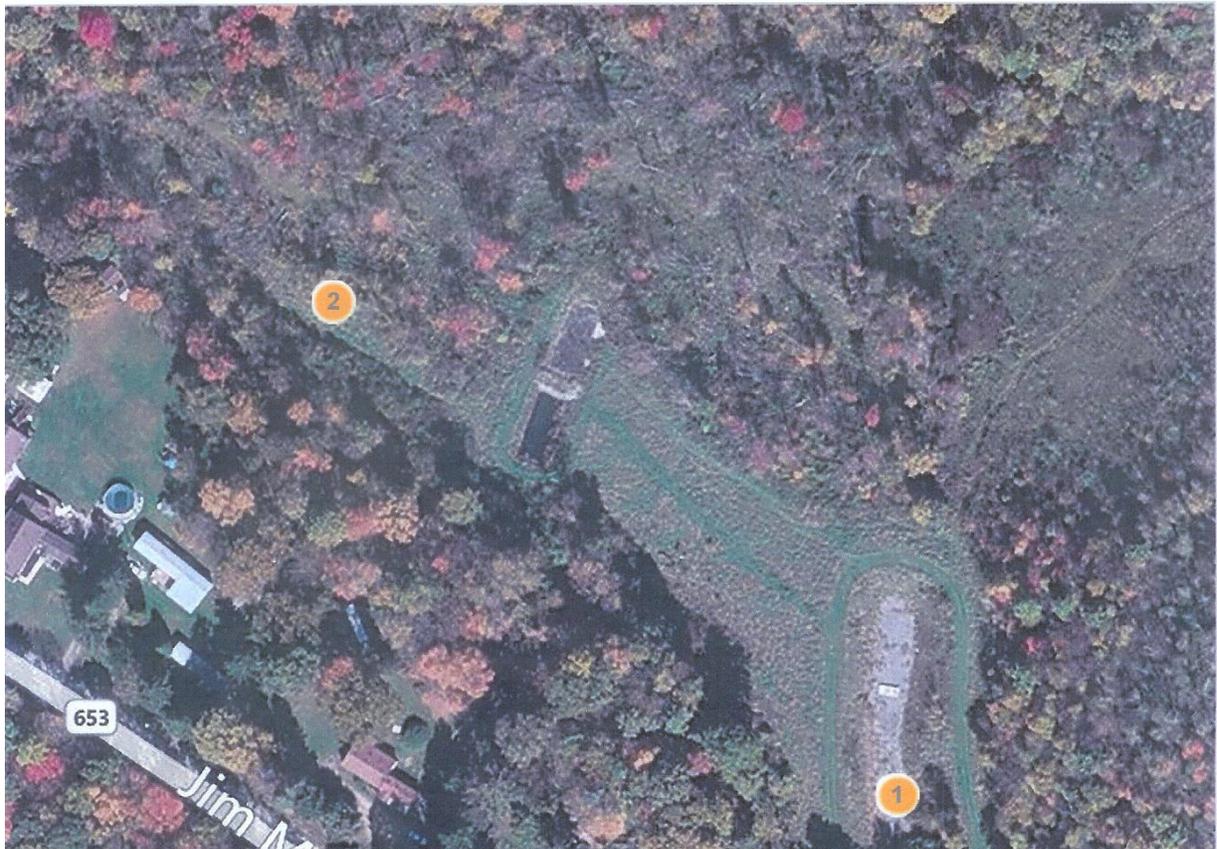
PERMAPRESS TREATMENT SYSTEM

1. **PERMIN** –Raw discharge entering in the top corner of the treatment system.
2. **PERMOUT** –Final effluent of the system, which lies 150 feet beyond the lower pond.

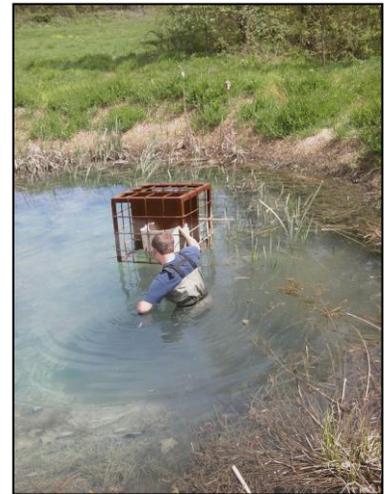
2011 Summer Intern unclogging the final effluent drain in the final pond at the Permapress Treatment system

The Mountain Watershed Association is responsible for all maintenance activities. Maintenance activities include vegetation control, maintaining outlets of pipes, cleaning the siphon, and repairing any damage caused by vandals or natural vectors. Occasionally the drain in the lower pond that discharges the final effluent becomes clogged and needs to be cleaned out. This can be done by wading or kayaking into the pond and unclogging the small hole located below the half piece of PVC pipe that is attached to the larger pipe.

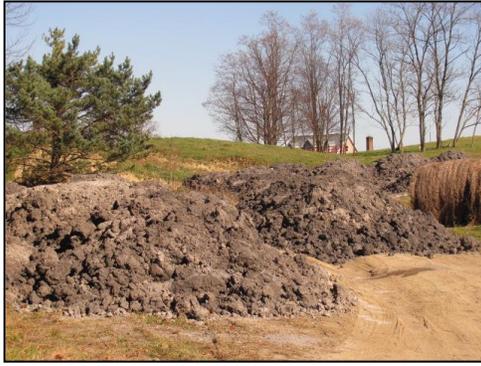
Land liming staging area at one of the sites in the Poplar Run project area

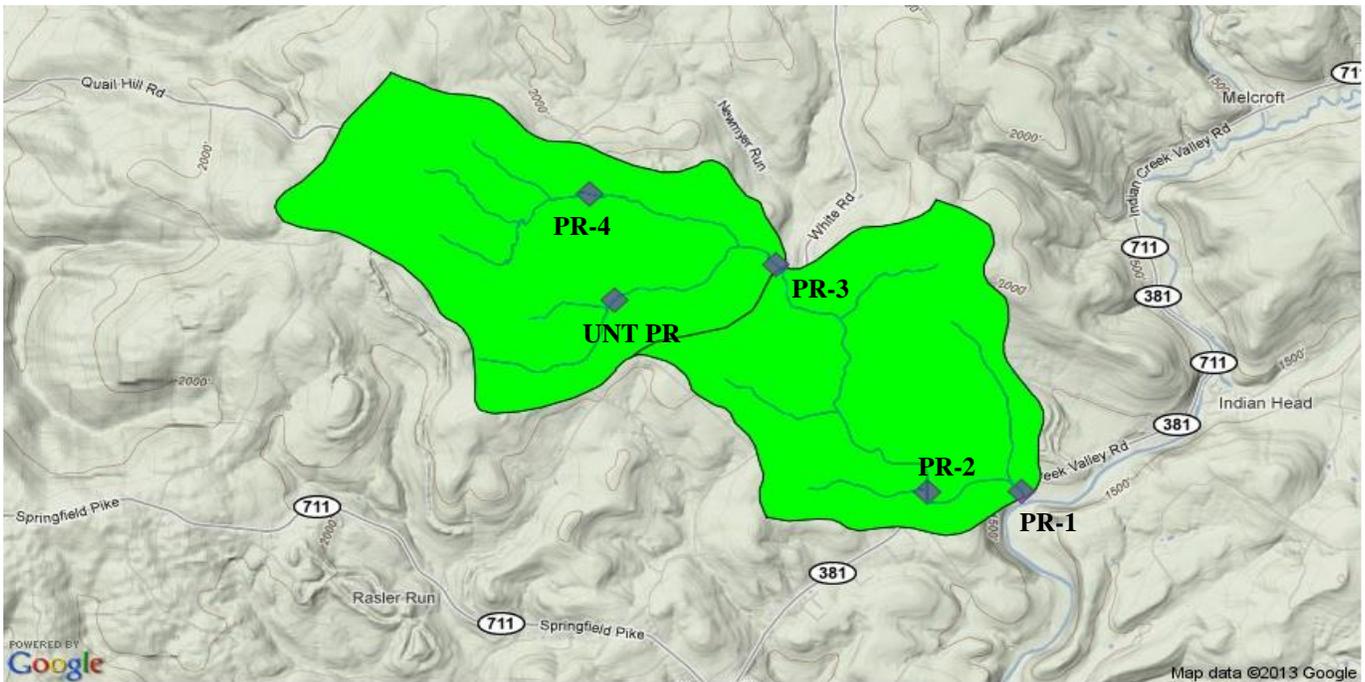
Poplar Run Monitoring Locations

Chemical water samples will be collected quarterly for the first two years following the lime application and then bi-annually for the next eight years. Samples will be collected following DEP's water monitoring protocol identified in Appendix A.

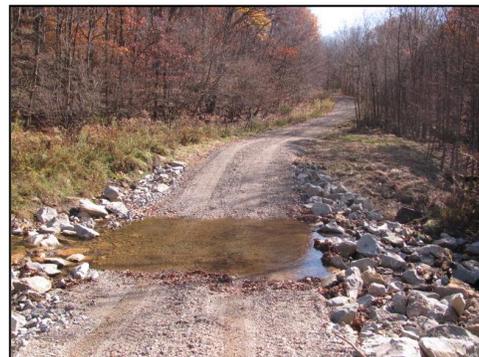
The completed access road and stream crossing

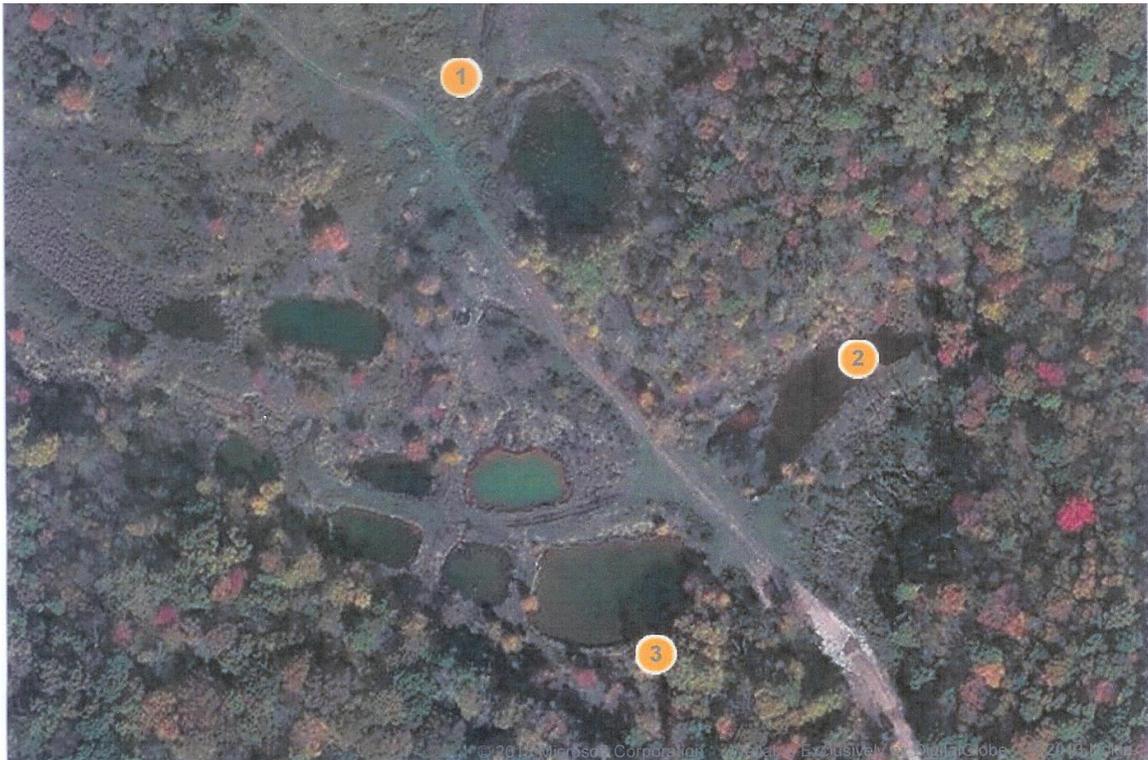
MARSOLINO-LEIGHTY DISCHARGE

1. **MRD** – Raw discharge approximately three quarters of the way up the hill on the right hand side before it enters the culvert that flows under the access road
2. **MSD** – Effluent of the sump discharge by walking along the barbed wire fence on the right hand side of the access road, as you're going up the hill, just after crossing the ford
3. **MPD** – Discharge pipe coming out of the final pond discharge. The final pond is located on the left hand side of the access road, just after crossing the ford on your way up the hill

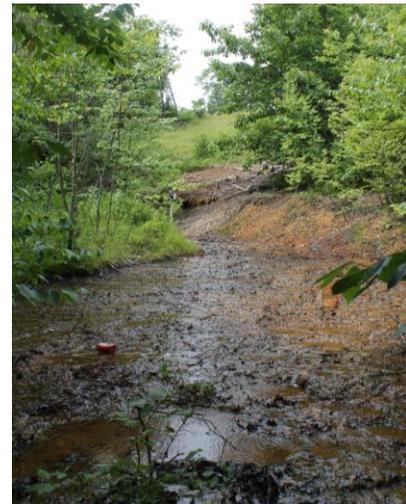
Discharge from the Rondell-Correal Mine site along Knopsnider Rd

Located on the western edge of the Indian Creek watershed, the Rondell-Correal discharge impacts the Newmyer Run subwatershed of Poplar Run. The discharge is released from the Rondell strip mine operation that mined the Middle Kittanning and Brookville-Clarion coals. Low wall clay sealing technology was used to trap water into the backfilled strip mine pit in order to reduce oxygen levels with the intention of a lowering acid production. However, the clay had a high aluminum content, which caused high levels of acidity to be produced. The acidity levels in the discharge range from 908 to 1,188 milligrams. Iron levels range from 61 to 123 milligrams per liter while aluminum ranges from 68-124 mg per liter. This discharge has the most degraded water quality in the Indian Creek watershed. The flow rate varies at the site from 2 gallons per minute during low flow to 45 gallons per minute during times of high flow.

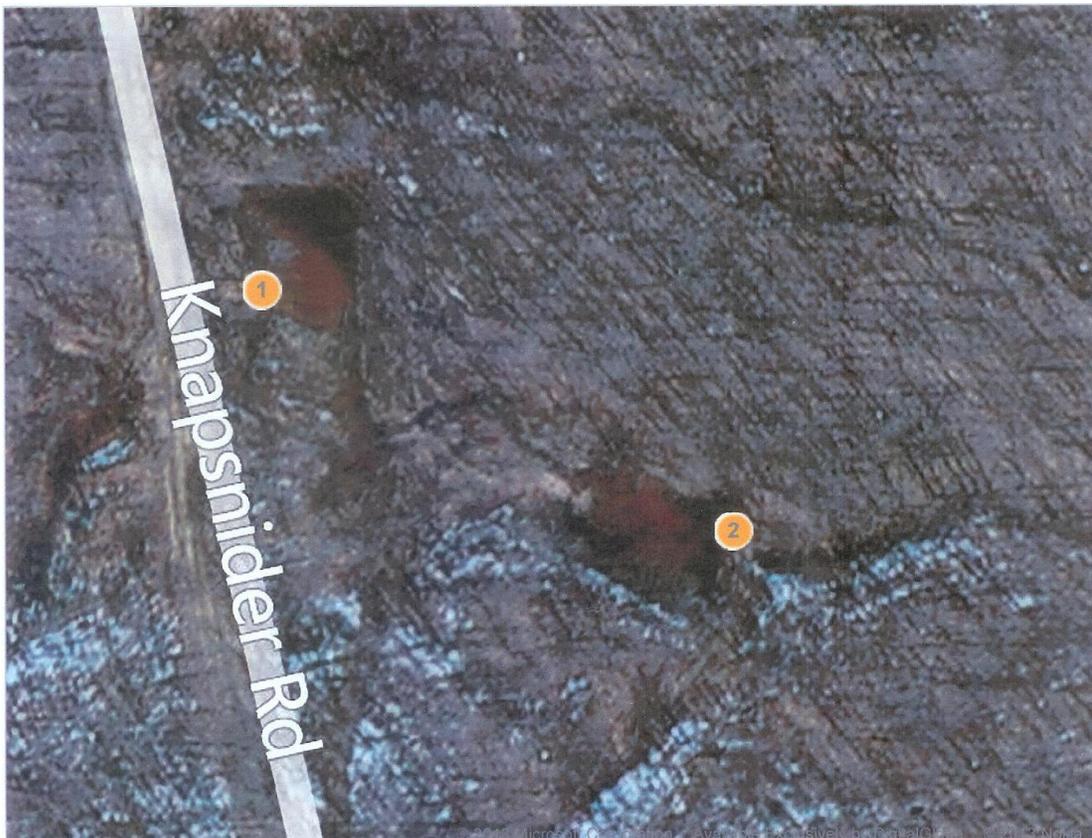
RONDELL-CORREAL DISCHARGE

- 1. DRAIN** – *Spoil drain pipe, next to the road*
- 2. FPO** – *Outlet of the final pond*

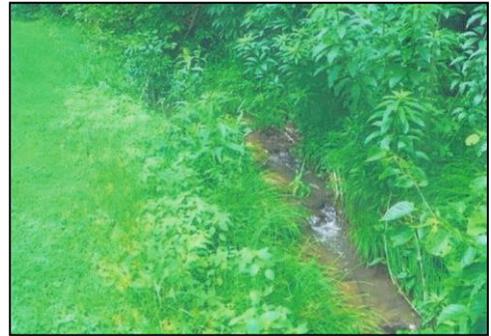
Before (top) and after (bottom) streambank stabilization project

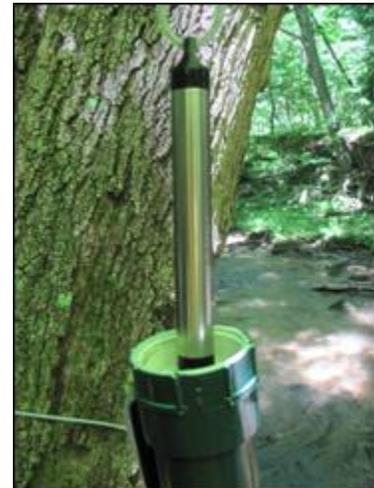
Vertical datalogger installation

Solinist Jr. LTC leveloggers were purchased and installed beginning in 2011. These dataloggers monitor conductivity, temperature, and water level of the stream

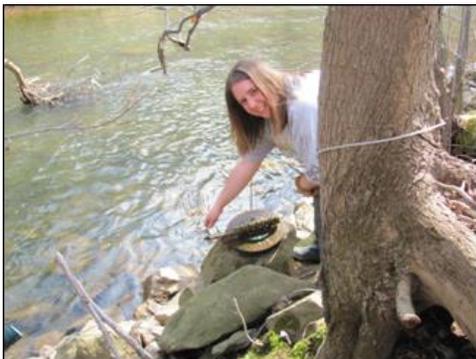
A horizontal datalogger installation

The dataloggers are placed in waterways which have been identified as potential locations for Marcellus shale development based upon permitting, drilling, leasing, and the locations of natural gas pipelines. The coalition currently has 93 dataloggers installed; of these, MWA is responsible for maintaining 28 dataloggers.
